This is a repository copy of *Bond of textile-reinforced belite calcium sulfoaluminate cement mortar to concrete substrate*.

# Bond of textile-reinforced belite calcium sulfoaluminate cement mortar to concrete substrate

**Abstract** The fast aging of existing building stock requires effective and sustainable strengthening solutions. Textile-reinforced mortars (TRM) have already proved to be very effective as well as versatile retrofitting solutions for reinforced concrete and masonry structures. TRMs can enhance the load bearing capacity of reinforced concrete structures; however, current TRM systems are based on standard Portland cement-based binders, which largely contribute to global human-induced CO<sub>2</sub> emissions. This work, for the first time, explores the use of belite calcium sulfoaluminate (BCSA) binder for carbon textile reinforcement through a cross-disciplinary study combining structural engineering and materials science. An experimental study was carried out on concrete block members with externally bonded strips of

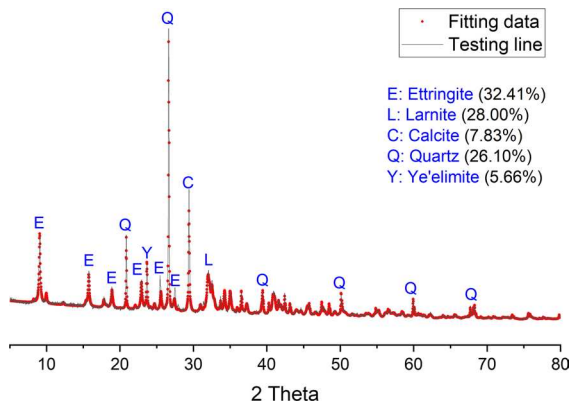
**Fig. 8** The XRD curve of BCSA mortar

BCSA-based composite were studied via X-Ray diffraction analysis (XRD), and Rietveld analysis was conducted using the phases shown in the Supplementary Materials. The fitting curve and relative phase contents are shown in Fig. 8. It should be noted that Rietveld analyses does not account for any amorphous/gel phases such as AH<sub>3</sub> or calcium silicate hydrates (C–S–H) formed in the specimen, and the quantity of sand in the specimens leads to an inaccuracy in the amorphous calculation. Hence, the XRD data can only calculate the relative content of crystal phases in BCSA mortar. Figure 8 shows that belite (larnite) was identified because of its low hydraulic reactivity. In addition, a high amount of ettringite, which is the main hydration product of calcium sulfoaluminate cement (CSA), was found in the specimen at age of testing. No stratlingite and calcium aluminate monosulfate (Afm) was detected.

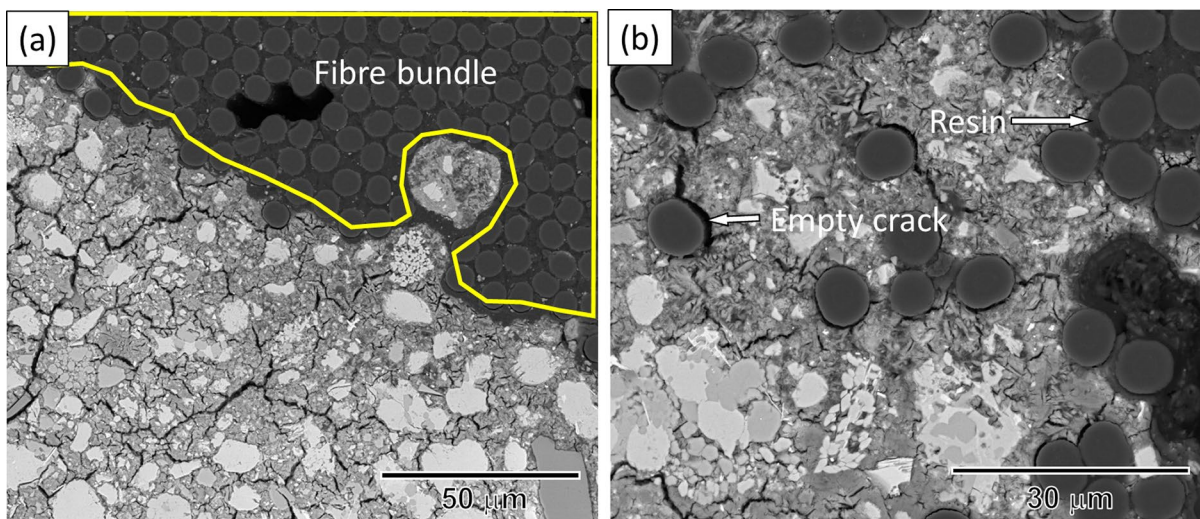
The bond properties of the BCSA-based composite are shown in Fig. 11. Similar to the case of the OPC-based composite, the BCSA binder was unable to penetrate inside the fibre bundle enclosed within the yellow boundary lines shown in Fig. 11a. Compared to the OPC binder, more micro cracks were found in the hardened mortar, but no resin was found in these cracks indicating the cracks

**Fig. 11** The BSE images of sections of BCSA

developed after the epoxy impregnation process. The polished sample was placed in a desiccator with silica gel inside for a few weeks before SEM testing to stop the hydration process, which could cause some cracks due to the dry environment. Bizzozero et al. [43] found that the drying process can lead to such cracks in the CSA samples, hence, some of the cracks around the fibres shown in Fig. 11a and b could have been developed upon drying.

Despite the above, the BCSA composite showed enhanced bond performance, which effectively engaged more fibres and shifted the failure from the mortar-textile interface to the mortar-concrete interface and further to the textile itself for larger bond lengths. As can be seen in Fig. 11, fewer voids could be identified at the edge of the fibre bundle and mortar paste was more adjacent to the fibres, thus

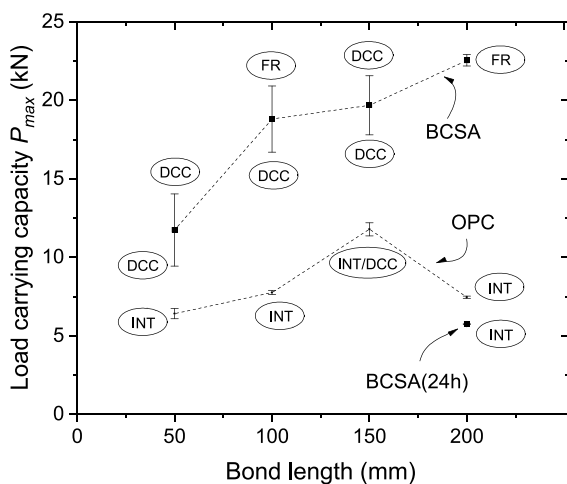
The effect of the bond length on the peak load capacity of the TRM is shown in Fig. 14. Past research demonstrated that the bond behaviour of FRP and TRM strips is characterised by a specific behaviour highly affected by the composites' material properties; after a certain bond length, the axial force in the composite strip (which is equal to the anchorage force) tends to reach an almost constant value which is considered as the maximum anchorage force [51], while especially for TRMs it keeps increasing with low stiffness linear indents after

**Fig. 14** Effect of bond length on the load bearing capacity (with the corresponding failure modes). The bars represent the range of the results

reaching the effective bond length, [52]. The results of the OPC series showed that the increase in the bond length led to a non-linear increase in the load capacity, which is in agreement with the observations from past experimental studies [17, 19, 20, 22]. The only exception to this was the case of the twin specimens OPC\_3C\_200\_1&2, which exhibited significantly lower load capacity compared to the specimens with the bond length equal to 150 mm. Although the load bearing capacity should not decrease with the increasing bond length, the scatter in such tests can be considerable, especially when different failure modes are present. The drop in the load capacity between the bond lengths 150 mm and 200 mm can be attributed to the slightly different failure modes. OPC\_3C\_150\_1&2 were the only ones from OPC series that showed mixed failure modes involving interlaminar failure (INT) and failure at mortar-concrete interface (DCC). On the other hand, OPC\_3C\_200\_1&2 failed due to interlaminar shearing between the textiles and the mortar on the non-test side (300 mm). The failure on the longer non-test side indicated that effective bond length was already developed also on the test-side, and the failure could occur on either side, whichever has poorer bond. As such, the scatter between these two pairs of samples can be either a product of poor level of the fibre impregnation through the textiles (for OPC\_3C\_200\_1&2) or exceptional bond to the substrate (for OPC\_3C\_150\_1&2). Based on the tests carried out on the OPC series, it can be concluded that effective bond length was somewhere between 100 and 150 mm, and such bond lengths allowed to approach the failure related to the concrete substrate.

The BCSA series showed a clear trend of load capacity increase with increasing bond length until reaching the fibre rupture (FR). The longer the bond length, the larger the load capacity and fibre utilisation. With the increasing bond length, more concrete was engaged in resisting bond stresses and, hence the failure shifted from the concrete to the textile. A larger scatter between two identical tests was observed compared to the OPC series, but this was due to the involvement of two different failure modes at the same bond length, which indicates that between certain bond lengths the concrete substrate was mobilised to a different extent, and the longer the bond length the more textile engagement can be expected. The failure due to the fibre rupture was already seen

for 100 mm bond length (BCSA\_3C\_100\_1), with the other twin sample failing due to DCC at a lower load. A clear result was seen for 200 mm bond length, at which both twin specimens failed due to FR at similar load levels. Hence, despite some mixed failure modes, the anchorage force could already develop at 100 mm bond length, at an even shorter length than for the OPC binder.
