PHYSICAL ENVIRONMENT OF CAMP MABRY, AUSTIN, TEXAS

E. G. Wermund and Arten J. Avakian

Texas Army National Guard

June 1994

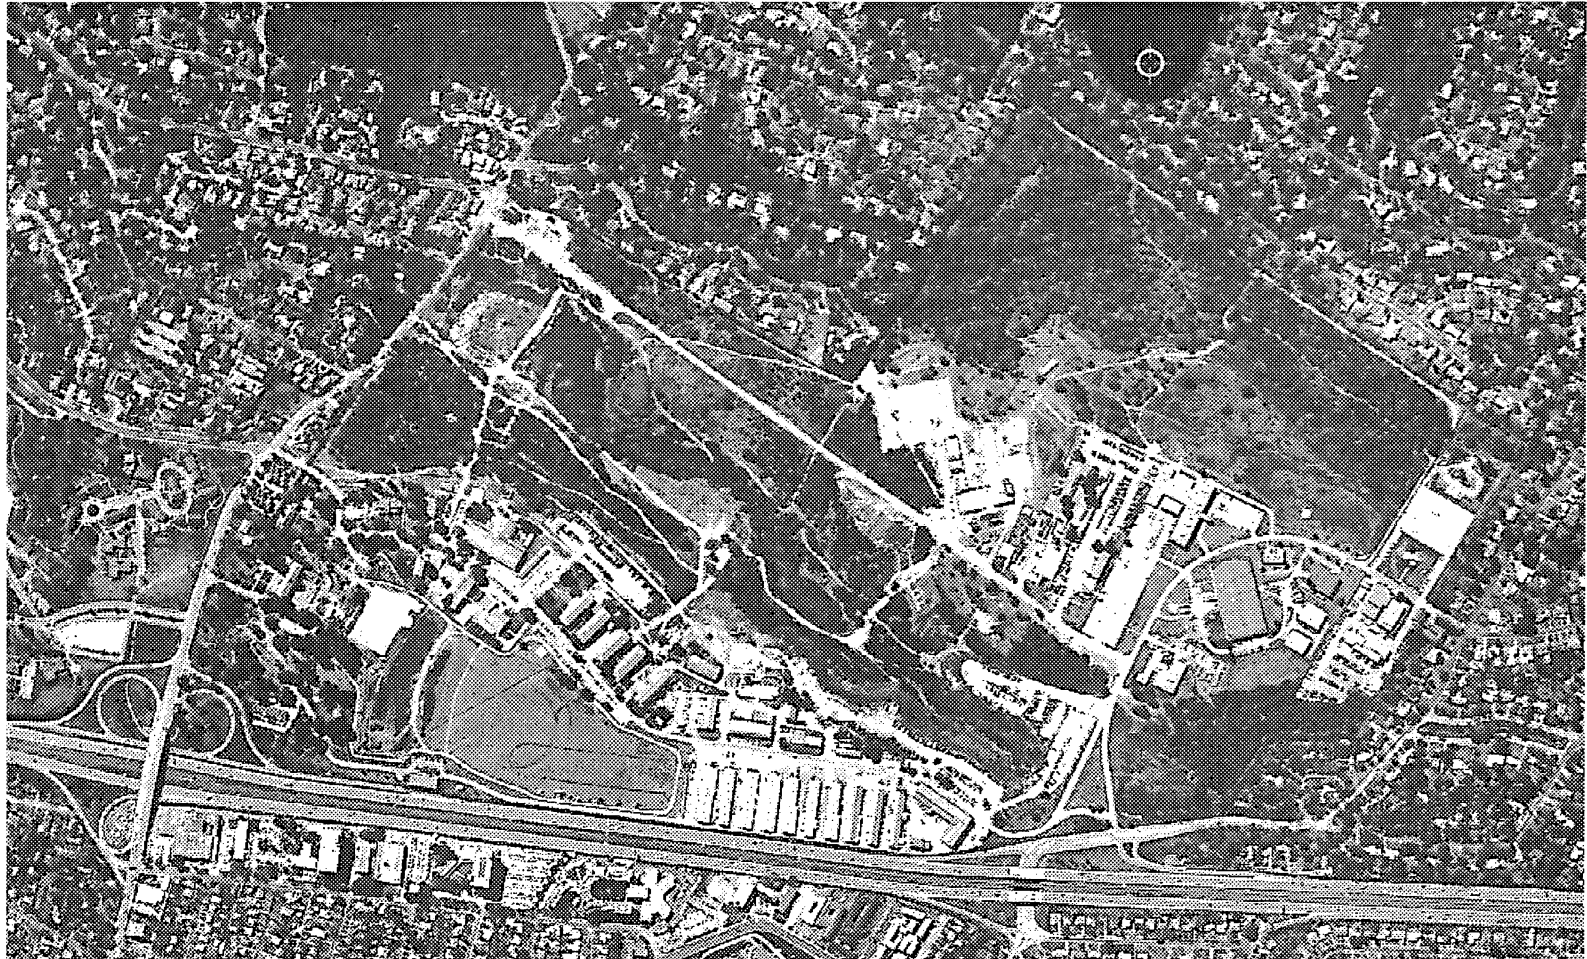
Plate 1. Aerial photograph of Camp Mabry. Concentrations of tall trees are most prominent on the northwestern property line boundary and in the easternmost drainage.

Little natural area remains on site; most of the camp area has been cleared at least once, as is readily seen on an aerial photograph (pl. 1). More than 60 percent of the area is both landscaped and regularly mowed. Old and modern fills modify the natural slopes. Natural areas are riparian strips along streams flowing across the camp in the northwest third and southwest corner of the property. In the northwest third of the property, a heavy second growth of large trees occupies east-sloping hillsides. In landscaped areas, large live oak trees remain common on the site and have grown unnaturally large from access to constant water supply and applied fertilizers.
