# **Strength and Deformation Properties of Tertiary Clay at Moesgaard Museum**

**DCE Technical Report No. 103**

The tertiary clay at Moesgaard Museum near Aarhus in the eastern part of Jutland in Denmark is a highly plastic, glacially disturbed nappe of Viborg Clay. The clay is characterised as a swelling soil, which could lead to damaging of the building due to additional heave of the soil. To take this characteristic, as well as the strength and deformation properties, into account during the design phase, two consolidation tests and one triaxial test have been conducted. This paper evaluates the results of the laboratory tests leading to the preconsolidation stress, the deformation parameters consisting of the swelling pressure, the constrained modulus and the compression index, and the strength parameters comprising the undrained shear strength, the drained shear strength and the effective angle of internal friction.

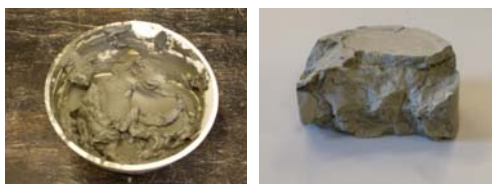
**Figure 3:** Homogenised soil used for the classification tests (left) and traversed dried soil specimen used in the first consolidation test (right).

Samples of the clay can be seen in Fig. 3. Both a homogenised, wet sample used for the classification tests and the dried, traversed soil specimen for the first consolidation test is shown.

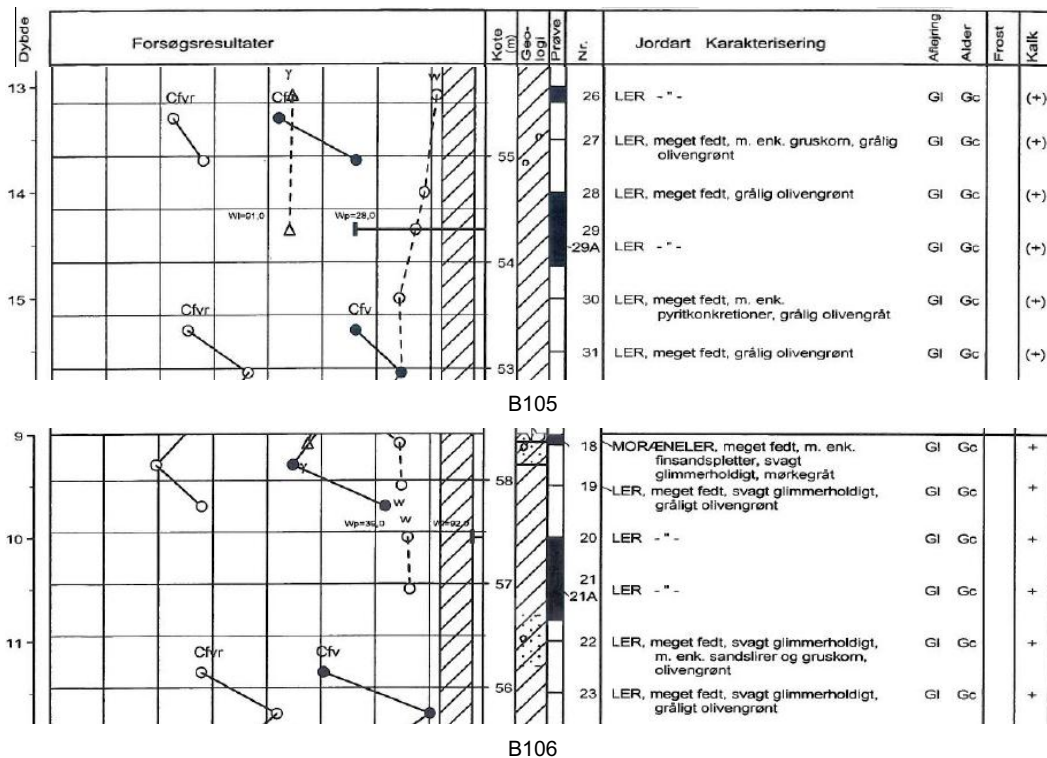
Figure 4: Segments of boring records B105 and B106 in depths of the soil specimens (29 and 21, respectively).

nection with the laboratory tests. Boring B106 is more sandy than boring B105. Segments of the boring records in the depths of the soil specimens can be seen in Fig. 4.

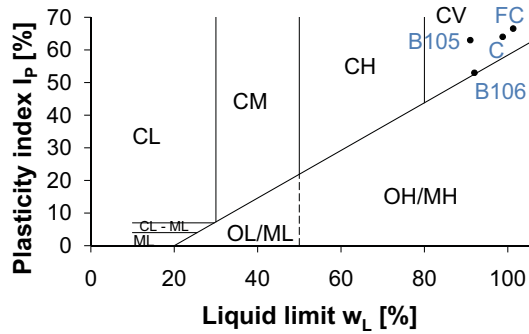
**Figure 5:** Classification of the tertiary clay at Moesgaard Museum according to the Casagrande Chart. *FC* is fall cone and *C* is Casagrande. According to Krebs Ovesen et al. (2007, Fig. 1.13).

The results of the Casagrande method and the fall cone method differ about 2–9 %, cf. Fig. 5.

The liquid limit and the plasticity index determined by the two boring records and the mean values of the laboratory tests are plotted according to the Casagrande Chart, cf. Fig. 5.

Hence, the clay is characterised as very high plasticity clay marked by *CV* in the figure in accordance to the geological description of the boring records. For comparison, the classification of Søvind Marl and Little Belt Clay are plotted in Fig. 6 together with the tertiary clay at Moesgaard (Johannesen et al., 2008; Thøgersen, 2001).

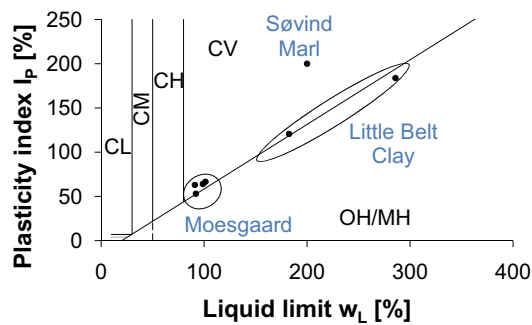
**Figure 6:** Classification of Søvind Marl, Little Belt Clay and the tertiary clay at Moesgaard Museum according to the Casagrande Chart. According to Krebs Ovesen et al. (2007, Fig. 1.13).

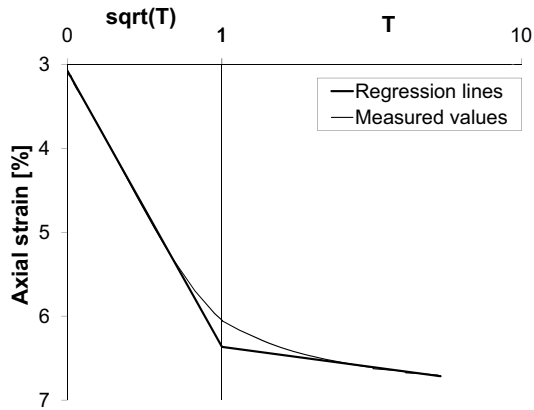
**Figure 7:** Strain–time curve for load step 6.  $T = 1$  is after about 0.5 day and the final  $T$  is after two days.

To ensure that secondary consolidation has occurred, the duration of each load step is two–three days depending on the progress of the strain–time curve. For example, the strain–time curve for load step 6, which is an increase of the loading from 600 kPa to 1200 kPa, can be seen in Fig. 7. The duration of the load step is two days by which the progress of the secondary consolidation can be described by a linear regression line.

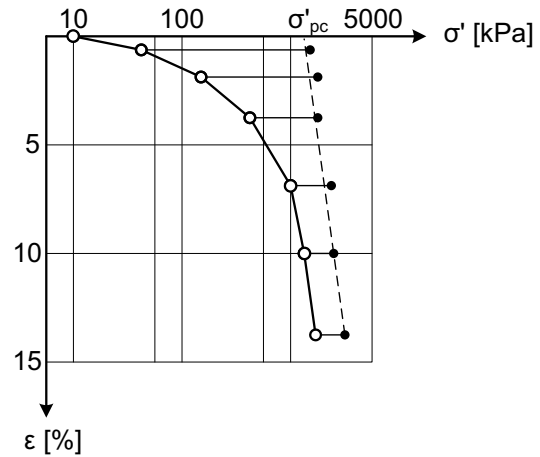
**Figure 8:** Determination of the virgin curve (the dashed line) used for Terzaghi’s method.

Where  $C_{c\varepsilon}$  is the compression index,  $\sigma'_k$  is a reference stress and  $\varepsilon_0$  is the start value of the consolidation strain (not equal to the initial strain  $\varepsilon_i$ ). The reference stress  $\sigma'_k$  is the addition to  $\sigma'$  by which the primary path gets linear in a semi-logarithmic depiction, named the virgin curve, cf. Fig. 8.

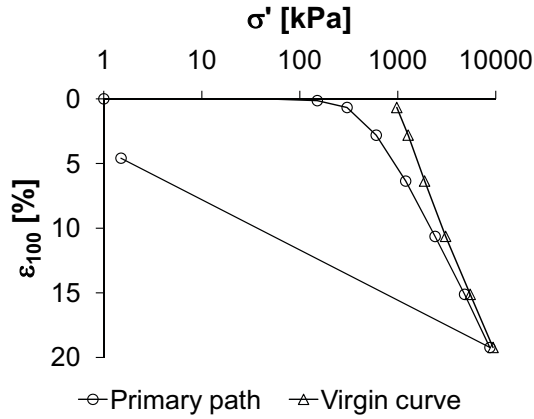
**Figure 9:** Primary path and virgin curve of the first consolidation test.

The primary path and the virgin curve of the load–displacement curve can be seen in Fig. 9.

The preconsolidation stress is found to  $\sigma'_{pc} = 1350$  kPa which implies an overconsolidation ratio of approximately  $OCR = 6.8$ . Additionally, estimations based on Akai’s method, Janbu’s method and the coefficient of consolidation, cf. Figs. 10–12, have been investigated leading to  $\sigma'_{pc}$  in the range 1200 – 1800 kPa.

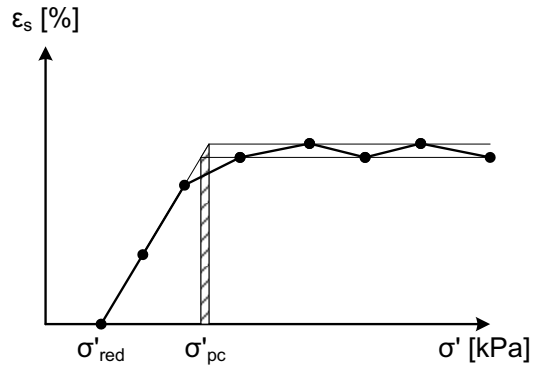
**Figure 10:** Akai's method of determining  $\sigma'_{pc}$ .  $\sigma'_{red}$  is the lowest effective stress of the soil. According to Moust Jacobsen (1993, Fig. 5.13).

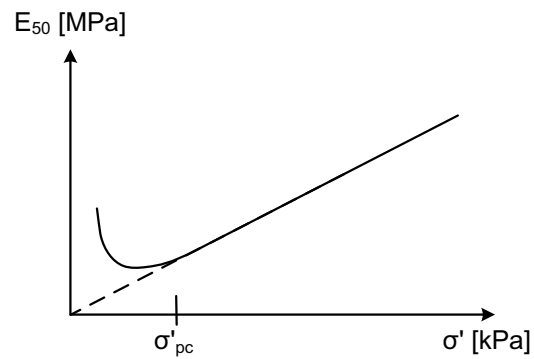
**Figure 11:** Janbu's method of determining  $\sigma'_{pc}$  based on the secant modulus  $E_{50}$ .

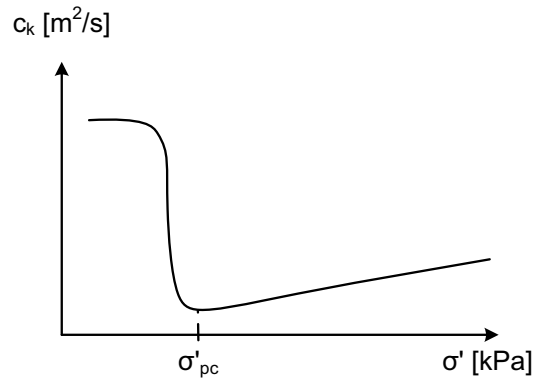
**Figure 12:** Determination of  $\sigma'_{pc}$  based on the coefficient of consolidation  $c_k$ . According to Thøgersen (2001, Fig. 5.9).

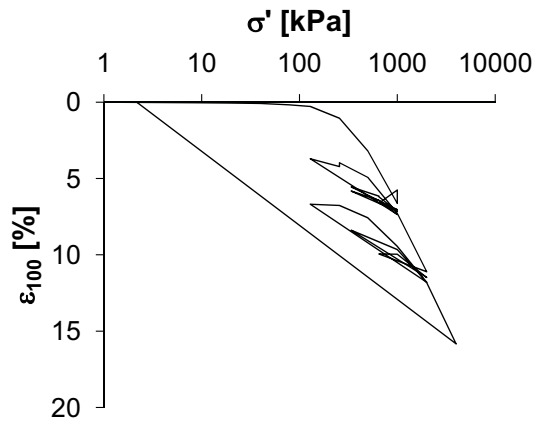
**Figure 13:** Primary path and unloading/reloading paths of the second consolidation test.

The primary path of the second consolidation test can be seen in Fig. 13.

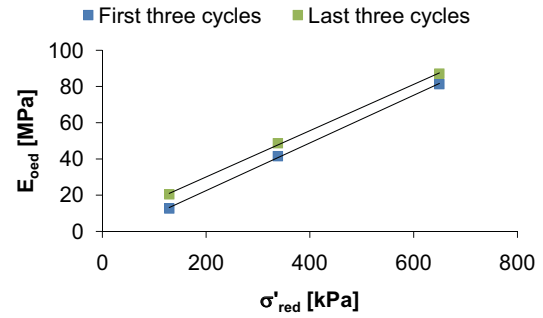
**Figure 14:** Initial slopes for the first three cycles and the last three cycles based on the first and last points of each reloading path.

As an approximation of the constrained modulus, a linear regression between the first and last points of each reloading path is applied. This leads to the relation in Eq. 5 for the first three cycles and in Eq. 6 for the last three cycles, cf. Fig. 14.

$$E_{oed,1} = -3818 + 132 \cdot \sigma'_{red} \quad [\text{kPa}] \quad (5)$$

$$E_{oed,2} = 4560 + 128 \cdot \sigma'_{red} \quad [\text{kPa}] \quad (6)$$

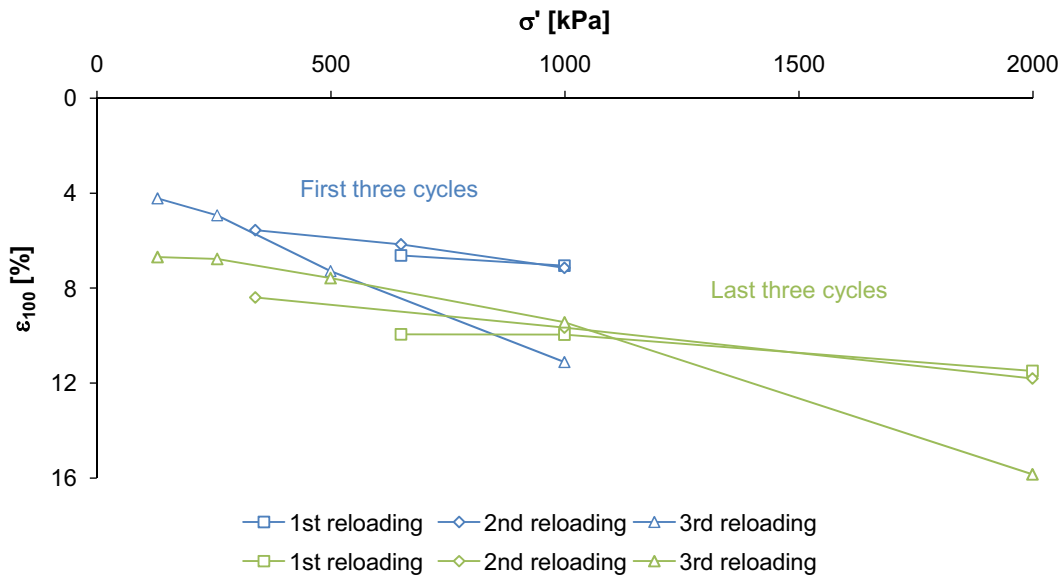
Figure 15: Reloading paths for the second consolidation test.

The reloading paths can be seen in Fig. 15. As seen in the figure, the magnitude of  $E_{oed}$  for each reloading path depends on the choice of considered points. Choosing for example the first two points of the first reloading path for the second three cycles, i.e. (650 kPa, 9.9 %) and (999 kPa, 10.0 %), leads to  $E_{oed} = 1748$  MPa, whereas the first and last point of this reloading path, i.e. i.e. (650 kPa, 9.9 %) and (1999 kPa, 11.5 %), leads to  $E_{oed} = 87$  MPa. The constrained moduli for alle parts of the reloading paths are listed in Tab. 3.

As seen in Fig. 15 and Tab. 3, the constrained modulus depends significantly on the investigated stress level. Hence, multiple relations based on Eq. 4 for different stress levels could be a method of obtaining realistic values of  $E_{oed}$  in the future.

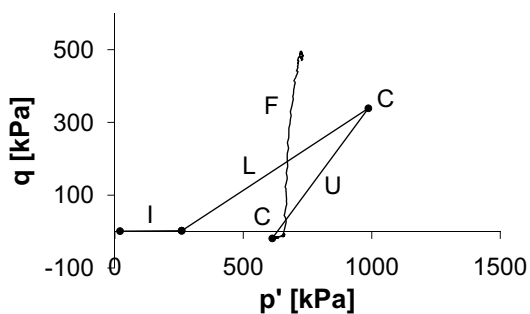
Figure 16: The effective mean stress  $p'$  as a function of the deviatoric stress  $q$ . I: Installation, L: Loading, C: Consolidation, U: Unloading, F: Failure.

The strength properties of the tertiary clay at Moesgaard Museum are determined by a  $CAU_{u=200}$  triaxial test with  $H = D = 70$  mm and smooth pressure cells. The test is conducted according to Laboratoriehåndbogen (DGF's Laboratoriekomité, 2001). The loading phase is conducted as an anisotropic loading controlled by the coefficient of horizontal earth pressure at rest  $K_0$ . The specimen is unloaded with constant  $K_0$ . The effective mean stress  $p'$  as a function of the deviatoric stress  $q$  can be seen in Fig. 16.

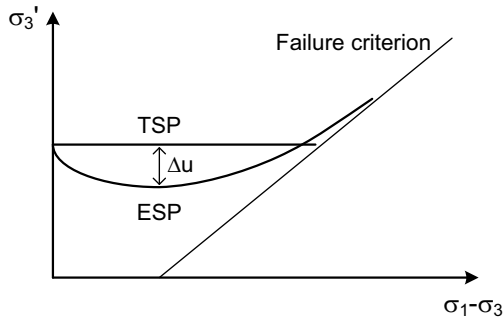
**Figure 17:** Total stress path (TSP), effective stress path (ESP) and failure criterion for undrained triaxial tests.

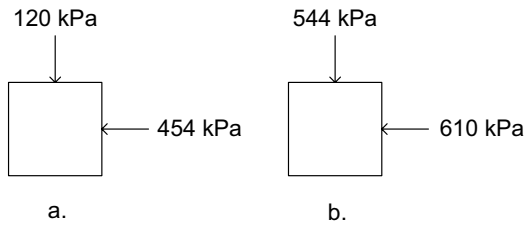
**Figure 18:** a. Desired stress levels after unloading. b. Actual stress levels after unloading.

the test. This does, however, not have any significant consequence because the effective stress path and not the total stress path is followed during an undrained triaxial test, cf. Fig. 17. Problems appeared with the unloading equipment. This implied that the specimen was not unloaded to the desired stress level, cf. Fig. 18, and, thus, with a varying  $K_0$ .

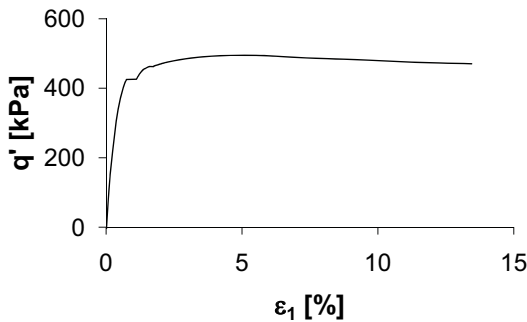
**Figure 19:** The axial strain as a function of the deviatoric stress.

The axial strain  $\varepsilon_1$  is plotted as a function of the effective deviatoric stress  $q'$  in Fig. 19.

additional strain is found to  $q = 495$  kPa leading to  $c_u = 247.5$  kPa. This corresponds well with the vane shear strength of  $c_v = 280$  kPa which indicates a non-fissured clay.

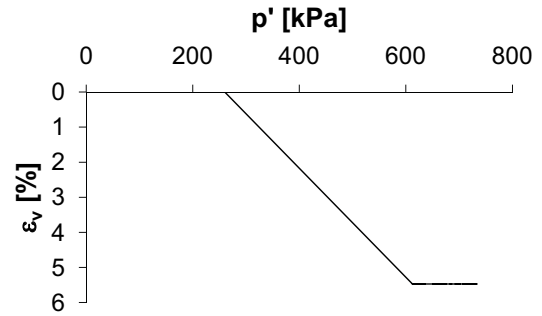
**Figure 20:** Volumetric strains  $\varepsilon_v$  as a functions of the effective mean stress  $p'$ .

For preconsolidated clays, the soil tends to dilate during loading. As seen in Fig. 20, this is not the case for the present triaxial test.

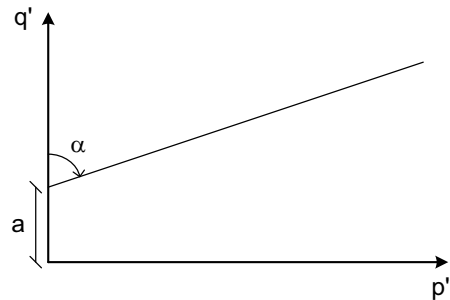
**Figure 21:** Failure criterion of triaxial test.

The parameters  $\alpha$  and  $a$  are found by the failure criterion, cf. Fig. 21.

Because only a single failure point is found by the triaxial test, it is difficult to plot a unique failure criterion, cf. Fig. 21. Thus, both a solution including a cohesion defined by the parameter  $a$

and a solution intersecting with  $(0, 0)$  are used. This leads to  $(c'_{tr}, \phi'_{tr}) = (0, 17.8^\circ)$  and  $(c'_{tr}, \phi'_{tr}) = (47.1 \text{ kPa}, 14.5^\circ)$ , respectively. It should be noted, though, that for the simple relation  $c' = 0.1 \cdot c_u$ , the value of  $c'_{tr} = 47.1 \text{ kPa}$  implies  $c_u = 471 \text{ kPa}$ . This value is almost twice the undrained shear strength determined earlier as  $c_u = 247.5 \text{ kPa}$ . Hence, the second set of drained strength parameters including a cohesion is considered unrealistically high.
