THE HIP & KNEE

Hip Knee J. Vol. 2, No. 2, 2021, pp. 83-88

Excellent Result of Revision Total Hip Replacement with Unexpected Metallosis

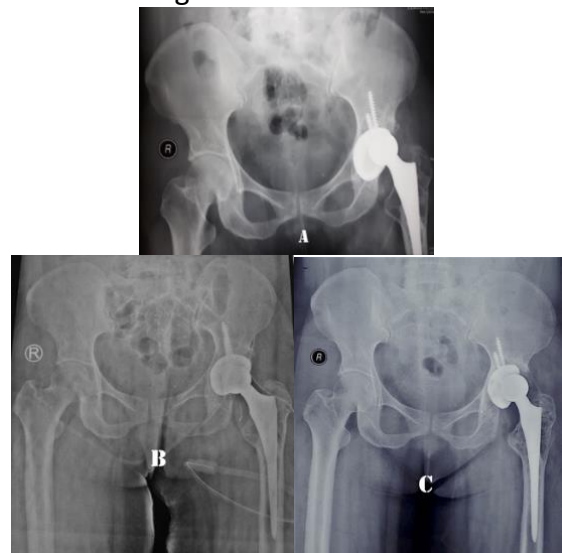
Hip radiographs revealed amorphous densities in the anterosuperior capsule and the posteromedial consistent with the "cloud sign" and curved radio densities around the acetabular cup and femoral stem, consistent with the "bubble sign." There was osteolysis with the loosening of both the acetabular and femoral components (figure 1A). Blood work was obtained, with CRP and ESR levels within the normal range. Given the severe pain, signs of osteolysis and unstable implant, the recommendation was made for the patient to undergo revision THR.

Figure 1: A) Pelvic radiograph before revision surgery showing osteolysis and amorphous density around the implant. B) Pelvic radiograph after revision surgery showing acetabular and femoral implant stable and fixed. C) Pelvic radiograph after 1-year follow-up showing acetabular component a little shear.

The patient was allowed to be non-weight bearing using two crutches until 6-8 weeks. She was able to ambulate, perform quadriceps muscle strengthening and range of motion exercises with physical therapy, and was discharged on the third day postoperative. At eight weeks follow-ups, her incision was healed, she was ambulating good weight-bearing with an assistance device two crutches, and her range of motion was 0-110 degrees. After 1-year follow-up, the patient was able to ambulate without any device, the patient walked with a limp but no discrepancy, able to puts on shoes and socks with ease, railing climbing up the stairs without using the railing, comfortably sitting on the ordinary chair for one hour, no limitation walked distance but felt slight pain occasionally with no compromise inactivity. Patients could use a transportation bus and ride a motorcycle, patients able to rise from a squatting position without holding a device and normal activities sexual intercourse. Patients can feel fully flexion of the hip 140 degrees, abduction 20 degrees, adduction 10 degrees, and external rotations 15 degrees (figure 4). Pelvic radiograph performed after revision surgery and 1-year follow up an expected position with no evidence of hardware failure or loosening (figure 1BC). She reported that she was satisfied with her prosthesis.

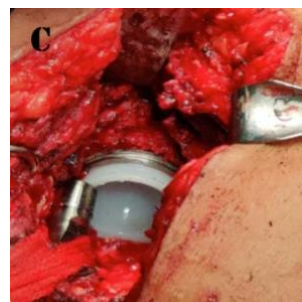
Figure 3: A) Osteolysis of acetabulum B) Reconstruction acetabular using augmentation femoral head allograft. C) Placement of the acetabular and femoral component.

Unexpected findings during the operation were extensive necrotic black material overlying the entire hip joint after arthrotomy (figure 2A). A complete synovectomy was performed at the anterosuperior, posteromedial around acetabular, and femoral component regions to remove metallic debris. The acetabular polyethylene liner was severely worn, and the screw of acetabular metal had broken (figure 2B). After component removal, there was evidence of severe osteolysis of the inner acetabulum and extensive metal debris (figure 2C). After irrigation and debridement, most of the metal debris was removed, the acetabulum bony surface showed destruction (figure 3A). It was considered reconstruction bone loss using augmentation of femoral head allograft and restore the acetabulum's anatomical joint line by reamed it (figure 3B). The revision implants included long press-fit fitting stems in the acetabulum and femur cementless (figure 3C).
