*The Storebælt Link - a geotechnical view*

Steenfelt, J.S.; Hansen, H.K.

*Publication date:*  
1995

Foundation Engineering Paper No 2

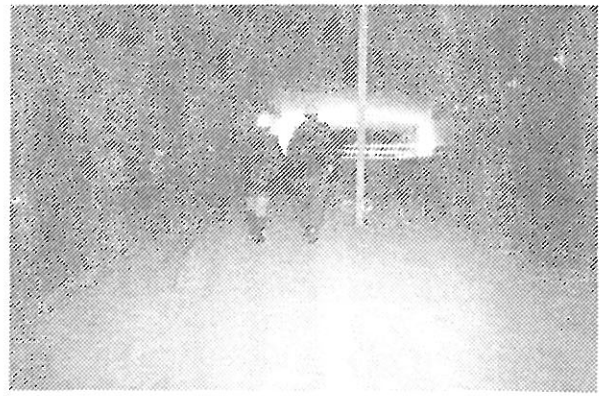
Fig. 12. View inside a West Bridge motor way segment

Figures 11 and 12 show views from below and inside the super structure of the West Bridge. Walking the length of the Bridge internally gives a certain "Cathedral" feeling.

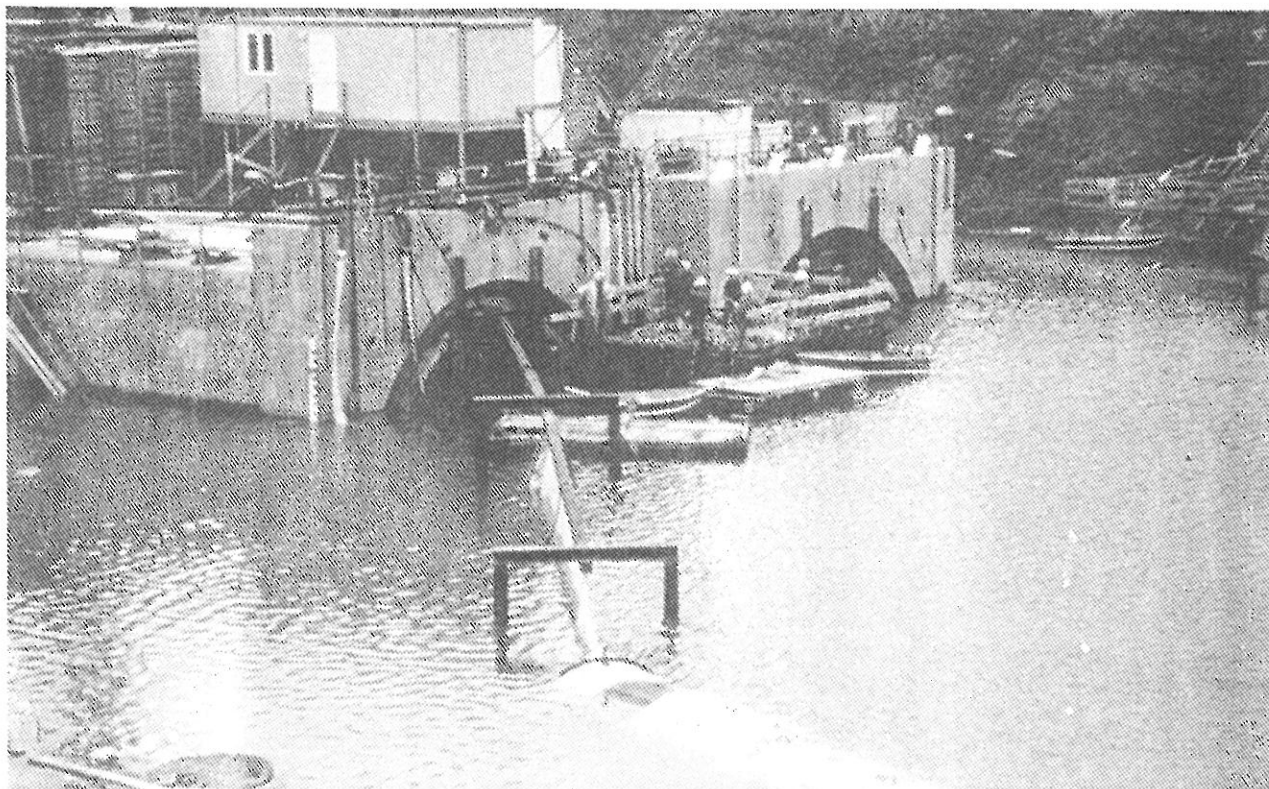
On the morning of October 14, 1991 a sorry sight met the eyes of spectators at the tunnel ramp area on Sprogø, as seen in Figure 23. The ramp area and the two Eastbound tunnel tubes were inundated in what is referred to as the *Jutlandia incident*.

During a period of maintenance stoppage of the TBM Jutlandia a chimney-like connection to Storebælt formed allowing ingress of sea water into the tunnel. Both TBMs and tunnel tubes were successfully evacuated without loss of lives, but both ongoing mining operations had to be postponed for a long time (restart of first eastbound TBM in August, 1992) to allow remediation and to ensure that a similar incident would not occur again at any of the four TBM-positions.

Fig. 23 Jutlandia incident with inundation of the tunnels and ramp on Sprogø 14 Oct. 1991

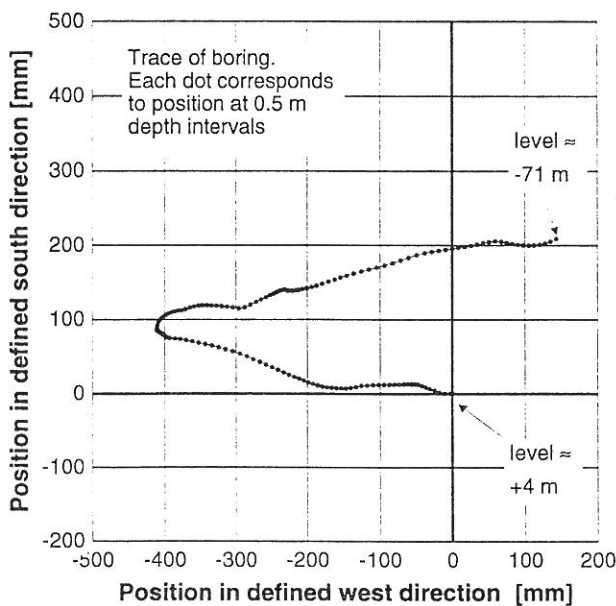
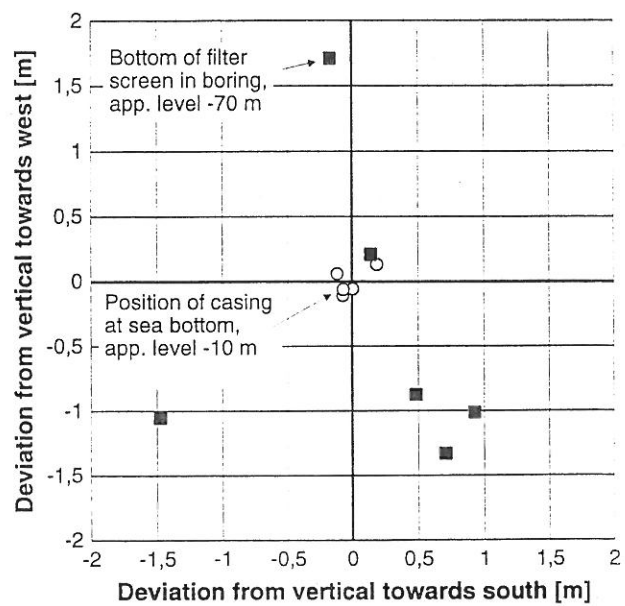
Fig. 28 Results of inclinometer measurements. (a) trace in plan of one of the boreholes from sea bottom to the end of the boring (each dot corresponds to an increase in depth of 0.5 m); (b) plan of borehole positions at seabed and at bottom of boring

ground conditions with tills containing stones and boulders. However, Figure 28b also illustrates, that this is by no means a given thing, as obstacles may certainly deflect the drill string in the plane at a given depth. The inclinometer measurements, however, once more bore out the value of the seismic data collected for the project. The deflections of the boreholes all occurred at seismically determined soil boundaries and coincided with notes of "stone" in the borehole logs.

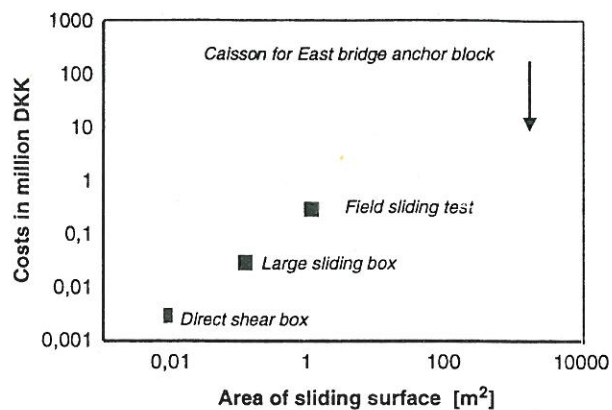
Fig. 30 Cost of tests versus sliding area

The field tests were then used as bench mark tests to check the correlations and to provide the means for safe extrapolation to prototype scale. The cost dictated strategy is borne out by Figure 30, where the cost of testing is compared to the sliding area in question.

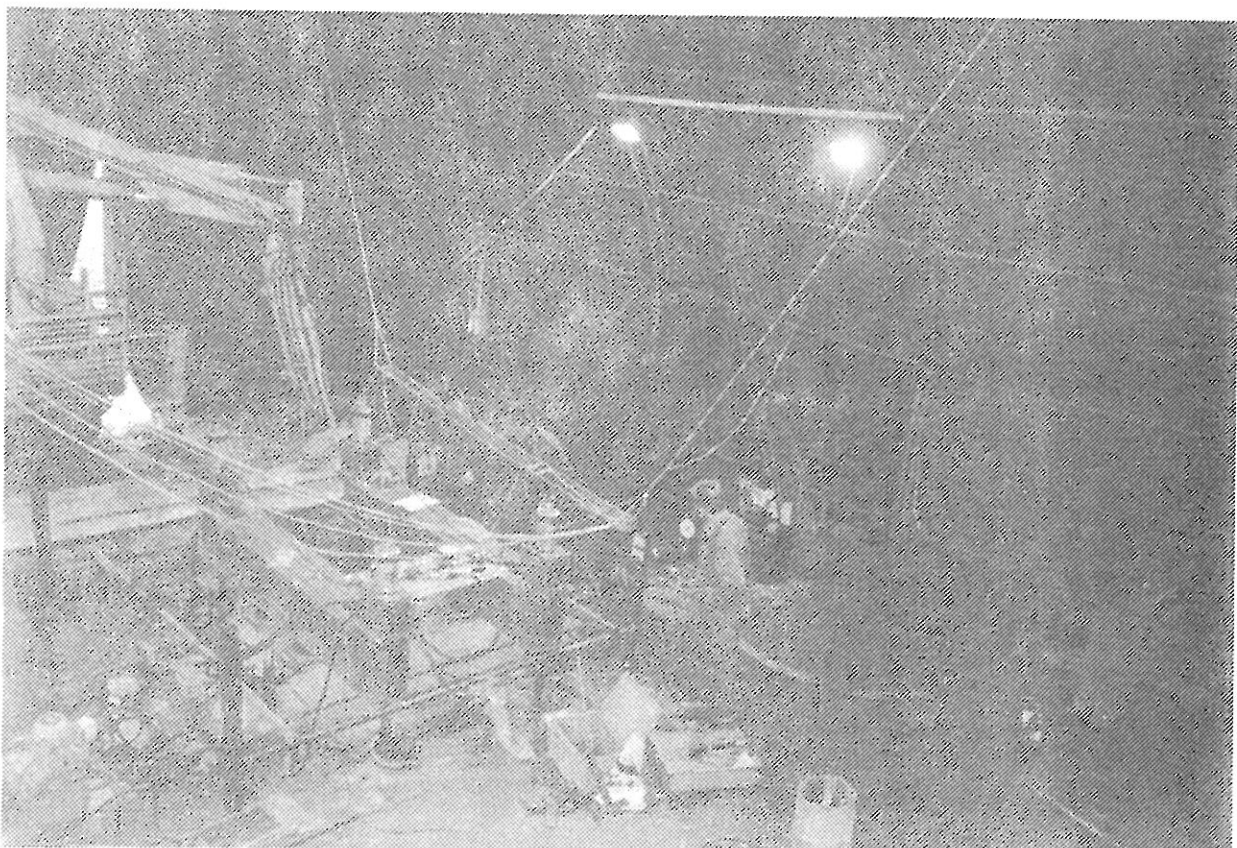
Fig. 35 Set-up of field sliding tests in main tent with control and office facilities

Figures 34 and 35 show that the 300 mm casing around the top 10 metres of the ground anchors allows unrestricted horizontal movement of the test block.

The test site was situated close to Storebælt's Exhibition Centre in Halsskov. As seen in Figure 35 the test set-up and test site were protected by a large tent for climatic reasons.

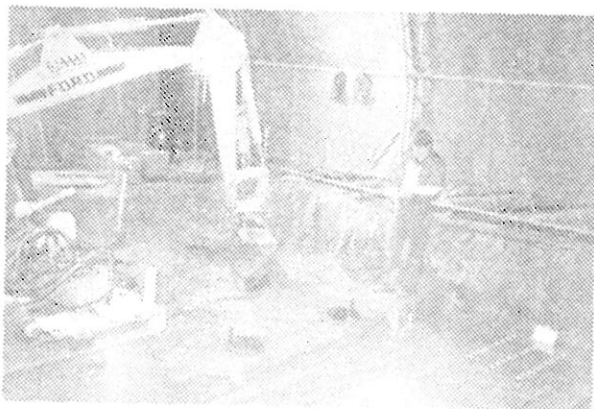
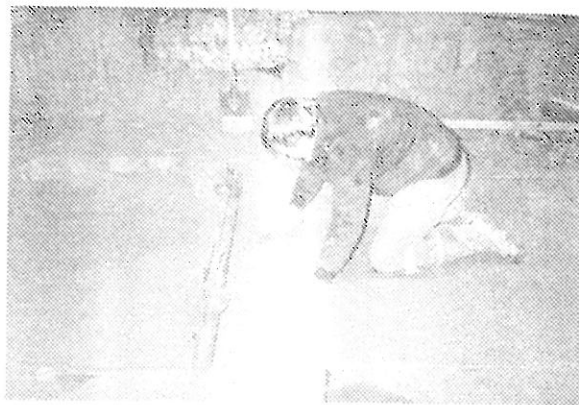
Fig. 36 Preparation of test surface of intact clay till. (a) grab-excavator; (b) finish by hand tools

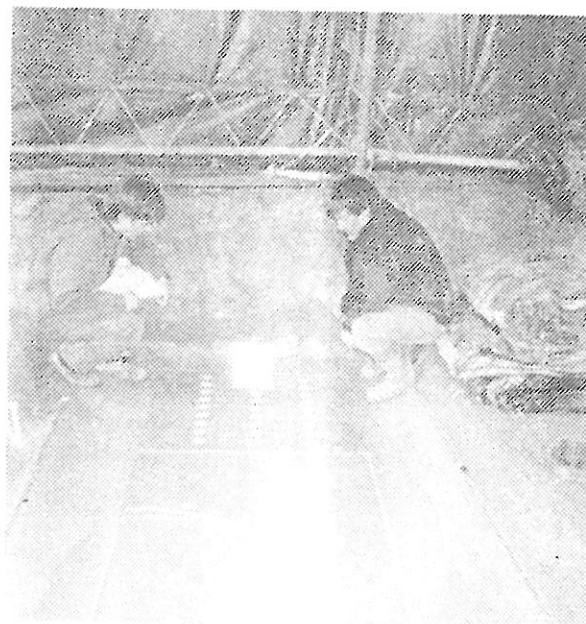
Fig. 37 Monitoring of displacements in interface by markers (coloured sand in grid pattern)

The displacements in the potentially affected clay till zone were monitored by initially vertical tell-tale holes drilled into the clay till and filled with markers at the top of the clay till (Figure 37) and washers or coloured clay (Figure 38, showing special transparent sheets for easy recording of failure patterns).

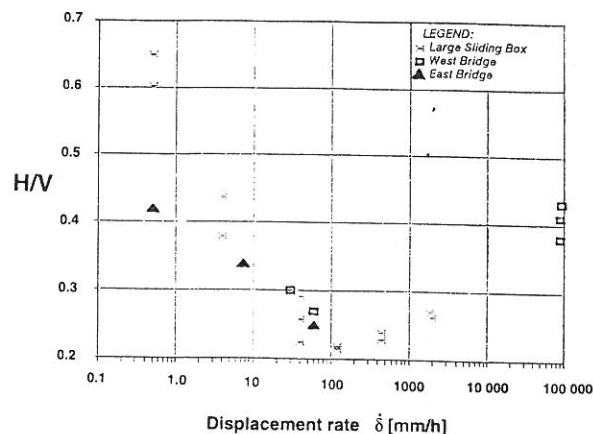
Fig. 39 Resistance ratio versus displacement rate for remoulded clay till (corrected for  $t_a$ )

Figures 39, 40 amply demonstrate that the drained and undrained conditions are not clearly defined and alternative descriptions, particularly for the so-called *undrained state* may be needed. This state not only depends on the rate of pore pressure dissipation, but creep and degrees of freedom in the test (confinement) also play an important role.

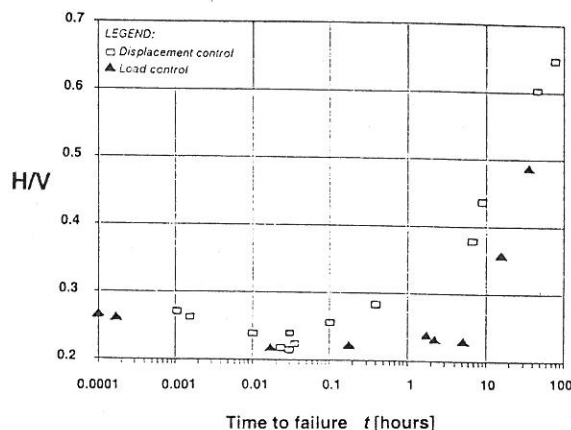
Fig. 40 Resistance ratio versus time to failure in displacement and load controlled tests (LSB)

In order to compare displacement and load controlled tests in the LSB, the time to failure has been used in Figure 40 as controlling parameter. The same trough-like behaviour is recognised, but it is also clear that the transition from drained to most adverse condition is much more rapid for the load controlled tests. Furthermore, the influence of increasing loading rate is not as pronounced (very flat minimum).
