Field Cone Penetration Tests with Various Penetration Rates – Test Results

DCE Technical Report No. 123

December 2011

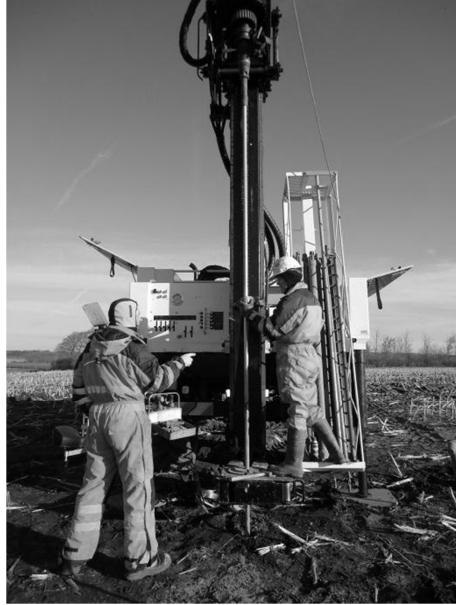
Figure 2. Picture showing the test setup.

In order to keep the penetration rate as constant as possible the CPTs were conducted by a drilling rig which has a trust capacity of 5.5 ton and has an automatic feed, which can be seen in Figure 2.
