UNIVERSITIES COUNCIL ON WATER RESOURCES JOURNAL OF CONTEMPORARY WATER RESEARCH & EDUCATION ISSUE 137, PAGES 47-54, SEPTEMBER 2007

Land Use Change Impacts on *Acequia* Water Resources in Northern New Mexico

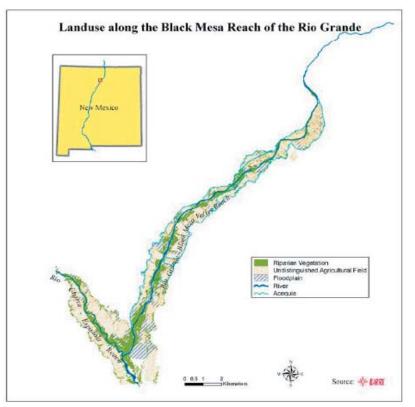
Figure 1. The area of investigation for this research project.

As detailed in Figure 1, the Alcalde Reach of the Rio Grande is located in north central New Mexico. It is a region that is unique in both its physical and cultural landscapes. Land use along this reach includes irrigated cropland, rangeland, riparian vegetation, and small rural communities. For centuries the *acequia* system has traditionally supported agricultural practices in the region. The irrigated crops grown include alfalfa, apples, chile, sweet corn, and other crops of regional importance. Riparian vegetation grows along both the Rio Grande and along the acequias that are situated along this reach. Similar to other regions in northern New Mexico, this region is undergoing increasing pressures from rapid population growth to convert agricultural land and acequia delivered water to other uses. These qualities of the river reach and the presence of a New Mexico State University research station in the region make it a highly appropriate study area.²

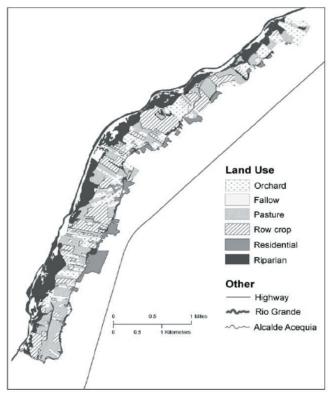
Figure 2. Land use in Alcalde, 1962.

crop, pasture, and fallow. The mapping results showed some key land use conversions in the region, and these changes are detailed in Table 1 and Figures 2 through 4. The total orchard acreage has changed considerably since 1962. By 1997, orchards had decreased to 100 acres from 289 acres in 1962, a decrease of approximately 65 percent. The orchard acreage had further decreased by 2003, encompassing only 88 acres. Similar to orchards, row crops have also decreased. In 1962, row crops consisted of 415 acres. In 1997, row crops made up half of that figure with only 207 acres and, by 2003 there were only 192 acres. Another major change in the region was residential land use, which has increased significantly since 1962. Residential land use consisted of 139 acres in 1962. By 1997 residential land use increased to 639 acres, and the 2003 figure was 908 acres. The total riparian acreage doesn't appear to have been significantly affected by land use change during this time period. The total riparian cover in 1962 was 436 acres; in 1997 it was 382 acres; and by 2003 it was 420 acres. It is difficult to identify whether the riparian increase was a result of actual growth, or if the spatial resolution of the imagery used for mapping determined these figures. The main result we see is that the extent of this land cover classification has not varied more than 10 percent over the time period being examined.

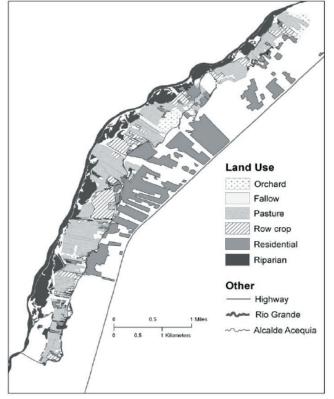
Figure 3. Land use in Alcalde, 1997.

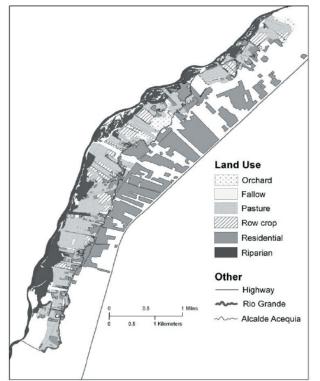
Figure 4. Land use in Alcalde, 2003.

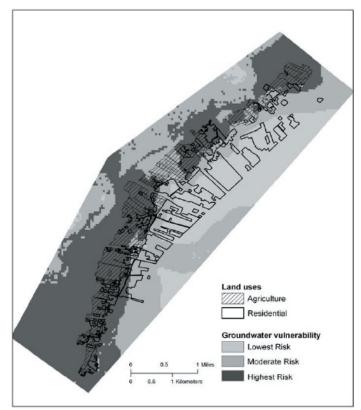
Figure 5. Relative groundwater risk in the Alcalde region.

step was to overlay the weighted raster datasets using the raster calculator in ArcMap, which provided us with the final aquifer vulnerability areas, as depicted in Figure 5. Inspection of this map indicates that the sub-regions of the study area that are at the highest risk largely coincide with agricultural land use. Accordingly, efforts at preserving agricultural areas that are already underway and supported by the region's residents may have an additional benefit in preventing large scale residential development that present risks to ground water quality due to the use of on-site wastewater treatment systems.

To generate a surface of aquifer vulnerability, we completed weighted raster calculations using Map Algebra routines, specifically, the raster calculator in the Spatial Analyst extension of ArcMap. To generate an infiltration surface, we combined the slope and soil datasets, weighting the slope layer by a factor of 0.4 and the soils by a factor of 0.6. The next calculation included both the infiltration raster and depth to water raster, with the infiltration surface being multiplied by 0.4 and the depth to water surface being multiplied by 0.6. The final
