## **Life Cycle Environmental Impacts from Refurbishment Projects - A Case Study**

Proceedings of the CESB 2016 - Central Europe Towards Sustainable Building 2016: Innovations for Sustainable Future

# LIFE CYCLE ENVIRONMENTAL IMPACTS FROM REFURBISHMENT PROJECTS – A CASE STUDY

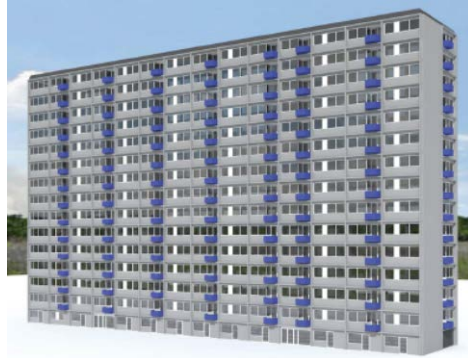
**Fig. 2** One of the three Sorgenfrivang blocks prior to refurbishment. Illustration by DOMINIA Consulting Engineers.

The case study, is a complex of three residential 14-storey buildings erected in 1960 and known by the name Sorgenfrivang. The blocks contain a total of 428 flats varying in size from 26 m<sup>2</sup> to 130 m<sup>2</sup> gross floor area. The total gross floor area of the three buildings is 41,991 m<sup>2</sup>. The buildings are located in Virum, Denmark. The annual energy consumption before refurbishment was measured at 112 kWh/m<sup>2</sup> district heating and 5.7 kWh/m<sup>2</sup> electricity.

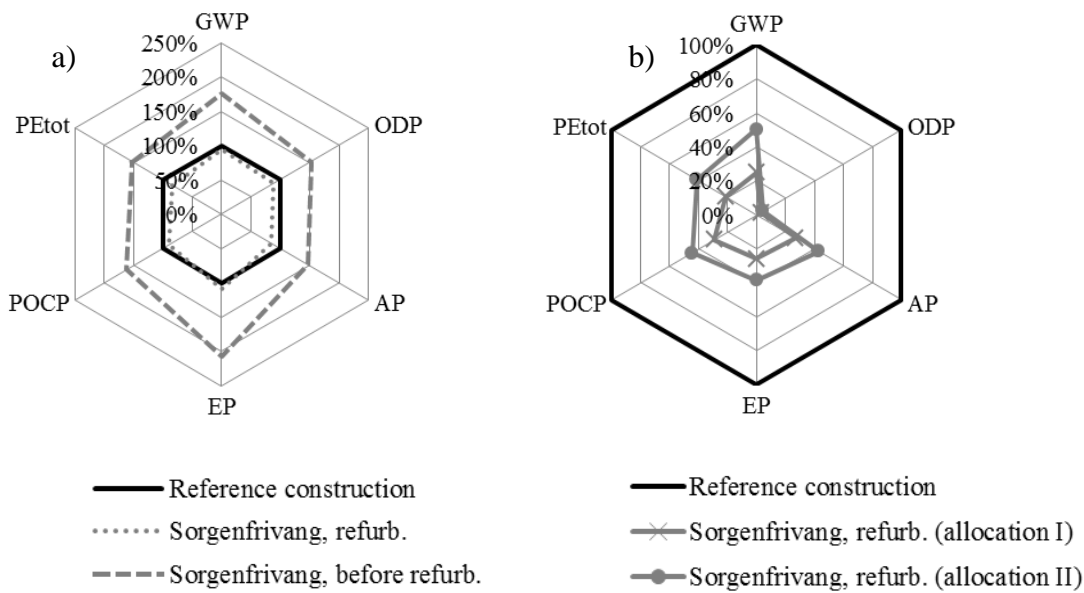
**Fig. 3** a) Impacts from the operational energy use (module B6) of Sorgenfrivang compared with a reference building. b) Embodied impacts from the material use (modules A1-A3, B4, C3-C4) of the Sorgenfrivang refurbishment. Allocation I: the existing structure is accounted for as “free”. Allocation II: existing structure is accounted for by remaining service life of building elements.

Figure 3a illustrates the impacts from the operational performance of the Sorgenfrivang building before refurbishment and after refurbishment, both in relation to a reference building, as defined in the Danish DGNB certification system, reflecting the minimum requirements of the national building regulations in force at the time of the project approval. The impacts from Sorgenfrivang before refurbishment are 150-200% of the corresponding impacts of the reference building. For the refurbished Sorgenfrivang on the other hand, impacts related to the operational energy use come close to, although a bit better than, the impacts associated with the reference building, reflecting the minimum requirements of the national building regulations in force at the time of the project approval.

Figure 3b illustrates the embodied impacts of the refurbishment project at two levels of allocation and in relation to the embodied impacts of a reference building. By the allocation I procedure, embodied impacts correspond to 20-30 % of reference building's embodied impacts in all categories but ODP. By the allocation II procedure, embodied impacts correspond to 40-50 % of embodied impacts in all categories but ODP.
