The Reusser House: a Log Structure in Iowa's 'Little Switzerland'

J. Sanford Rikoon

Rikoon, J. S. "The Reusser House: a Log Structure in Iowa's 'Little Switzerland'." *The Annals of Iowa* 45 (1979), 3-43.

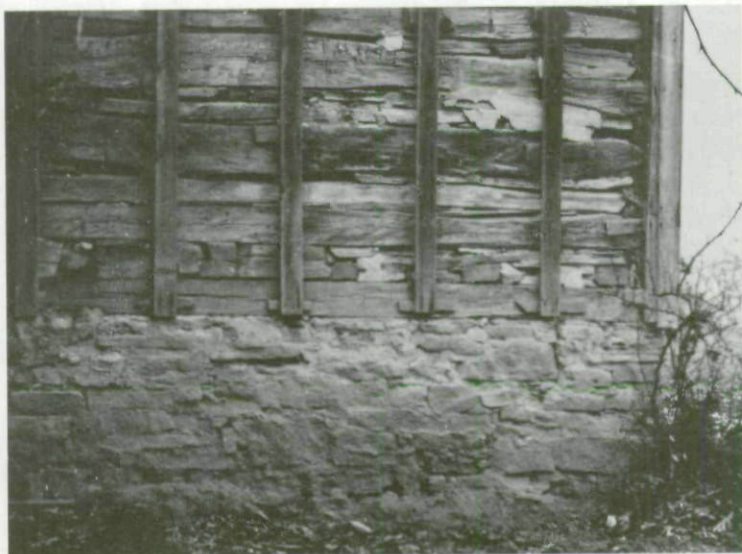
Photo #1

West-south corner of 1891 house. The Niagara limestone foundation dominates the foreground; above this one can note the sill log, first floor joists' ends, and the first four course of hewn logs. Notice also the chinking between the logs and the vertical boards which supply the base for the weatherboarding.

(Photo 1). This rock, available locally, is considered a magnesium limestone and contains some silicious matter. Niagra limestone is a common building material in the area. The stone foundation was built originally as a solid wall on the north, west, and south sides. This pattern is broken in two places—along the north side where a cellar door was placed, and along the south wall for a small window. The door, two feet six inches wide and four feet six inches high, is of board-and-batten style, using three-fourths-inch by five- and one-fourth-inch tongue-and-groove boards for vertical pieces. This fixture, and the other board-and-batten doors in the house, do not utilize any diagonal braces as is often found on Anglo-American doors of similar style. Five cement stairs lead down from the outside to the door-opening. While it is likely that the door is the original item, it is difficult to determine whether or not Christian laid the stairs. The cement was available, for as early as 1875 the Dibble's store in Elgin advertised "White brick, red brick, lime, pumps, and Louisville Cement."⁵

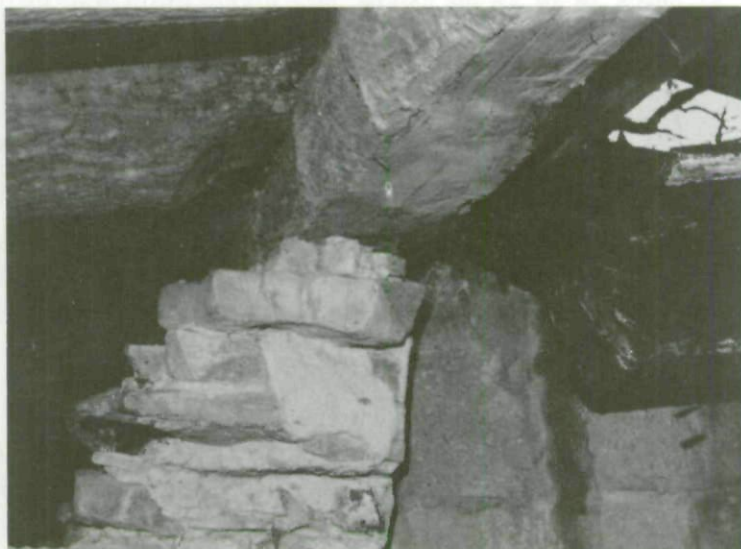
Photo #2

West sill log of 1891 house. The sill log, with its hewn bottom edge, rests on top of the limestone wall. The floor joist logs, in the upper left-hand corner, are lap-notched to the top of the sill. One can also see the forms of the limestone pieces and the mortaring between the stones.

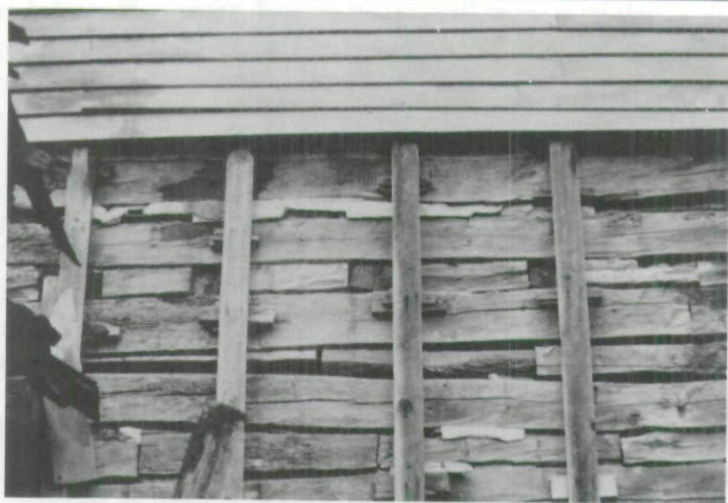
Photo #3

Section of west horizontal wall, 1891 house. Notice the unevenness in width of the large hewn logs, the pieces of wood used as chinking between the logs, and the remains of the plaster chinking. Broad axe marks are visible on the logs. Over the courses are the shims, vertical boards, and weatherboarding which provide the exterior finish.

not so concerned with using perfectly straight timbers, nor did he consider it necessary to square his logs. Where a log bowed or "fell off" Reusser chinked the resulting open spaces with smaller pieces of logs or split boards (Photo 3). The technique of chinking is common to both Anglo-American and German-American log structures. For Reusser, the use of chinking was further necessitated by his use of half-dovetail notching in the corners. The house height of the largest log is fifteen and one-half inches while the average height is ten inches. Full twenty-four foot logs are found on the east and west walls. It is likely also that Reusser utilized the trees near to the house, or higher up on the hill rather than those trees closer to the creek. The latter group, although they tend to grow faster, have a wider grain pattern which is more likely to rise when the wood becomes damp. Reusser had no time to age his logs, and thus probably preferred the closer-grained and stronger hillside trees.

The second-floor joists are notched similar to the ground-floor joists. The protruding ends of the second-floor joists can be seen in Photo 3. The joists are of two varieties—those hewn on all four sides, and those hewn flat on top and bottom edges only. The two styles do not appear in any specific pattern, and it is difficult to explain their existence. The hewing of the inside and outside edges seems to have no pragmatic explanation; it is possible that these logs were cut for the exterior walls and then never used in that capacity. If these entirely hewn logs had half-dovetail ends, it would have been an easy task for Reusser to axe these away and form a lap notch.

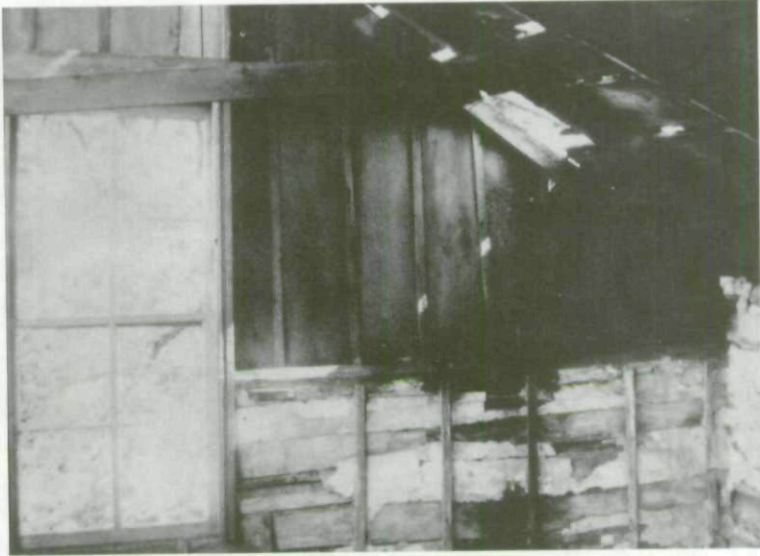
Photo #4

South gable-end of loft, 1891 house. This photograph shows the horizontal log walls with their interior plastic coat. One-inch boards, with their splices of vertical lathes, rise from the wall to the roof ridge. In the upper right-hand corner are the one-inch planks which form the roof foundation.

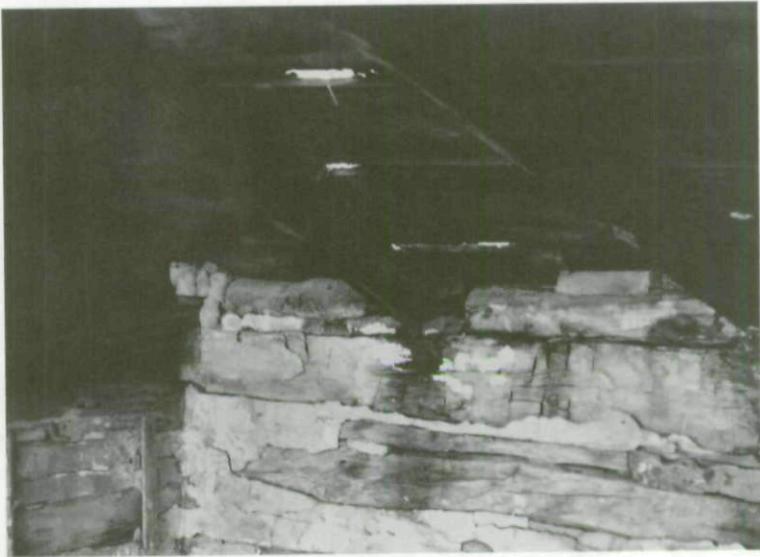
Photo #5

Rafter-horizontal log wall joint, 1891 house. The rafter ends are notched over the top tier of the log wall. Short spacer logs, unhewn, are placed between the rafters to prevent movement. Above these rafters are the one-inch planks with their gapped spacing.

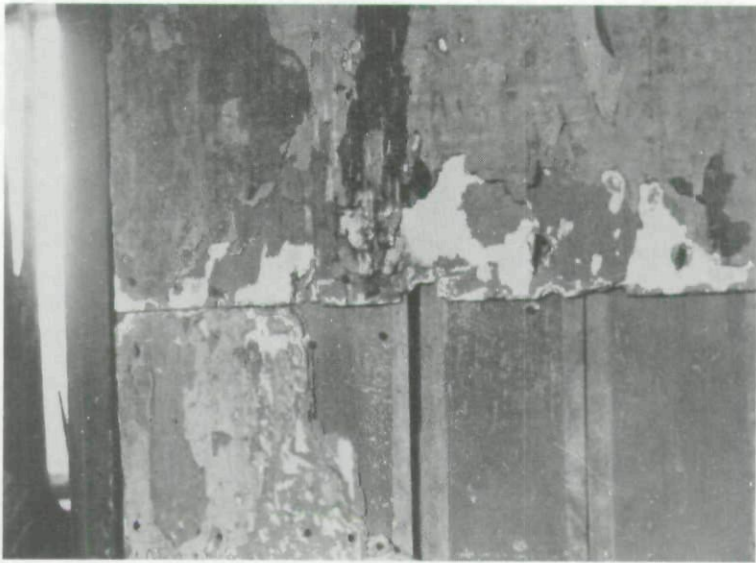
Photo #6

Section of interior wall of 1891 house. The painted and unpainted areas indicate that battens originally covered the vertical board joints. These boards, as well as the spaces between them, vary in width. The thin double-sheet of plasterboard were added at a later date.

The separating partition is constructed of vertical boards and battens (Photo 6). Rarely found in interior usage, this style of wall construction reveals varied widths (five to nine inches) of one-inch boards which span from floor to ceiling. These planks are nailed to strips of two-inch by four-inch boards nailed flat to both floor and ceiling. One-inch by three-inch boards are used as battens along the board joints. The wall is actually built in two sections, one on each side of the chimney. It is painted brown, but it is not known if Reusser was responsible for this work. Today there are thin sheetrock panels nailed on the interior wall, but these are definitely more recent improvements.

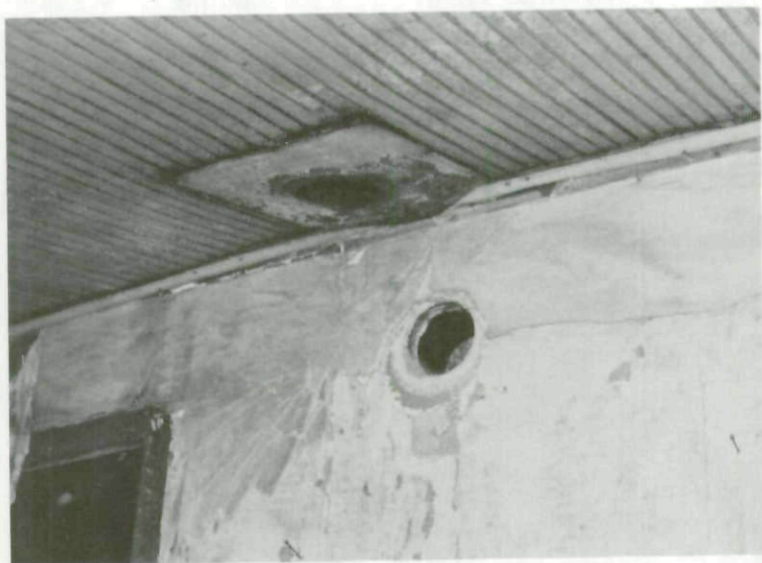
Photo #7

Stovepipe holes and ceiling of ground-floor. The lower stovepipe hole leads to the chimney behind the wall, while the upper opening, in the ceiling, leads to the loft and provides the mechanism for carrying heat to that area. This photograph also gives a clear view of the "car-siding" used in the ceiling.

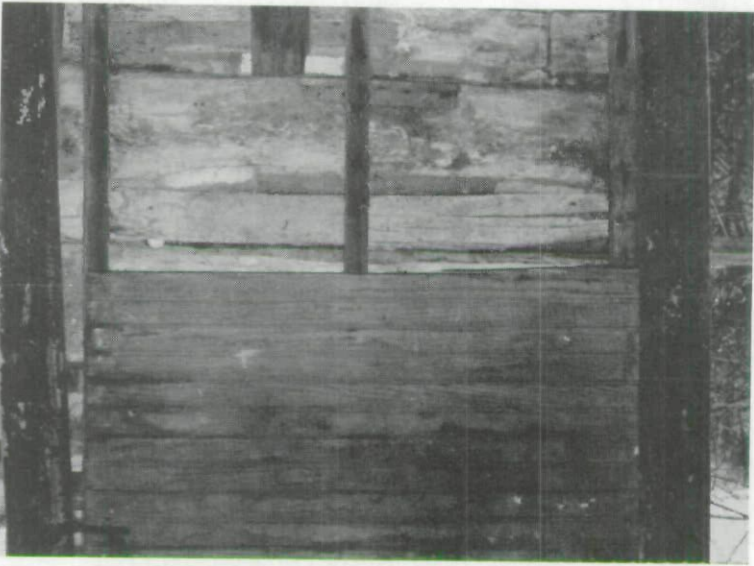
Photo #8 *1891 house interior finish on ground-floor.
The use of "car-siding" nailed to vertical
lathes on the horizontal log walls marks this
finish. Notice that the log wall was chinked
with plaster before this finish was applied.*

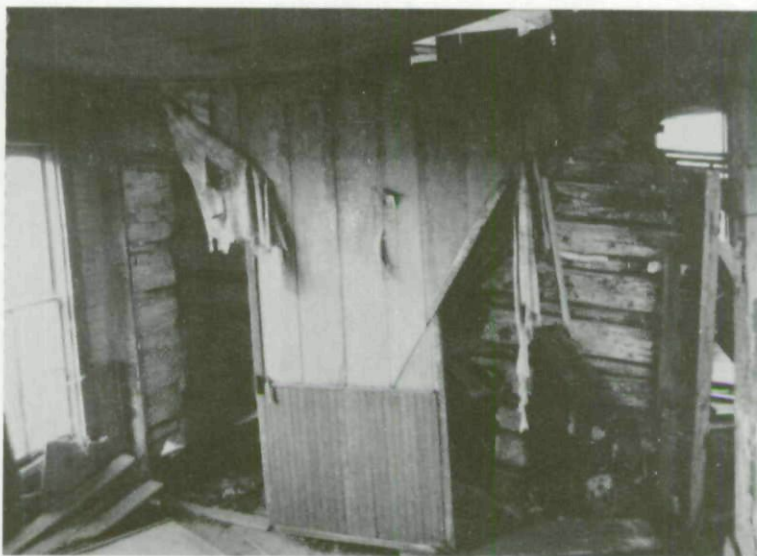
Photo #9

Exterior view of boxed stairway, 1891 house. One-inch wide planks are utilized to enclose the stairway which rises along the east wall of the north ground-floor room. Vertical wainscoating lines the lower section, with wallpaper (of which only tattered pieces remain) above this finish. A board-and-batten door, not visible, spanned the opening to the stairs.

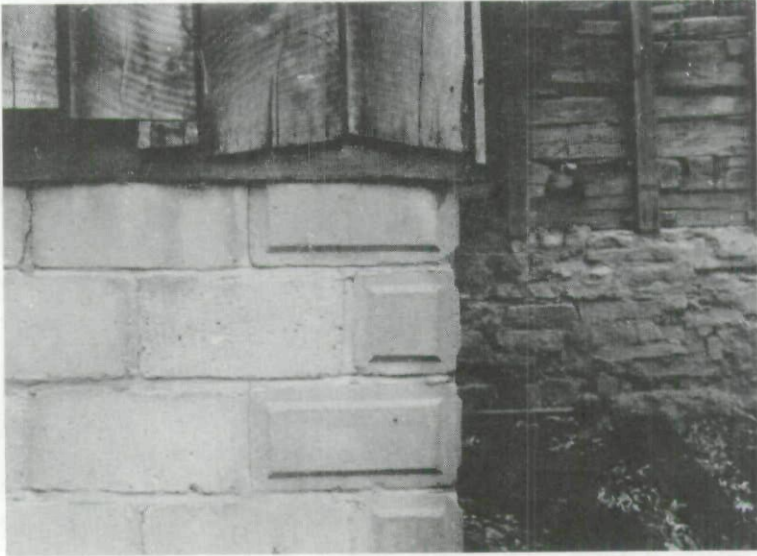
Photo #10

West-south corner of foundation, 1895 addition. The ashlar-faced blocks dominate the foreground of this photograph. Small portions of the exterior edge of the hewn sill log can be seen under the vertical boards which provide the exterior finish. A close look at these boards reveals circular saw marks from a milling process.

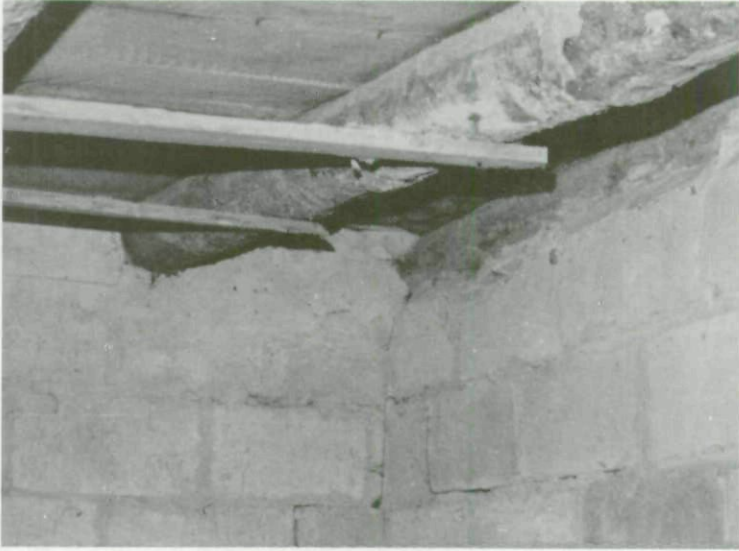
Photo #11

Foundation, sill, and joist construction, 1895 addition. The sill log, unhewn on its bottom edge, is mortared over the last course of cinderblocks. The floor joists are mortared in a similar fashion, with half-height cinderblocks used as spacers between the joists. Only the top edge of these logs are hewn flat, anticipating the floorboards.

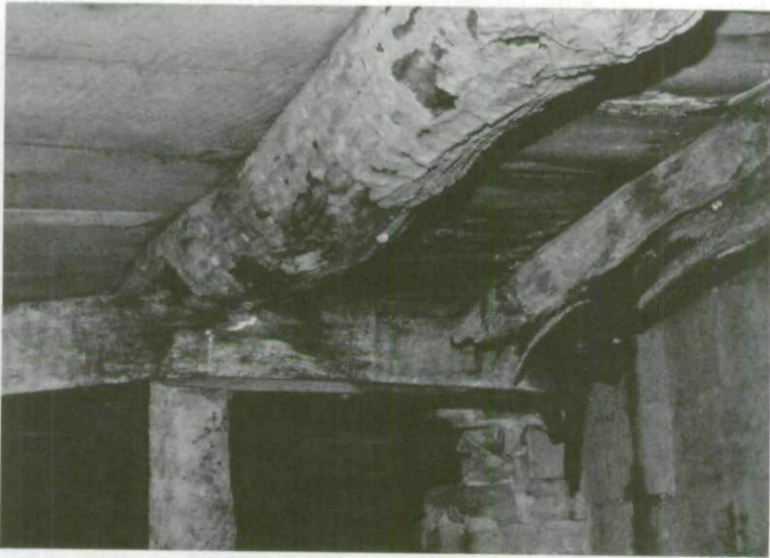
Photo #12

Summer beam and floor joists, 1895 addition. This supporting beam, with its circular saw marks still visible, forms the east wall of the foundation. The floor joists are notched over the beam by means of a rectangular notch cut into their underside. Note that the standing log which appears to be behind the beam was originally placed under this span for support.

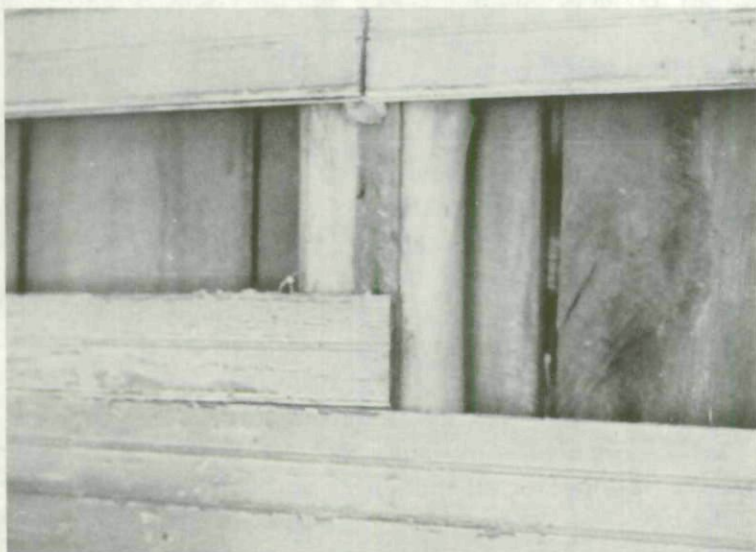
Photo #13

Pole wall stud, 1895 addition. These pole studs are hewn flat on their exterior and interior edges. The view from the interior shows the vertical lathes placed on the studs to provide a level nailing surface for the "car-siding" interior finish. Where the "car-siding" has been removed, one looks through to the one-inch wide planks which provide a base for the exterior weather-boarding.

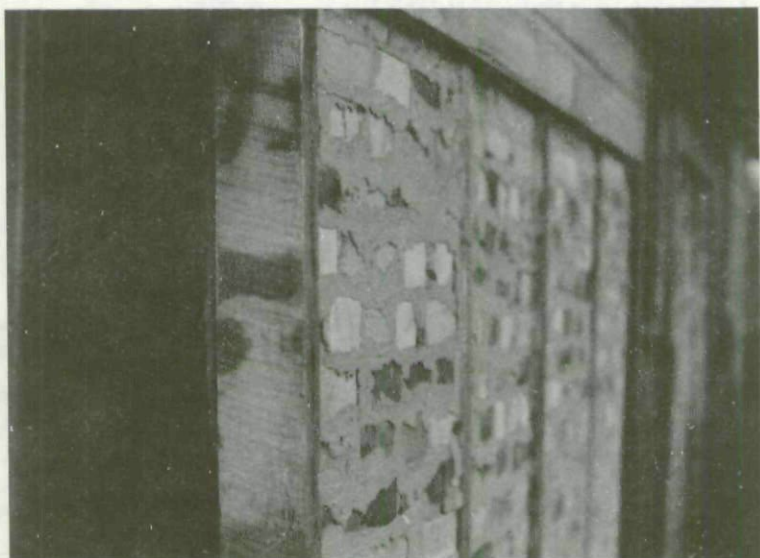
Photo #14

Brick nogging in stud walls, 1904 addition. Between the two-inch by four-inch studs is placed the brick nogging. The blend of the darker, red bricks with the lighter, white bricks can be seen as well as the heavy mortaring in these 'panels.' The exterior weatherboarding is nailed directly to the wall studs.

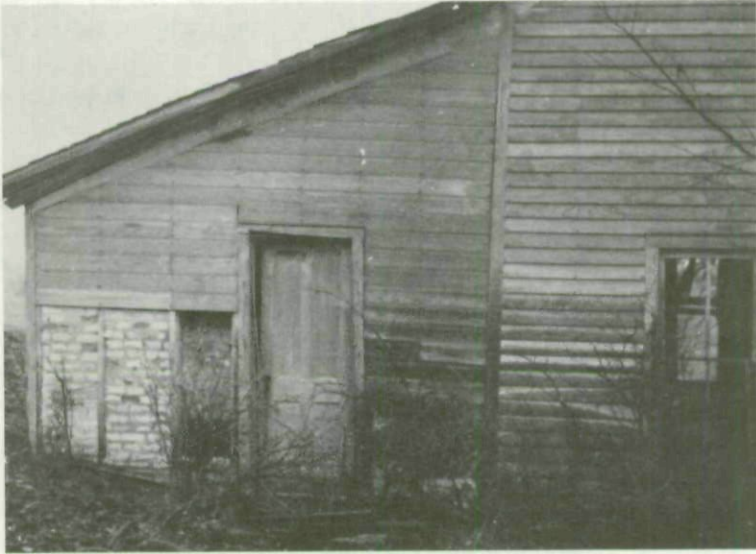
Photo #15

North side of 1904 addition. The slope of the roof of the addition is nearly half of the adjoining 1891 house. The contrasting styles of weatherboards can be seen with the beaded boards of the addition appearing flatter because of their tongue-and-groove joints. The door is a common four-pane unit.

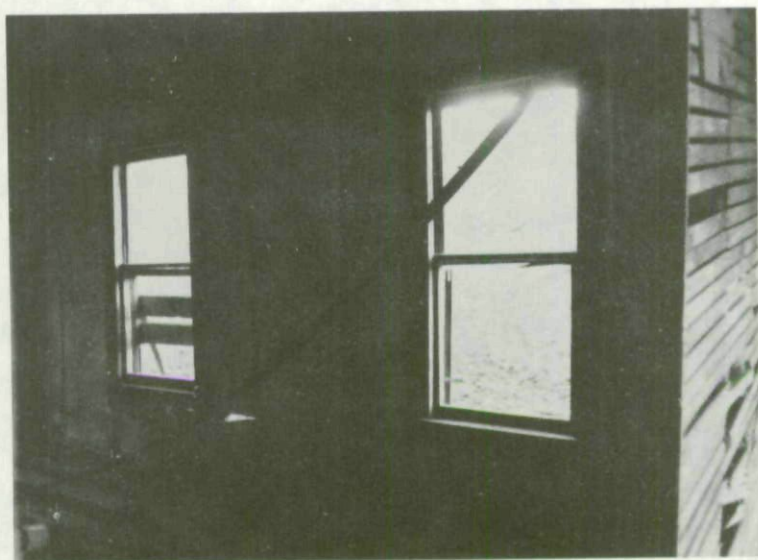
Photo #16

Interior view, 1904 addition. The interior finish is a plaster coat over the bricks. An interesting item is the long rail which passes directly above and below each window, the boards functioning as sill and header. Short studs are utilized to keep a uniform stud pattern.

are utilized. The opposite long edge of the window falls between normal stud spacing, yet extra studs are not employed. Instead, Reusser has extended four-foot rails, functioning as sill and header, between the studs (Photo 16). The window's long edge which lies between studs is then framed by a two-inch by four-inch board rising vertically between the two rails. Short studs are found above the header and below the sill on the sixteen-inch center points. This style of window framing within the brick nogging is noted by Hansen as common in Swiss-German construction in Europe.¹⁹ It is logical that Reusser employs this
