## **BIOLOGICAL RESPONSE TO A BIOACTIVE GLASS COATED IMPLANT: EXPERIMENTAL DATA.**

**Keywords:** biomaterials; bioactive glass; coating metallic implant.

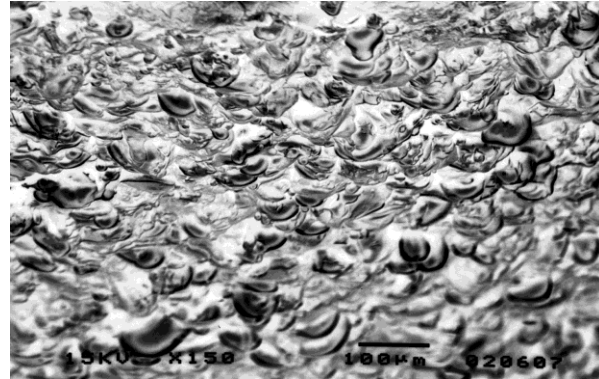
Fig.1 – SEM micrographs of the implant: a) transverse section of the metallic titanium alloy (T) coated with a bioglass layer (B) (50x); b) surface view of the bioglass coating (150x).

A metallic titanium alloy (TiAl6V4) similar to those used for a human orthopaedic prosthesis with a cylindrical form (10 mm x 3mm) was submitted to a superficial treatment, following the spraying process. The bioglass coating, with a constant thickness of about 80 µm, was reasonably homogeneous with the presence of microcavities (Fig. 1). The implants were subsequently sterilised by gamma radiation.

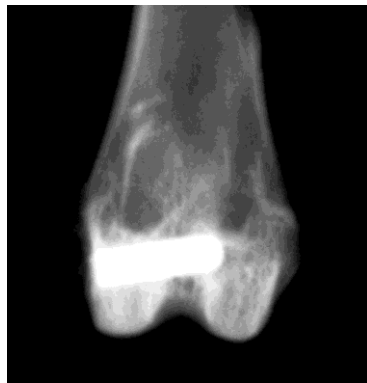
Fig. 2 – Radiograph image of an implant after 180 days of insertion, showing osteointegration of the implant surface, without lucent lines in the bone-implant interface.

Radiologically, no lucent lines were detected in the bone-implant interface in the three experimental groups. At the 180<sup>th</sup> day after the surgery, osteointegration of the implant surface was observed in all cases (Fig. 2).
