# Effects of Damage Models in Probabilistic Assessment of Structures: An Illustrative Example

# Vikram Pakrashi<sup>1</sup>, Alan O'Connor<sup>2</sup> and Denys Breysse<sup>3</sup>

Keywords: Damage Model, Probabilistic Assessment, Probability of Failure, Wood.

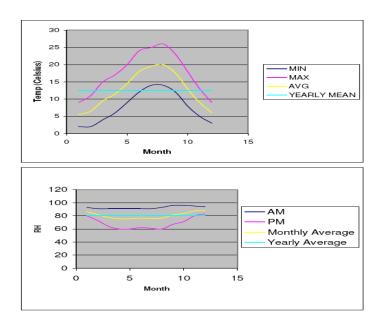
Figure 1. Temperature and Relative Humidity in Bordeaux.

The monthly variation of temperature and relative humidity for Bordeaux (bbc.co.uk, accessed 2007) is shown in Figure 1. The activity rate of a fungus for such environment can be found from the activity contour plots provided by Krus et al. (2001). The activity rate of a fungus is defined to be the rate at which the fungus grows under a given temperature and humidity condition. This rate can be expressed as the equivalent distance per unit time and directly used for engineering calculations. Due to the seasonal nature of the temperature and humidity at any location, the activity rate approximately repeats itself every year. As a result, an activity profile for a certain location can be constructed by considering the average monthly activity profiles over an entire year. Since the environmental conditions vary randomly about the average cycle every year, a random noise has been added to the yearly activity profiles to obtain a more realistic fluctuating

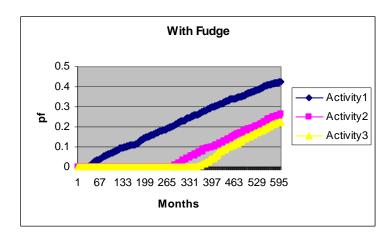
Figure 3. Probability of Failure for Owner's Criteria.

The probability of failure for the owner's definition of failure for different activities with fudge (associated random noise) is given in Figure 3. The values are comparable in terms of average activity over a year. The nearly parallel loci of points of the points indicate the basic deterministic nature of the failure process and the deviations account for the interaction between the germination time and activity rate. Figure 4 shows the numbers of failures for different activity rates for each of the months in a year for owner's definition of failure. The high activity months account for more number of failures. The presence of noise smoothes out any sudden change in the modal month that might numerically arise due to the specification of a definite cut-off value for the affected length of failure.

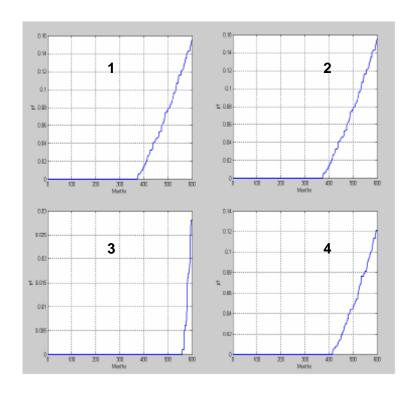
Figure 5. Probabilities of Failure for Engineer's Criteria for Combined (1), Moment (2), Shear (3) and Deflection (4).

Figures 5 and 6 represent the cumulative probabilities of failure from the engineer's viewpoint and the numbers of failures for a given month respectively. The shape of the activity profile resembles a triangular pattern. The pf and the number of failures are according to combined (1), moment (2), shear (3) and deflection (4) criteria respectively in Figure 5. Figure 6 illustrates the presence of modal months using the engineer's criteria for moment (1) shear (2) and deflection (3) respectively. The moment failure criterion governs the total failure probability. The months of higher activity in terms of failure are seen to match the activity pattern of fungal activity.

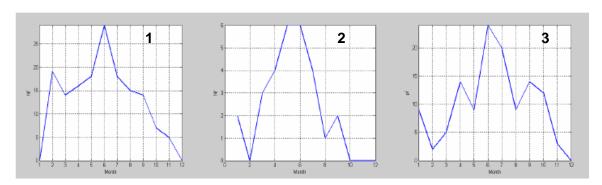
Figure 6. Number of Failures over Different Months for Moment (1), Shear (2) and Deflection (3) following the Engineer's Criteria.
