The Corrosion of Carbon Steel under Deep Geologic Nuclear Waste Disposal Conditions

Shannon L.W. Hill
The University of Western Ontario

Graduate Program in Chemistry
A thesis submitted in partial fulfillment of the requirements for the degree in Doctor of Philosophy
© Shannon L.W. Hill 2016

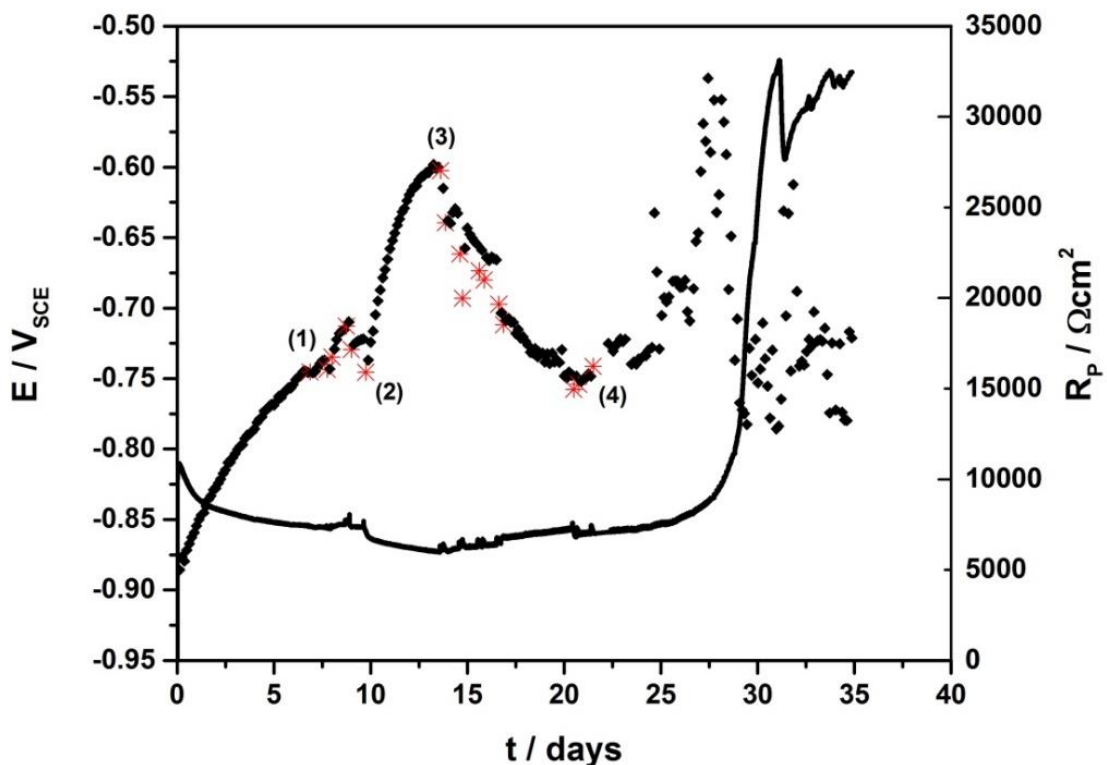
Figure 3-2: Corrosion potential (E_{CORR}) under deaerated conditions. Points indicate the R_p values, with the red points showing R_p values recorded after an addition of H_2O_2 .

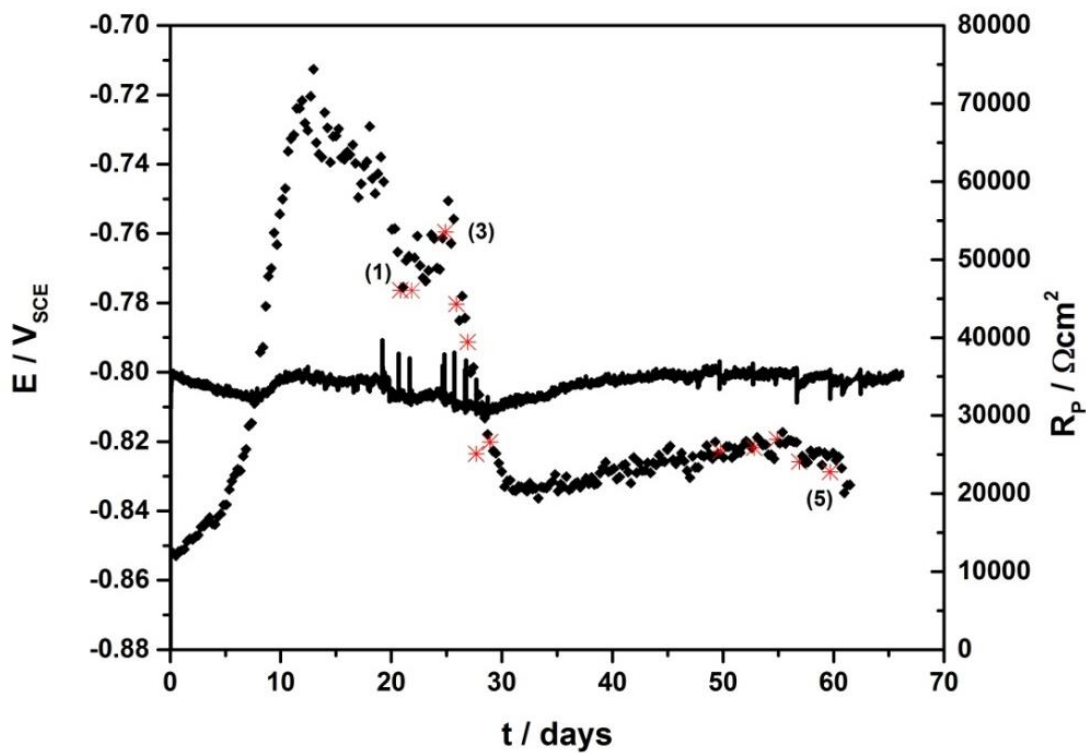
Figure 3-3: Corrosion potential (E_{CORR}) under anaerobic conditions ($[O_2] \sim 0.1$ ppb). Points indicate R_p values, with the red points showing R_p values recorded after the addition of H_2O_2 .

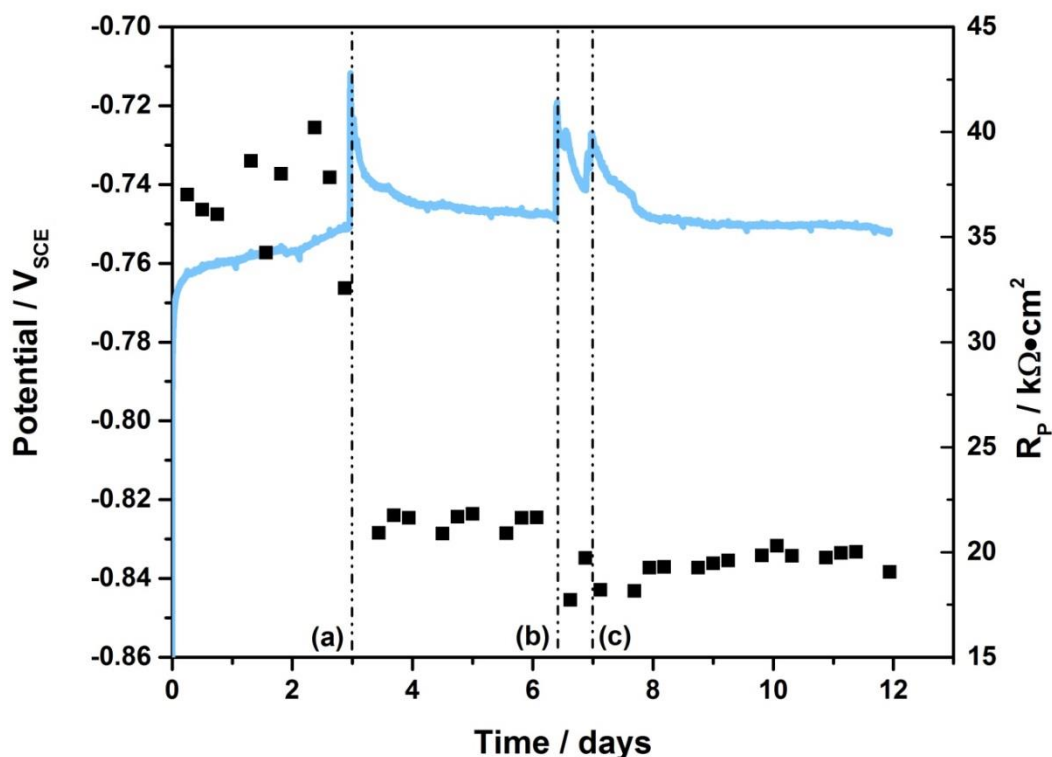
Figure 4-3: Corrosion potential (E_{CORR}) and polarization resistance (R_p) measurements recorded in the $[Cl^-]=5.00$ M (#1) solution.

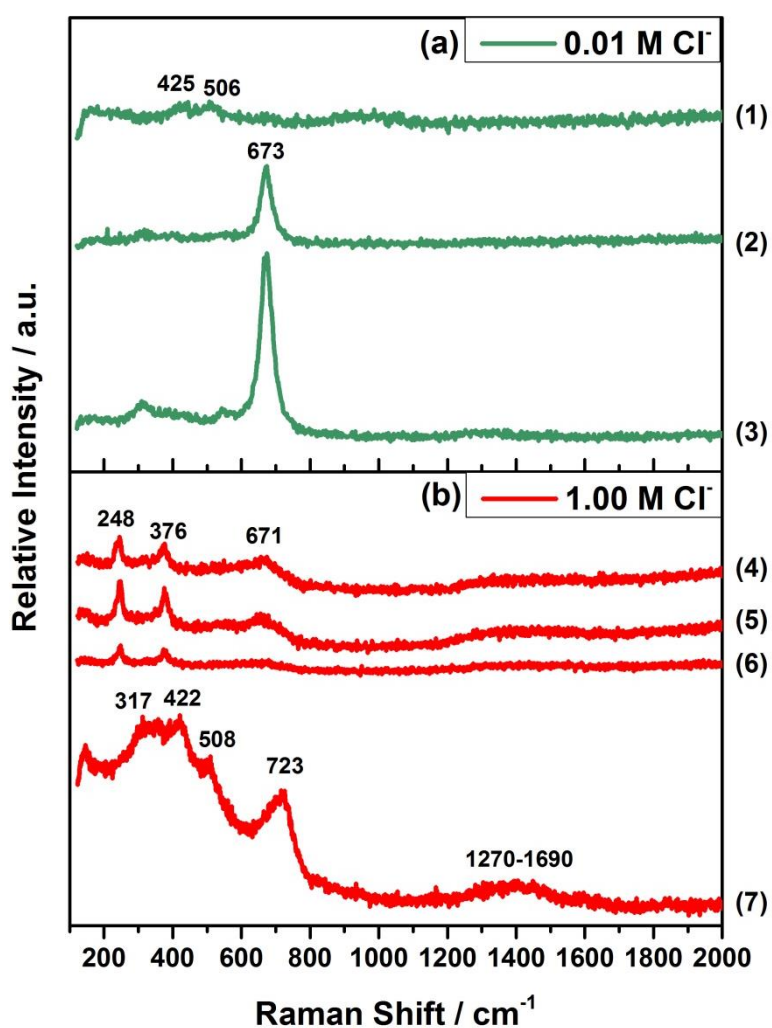
Figure 4-4: Ex-situ Raman spectra (1-7) recorded at various locations on the steel surface after exposure to (a) $[\text{Cl}^-] = 0.01\text{ M}$ and (b) $[\text{Cl}^-] = 1.00\text{ M}$.

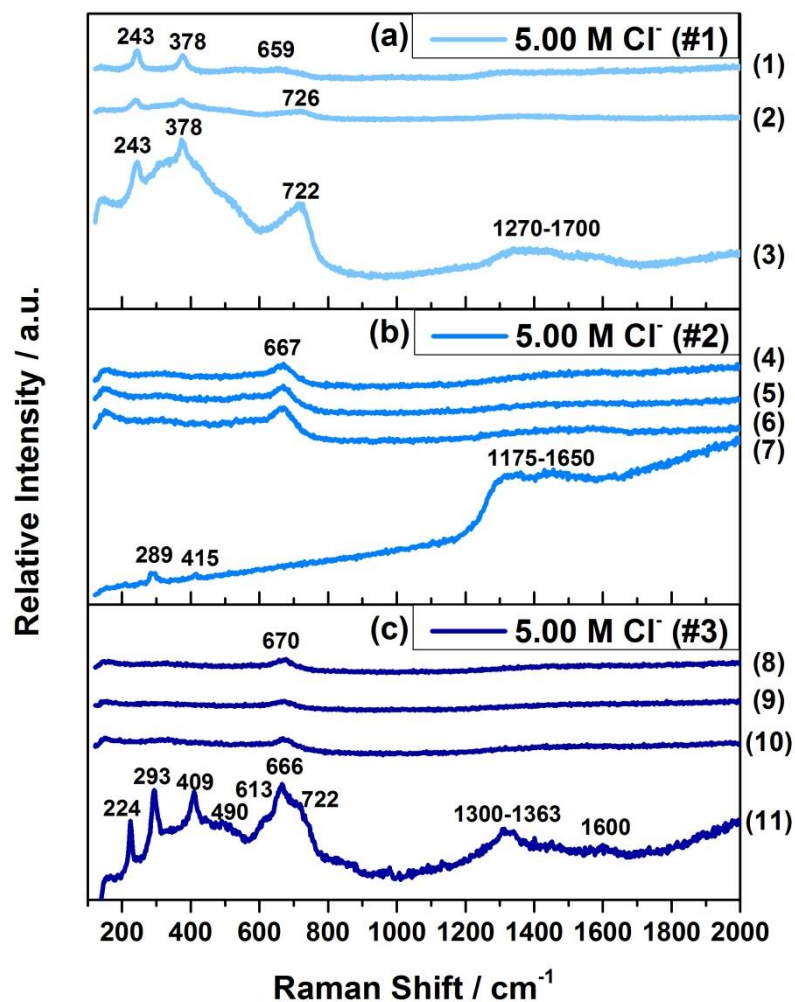
Figure 4-5: Ex-situ Raman spectra (1-11) recorded at various locations on the steel surface after exposure to $[Cl^-]=5.00$ M environments.

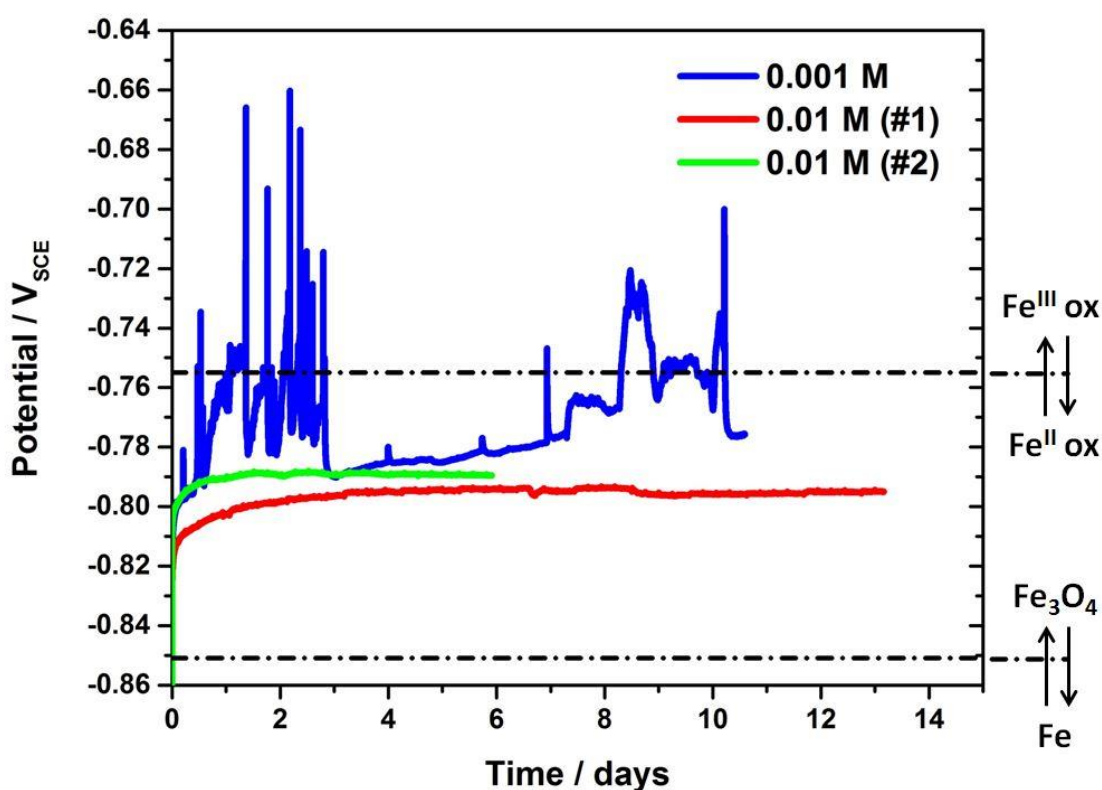
Figure 4-15: Corrosion potentials (E_{CORR}) for solutions in $[\text{Cl}^-]=5.00$ M containing $\text{HCO}_3^-/\text{CO}_3^{2-}$ at concentrations of 0.001 M and 0.01 M. Dashed horizontal lines represent the thermodynamic boundaries for the oxidation of Fe to Fe_3O_4 and $\text{Fe}(\text{OH})_2$ to $\alpha\text{-Fe}_2\text{O}_3$.

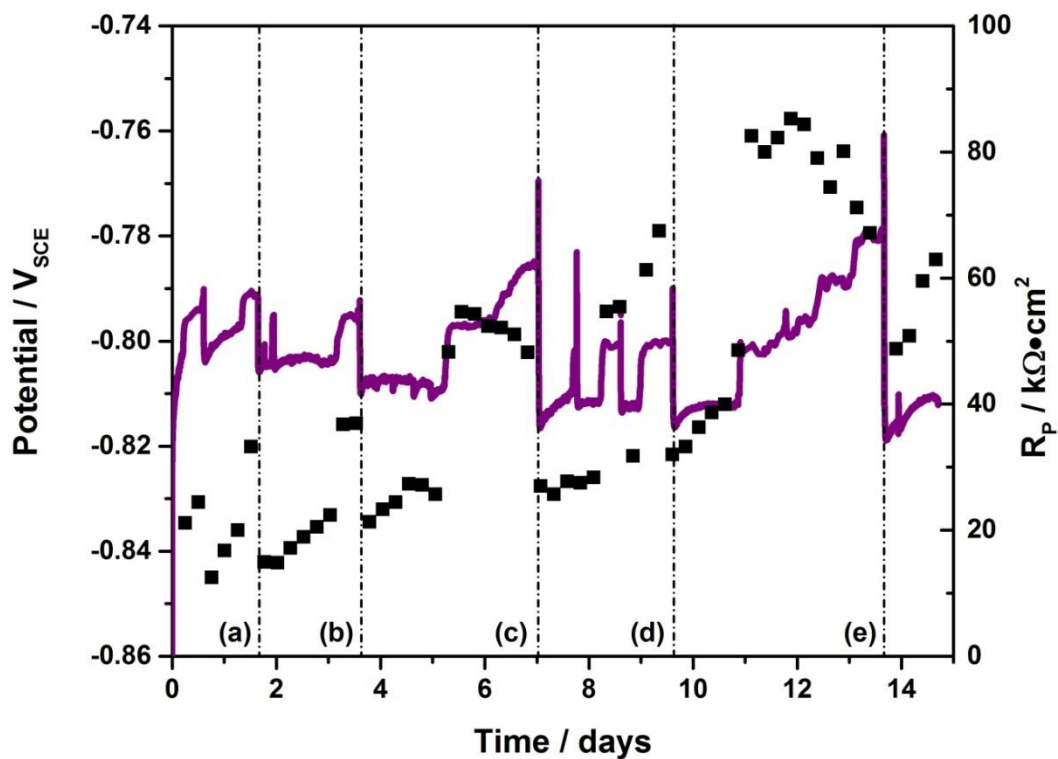
Figure 4-17: Corrosion potential (E_{CORR}) (solid line) and polarization resistance (R_p) (points) values recorded in $[Cl^-]=5.00$ M and $[HCO_3^-/CO_3^{2-}]=0.10$ M (#1). The dashed vertical lines indicate points at which the Ar sparging system needed to be replaced due to precipitate build-up.

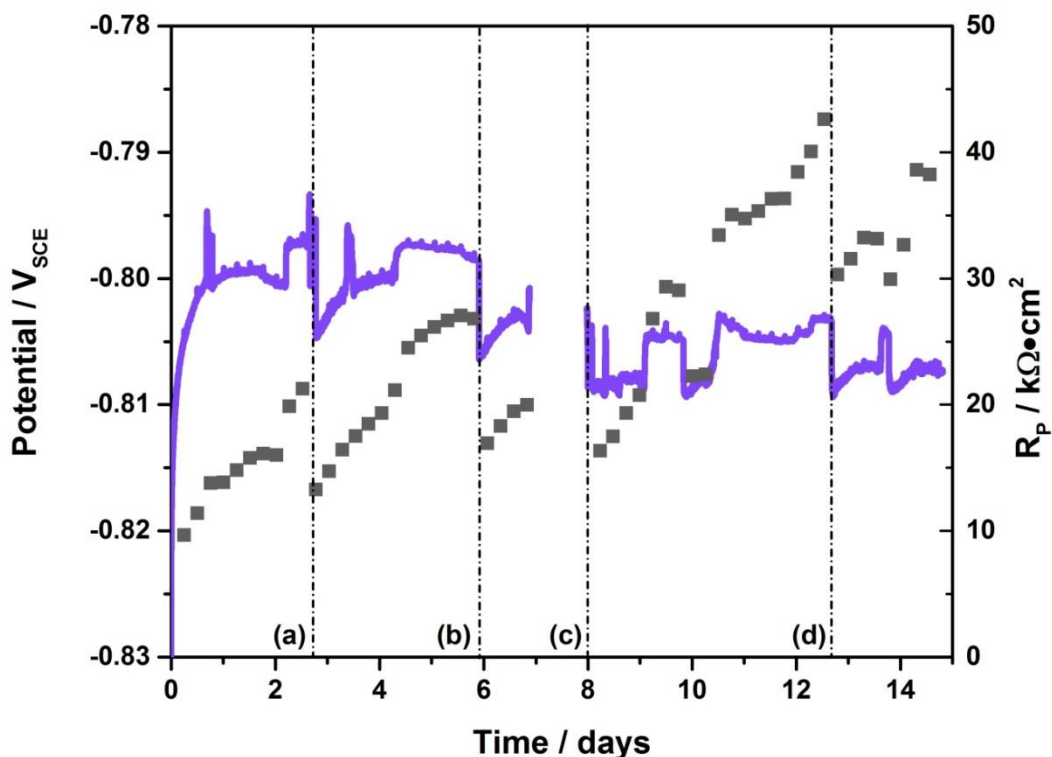
Figure 4-18: Corrosion potential (E_{CORR}) (solid line) and polarization resistance (R_p) (points) values recorded in $[Cl^-]=5.00\text{ M}$ and $[HCO_3^-/CO_3^{2-}]=0.10\text{ M}$ (#2). The dashed vertical lines indicate points at which the Ar sparging system needed to be replaced due to precipitate build-up

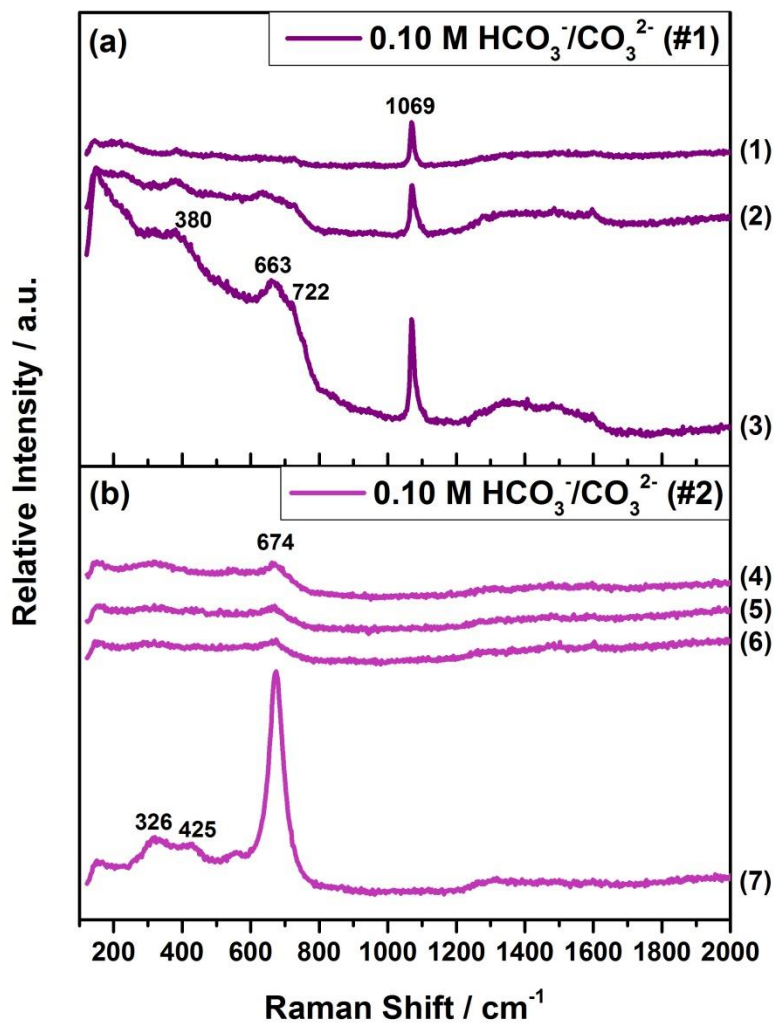
Figure 4-20: Ex-situ Raman spectra (1-7) recorded at various locations on the steel surface after exposure to 5.0 M Cl^- solutions containing $[\text{HCO}_3^-/\text{CO}_3^{2-}]=0.10$ M.

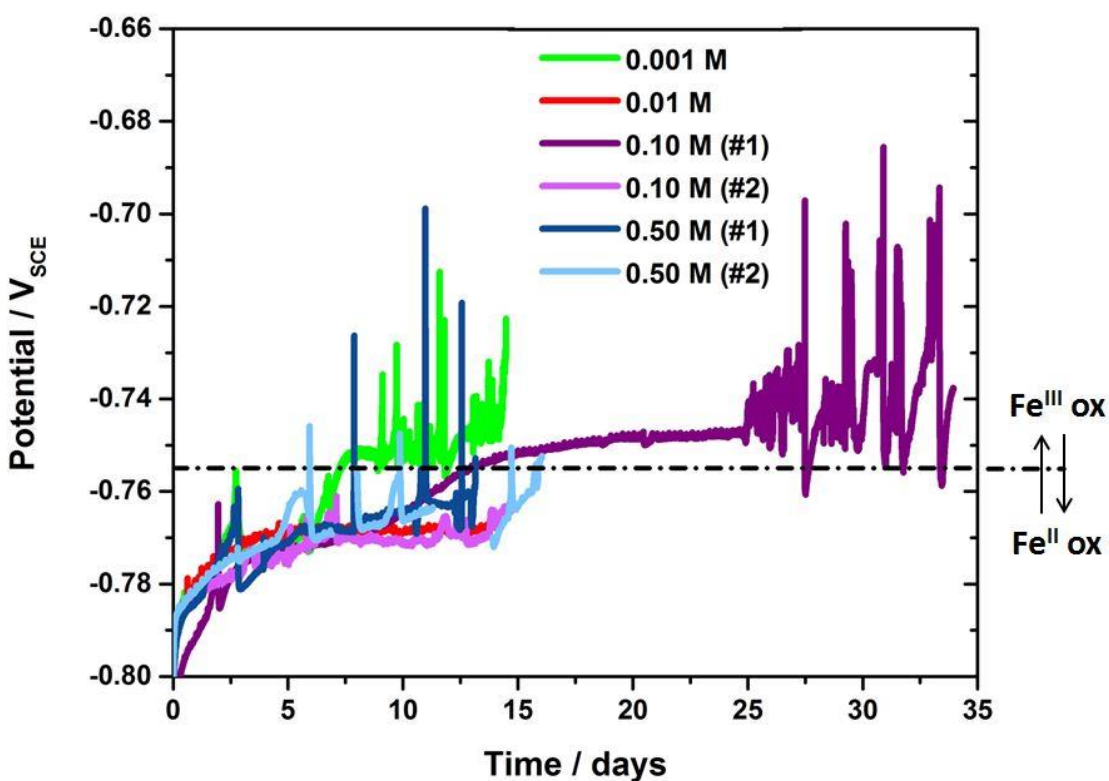
Figure 4-26: Corrosion potentials (E_{CORR}) for solutions containing 5.00 M Cl^- and various concentrations of SO_4^{2-} . The dashed horizontal line represents the thermodynamic boundary for the transformation of $\text{Fe}(\text{OH})_2$ to $\alpha\text{-Fe}_2\text{O}_3$.

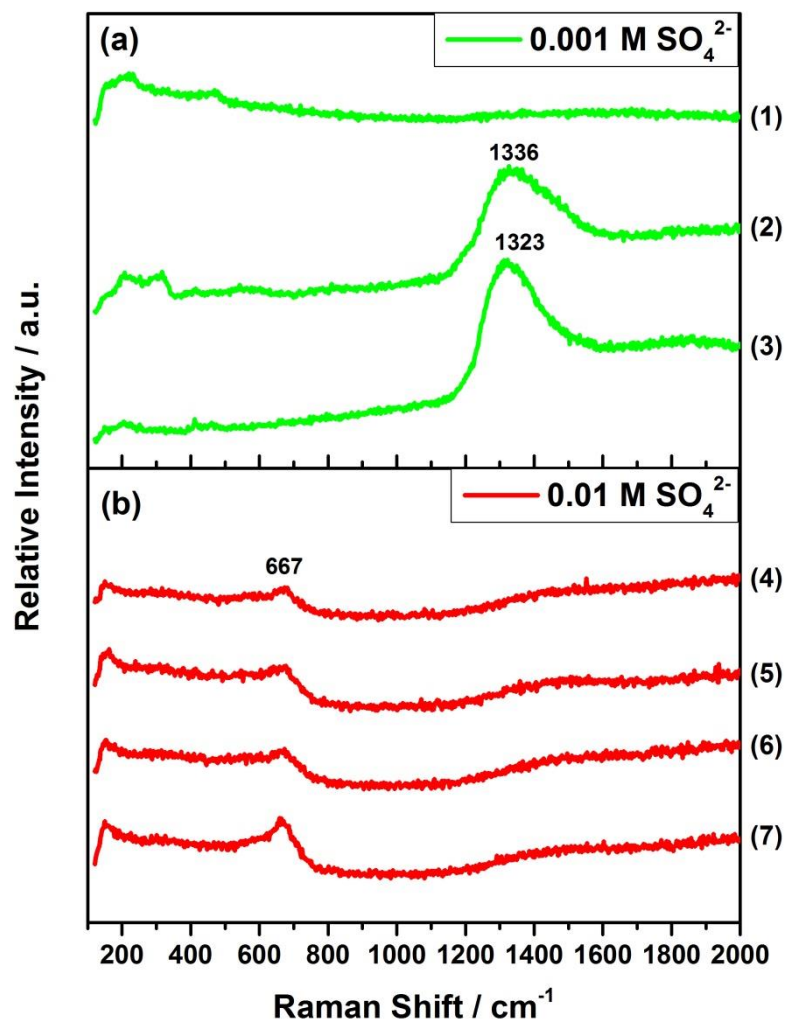
Figure 4-28: Ex-situ Raman spectra (1-7) recorded at various locations on the steel surface after exposure to 5.0 M Cl⁻ solutions with (a) [SO₄²⁻]=0.001 M; (b) [SO₄²⁻]=0.01 M.

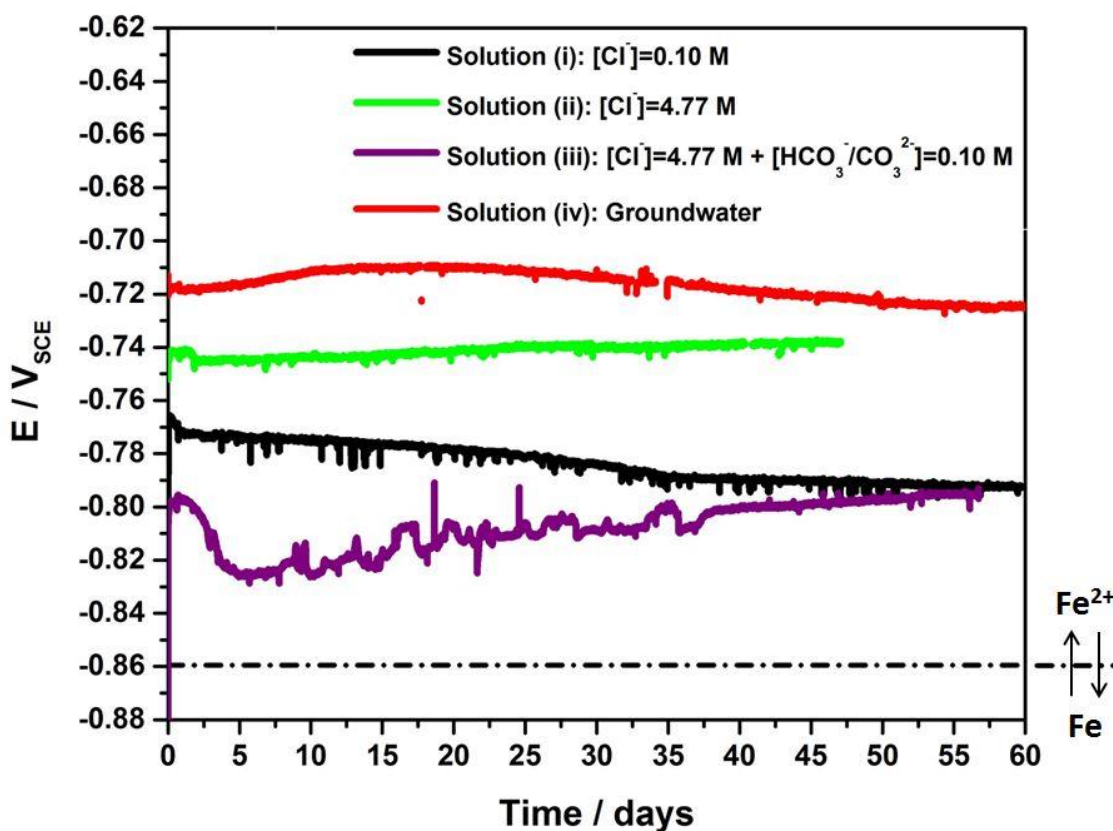
Figure 5-1: Corrosion potential (E_{CORR}) measurements recorded on steel exposed to solutions (i) to (iv) (Table 5-1 and Table 5-2).

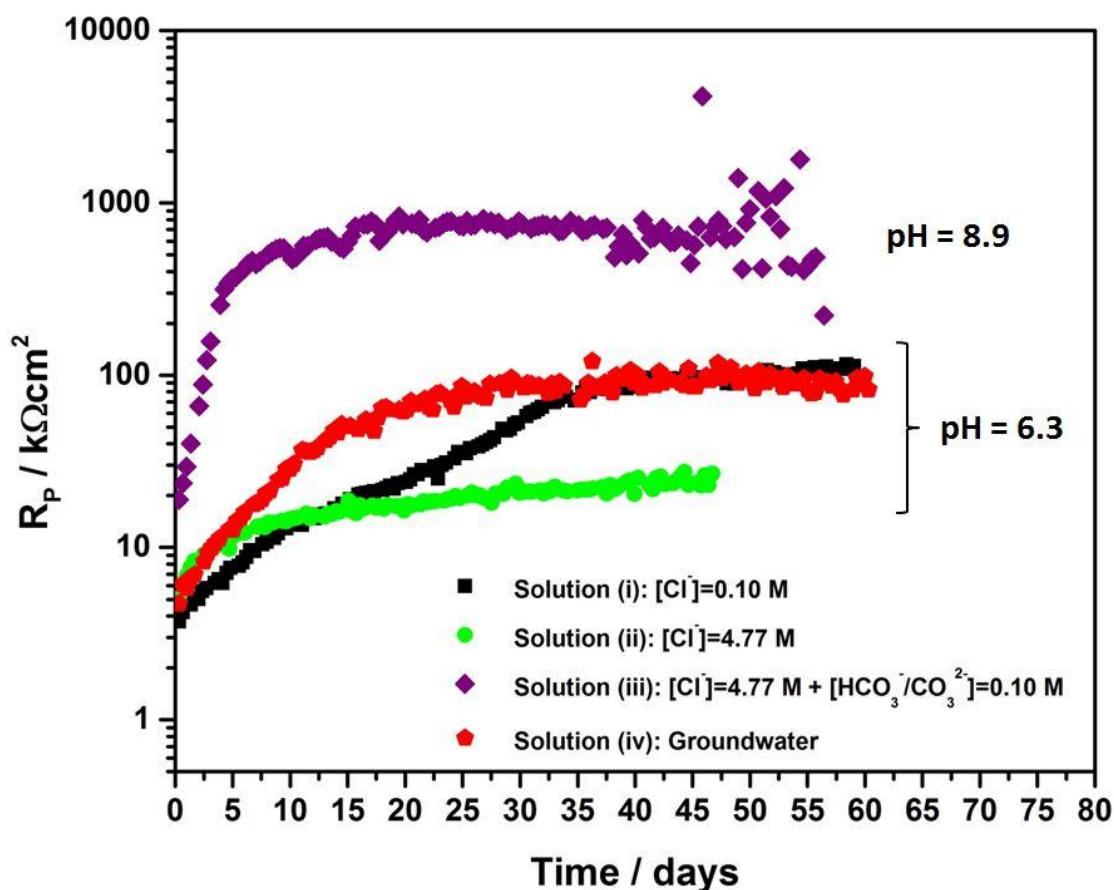
Figure 5-2: Polarization resistance (R_p) measurements recorded on steel exposed to solutions (i) to (iv) (Table 5-1 and Table 5-2).

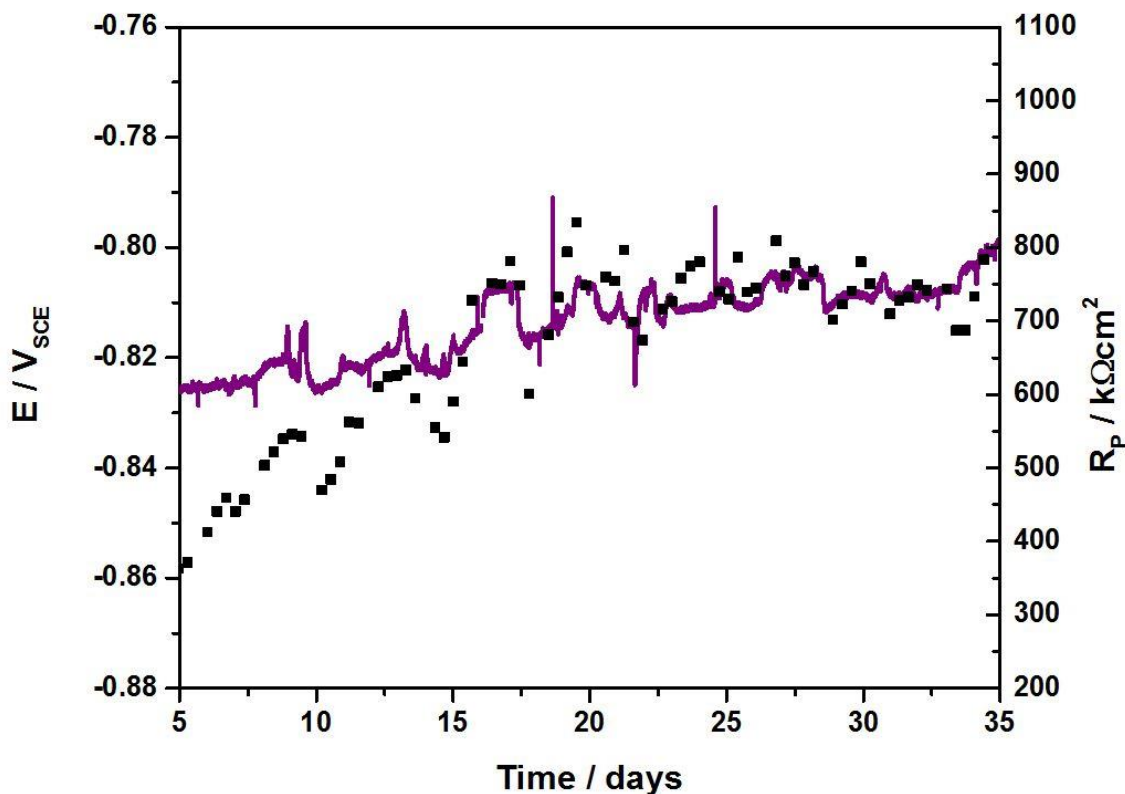
Figure 5-3: Corrosion potential (E_{CORR}) (solid line) and polarization resistance (R_p) (points) measurements for steel exposed to solution (iii) (Table 5-1) over a period of 5-35 days showing simultaneous fluctuations in the values of both E_{CORR} and R_p .

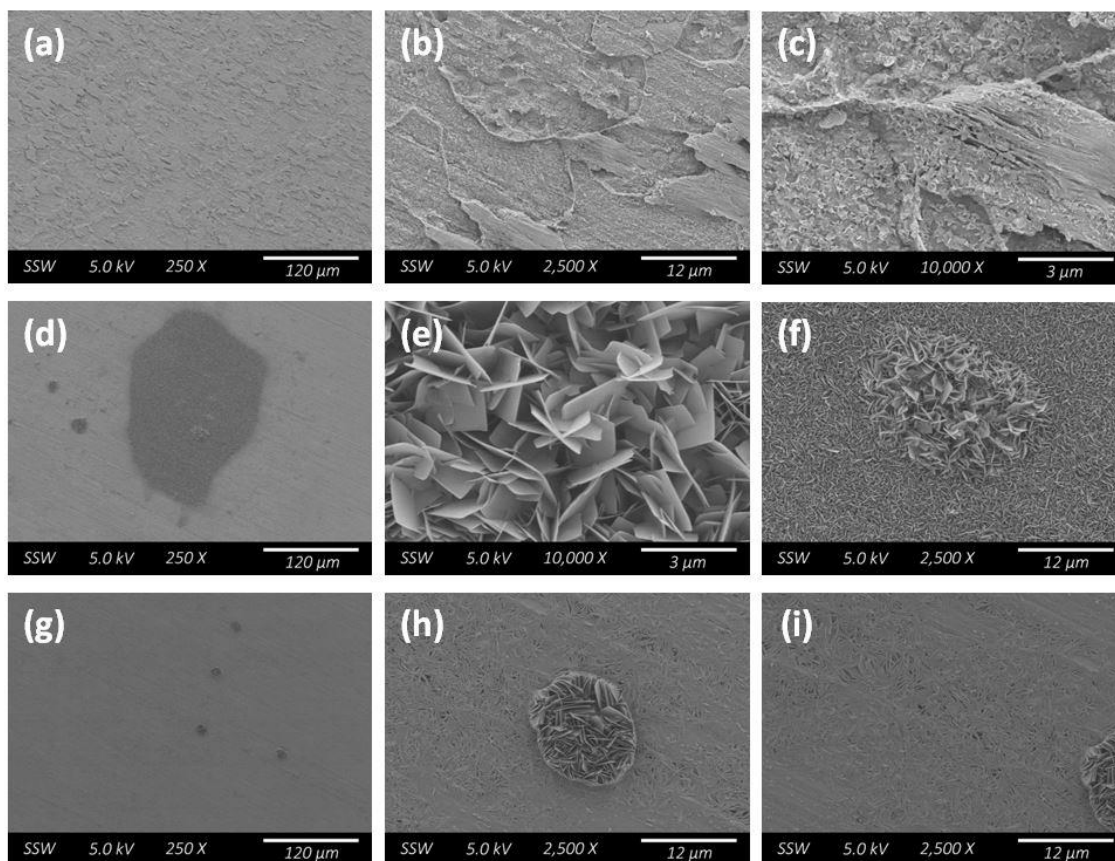
Figure 5-9: SEM micrographs of the corrosion product formed after 60 days of exposure to solution (i) (Table 5-1) for (a-c) the general steel surface; (d-f) patches of crystalline $\text{Fe}_2(\text{OH})_2\text{CO}_3$; and (g-i) additional locations showing distribution (g) and the morphology ((h) and (i)) of the crystalline patches.

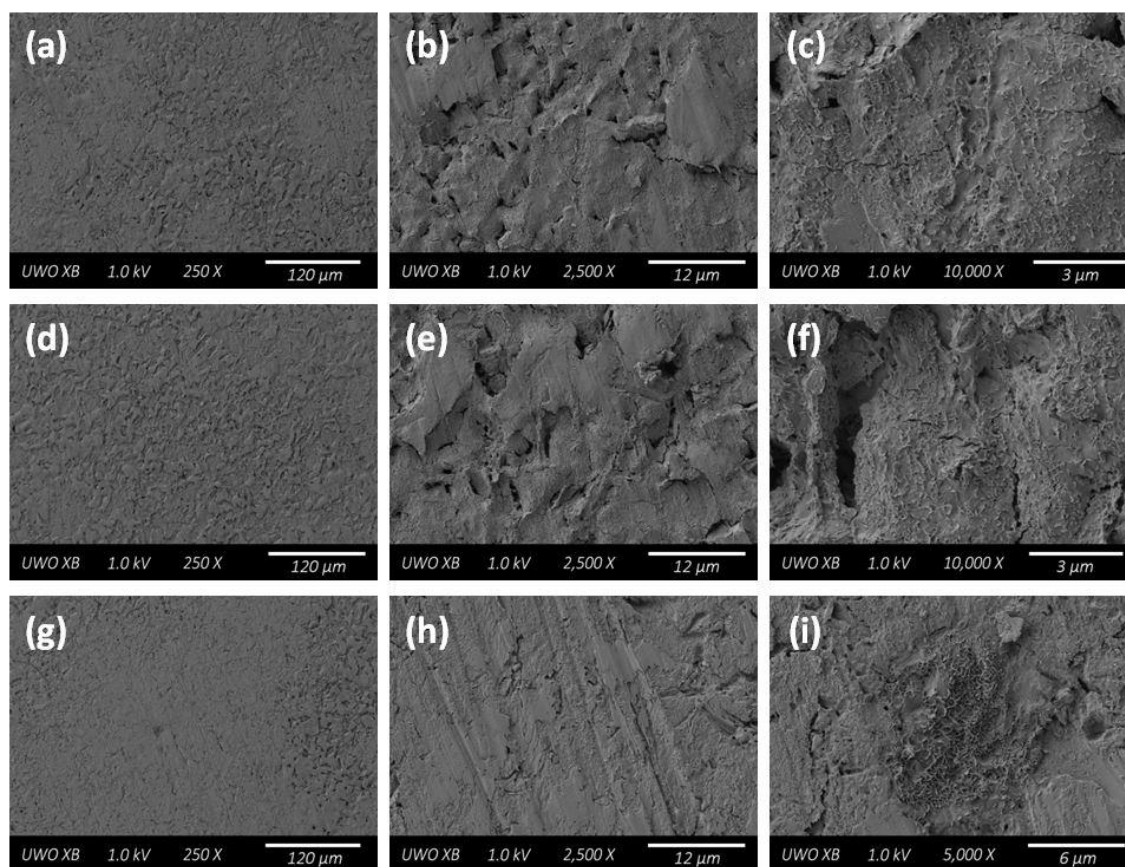
Figure 5-13: SEM micrographs recorded on three locations on the surface after 47 days of exposure to solution (ii) (Table 5-1).

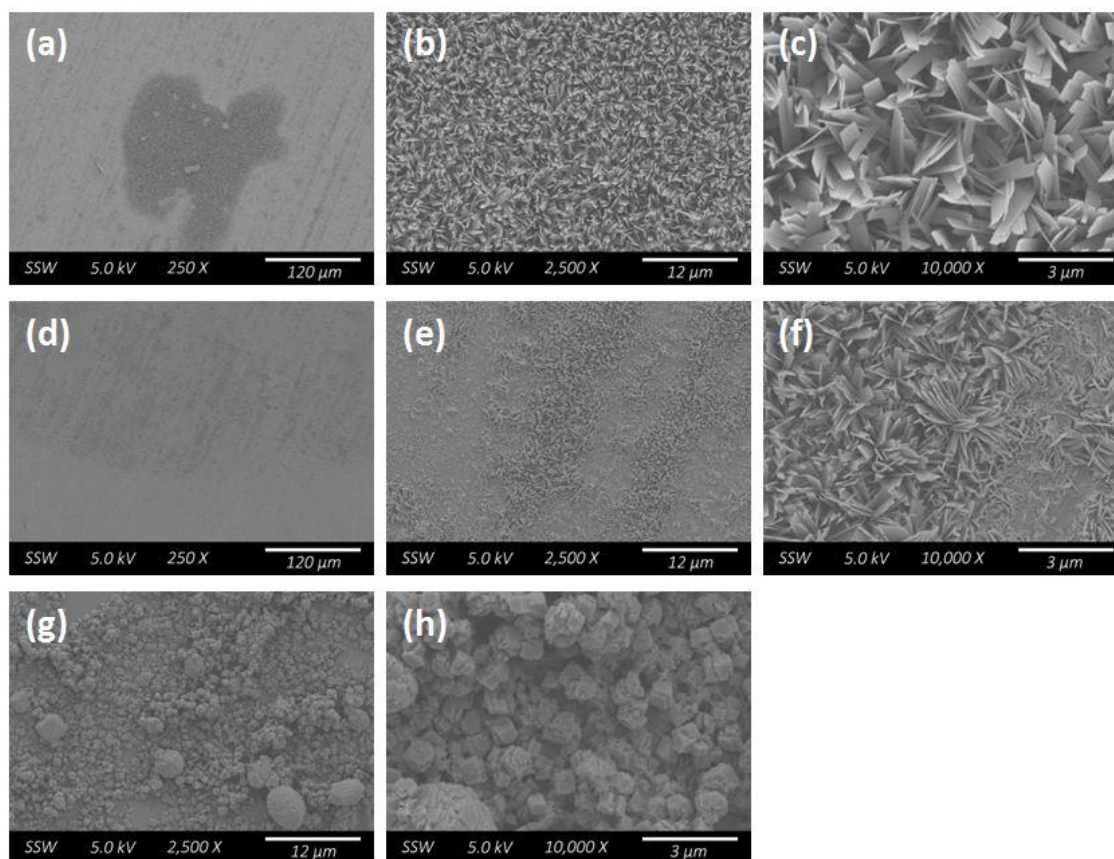
Figure 5-14: SEM micrographs recorded on the steel surface after 57 days of exposure to solution (iii) (Table 5-1) showing: (a-c) a large patch of $\text{Fe}_2(\text{OH})_2\text{CO}_3$; (d-f) the uneven distribution of $\text{Fe}_2(\text{OH})_2\text{CO}_3$ on the steel surface; (g-h) a location covered by small multi-faceted cubic crystals.

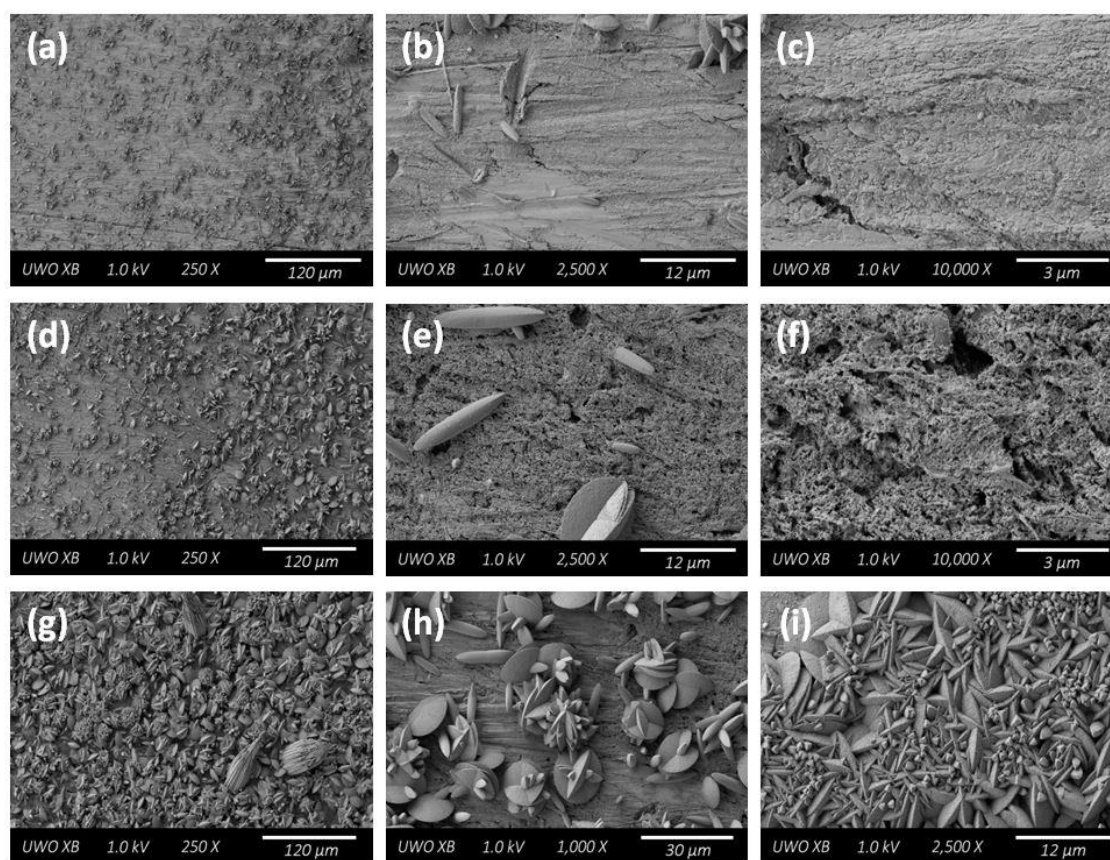
Figure 5-17: SEM micrographs recorded on the steel surface after 60 days of exposure to solution (iv) (Table 5-2) showing: (a-f) two regions on the sample surface with different coverages by deposits but exhibiting the same underlying morphology; (g) a region covered by a more dense crystal layer with the morphology of the disc-shaped and spherical star-shaped crystals shown in (h) and (i).

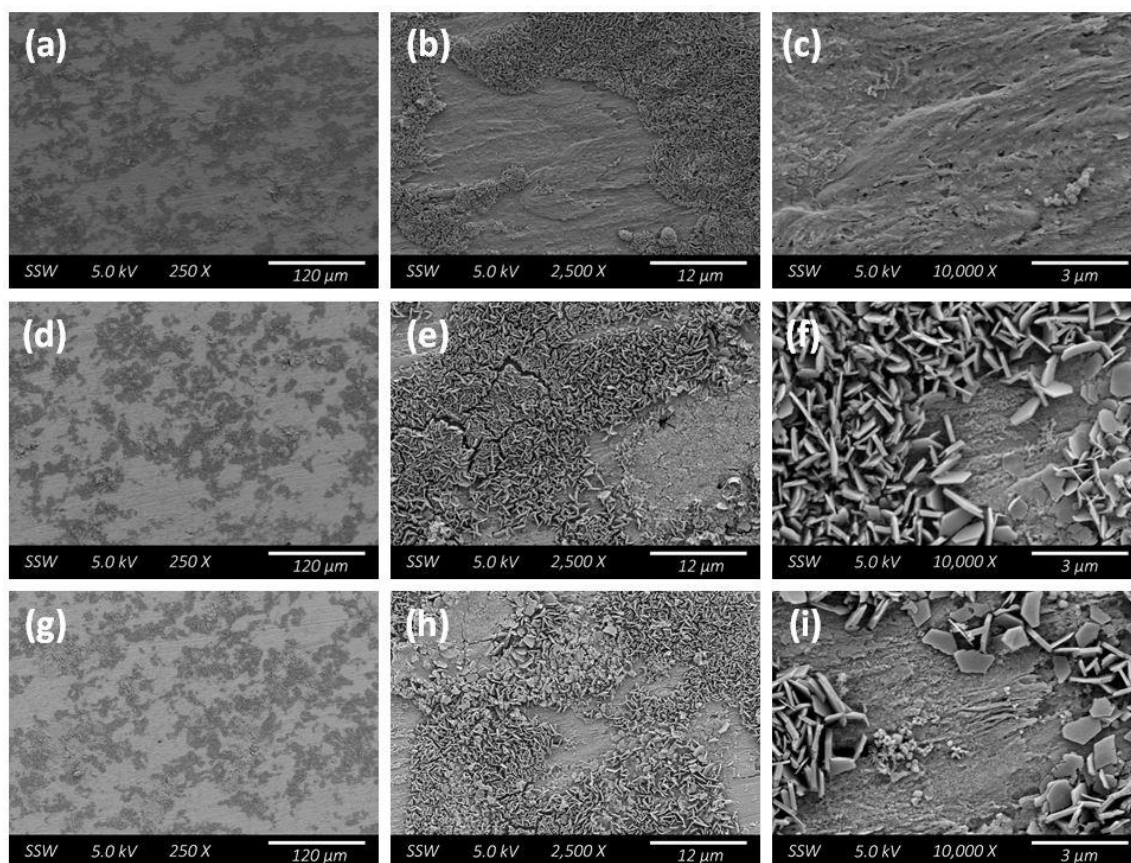
Figure 6-11: SEM micrographs recorded on three locations of a specimen surface (a-c), (d-f), and (g-h) after 4 days of exposure to solution (i) showing the distributions of crystalline $\gamma\text{-Fe}_2\text{O}_3$ and the general surface morphology.

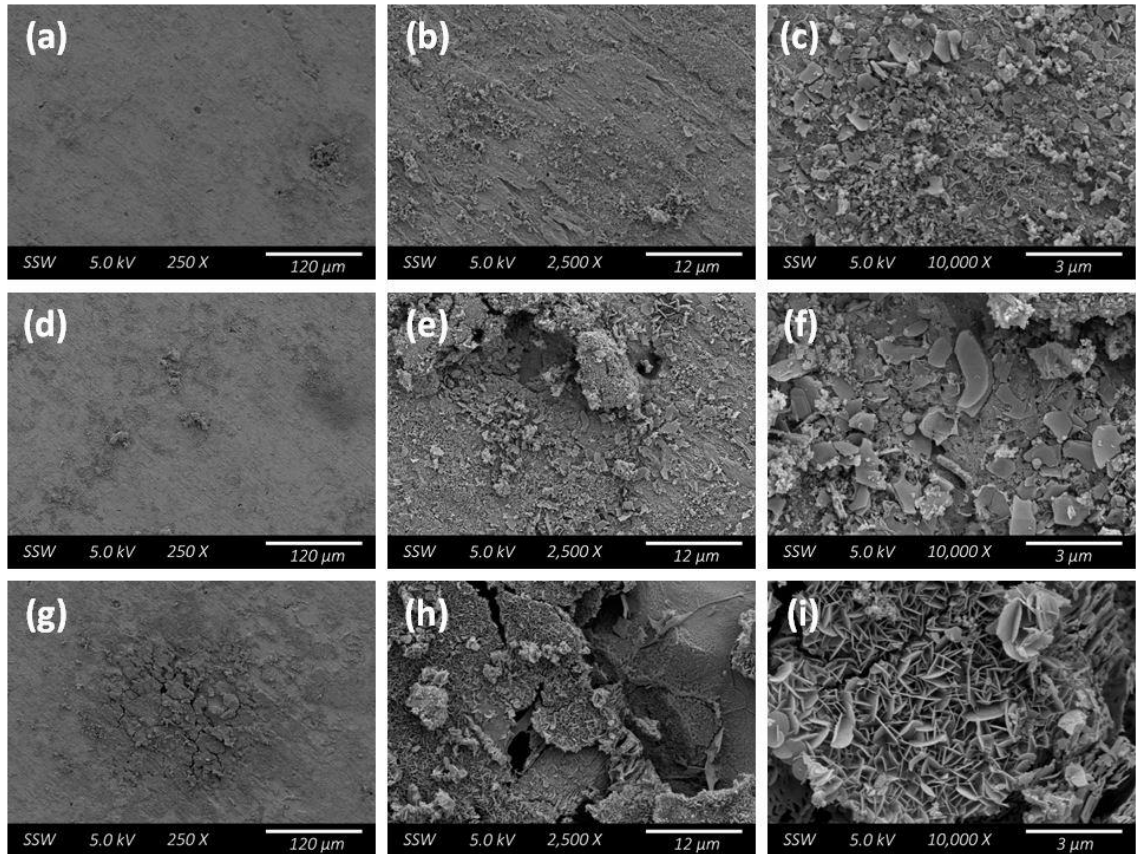
Figure 6-12: SEM micrographs recorded on a specimen surface after 14 days of exposure to solution (i) showing: (a-f) the general surface morphology; (g-i) a region exhibiting a higher degree of corrosion damage.

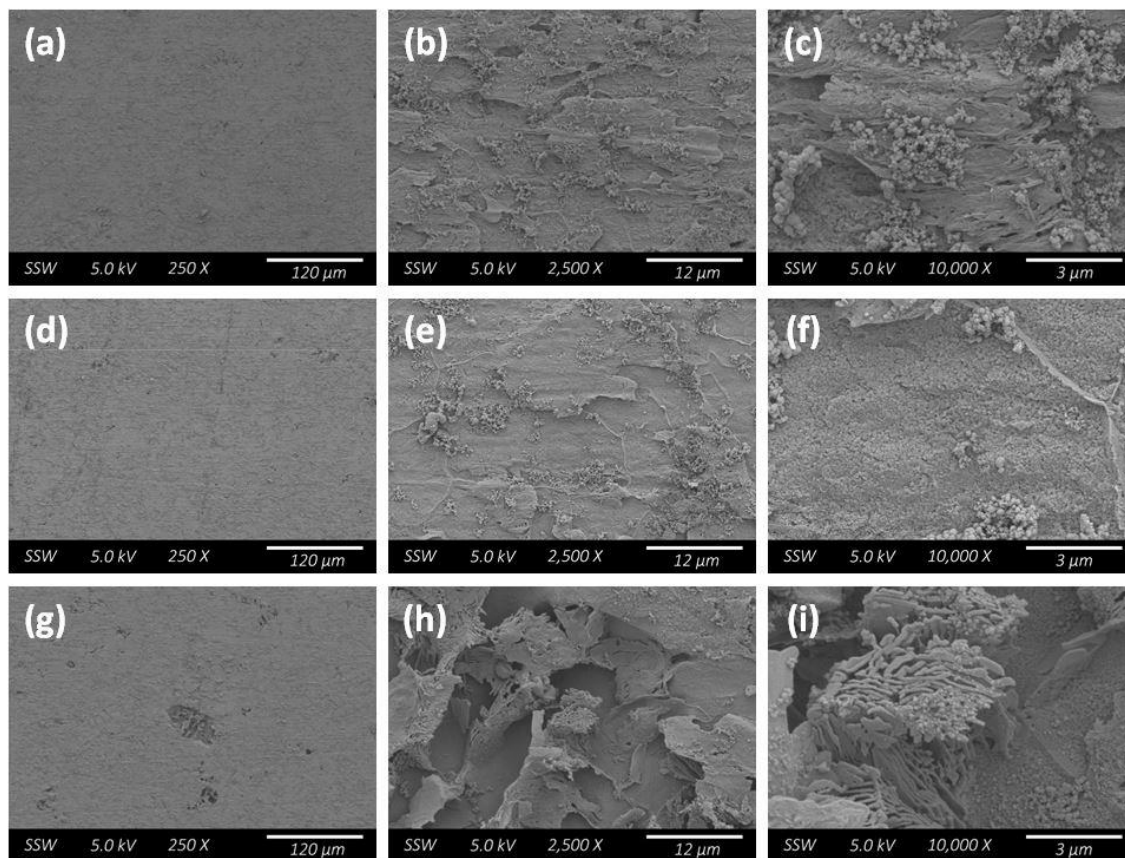
Figure 6-13: SEM micrographs recorded on a specimen surface after 110 days of exposure to solution (i) showing: (a-f) the general surface morphology; (g-i) a layered morphology consistent with the remnants of Fe_3C from ferrite dissolution of pearlite grains.

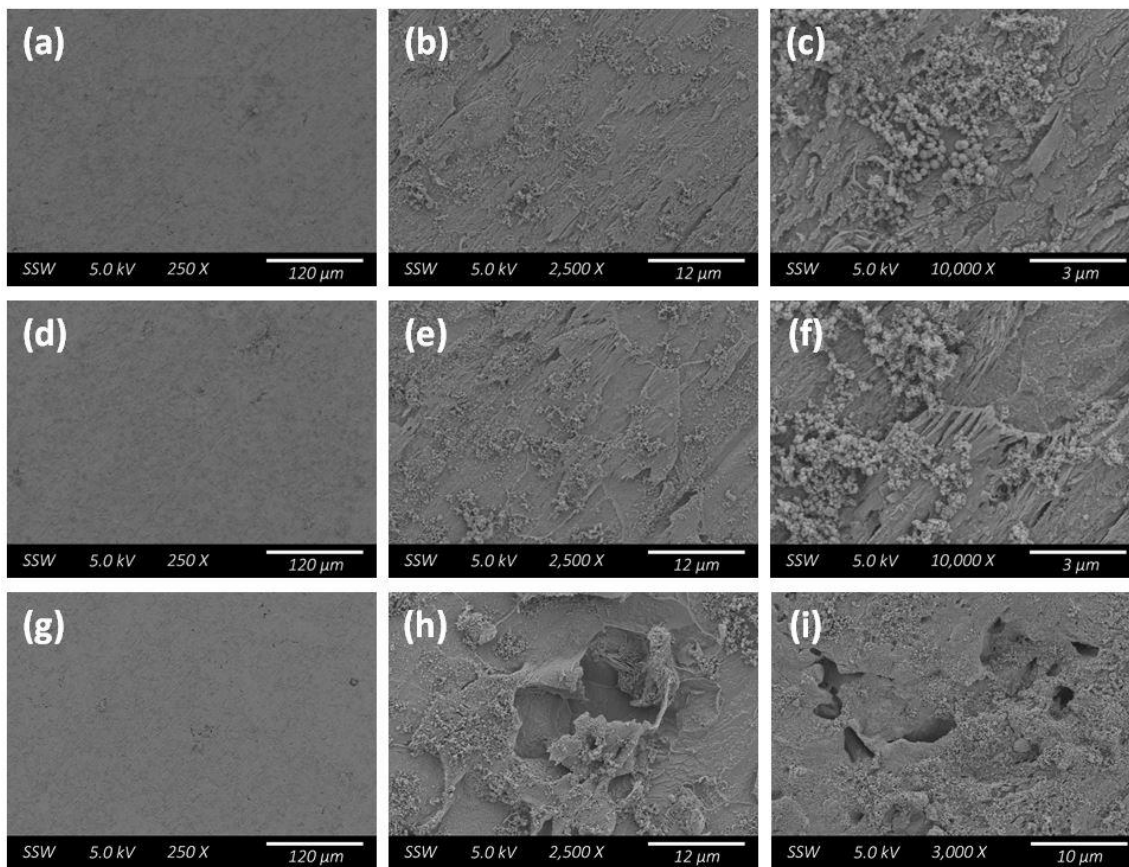
Figure 6-14: SEM micrographs recorded on a specimen surface after 252 days of exposure to solution (i) showing: (a-e) the general surface morphology; (f) the preferential corrosion of ferrite in pearlite grains; (g-i) a region of localized damage.

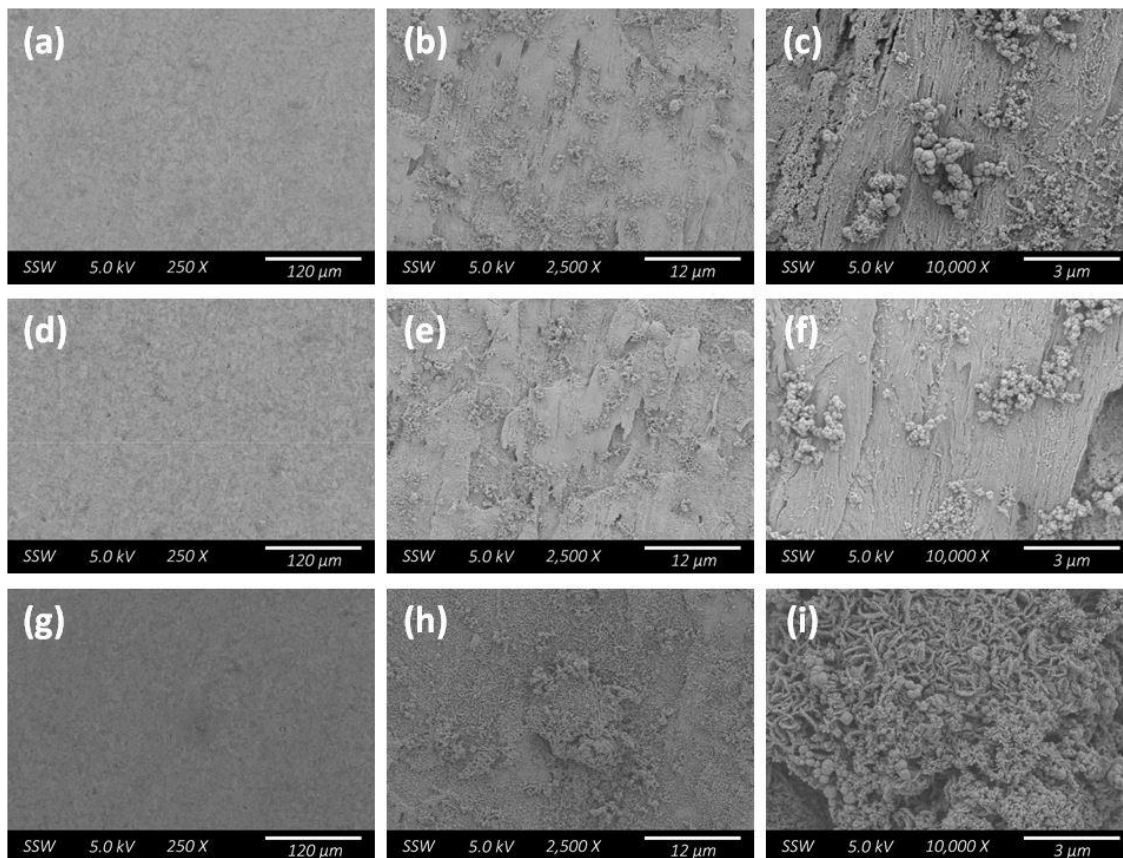
Figure 6-15: SEM micrographs recorded on a specimen surface after 365 days of exposure to solution (i) showing: (a-f) the general surface morphology; (g-i) a region exhibiting a more significant corrosion deposit.

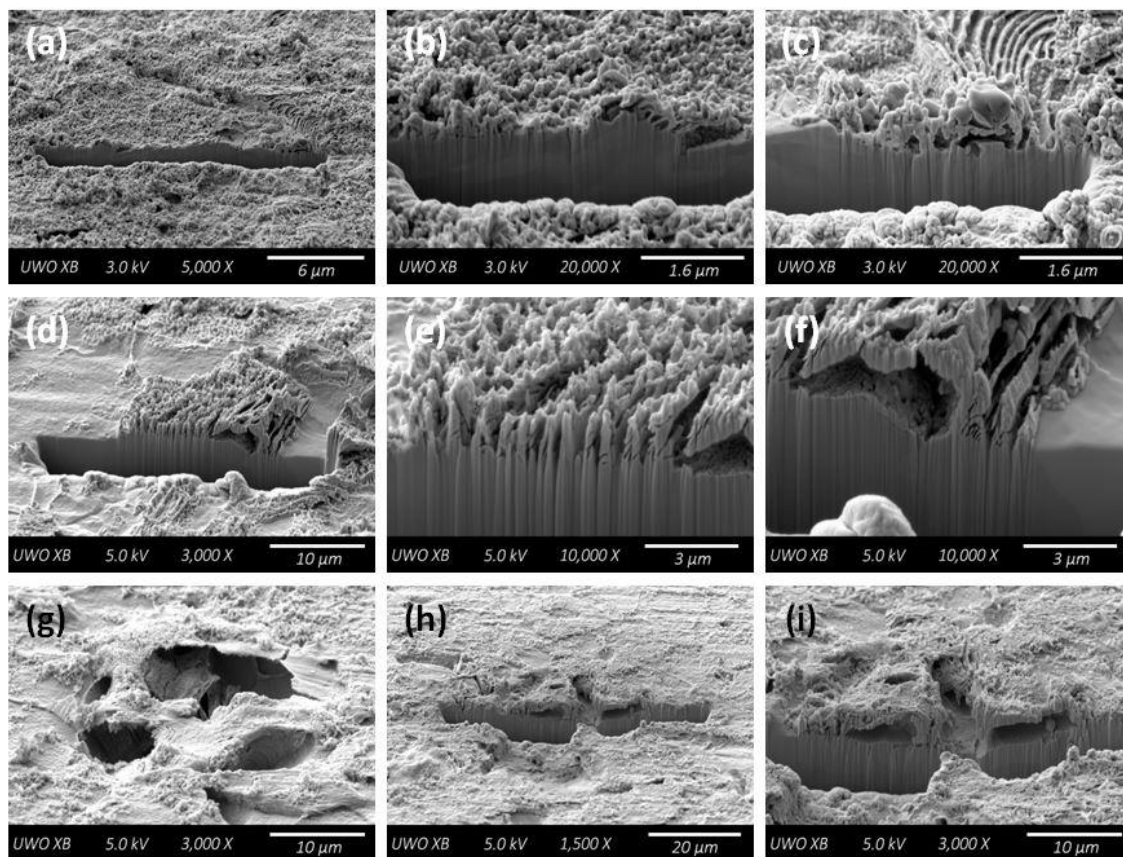
Figure 6-17: FIB cross-section micrographs recorded on a specimen surface after 252 days of exposure to solution (i) showing: (a-b) and (d-e) the thin nature of the corrosion film; (c) and (f) the residual bands of Fe_3C left behind after preferential dissolution of the $\alpha\text{-Fe}$ in the pearlite grains; (g-i) a region exhibiting void spaces created by corrosion under the surface oxide layer.
