The Corrosion of Carbon Steel under Deep Geologic Nuclear Waste Disposal Conditions

Shannon L.W. Hill
The University of Western Ontario

Graduate Program in Chemistry
A thesis submitted in partial fulfillment of the requirements for the degree in Doctor of Philosophy
© Shannon L.W. Hill 2016

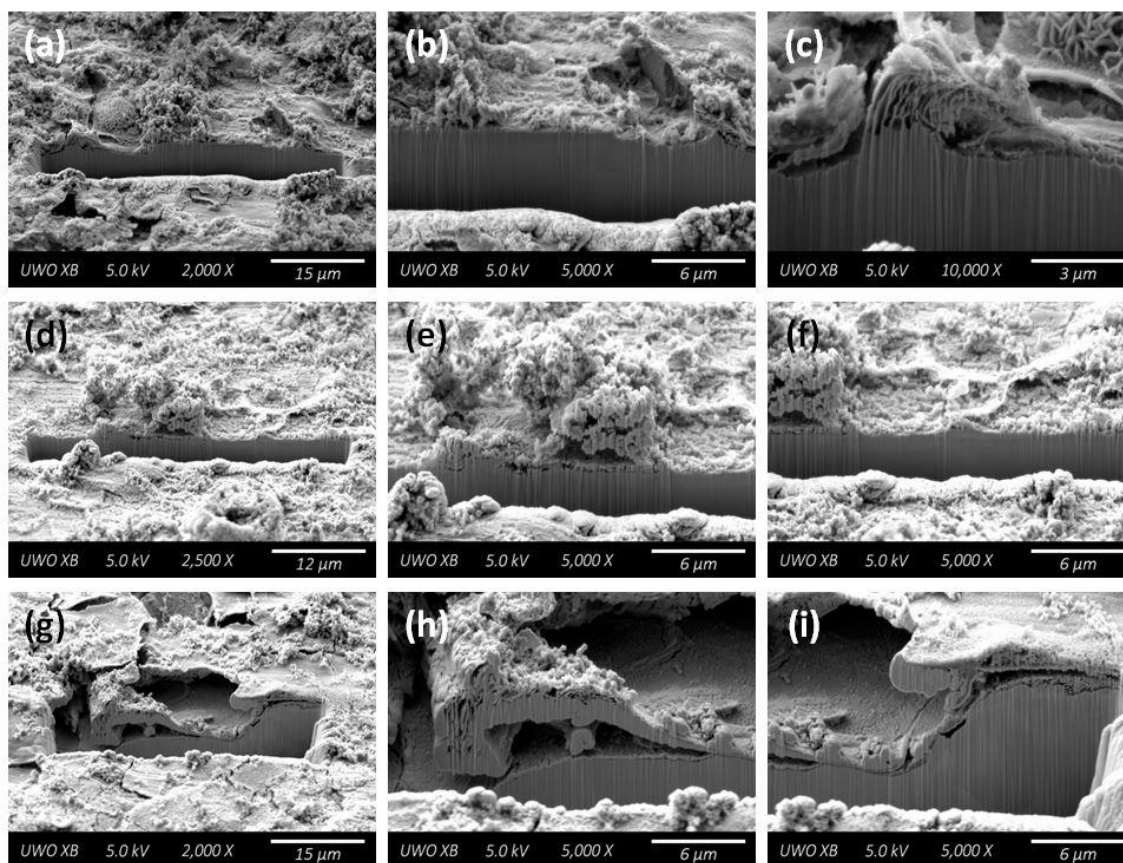
Figure 6-19: FIB cross-section micrographs recorded on a specimen surface after 604 days of exposure to solution (i) showing: (a-f) the thin nature of the corrosion film; (c) lamellae of Fe_3C left after the preferential dissolution of $\alpha\text{-Fe}$ from the pearlite grains; (g-i) a region exhibiting void spaces created by corrosion under the surface oxide layer.

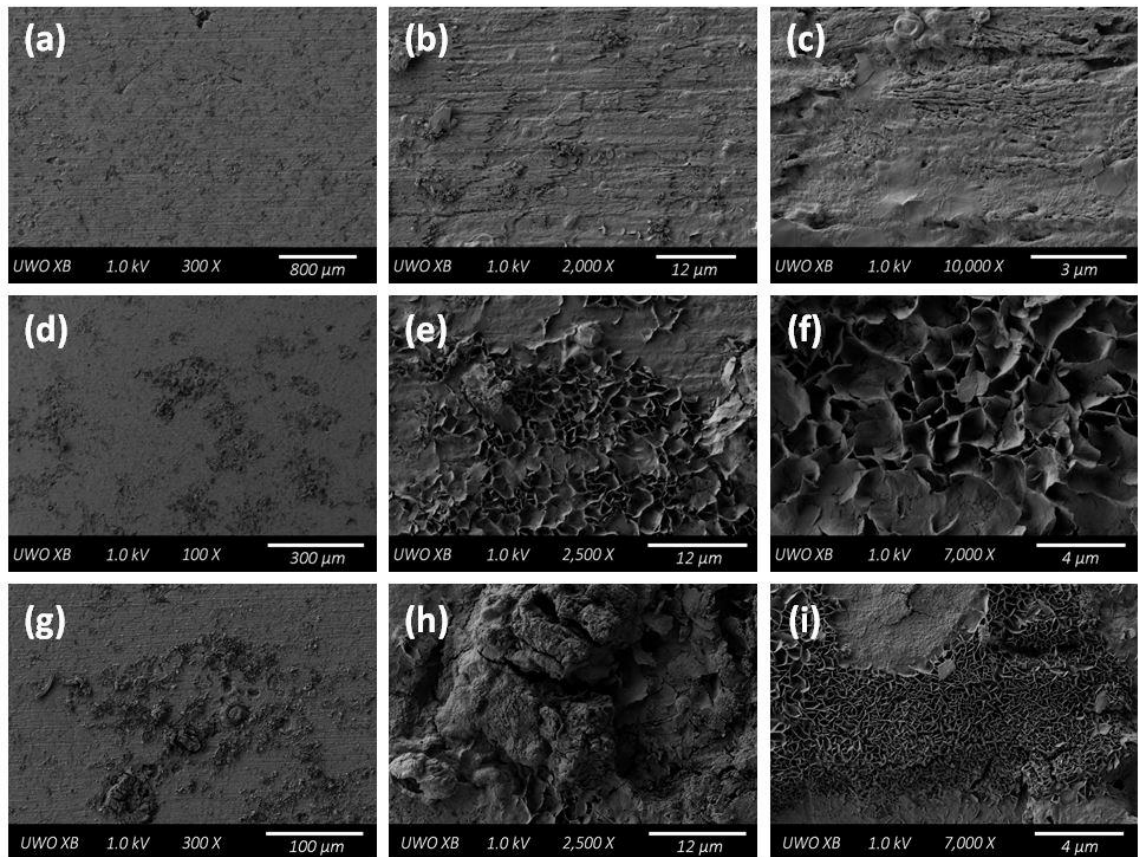
Figure 6-27: SEM micrographs recorded on a specimen surface after 4 days of exposure to solution (ii) showing a lightly corroded surface with (c) early stages of visible pearlite corrosion; (d-f) a region of crystalline corrosion product; (g-i) a more heavily corroded location.

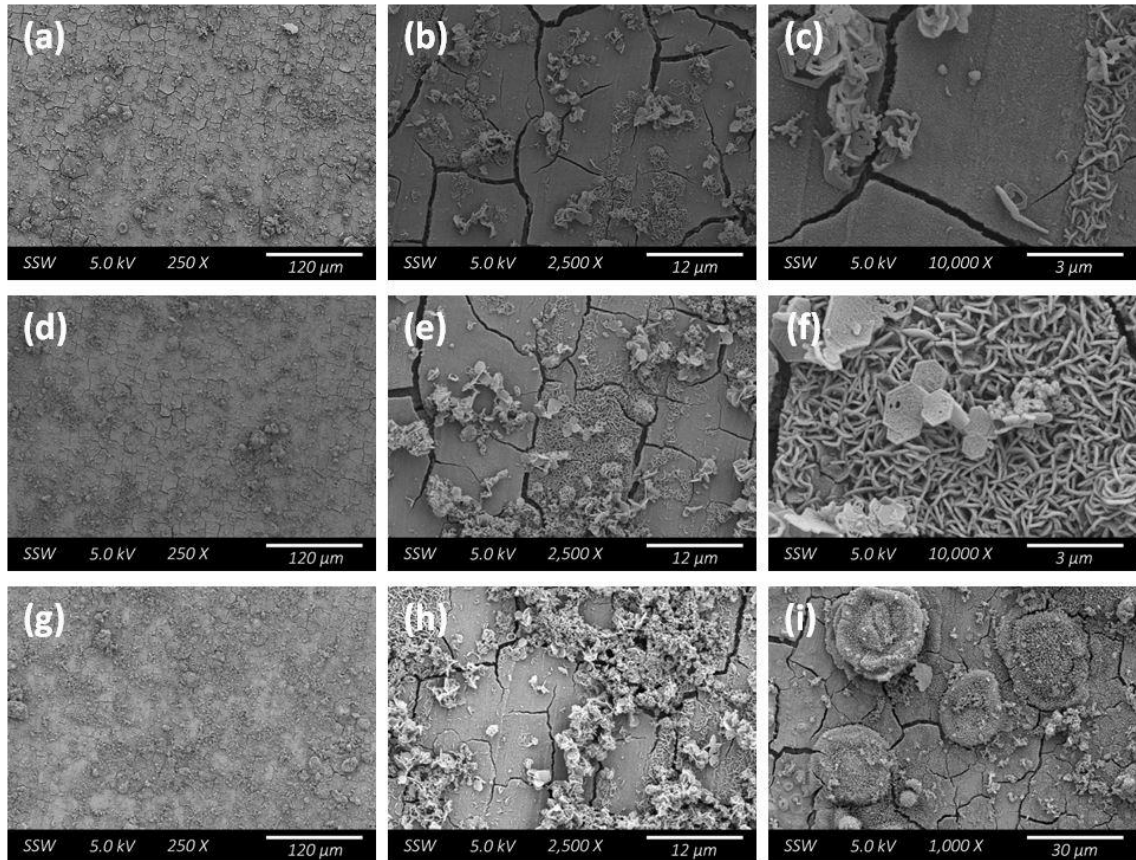
Figure 6-28: SEM micrographs recorded on a specimen surface after 110 days of exposure to solution (ii) showing: (a-f) regions of the general surface with a compact underlying film with interspersed platelet structures; (g-h) regions with overlying corrosion product deposits; (i) localized corrosion products on the order of 15-30 μm .

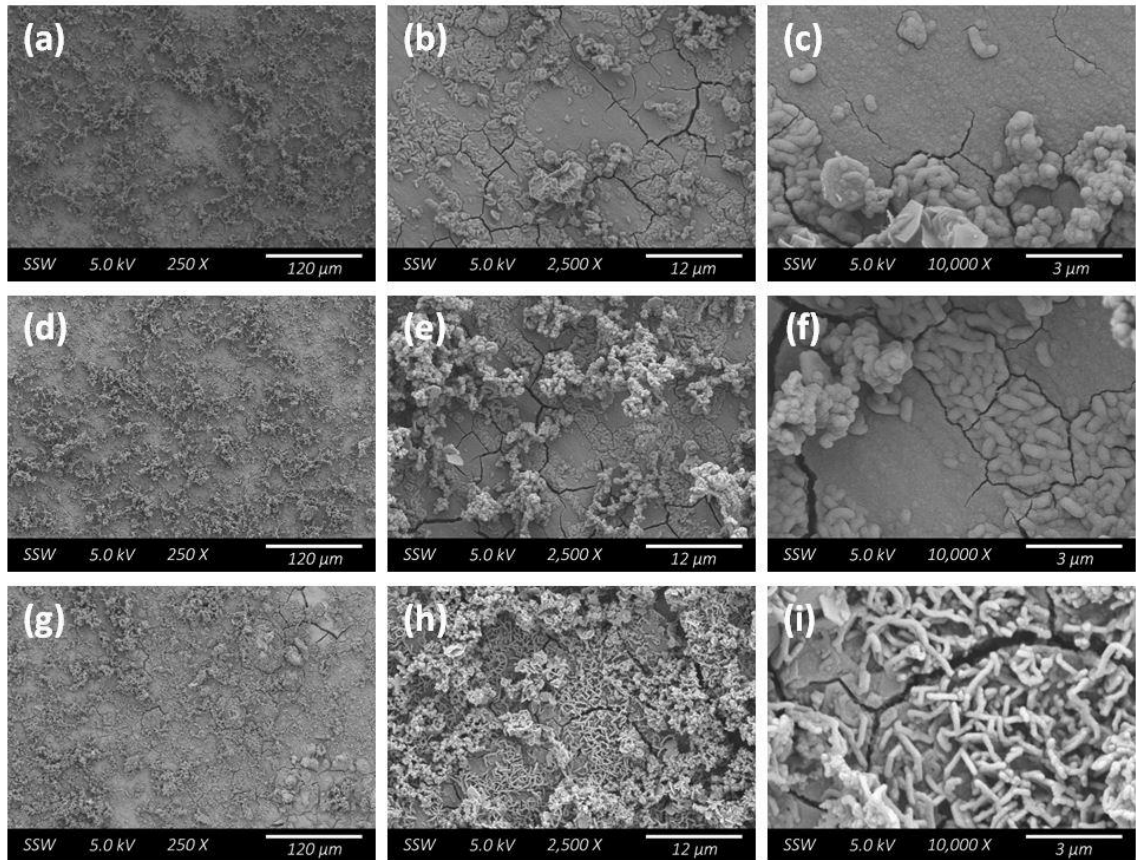
Figure 6-29: SEM micrographs recorded on a specimen surface after 252 days of exposure to solution (ii) showing: (a-f) the general surface and underlying corrosion layer; (g-i) corrosion product deposits, possible $\gamma\text{-Fe}_2\text{O}_3$.

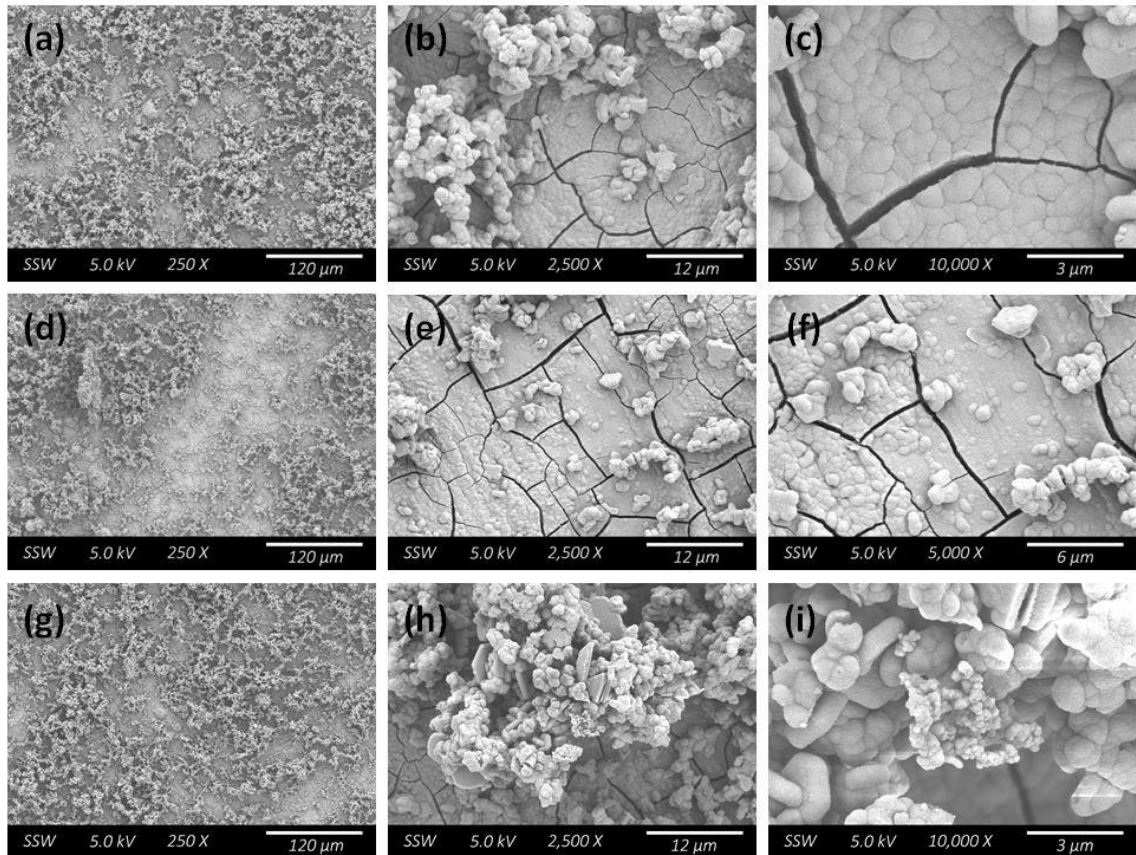
Figure 6-30: SEM micrographs recorded on a specimen surface after 548 days of exposure to solution (ii) showing: (a-f) the general surface with increasing levels of corrosion product deposits; (g-i) the morphology of the overlying corrosion product deposits.

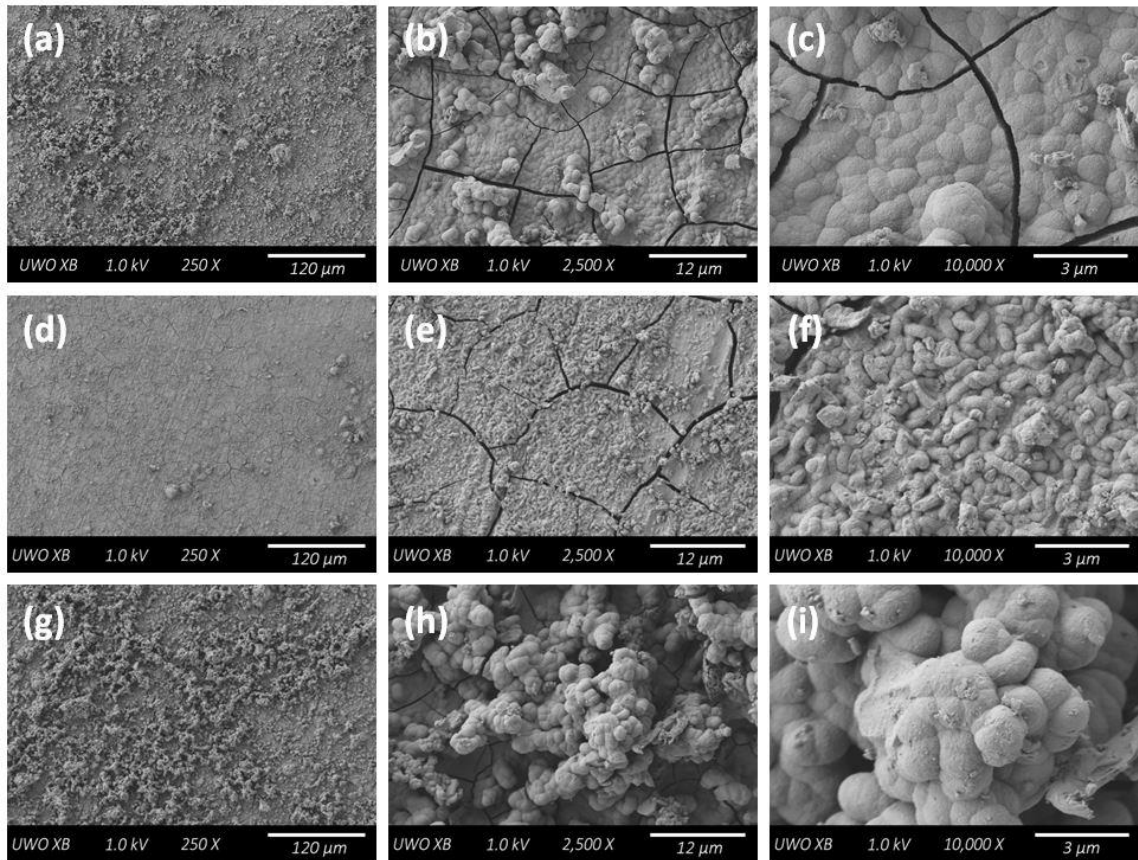
Figure 6-31: SEM micrographs recorded on a specimen surface after 716 days of exposure to solution (ii) showing: (a-f) regions with a visible underlying corrosion layer; (g-i) a region exhibiting extensive overlying corrosion product deposits.

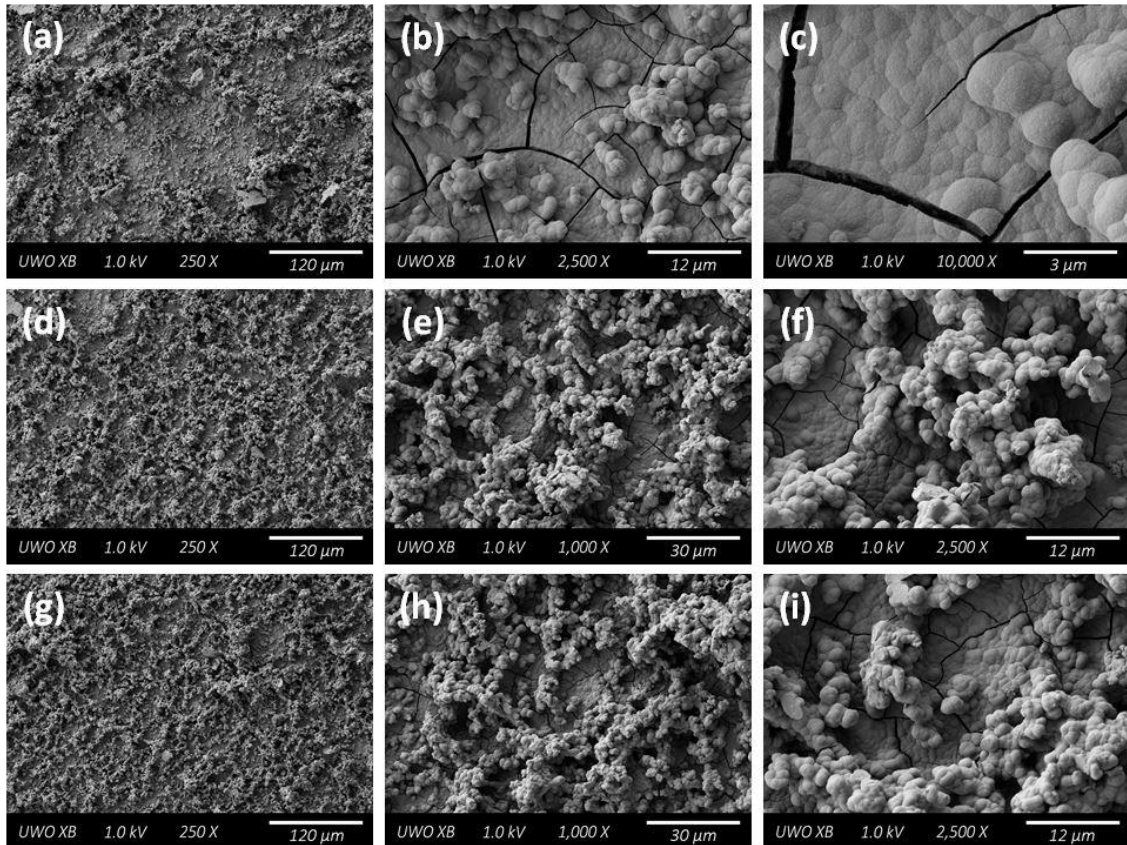
Figure 6-32: SEM micrographs recorded on a specimen surface after 910 days of exposure to solution (ii) showing: (a-c) the general underlying corrosion film; (d-i) the increasing extent of surface coverage by corrosion product deposits.

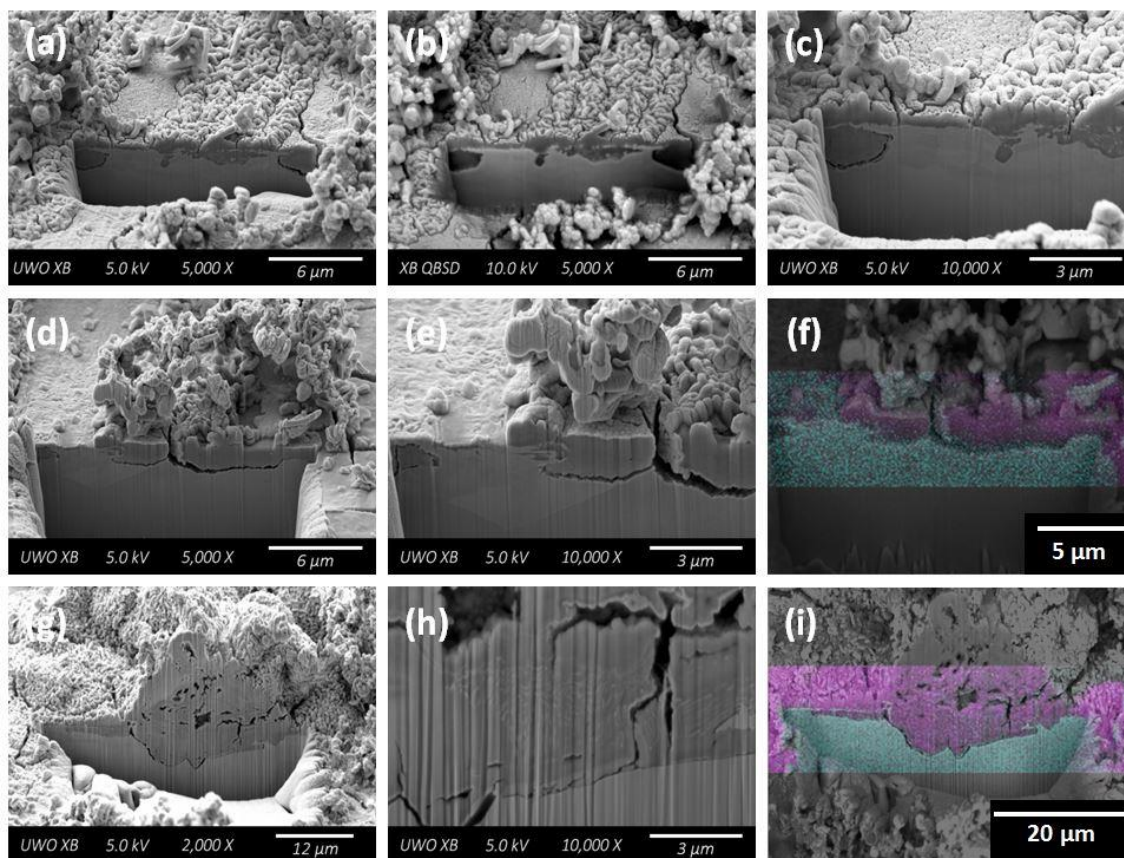
Figure 6-33: FIB cross-section micrographs recorded on a specimen surface after 252 days of exposure to solution (ii) showing: (a-c) that penetration beneath the compact film is minor; (d-f) a cut through an overlying deposit which has experienced more extensive penetration; (g-i) a cut through a large corrosion deposit at a location which has experienced more extensive corrosion. The backscatter image in (b) highlights the interface between the base metal (bright) and the oxide film (dark). EDX maps (f and i) further highlight the interface by mapping of elemental oxygen (pink) and iron (blue).

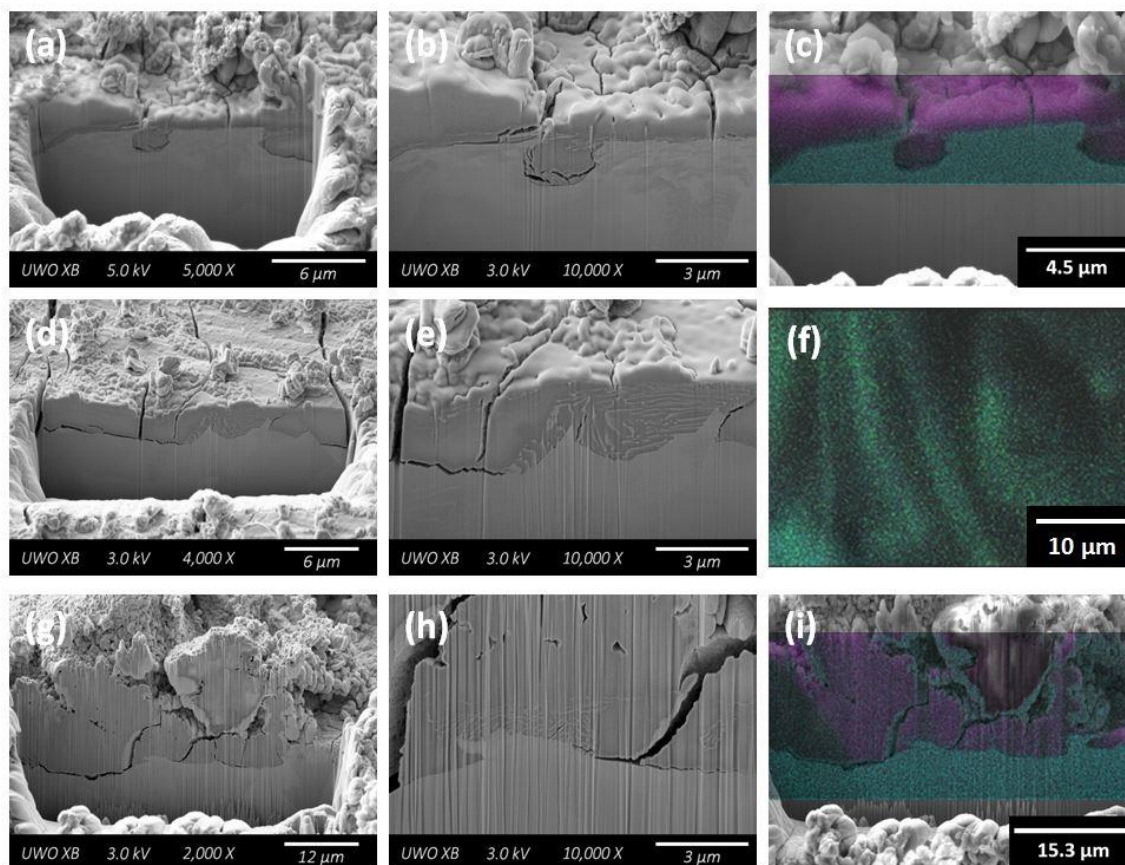
Figure 6-34: FIB cross-section micrographs recorded on a specimen surface after 548 days of exposure to solution (ii) showing: (a-f) a thickening of the film to $\sim 3 \mu\text{m}$ with more penetrating damage beneath thicker regions; (e) bright bands within the oxide structure, which the EDX map (f) for iron (blue) and carbon (green), shows are residual Fe_3C bands of the pearlite grains; (g-i) a cut through a large deposit which appears porous and non-protective. The EDX maps (c,i) highlight the interface between the base metal and the oxide film by mapping of elemental oxygen (pink) and iron (blue).

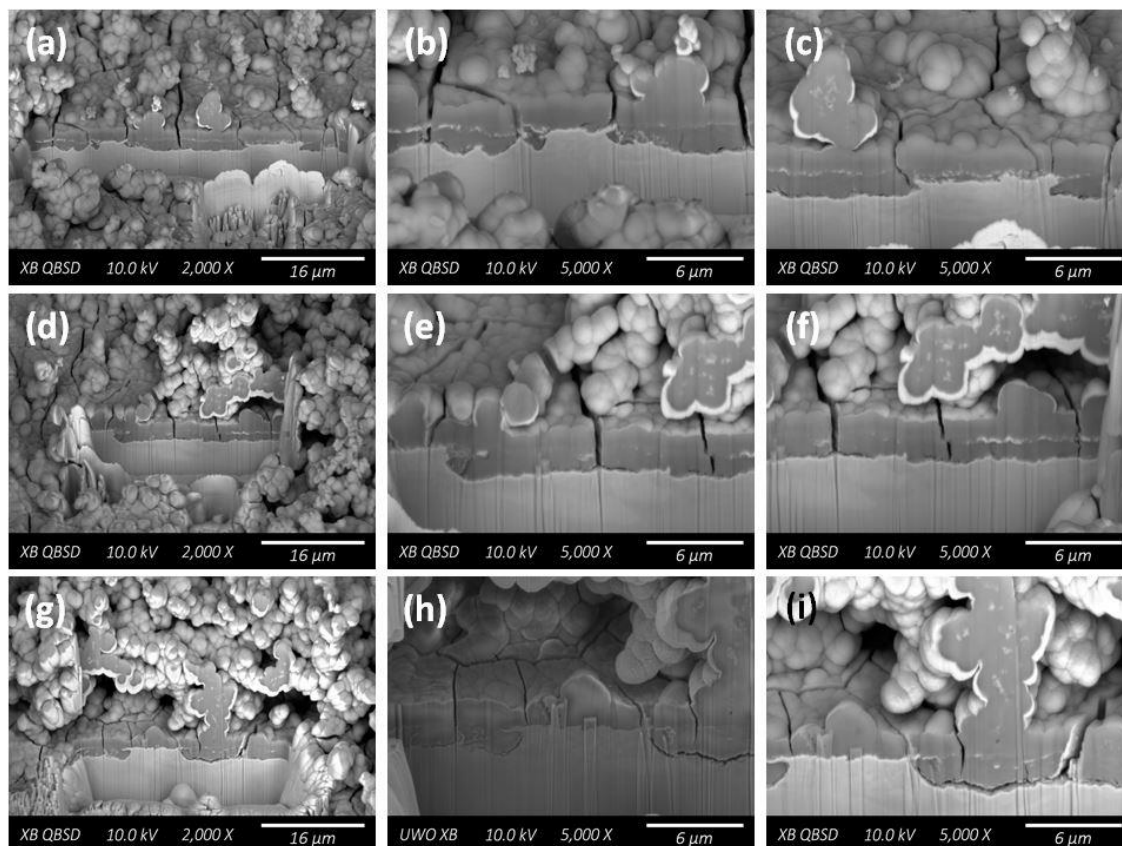
Figure 6-35: FIB cross-section micrographs recorded on a specimen surface after 910 days of exposure to solution (ii) showing: (a-c) a $\sim 3\text{-}5\ \mu\text{m}$ thick corrosion layer which appears generally uniform and protective; (d-i) regions showing deeper penetration which has spread laterally rather than developing as deep pits. The backscatter images ((b-c), (e-f), (i)) highlight the interface between the base metal (bright) and the oxide film (dark).

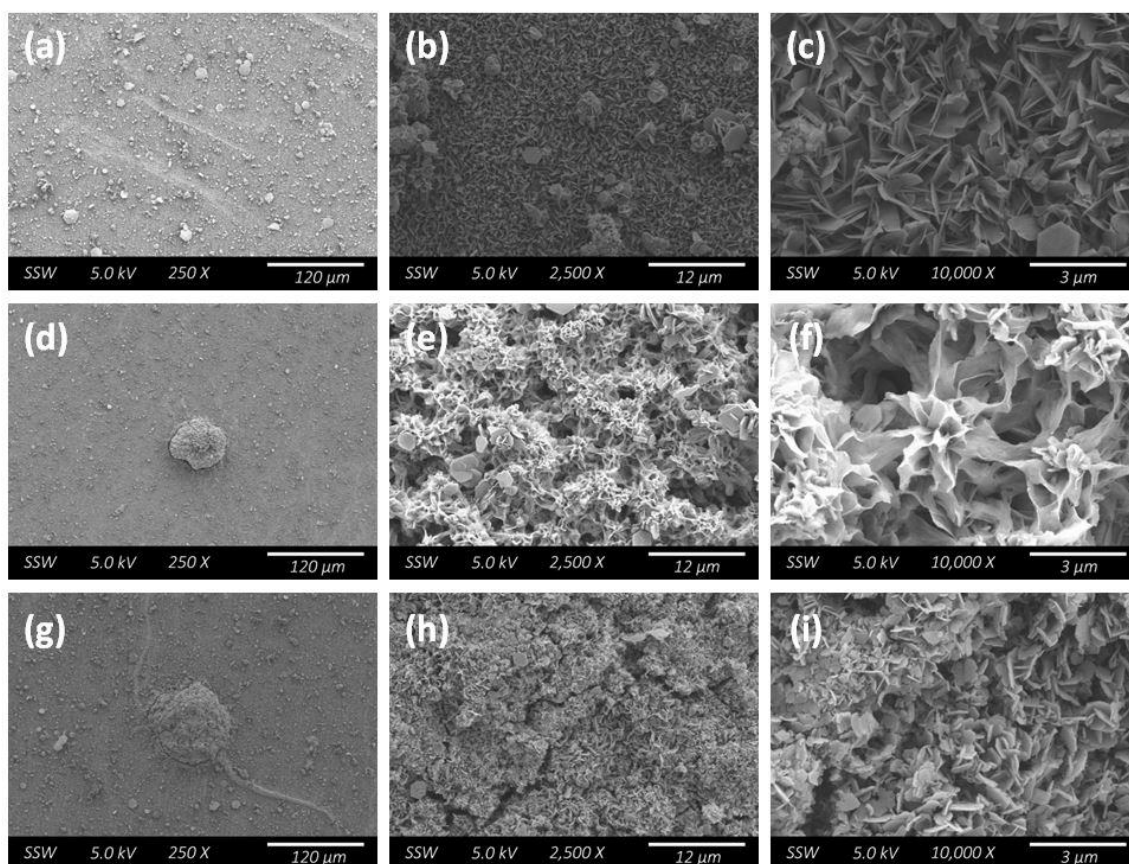
Figure 6-42: SEM micrographs recorded on a steel specimen after 4 days of exposure to solution (iii) showing: (a-c) needle-like acicular crystals expected of $\text{Fe}_2(\text{OH})_2\text{CO}_3$; (d-i) large localized corrosion products 60-100 μm in diameter.

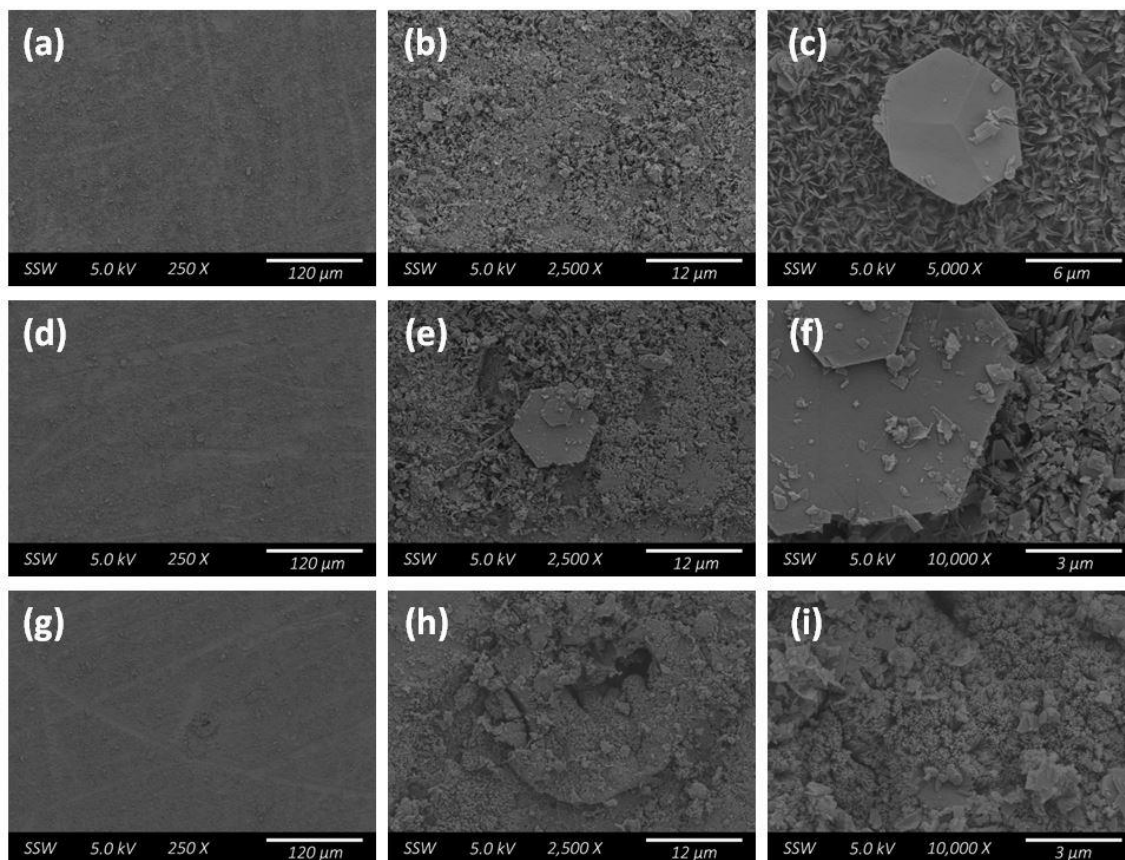
Figure 6-43: SEM micrographs recorded on a steel specimen after 14 days of exposure to solution (iii) showing that the morphology of the corrosion product has remained unchanged but that small hexagonal crystals (c, e-f) appear across the surface and evidence for small locally corroded sites (g-i).

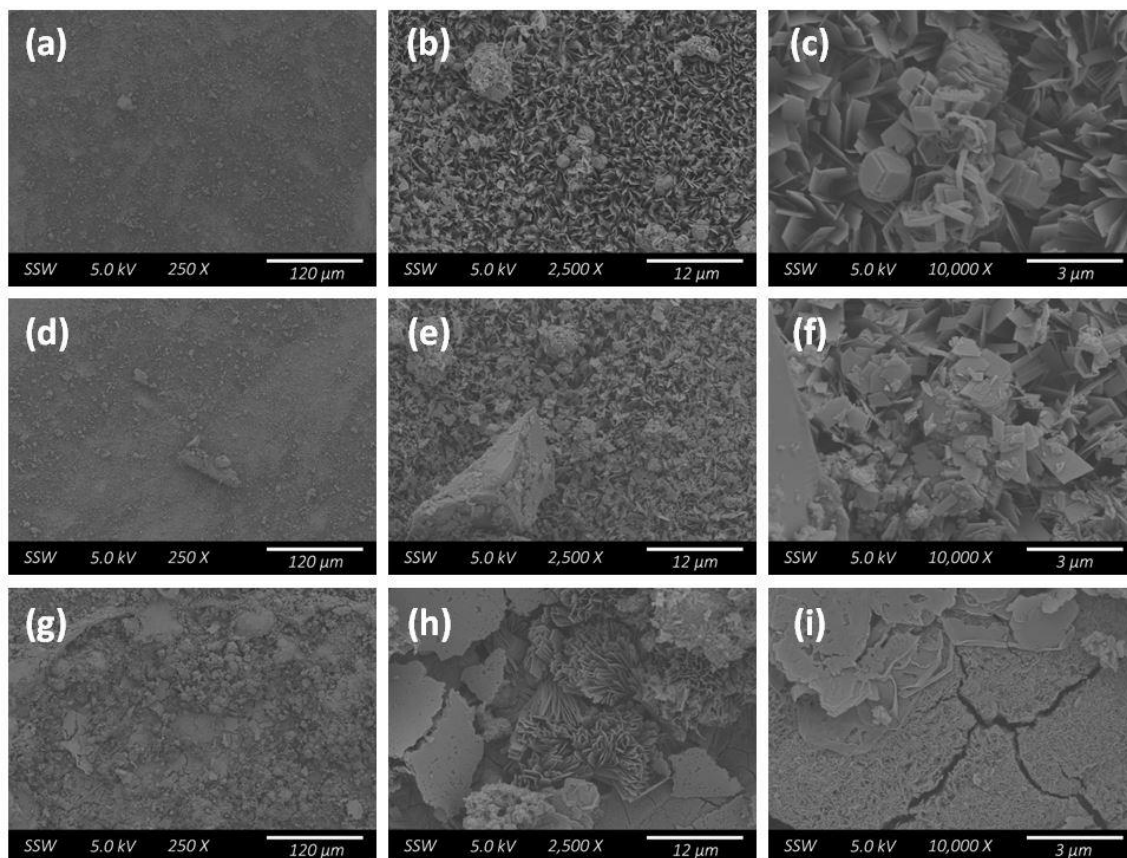
Figure 6-44: SEM micrographs recorded on a steel specimen after 109 days of exposure to solution (iii) showing the emergence of a different morphology of cubic structure best observed in (c) which suggests the formation of FeCO_3 .

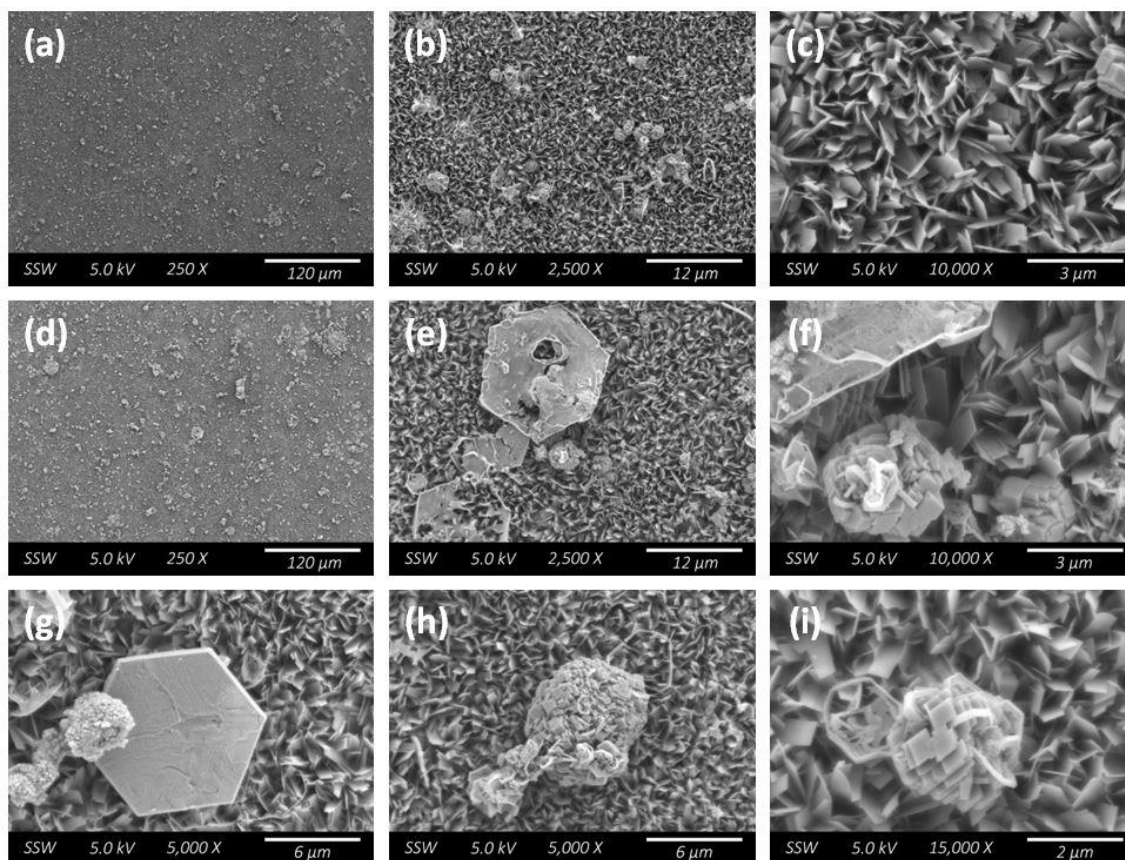
Figure 6-45: SEM micrographs recorded on a steel specimen after 252 days of exposure to solution (iii) showing a general $\text{Fe}_2(\text{OH})_2\text{CO}_3$ film with an increase in the density of the cubic structure, supporting FeCO_3 formation as well as hexagonal crystals in (e) and (g) which may indicate the presence of GR.

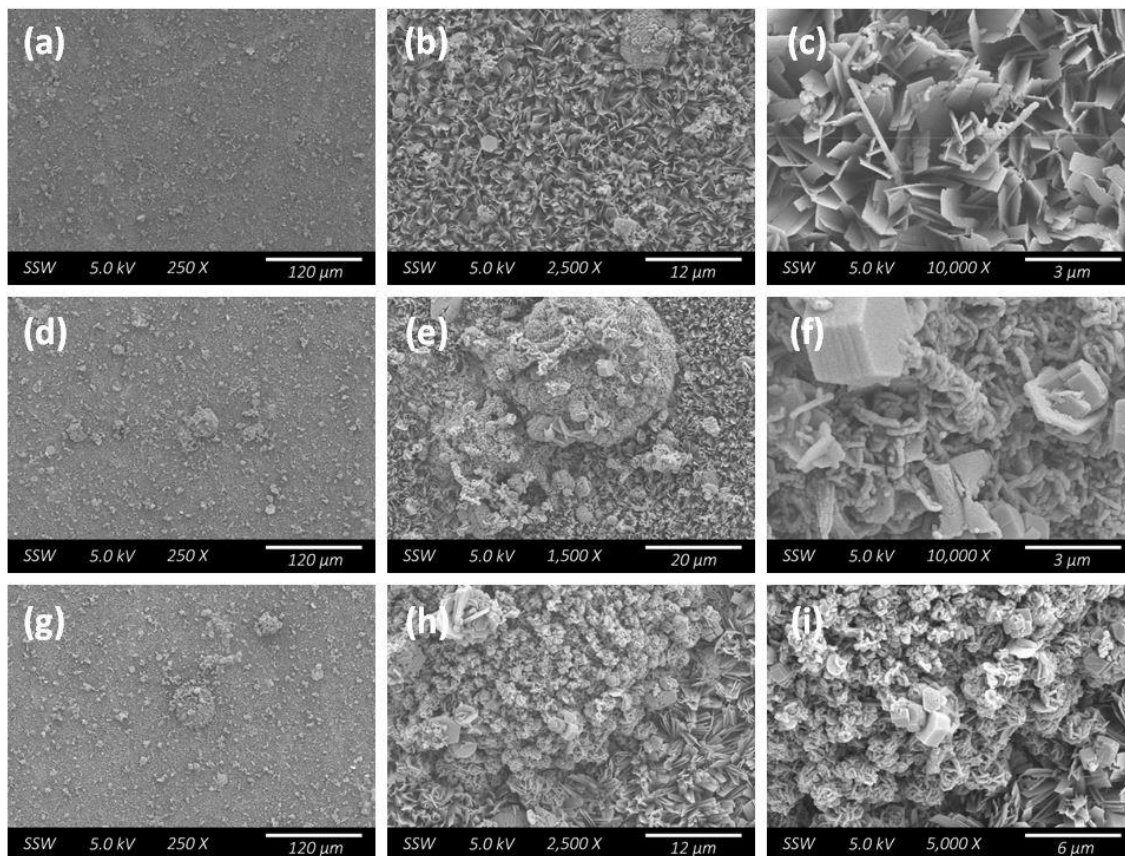
Figure 6-46: SEM micrographs recorded on a steel specimen after 365 days of exposure to solution (iii) showing: (a-c) the dominance of $\text{Fe}_2(\text{OH})_2\text{CO}_3$ with small amorphous deposits (c) visible on top of the $\text{Fe}_2(\text{OH})_2\text{CO}_3$ deposit; (d-i) two regions of localized corrosion deposits.

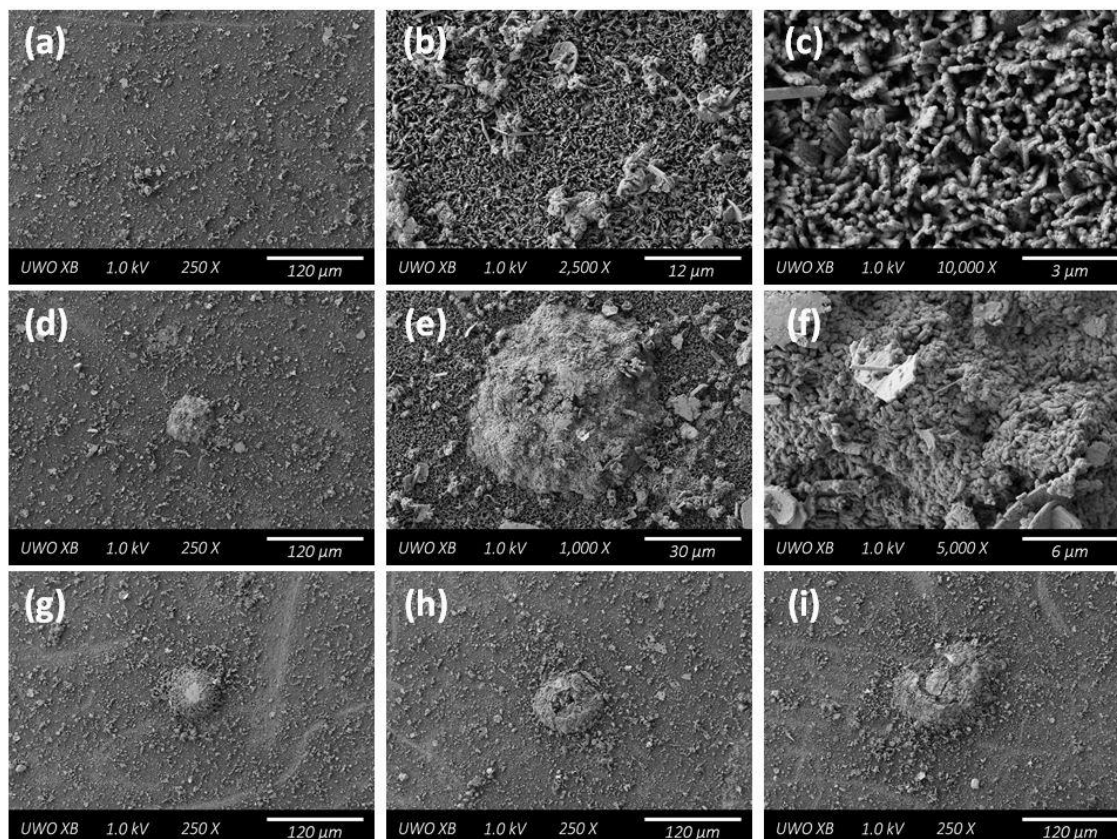
Figure 6-47: SEM micrographs recorded on a steel specimen after 639 days of exposure to solution (iii) showing: (a-c) a $\text{Fe}_2(\text{OH})_2\text{CO}_3$ film with more numerous small deposits; (d-f) a region with a localized corrosion deposit; (g-i) the size distribution of additional localized corrosion deposits.

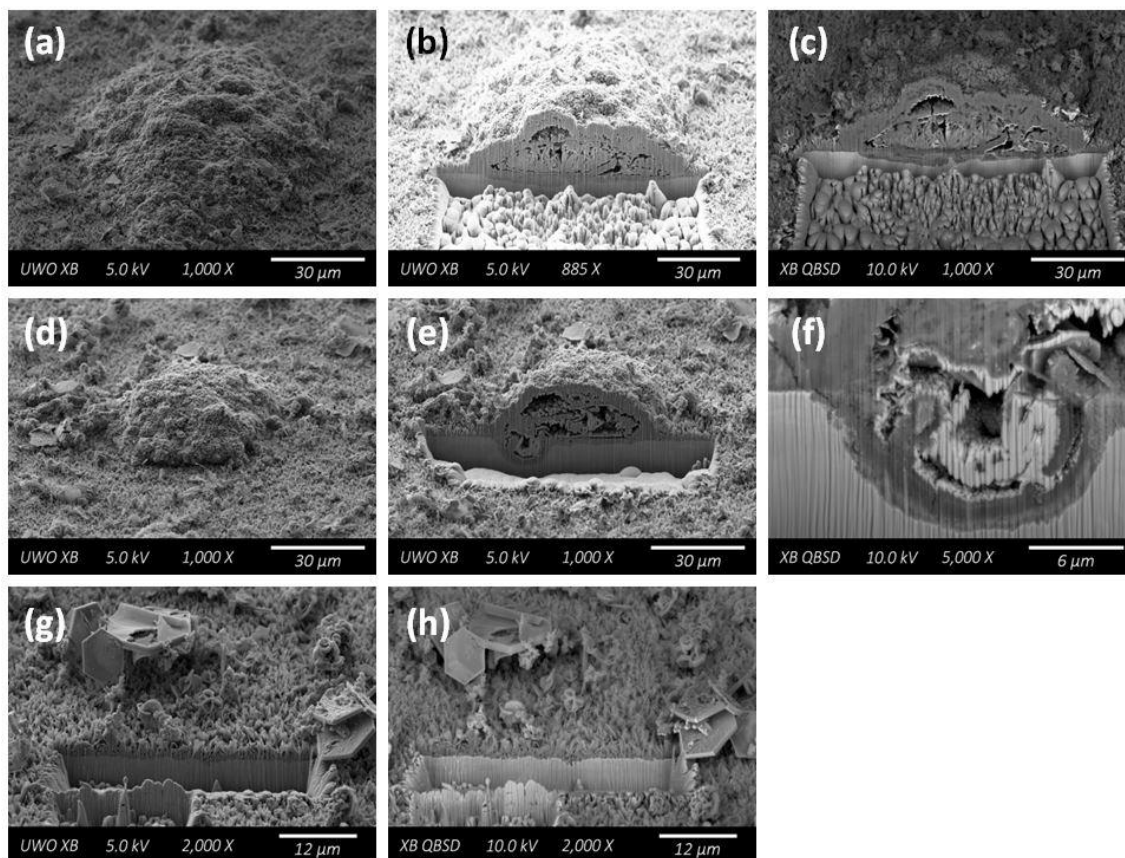
Figure 6-49: FIB cross-section micrographs recorded on a steel specimen after 546 days of exposure to solution (iii) showing: (a-c) a cut through a localized deposit indicating a more active location with shallow penetration shown in the backscatter image (c); (d-f) a cut through a region with significant penetration indicating an active pitting process had occurred; (g-h) a cut through the general $\text{Fe}_2(\text{OH})_2\text{CO}_3$ film showing that its thickness has remained unchanged.

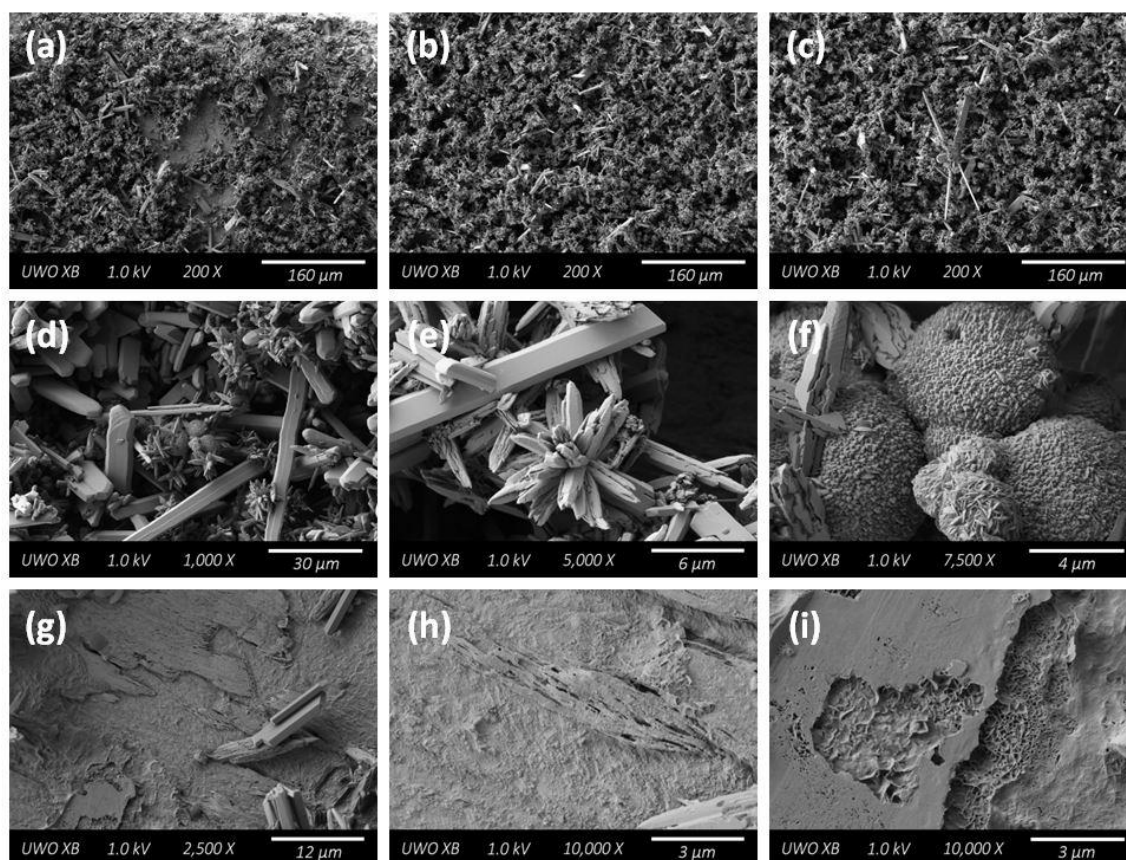
Figure 6-56: SEM micrographs recorded on a steel specimen after 5 days of exposure to solution (iv) showing: (a-c) the extend of CaSO_4 and CaCO_3 crystal coverage; (d-f) the fine crystal morphology with the long rectangular crystals the expected structure of CaSO_4 and the star-shaped crystals the expected structure of CaCO_3 (aragonite); (g-i) a region of the exposed steel exhibiting a roughening of the surface.

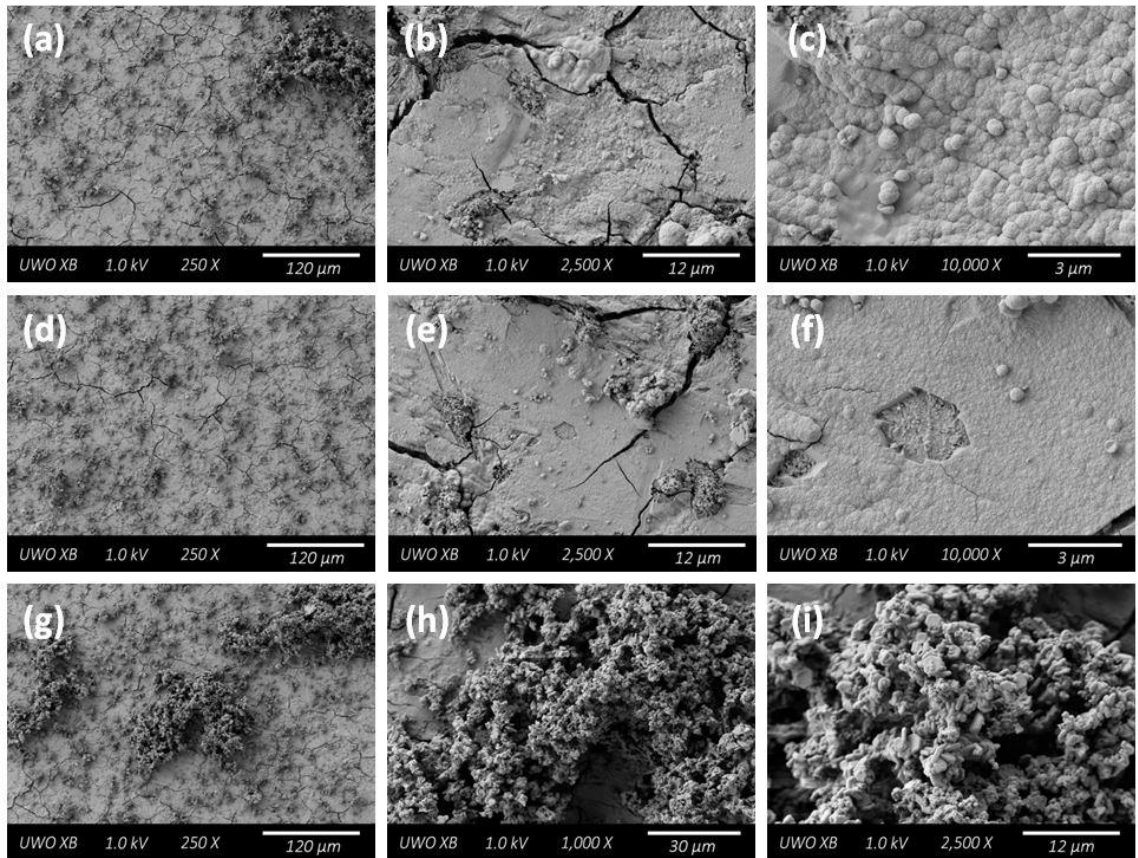
Figure 6-59: SEM micrographs recorded on a steel specimen after 728 days of exposure to solution (iv) showing: (a-f) the visible surface which exhibits a coherent oxide layer; (g-i) a region with a significant corrosion product deposit.

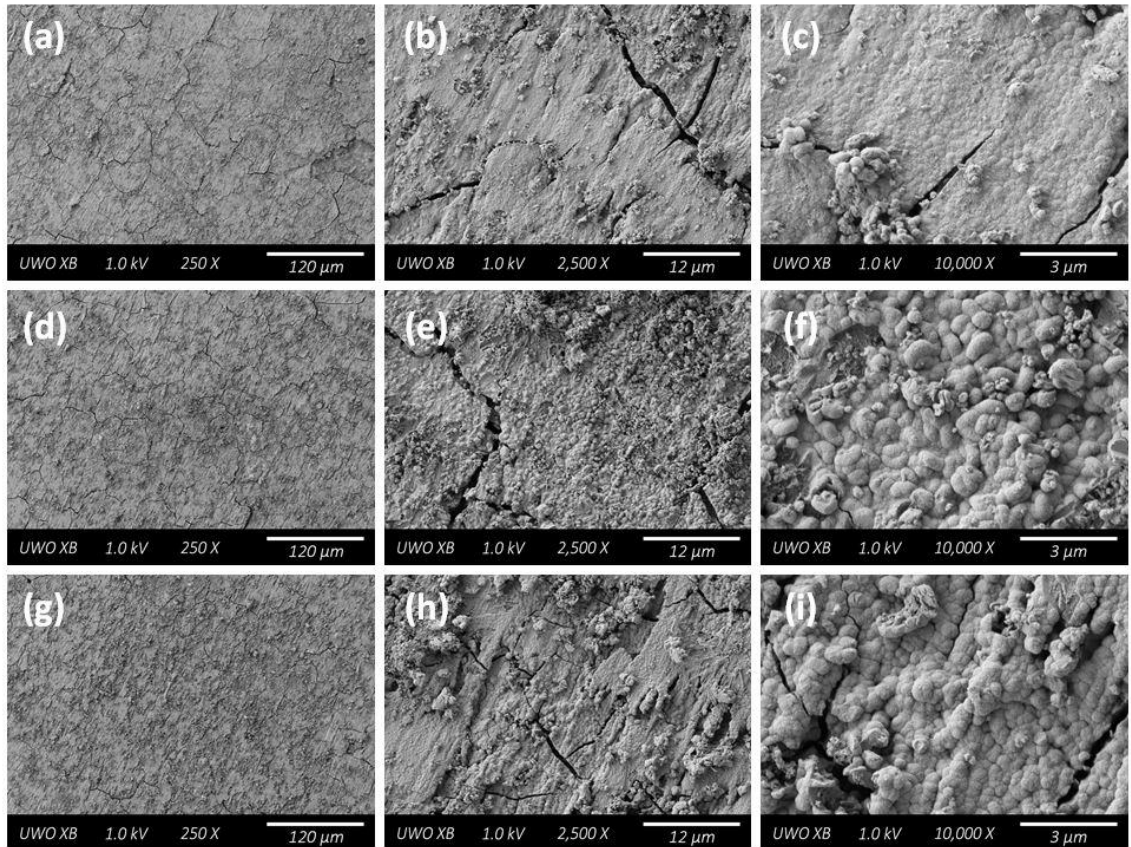
Figure 6-60: SEM micrographs recorded on a steel specimen after 910 days of exposure to solution (iv) showing an apparently thick protective layer of Fe_3O_4 with scattered corrosion deposits.

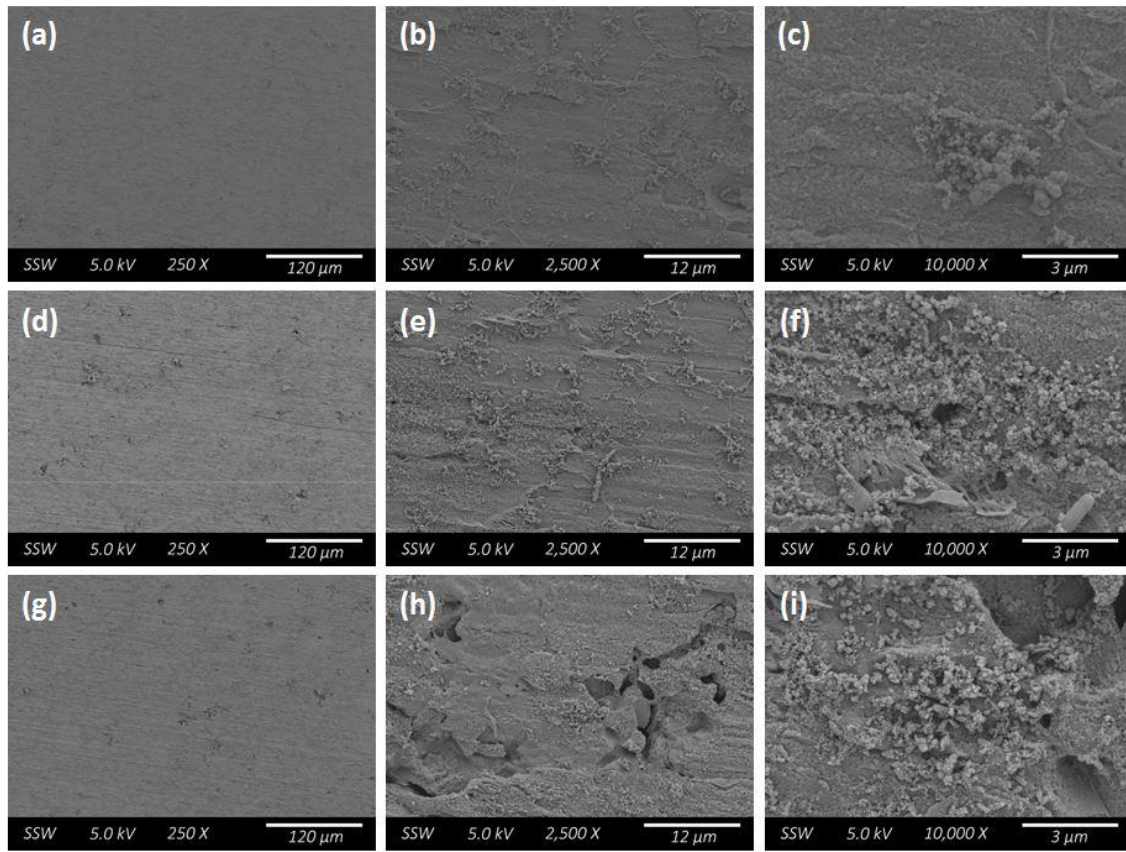
Figure A-24: SEM micrographs recorded on a specimen surface after 182 days of exposure to solution (i) showing: (a-f) the general surface morphology; (g-i) a region of localized corrosion damage.
