RESILIENT INFRASTRUCTURE

BARRIE LANDFILL RECLAMATION AND RE - ENGINEERING 2009 - 2015

Paul, J. Dewaele, P.Eng.
Golder Associates Ltd., Canada

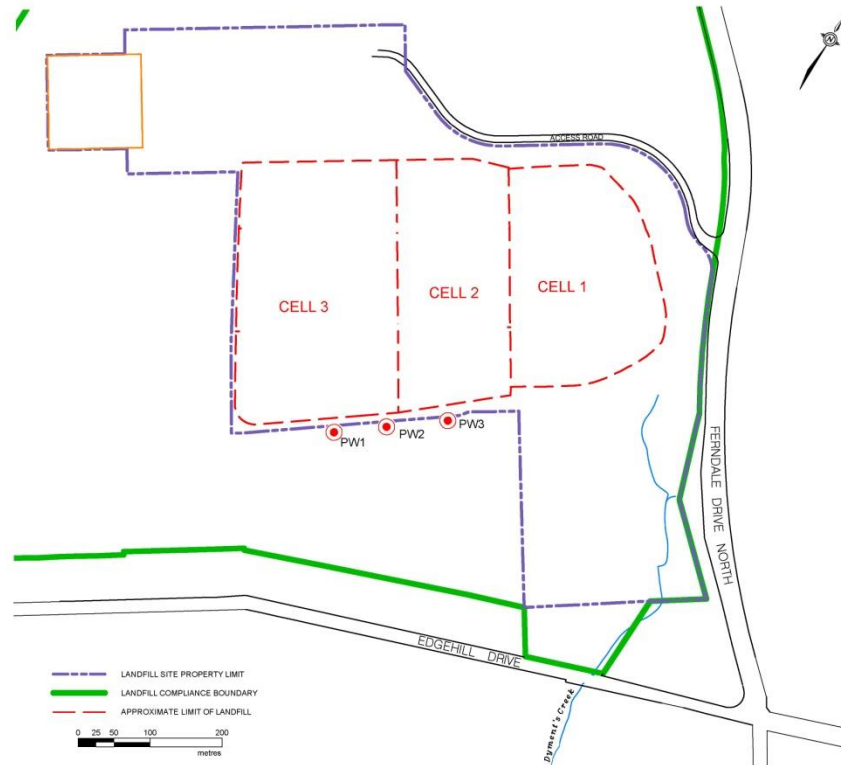
Figure 1: Barrie Landfill Site - Stream (blue) southeast of Cell 1, purge wells (red circles) to south of Cells 2 and 3.

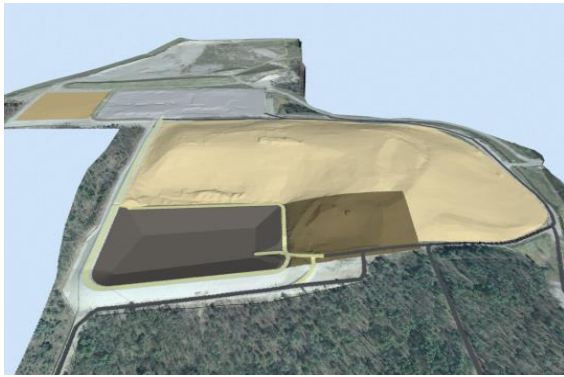
Figure 2: Phase 1 Reclamation

Subsequent to the pilot scale reclamation, full scale operations were completed between 2009 and 2015, of which 1,392,475 m³ was excavated, screened and recompacted. The average apparent waste density achieved during the full operation was 1,180 kg/m³, slightly lower than that identified in the pilot process. The operations were staged in three large phases, covering the south, central and northern parts of Cell 2 and 3. The first two phases are illustrated on Figures 2 and 3.

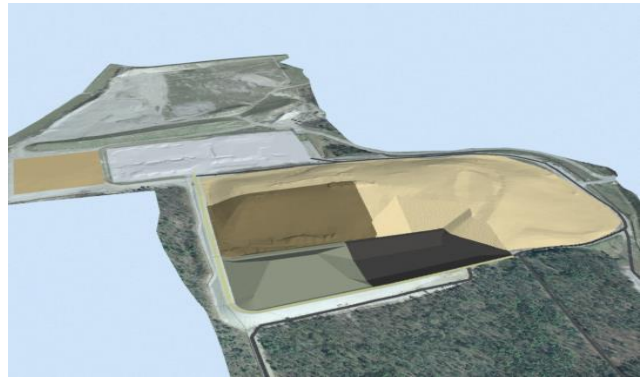
Figure 3: Phase 2 Reclamation

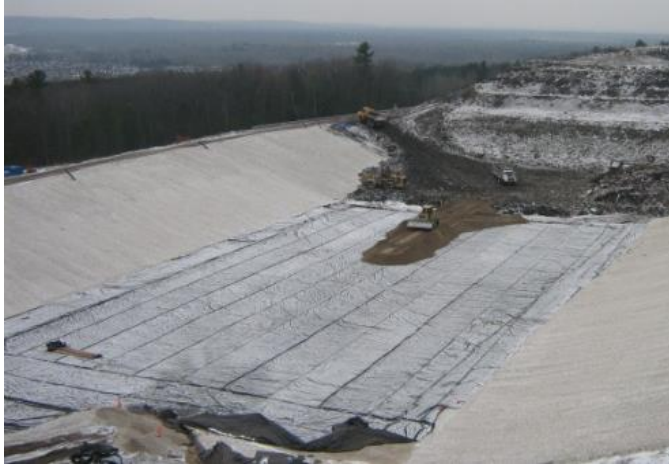
Figure 4: Construction of lined waste cell

In 2007, a liner and leachate collection system were installed in the south end of Cell 3, where no waste had been placed to date. The liner, which meets the current requirements under Ontario Regulation 232/98 based on transport model predictions, consists of a composite of a geosynthetic clay liner and a 60 mil high density polyethylene liner with non-woven separator and cushion cloth and sand. A continuous stone drainage layer comprised of 50 mm diameter stone and a leachate collection system (LCS) overlie the liner, and are ultimately directed to the City’s wastewater treatment plant. This design of liner and leachate collection was progressively extended into Cell 2 and the northern part of Cell 3 as the waste reclamation activities were completed in these areas. Figure 4 shows the construction of a new cell in the south half of Cell 2.

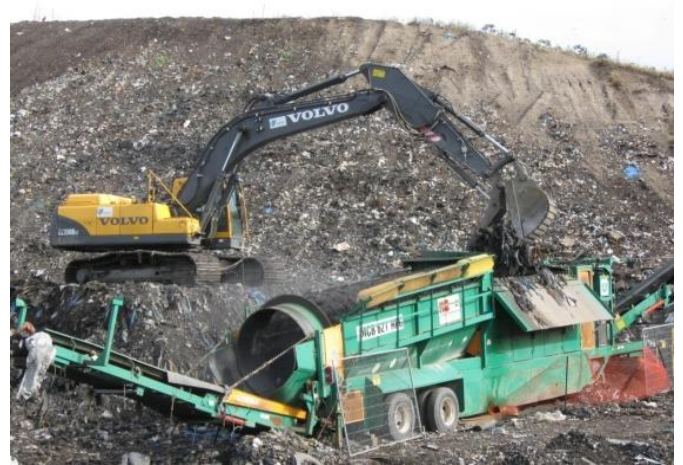
Figure 5: Waste Screening Operation

The waste screening operations for the full scale reclamation were undertaken using two 2.1 m diameter 10 m long rotating drum “trommel” screens with 52 mm openings (Figure 5). These screens were typically staged at the base of a waste slope and excavation operations were adjusted to push or occasionally transport waste to the screens. A 15 m stacker was occasionally used in order to manage the fines. The heavy equipment used in the operations typically included two to three large excavators with thumbs, two D-6 bulldozers and four articulated haul trucks (25 to 35 tonnes). The production rate for each screen averaged approximately 140 m³/hour for each screen over the project period.

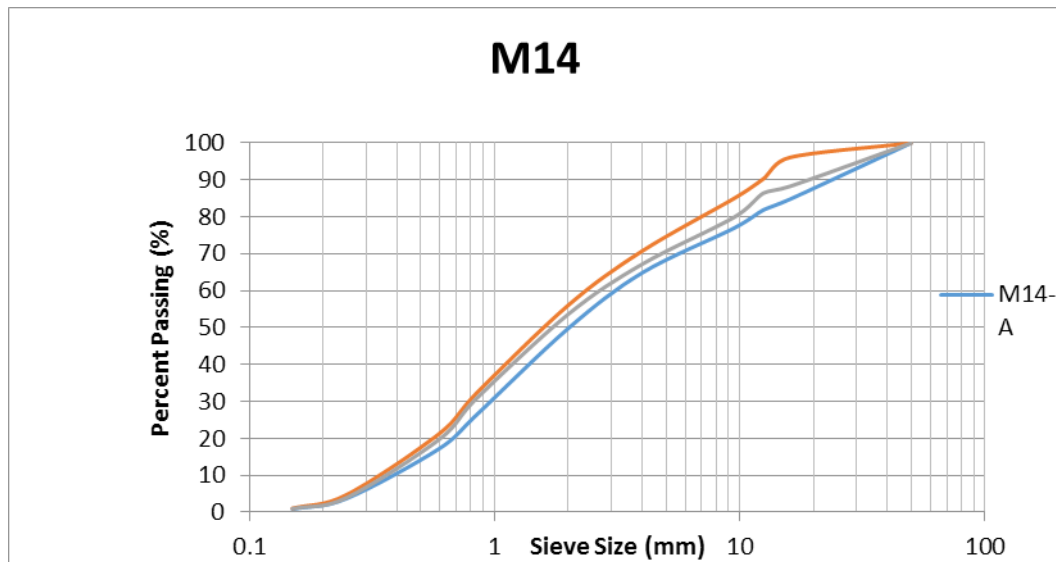
Figure 6: Grain size distribution of a typical sample of fine fraction from reclamation

The grain size of the fine component was largely consistent with that of fine sand, which was sourced from the on-site soils for daily cover. Figure 6 illustrates the grain size distribution of a typical sample of the fines fraction from waste placed after approximately 1992. This material is lighter than typical results for sand, as a result of the inclusion of paper and plastic, and is also slightly wetter, as a result of the inclusion of the organic/wood fraction. Geotechnical testing of the material was completed to confirm the properties for use as cover and base fill.
