## **Volumetric and chromatic reintegration in conservation of *in situ* glazed tiles**

*Volumetric and chromatic reintegration is one of the most important but challenging treatments in conservation of *in situ* glazed tiles due to the need to protect them from water intrusion and further deterioration despite the demanding conditions and requirements needed in outdoor exposure.*

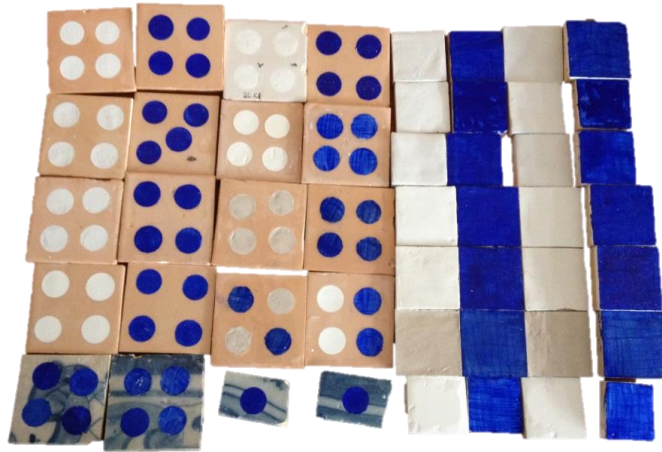
Figure 1. Samples prepared to be characterized after cure.

The properties of the different combinations (Figure 1) after cure were determined by means of: SEM, hydrostatic weighing, mercury intrusion porosimetry, water absorption by capillarity, water vapour permeability, flexural and pull-off strengths as well as water and thermal expansibilities. After natural (one year outdoor exposure) and artificial (NaCl salt ageing, UV-Temp-RH cycles -30°C with condensed water and 4h with 60°C and ultraviolet radiation and immersion in water every 168h up to 1000h of ultraviolet radiation) ageing, the samples were analysed and the differences registered. The ones submitted to artificial ageing were also tested to pull-off strength.
