Cost Effective Concrete Pavement Cross Sections - Final Report

REPORT NUMBER: WI/SPR-03-05

COST EFFECTIVE CONCRETE PAVEMENT CROSS SECTIONS

FINAL REPORT

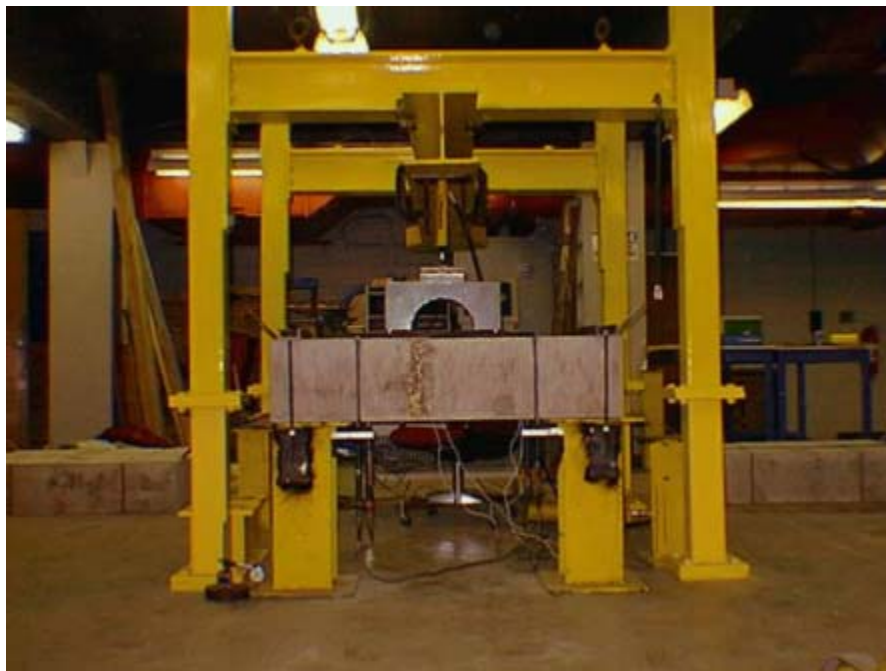
Figure 2.2.2: Joint Deflection Test Set-up

The test load was applied using a manually actuated ENERPAC hydraulic ram mounted on a steel reaction frame. The load ram was centered on the test specimen. Steel plates and arched steel blocks were positioned over the central portion of the specimen to distribute the load uniformly across the center section of the specimen. Four load cells were positioned near the corners of the arched steel block to monitor the applied load. Load cell and LVDT data were collected with a Datronic data collection system using a 2 Hz sampling rate. The load was increased at a rate of approximately 2000 lb/min until a maximum of 5000 lb was obtained. Figure 2.2.2 provides a photo of the test set-up during loading.

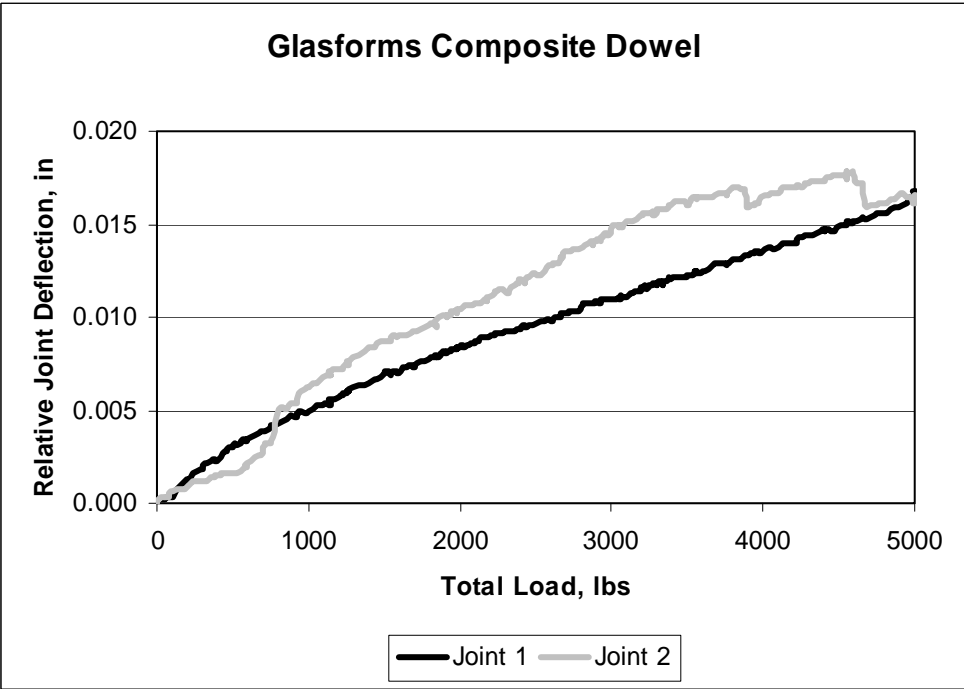
Figure 2.2.6: Test Results for the Glasforms Composite Dowels

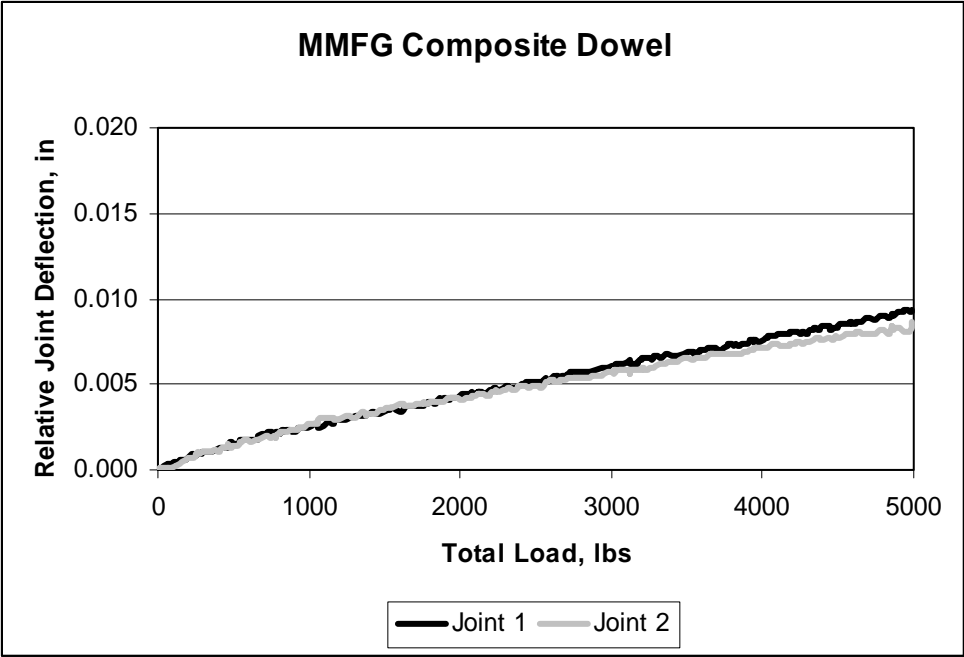
Figure 2.2.7: Test Results for the MMFG Composite Dowels

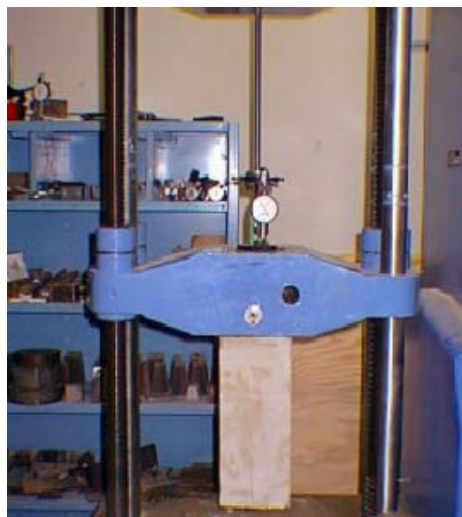
Figure 2.3.2 Pull-Out Test Set-up

The pull-out specimens were mounted into a Riehle compression machine and the pull rod was placed through the upper stationary head and capped. A dial gauge was mounted onto the dowel with the indicator rod resting on the movable crosshead to monitor relative displacements between the dowel and the moveable crosshead. Corresponding pull-out loads were manually recorded off the digital display of the Riehle compression machine. Figure 2.3.2 provides a photo of the pull-out test set-up.

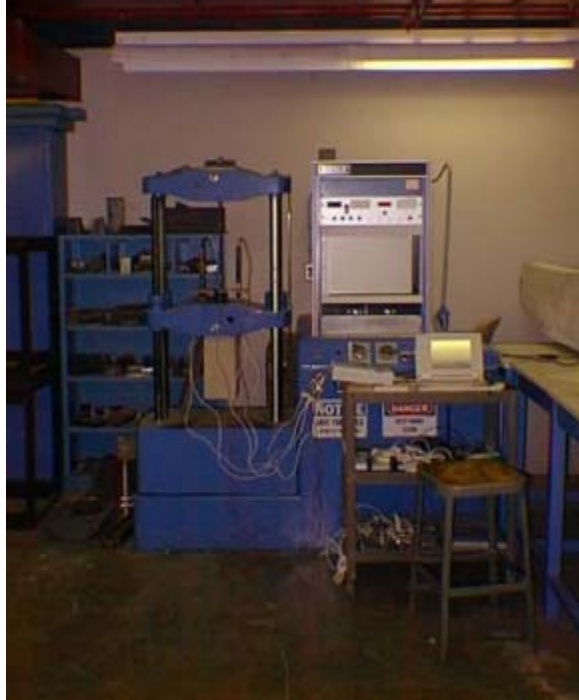
Figure 2.4.1: Modified Pull-Out Test Set-Up

Initial pull-out tests were conducted after 48 hours of concrete curing. The test specimens were then cured an additional 12 days prior to subjecting to 50 cycles of freeze-thaw in a 10% by mass sodium chloride solution. After freeze-thaw conditioning, a second pull-out test was conducted. During both test series, the data recording apparatus was modified from the initial apparatus used in the uncoated tests to allow for continuous data collection during the test. The modified apparatus utilized four load cells and two LVDTs for monitoring load and relative dowel displacement, respectively. Load cell and LVDT data were collected with a Strawberry Tree data collection system set at a 5 Hz sampling rate. Figure 2.4.1 illustrates the modified test set-up.

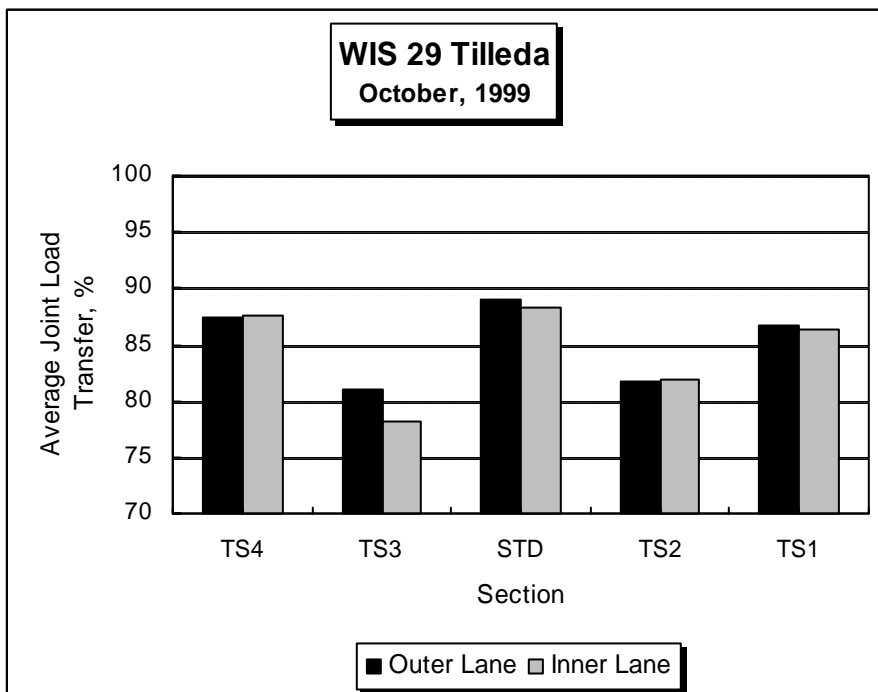
Figure 4.2.15: Joint Load Transfer – WIS 29 Tilleda

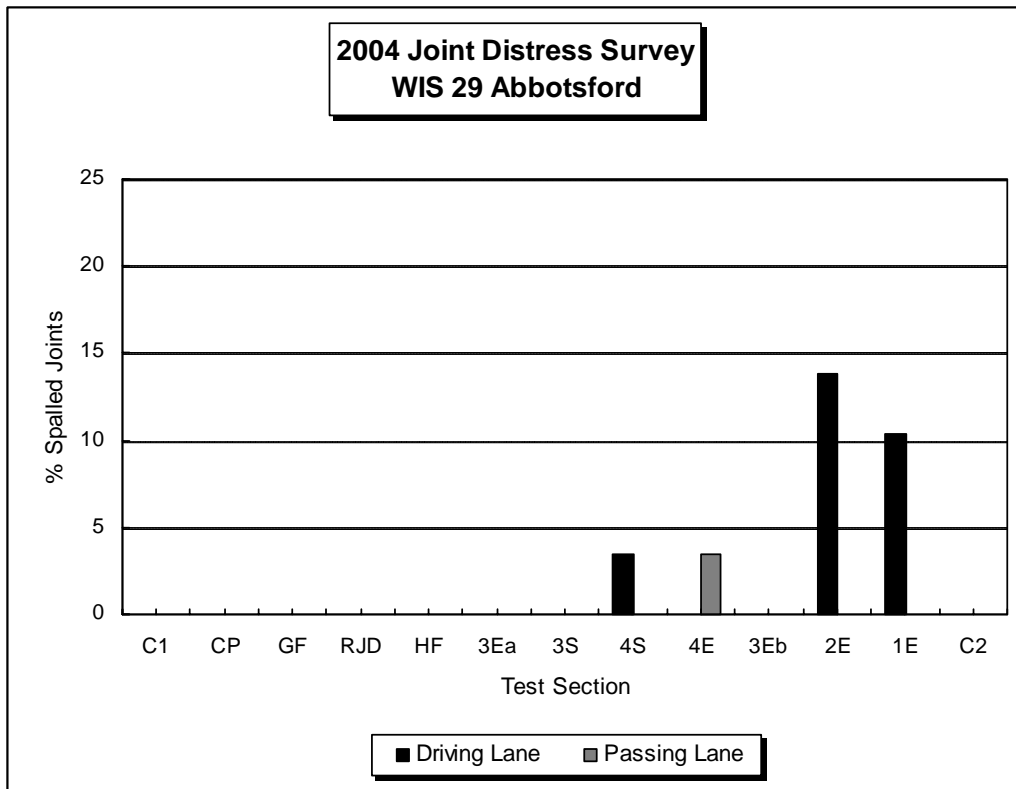
Figure 4.4.1 Joint Spalling Data – WIS 29 Abbotsford

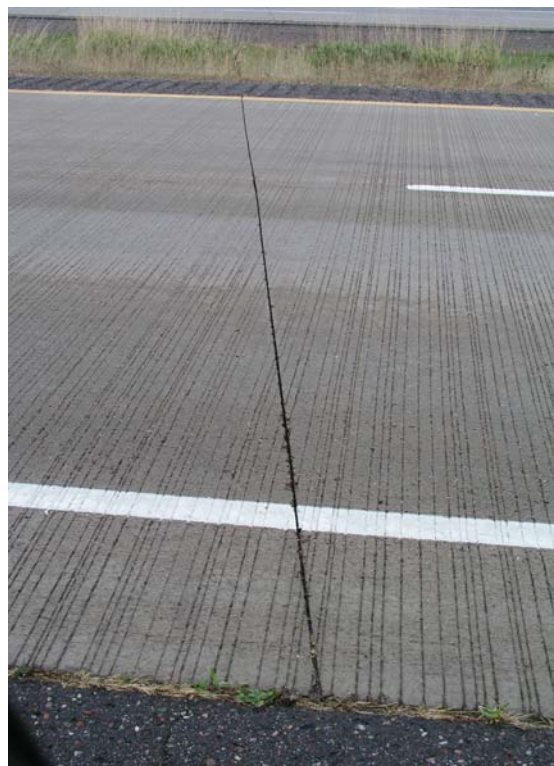
Figure 4.4.5 Typical Chipped Joint – WIS 29 Abbotsford

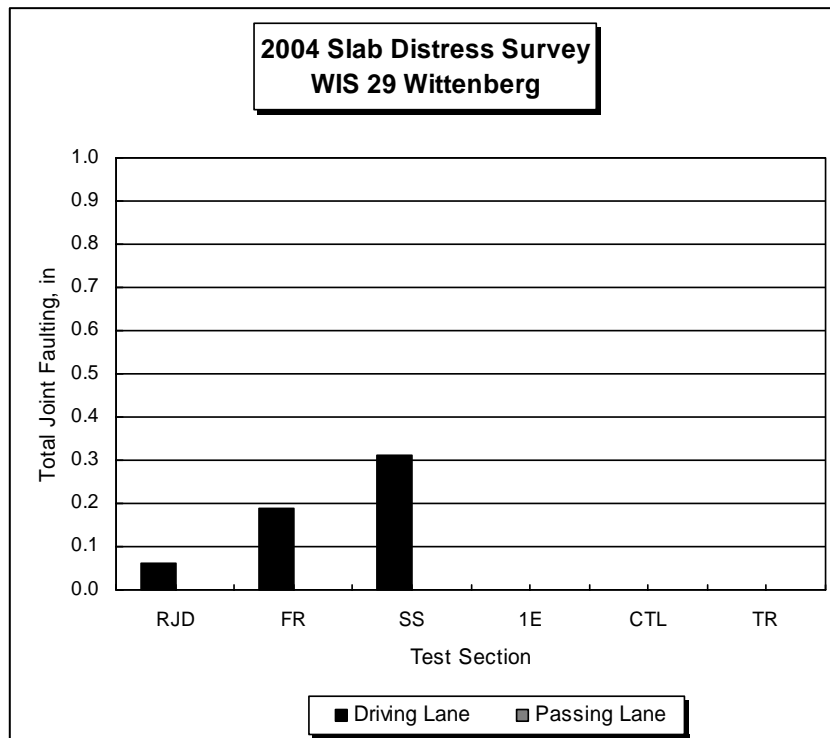
Figure 4.4.8 Joint Faulting Data – WIS 29 Wittenberg

Distress measures recorded during the year 2004 survey are provided in Figures 4.4.6 to 4.4.8. As shown there is a limited amount of joint spalling and faulting and more extensive joint chipping which has been evident since soon after construction. In general, all sections are performing well with a limited amount of joint faulting measured within the FRP composite and stainless steel test sections. The total faulting measured was across one joint with the RJD and SS section and 2 joints within the FR section.

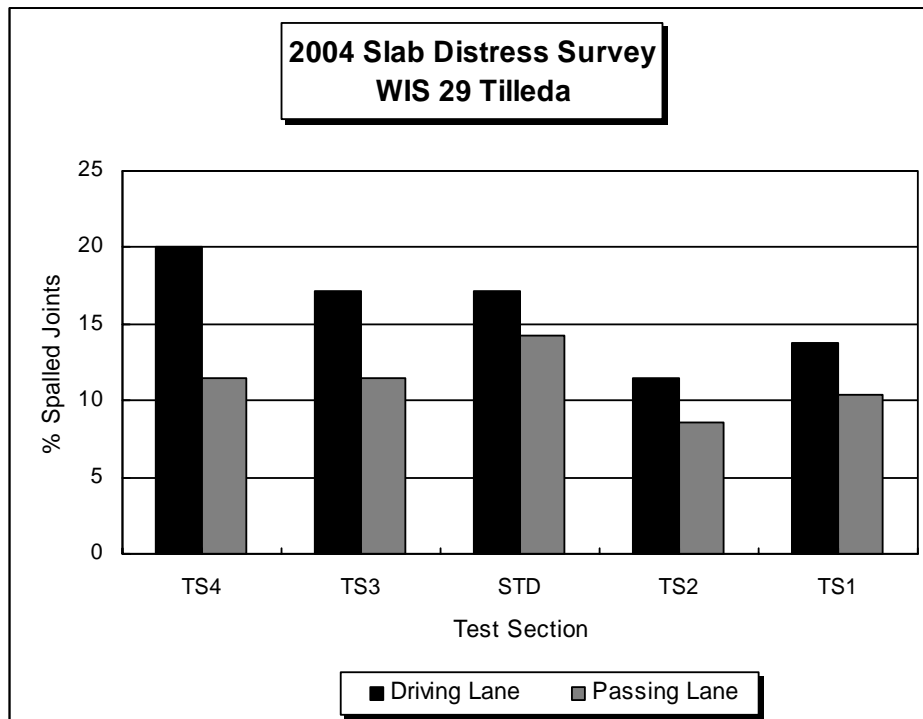
Figure 4.4.9 Joint Spalling Data – WIS 29 Tilleda

Distress measures recorded during the year 2004 survey are provided in Figures 4.4.9 to 4.4.11. As shown there is an increased amount of joint spalling and joint faulting as compared to test sections at WIS 29 Abbotsford and WIS 29 Wittenberg and reduced joint chipping. Transverse contraction joints within these test sections were saw cut with a multiple blasé joint cutter which appears to have produced a more durable joint face.
