Residential fall protection case study: Habitat for Humanity St. Louis.

Residential Fall Protection Case Study: Habitat for Humanity St. Louis

Vicki Kaskutas, Washington University School of Medicine Kyle Hunsberger, Habitat for Humanity

February 2013

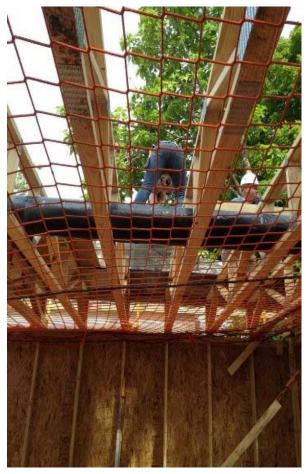
Figure 1 – Safety nets guard workers on second floor.

After the floor joists are installed, a safety net system is installed (Figure 1). Note that their floor joists are set 2' on center, so there is a significant risk of falling between the joists. They have several size nets that match the size of home (Figure 2). Since the bracket to attach the nets was designed for commercial applications and did not allow for the floor sheathing to be installed over the top plate, they had a special L-shaped bracket designed and fabricated (Figure 3). These brackets are hooked to a 2"x4" board for ease of placement. After the brackets are in place, it takes approximately 15 minutes to set the net. The nets must be pulled snug in order to protect the volunteers and workers. Since the nets stretch throughout the day, they are regularly checked and restretched. At the end of the workday, the net is loosened to allow it to return to its original position. At the beginning of the day, the nets are snugly stretched into place. The nets are inspected daily. In order to protect the nets from damage when not in use, they are stored in large rubber tubs (Figure 4).

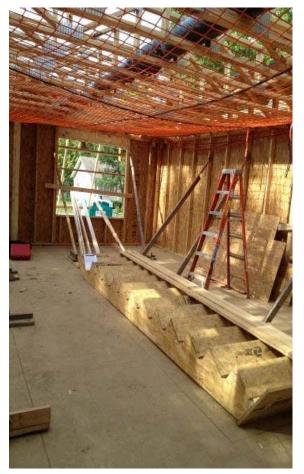
Figure 2 – Safety net spans the width of the home.

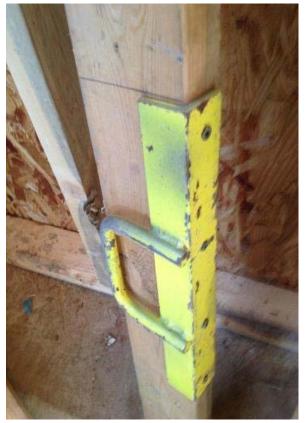
Figure 3 – Fabricated bracket for safety net.

This engineer volunteered his services and consulted with the crane company to ensure that the correct spreader bar was used to lift the roof assembly. In order to fasten safety nets in place when installing floor joists and sheathing, Mr. Hunsberger worked with a machine shop to design brackets that hook over the top plate; the shop fabricated enough brackets to position the net in place.

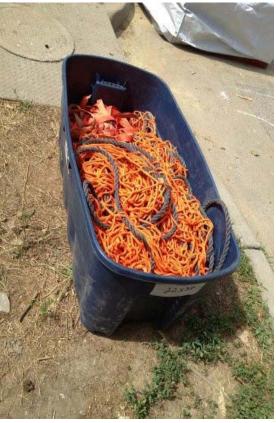
Figure 4 - Storage tub for safety net.

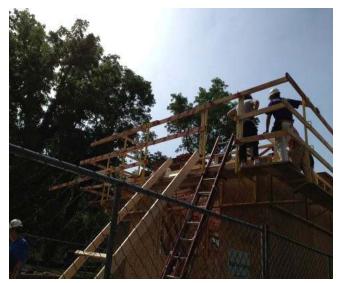
Figure 5 – Hanging scaffold system in place.

Exterior hanging scaffolds are used to protect workers from falling to the exterior of the home during construction (Figure 5). Before the first floor walls are raised, the brackets for the hanging scaffold are attached to the exterior walls; sheathing is notched to allow for the scaffold brackets to be installed (Figure 6). The bracket system requires interior bracing to support the weight of individuals on the scaffold, so they are installed immediately (Figure 7). A bin was fabricated on top of a skid to store the scaffolding and transport to and from the work site (Figure 8).

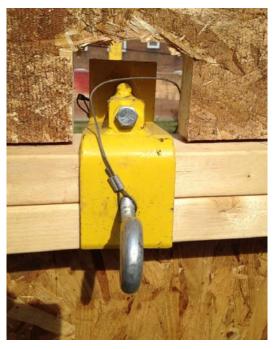
Figure 6 – Notching of wall scaffold bracket.

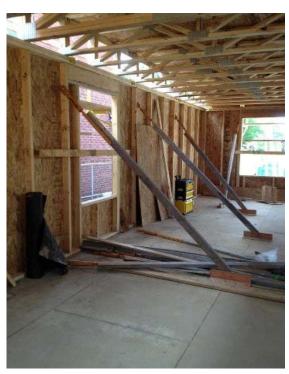
Figure 7 – Interior bracing supports scaffold and workers (right).

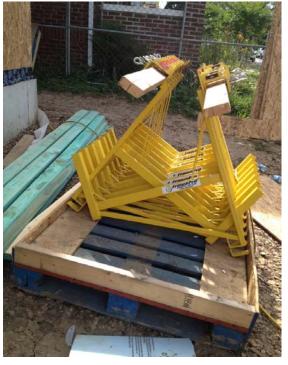
Figure 8 – Storage bin for hanging scaffold storage/transport.

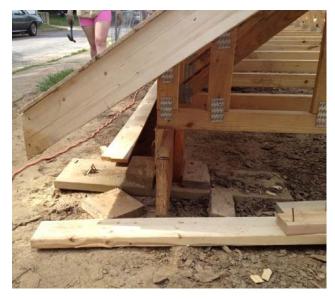
Figure 11 – Roof assembly built on stationary base.

The entire roof assembly is built on the ground next to the house, beginning with the roof trusses, which are set on a base that stays on the ground (Figure 11). A large wood-beam is built into the center of the roof system to support the weight of the roof when lifted into place by a crane; the beam is permanent. Roof sheathing and shingling are installed while the assembly is on the ground, as are soffits, plumbing stacks and flashing. Two small cut-outs in the roof are left unsheathed for the crane to hook up to the beam. Two permanent roof anchors are attached to the top of the roof. Guardrails on the end trusses protect workers from falls over either edge of the roof assembly (Figure 12). The crane company uses a spreader bar that is the size specified by the engineer to handle the weight of the roof assembly. If the crane must make a long lift, a 120 ton crane is required (Figure 13). Workers stand on ladders inside of the home to guide the assembly into place and fasten it down. After securing, one worker climbs onto the roof to patch the openings for the crane with sheathing and shingling. The roof anchors are left in place for use during maintenance operations.

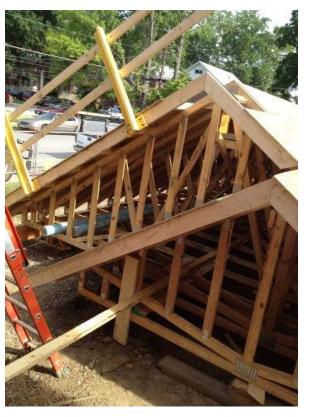
Figure 12 – Guardrail protects the gable end of truss.

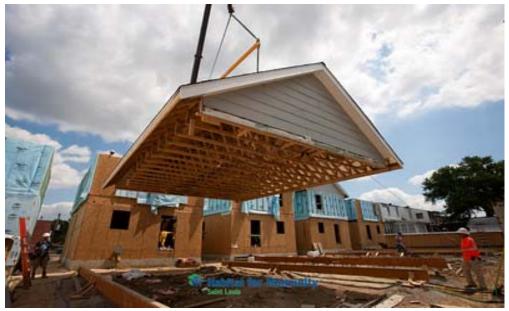
Figure 13 – Roof assembly being lifted by large spreader bar.
