Formulating a Strategy for Securing High-Speed Rail in the United States, Research Report 12-03

Formulating a Strategy for Securing High-Speed Rail in the United States

MTI Report 12-03

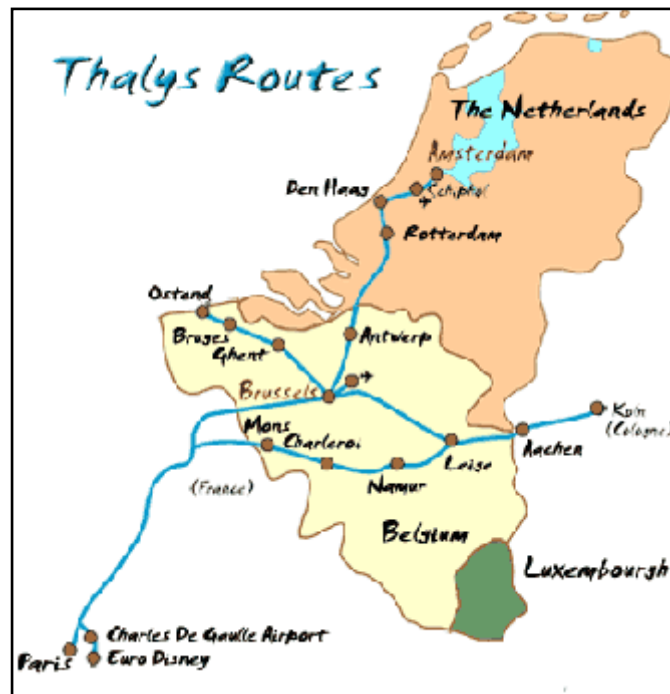
Figure 1. Thalys Route Map

Thalys is a joint service offered by the Belgian, French, and Dutch railways. The system is centered in Brussels, with three primary lines radiating outward (Figure 1). Two of the lines, one to Paris and one to Amsterdam, are also shared by the Eurostar service, and the third extends into Cologne, Germany. A fourth line extends northwest from Brussels to the city of Ostend, on the North Sea. A separate line leaves the Paris-Brussels line near the France-Belgium border, traveling through the cities of Mons, Charleroi, and Namur before joining the Brussels-Cologne line in Liege, essentially providing a southern bypass around Brussels. Service extensions now also include routes to Dusseldorf and Essen from Cologne and a line to Avignon and Marseille, south of Paris. Trains between Paris and Brussels, Brussels and Aachen, and Antwerp and Amsterdam use a variety of dedicated HSR lines. The remaining service runs primarily on conventional tracks.

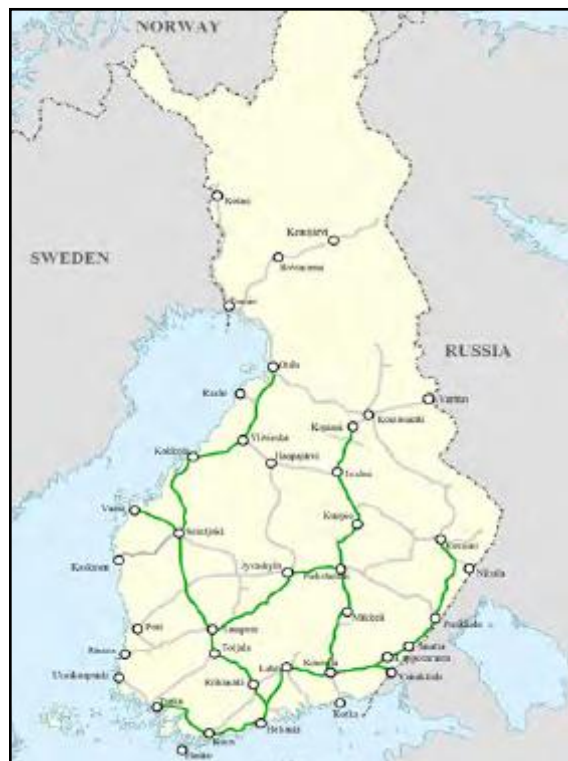
Figure 2. VR Pendolino Route Map

The state-owned VR (Figure 2) is responsible for managing the passenger and freight rail services in Finland. In 2010, the railway network infrastructure maintenance and construction functions were divested into the Finnish Transport Agency. Although the term Pendolino is a brand name of Fiat (later, Alstom) for a line or "family" of tilting trains, it is also the service brand used by the VG Group for their high-speed services. The service uses Pendolino (VR Class Sm3) trainsets built by Rautaruukki-Transtech between 2000 and 2006. The trains are capable of 140 mph service, although existing lines have limited their typical operation to less than 120 mph.

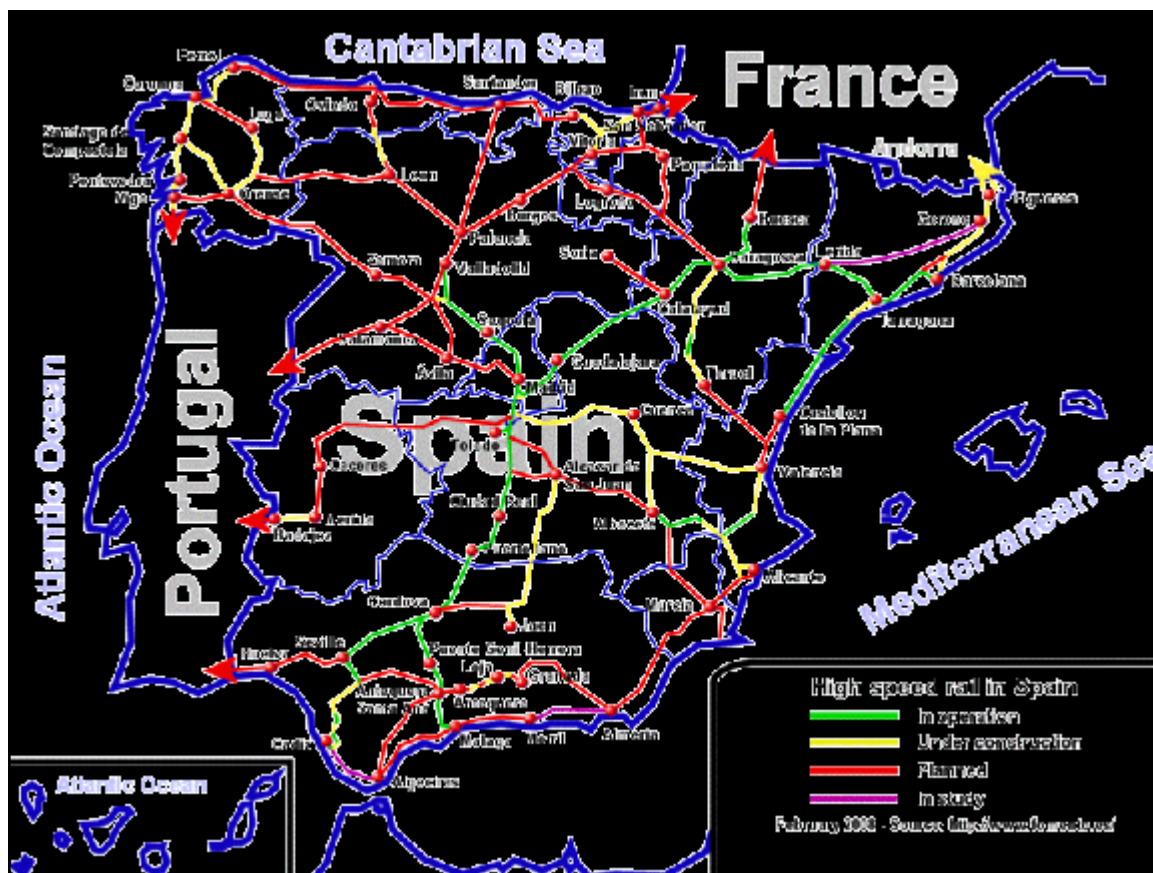
Figure 6. RENFE Route Map

Spain has the second largest network of HSR lines in the world (Figure 6). In 1941, its railways were nationalized, forming Red Nacional de los Ferrocarriles Españoles (RENFE). Since 2005, when an EU directive mandated the separation of track ownership from operations, the country's rail infrastructure has been under Administrador de Infraestructuras Ferroviarias (ADIF), which is responsible for the management, maintenance, and construction functions associated with RENFE, including high-speed-passenger and conventional, mixed-use lines.

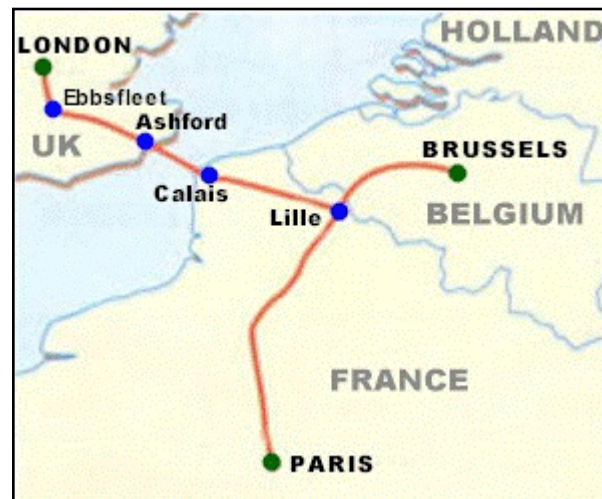
Figure 8. Eurostar Route Map

There are two primary routes in the Eurostar system: London to Brussels and London to Paris. Seasonal service is offered south of Paris to Avignon and Bourg-Saint-Maurice (Figure 8). Every Eurostar train operates out of St. Pancras Station in London, through the Channel Tunnel, to Lille in northern France. At Lille, trains head either south to Paris or other seasonal destinations or northeast to Brussels.

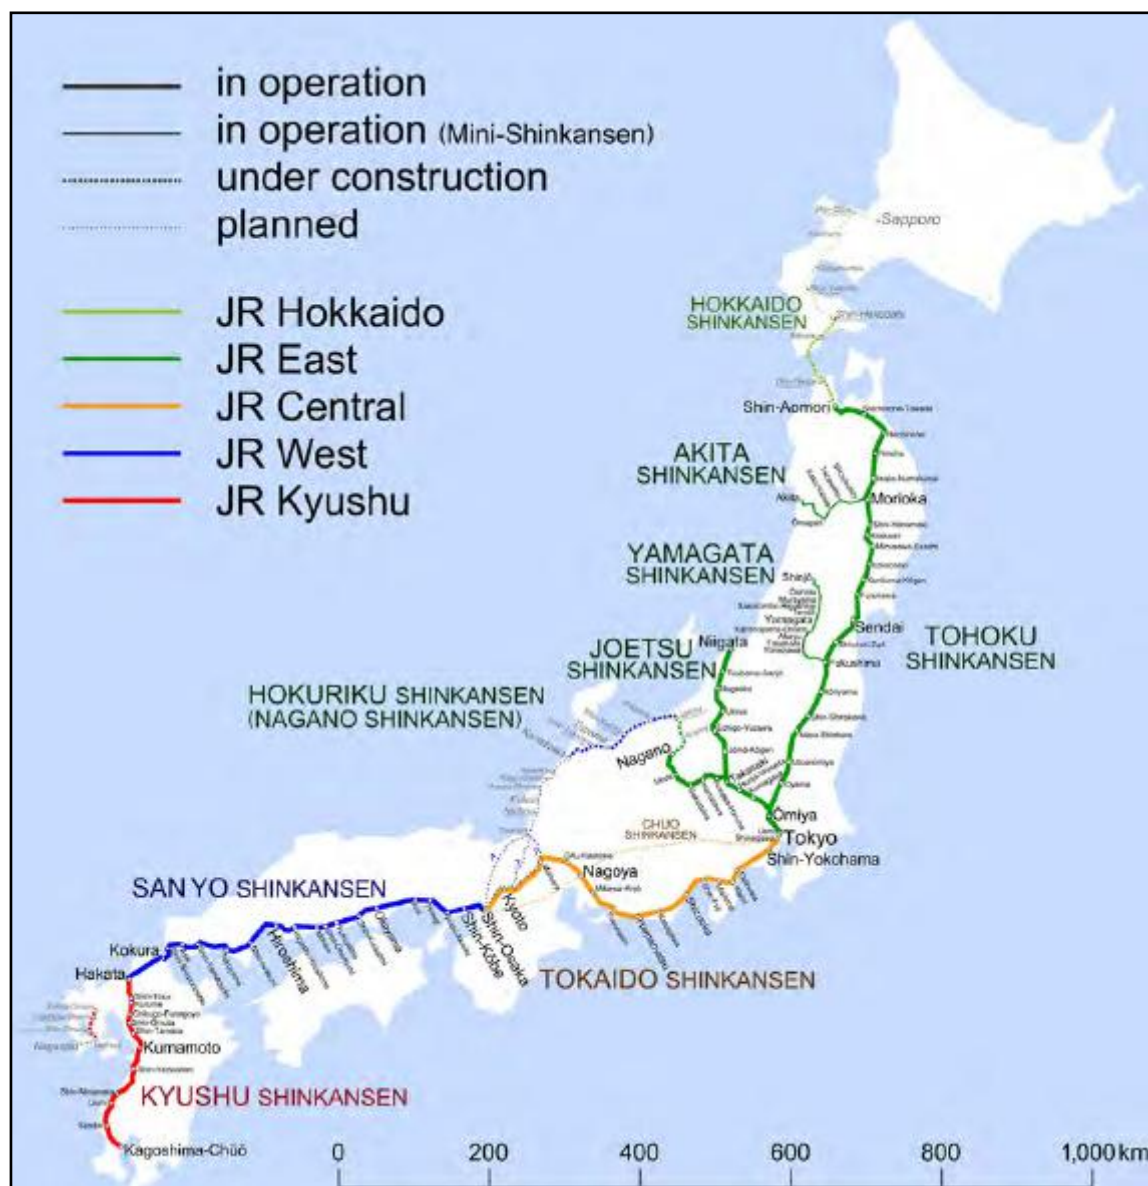
Figure 10. Shinkansen Route Map

Today, the Shinkansen network includes more than 1,600 route miles (Figure 10) and operates approximately 900 trains per day at speeds between 150 and 190 mph. It is owned and operated by five private companies of the JR Group: JR Kyushu, JR West, JR Central, JR Hokkaido, and the largest, by far, in terms of system size and passenger volume, JR East. These companies utilize 20 different styles and configurations of overhead electrically powered trainsets with power cars at each end. Capacities per trainset range from approximately 380 passengers on six- and seven-car sets to 1,200 passengers on 12-car bilevel trainsets and more than 1,300 on 16-car sets.

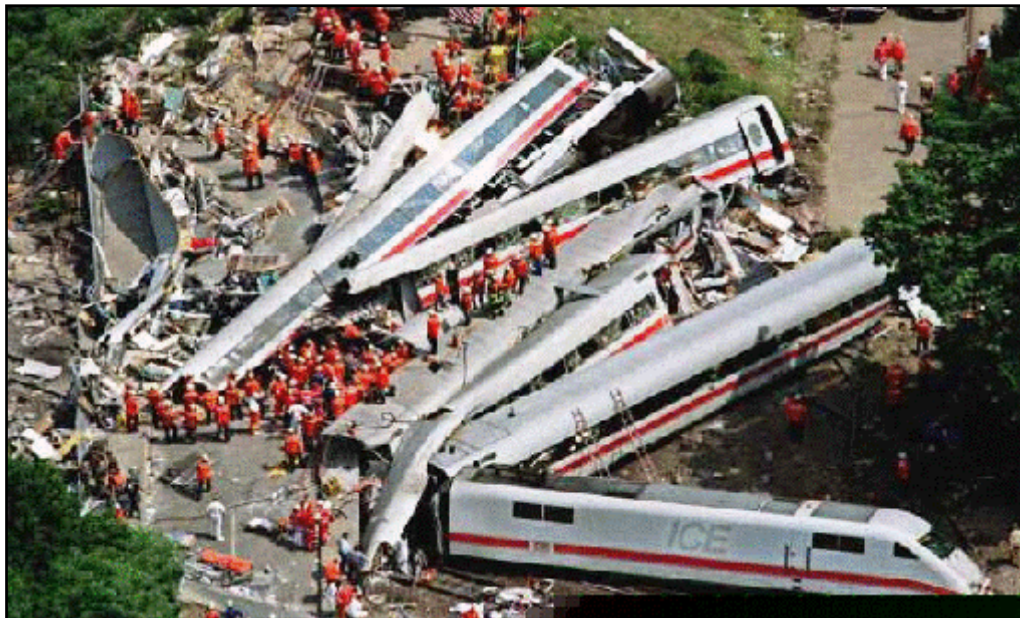
Figure 13. The Eschede Incident Scene

The lead power car stayed on the rails and came to a stop two miles down the line from the accident site. The first three coaches derailed but remained upright and came to a stop about 100 feet beyond the bridge. Coach four was moving fast enough to go under and clear the bridge before it collapsed. Car four was separated from the first three, derailed, and rolled over into trees along the ROW. Adding to the tragedy of the accident, two DB employees working along the ROW were crushed and killed by the car as it rolled over.

The fifth coach was actually severed by the collapsed bridge. The front half traveled about 300 feet past the bridge, while the rear half was crushed under the weight of the overpass. Car six was directly under the bridge at the time of the collapse and was completely flattened. Cars seven through 11 were all destroyed under or up against the remains of the bridge. The twelfth and final car of the train did not impact the bridge but was partially crushed by the rear power car, which, itself, received minimal damage. The train had a capacity of 743 passengers but was carrying only 287 at the time of the accident. The aftermath of the incident is shown in Figure 13.

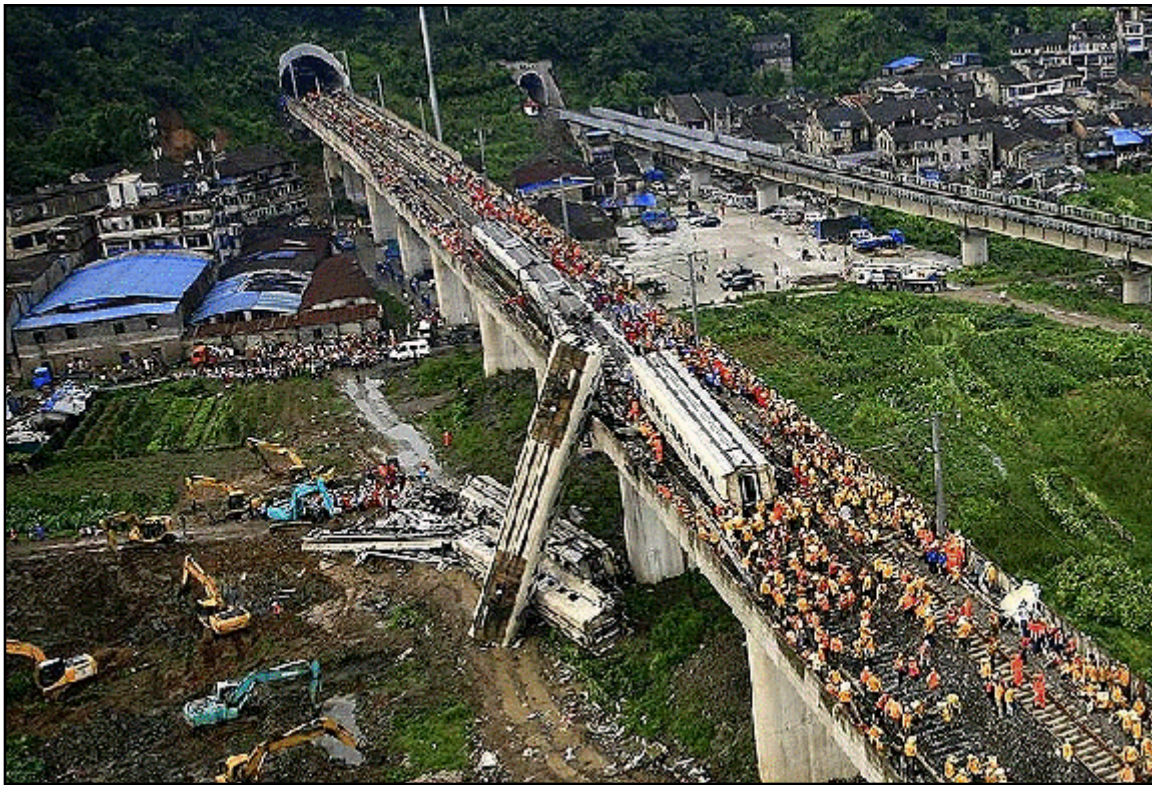
Figure 14. The Aftermath of the Wenzhou Collision

The last car of the lead train (a coach car with an engineer's cab) and the next three cars derailed and were knocked off the viaduct by the collision. Three of the cars fell 50 feet to the ground below, and one car ended up vertically—one end was on the ground and the other was leaning against the top of the viaduct. The lead coach/engineer's-cab car and the first car of the other train also derailed but remained on the viaduct. The first car was demolished by the impact, and the second car rode up on top of it. Although unconfirmed, it is speculated that most of the deceased were in the lead train cars that fell off the viaduct and the first car of the trailing train. Neither trainset design used articulated cars/bogies, but except for the six cars that derailed, the remainder of both trains stayed upright and linear with the track, the vast majority staying on the track. The aftermath of the collision is shown in Figure 14.

The lack of credible information regarding the incident or the post-incident response and investigations makes it difficult to identify lessons learned. The apparent cause seems to have been a poorly designed and/or inadequately tested and evaluated signal- and train control system that failed and did not communicate the presence of a train within a block to other trains in the area. In addition, similar to the ICE Eschede disaster, the severity of the incident was exacerbated by the environment in which the equipment failure occurred. The greatest number of fatalities and the most injuries and damage were caused by the car falling off the viaduct.
