# CHARACTERIZATION OF INSULATION CORKBOARD OBTAINED FROM DEMOLITIONS

L. GIL\*, P. SILVA

Laboratório Nacional de Energia e Geologia I.P., Unidade de Engenharia de Produto,  
Edifício C, 1649-038 Lisboa, Portugal

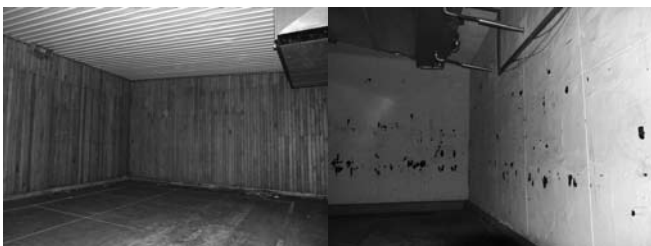
**Fig. 2.** Detail of two of the small cold chambers before demolition (the first with ICB protected by wood; the second with painted ICB).

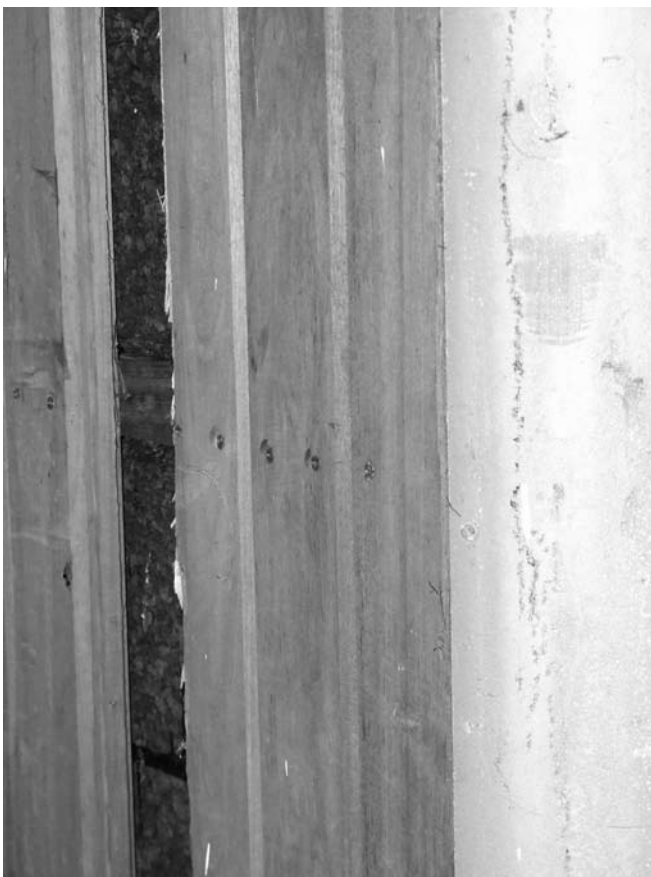
**Fig. 3.** Detail of ICB behind the wood paneling protection (wall insulation).

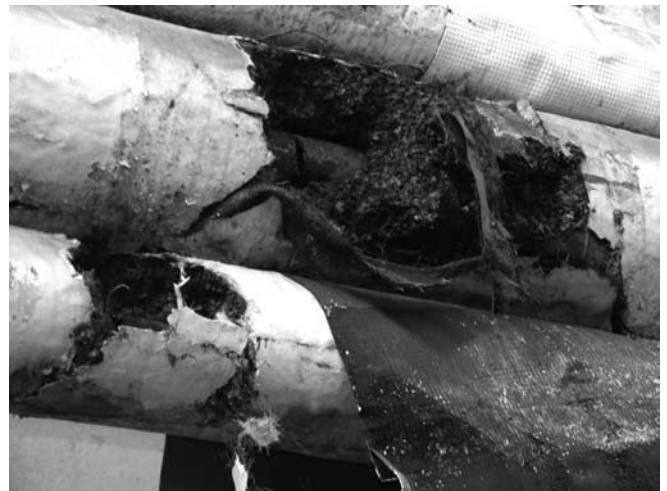
**Fig. 4.** Cooling pipes with ICB insulation before demolition.

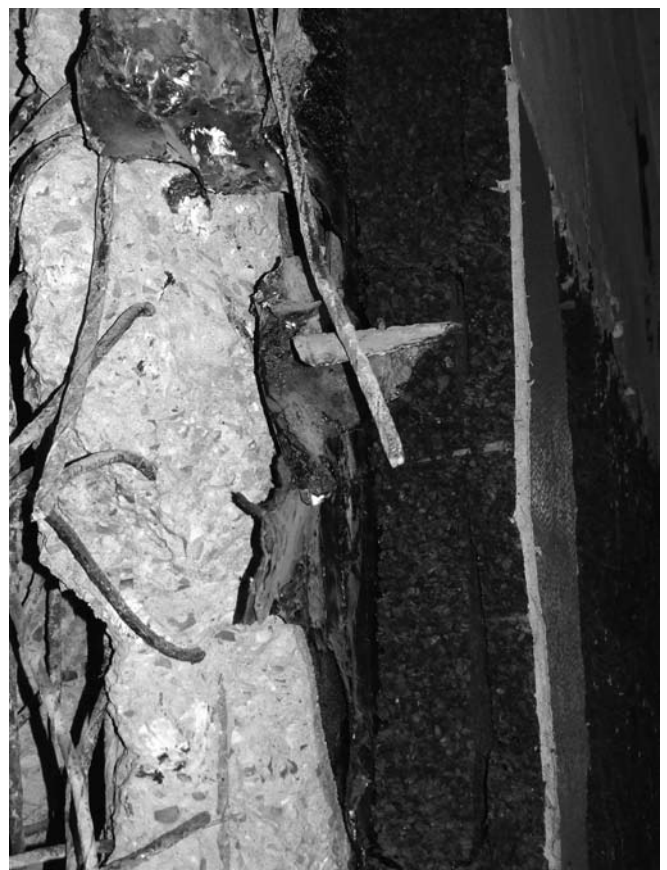
**Fig. 5.** Detail of the wall of one of the big cold chambers (reinforced concrete, asphalt sheet, two ICB layers (15+10 cm) and covering).

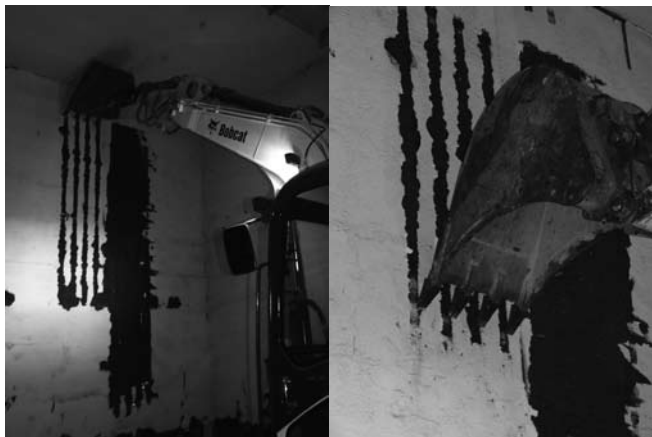
Fig. 6. Operation for the removal of ICB from the cold chambers walls.

The total amount of ICB obtained by demolition is going to be quantified, collected by an integrated waste management company and sent to ICB production companies where, after separation of impurities and grinding, it is going to be used to produce re-granulated expanded cork e.g. for light weight concrete.

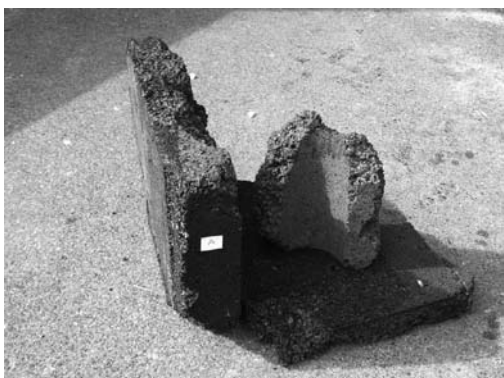
Fig. 7. Sample A for ICB testing.

Two samples were selected and collected, the sample A from the insulation of an interior cold corridor (for product transportation), 1 layer with a thickness of 15 cm and the sample B from cold storage chamber, two layers of 15 cm + 10 cm.

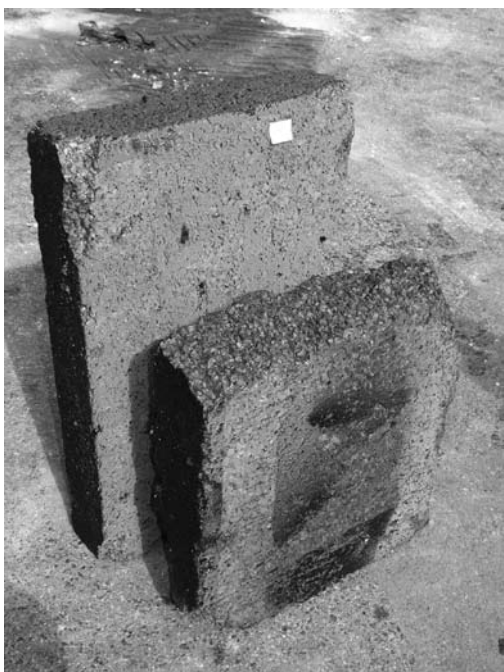
Fig. 8. Sample B for ICB testing.

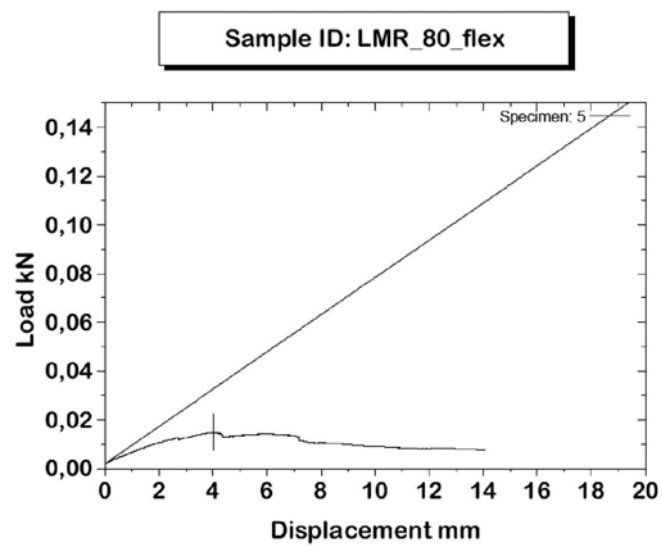
**Graphic 2.** Bending behavior of one of the test specimens (N° 2) of sample B.

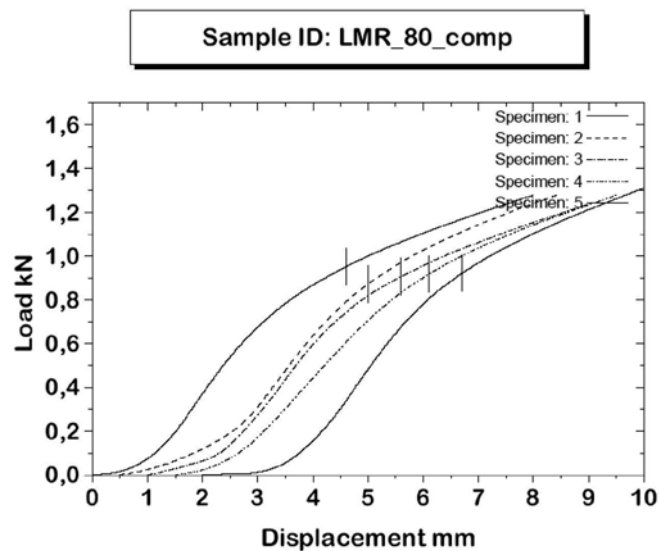
**Graphic 3.** Compression behavior of sample A.

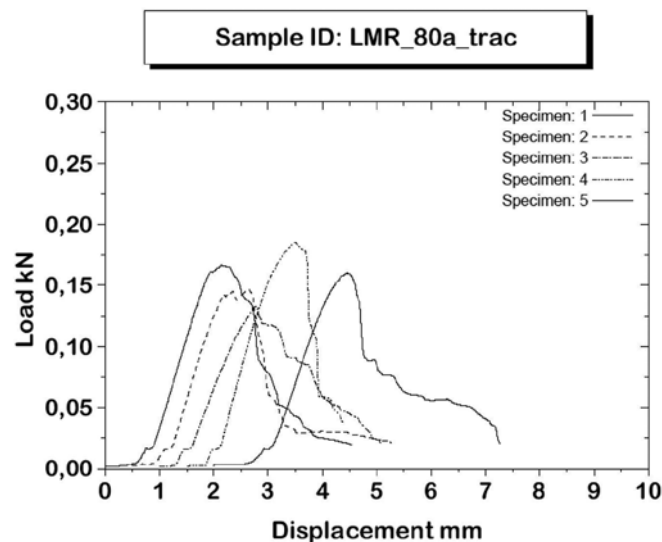
Graphic 6. Tensile behavior of sample B.
