DOE/MC/31203-97/C0743

Initial Failure Analysis of Ceramic Filters

Advanced Coal-Fired Power Systems '96 Review Meeting

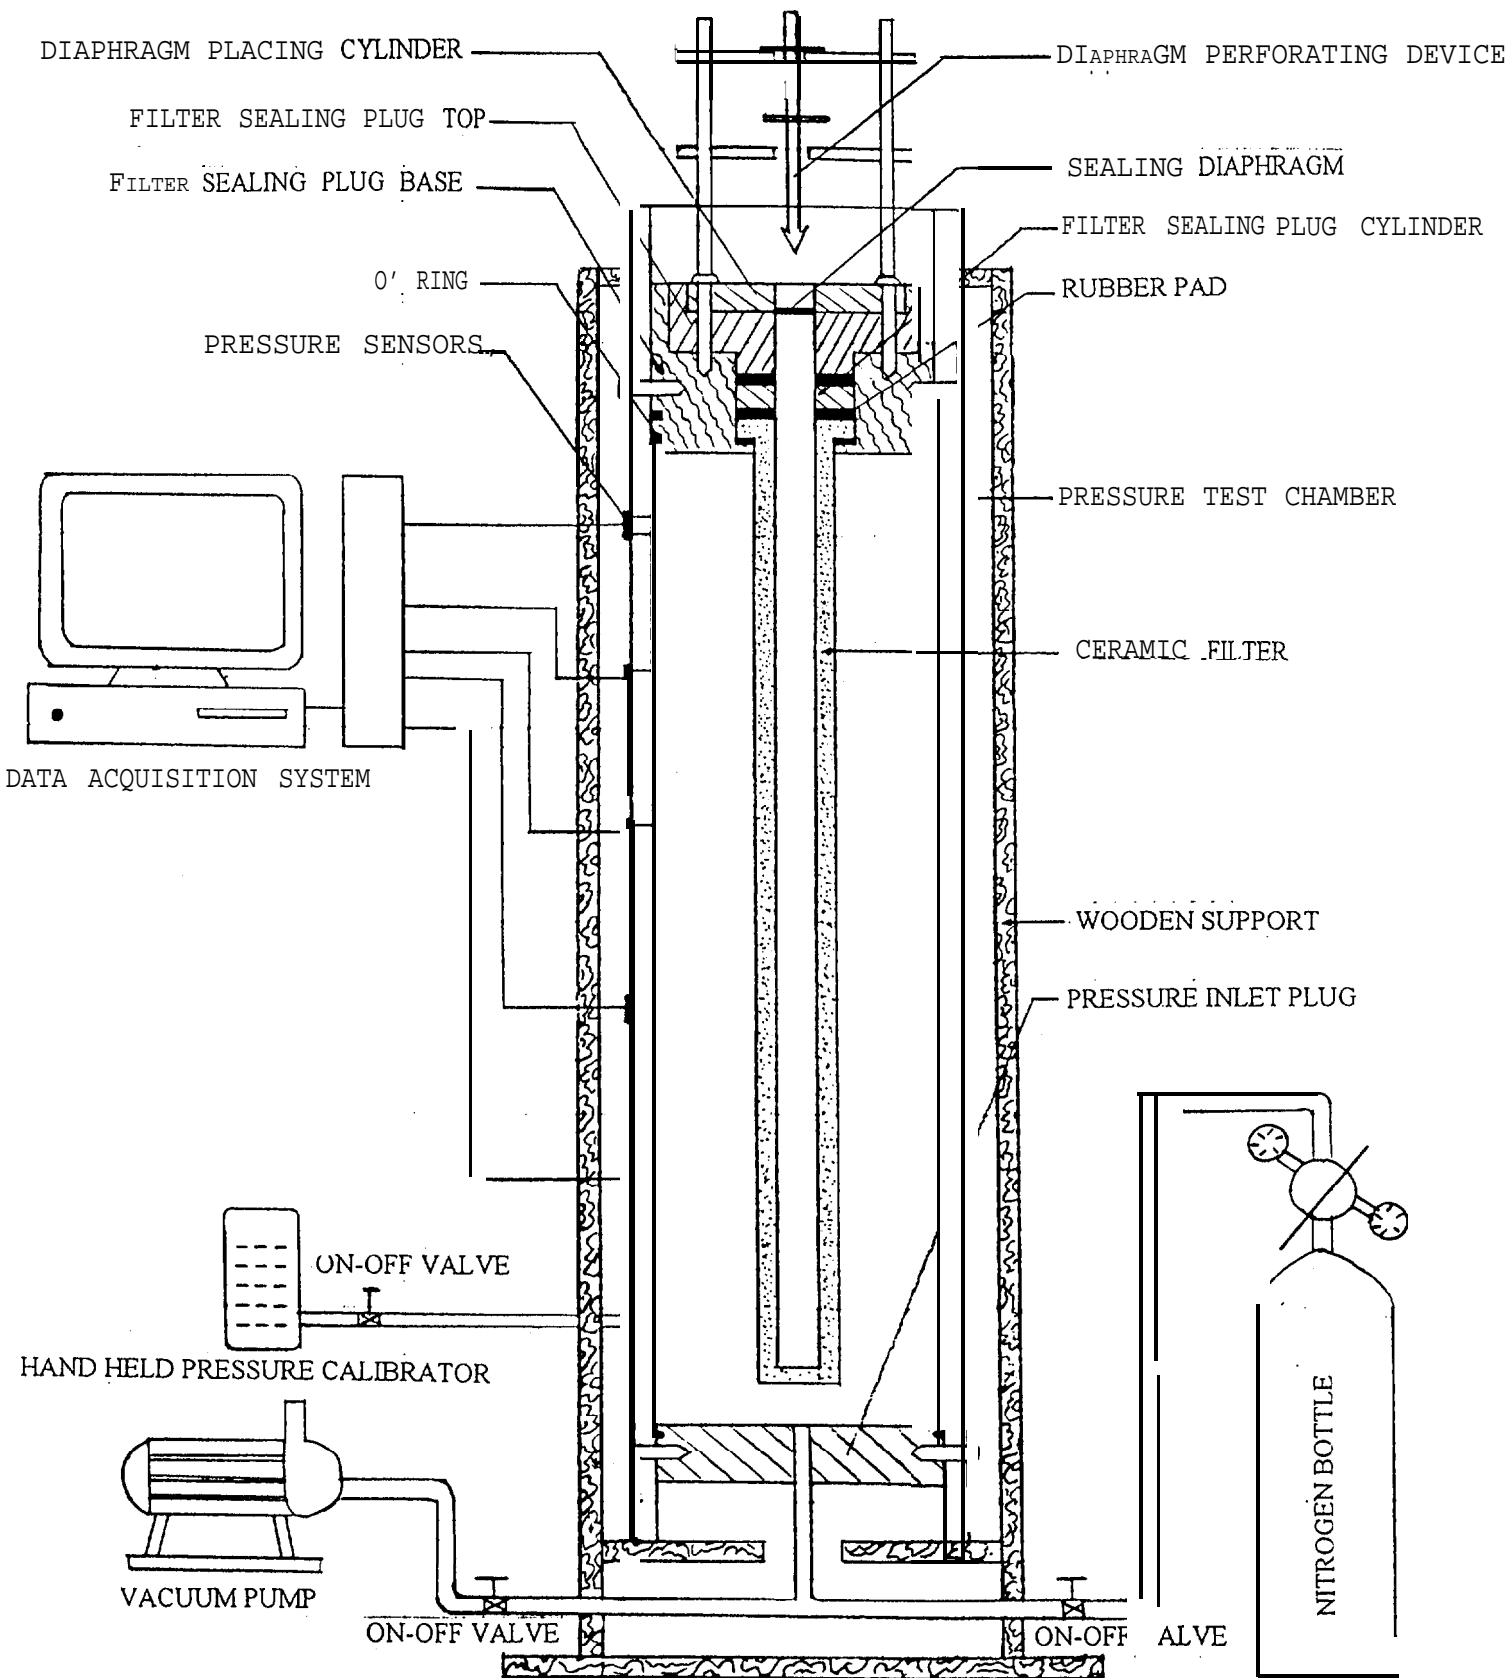
Fig. 1 SCHEMATIC DIAGRAM FOR UNUSED AND USED CERAMIC FILTER TEST

The schematic of the room ambient temperature filter test chamber is shown in Figure 1. To facilitate the testing, this test chamber vessel was made from a transparent plastic pipe with a 15,24 cm O. D., 198.12 cm long and 0,71 cm wall thickness. This test chamber vessel passed a 150.0 psig static pressure testing, compatible with Tidd APF pressure level, prior to its final assembly. Ten 1/2 -20 threaded holes are evenly spaced along the chamber axis to mount fast response pressure transducers and the pressure calibrator, A filter sealing plug base (15.33 cm diameter by 8.90 cm long) and a pressure inlet plug (1 5.33 cm diameter and 8.9 cm long) are placed at the top and bottom end of the test chamber respectively. All the test chamber components were carefully machined with a tight tolerance control within +/- 0,001 inches.

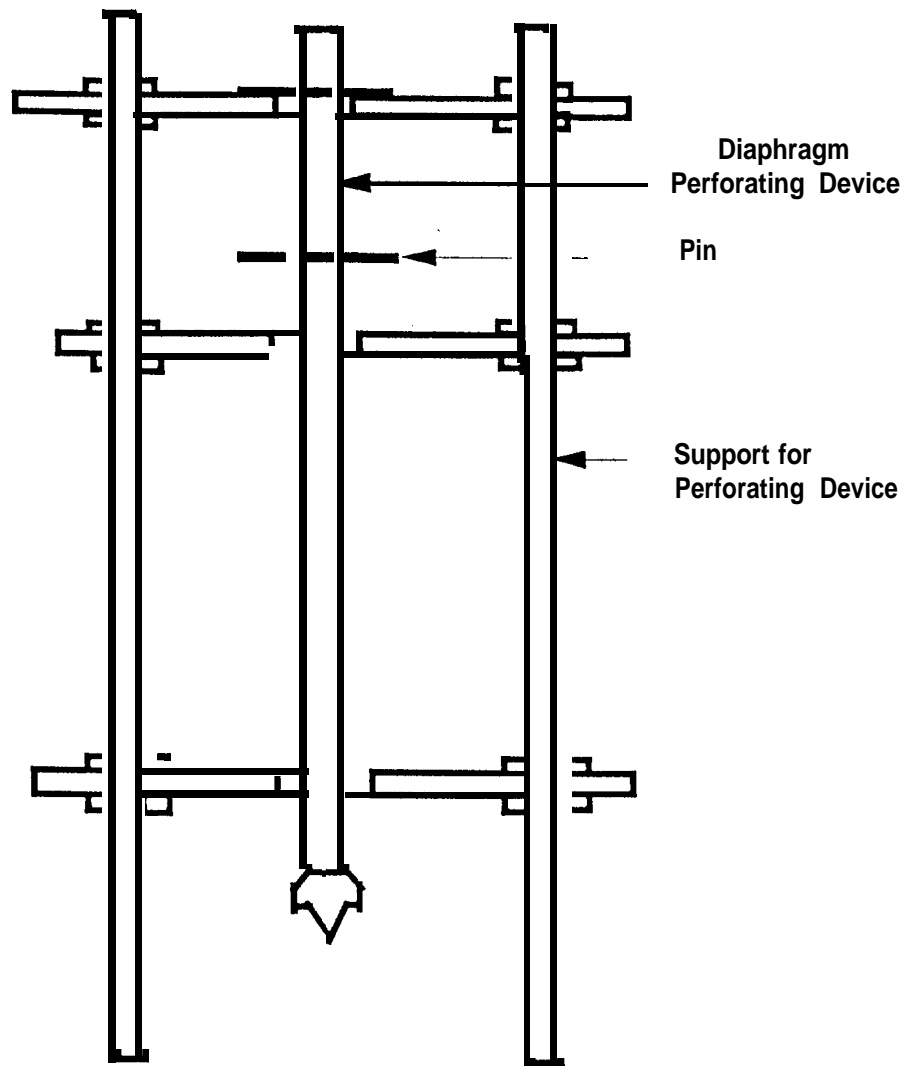
Figure 2 : Pressure Sealing Diaphragm Perforating Device

The candle filter is installed in the pressure sealing assembly to ensure the **hermeticity** of pressure sealing and the filter is located along the center of the vessel axis to provide a cylindrical symmetric system, Rubber pads are placed in between the filter and the sealing plug to reduce shock and mechanical stress on the filter flange during pressure testing, A pressure sealing diaphragm is installed on the top of the filter sealing assembly. The technique of perforating the diaphragm was utilized to seal and release filter test chamber pressure. The sealing diaphragm was **perforated** by a special designed perforating device to establish the chamber pressure per the ambient pressure test plan. Figure 2 shows the schematic of the diaphragm perforating arrangement.

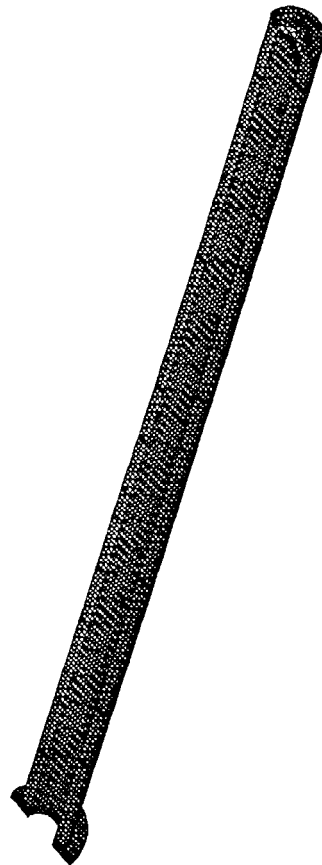
Fig. 3 Model of the filter

A finite element analysis was initiated using the commercial finite element code ANSYS (Version 5.0), The initial analysis was focused on temperature distribution within filter during dust cake cleanup process. Half of a filter cut along the vertical plane of symmetry was used as the calculation domain.

The module was developed by dividing the computation zone into five volumes. This **multizone** approach was used in order to overcome the difficulties in meshing due to high slenderness ratio (length to diameter) of the filter. **Discretization** of the computational zone was done using two types of 3-D elements from the ANSYS element library, The bottom closed end of the filter was meshed with 3-D 10-node tetrahedral thermal solid, The rest of the cylinder was meshed with 20-node Thermal Solid Brick, In total for the entire computation domain 3598 elements were used. Connective boundary conditions were used for both outside and inside surface, The inside environmental temperature was assumed to be 40 degree C and the outside environment temperature was taken as 800 degree C, selected because it is close to the working

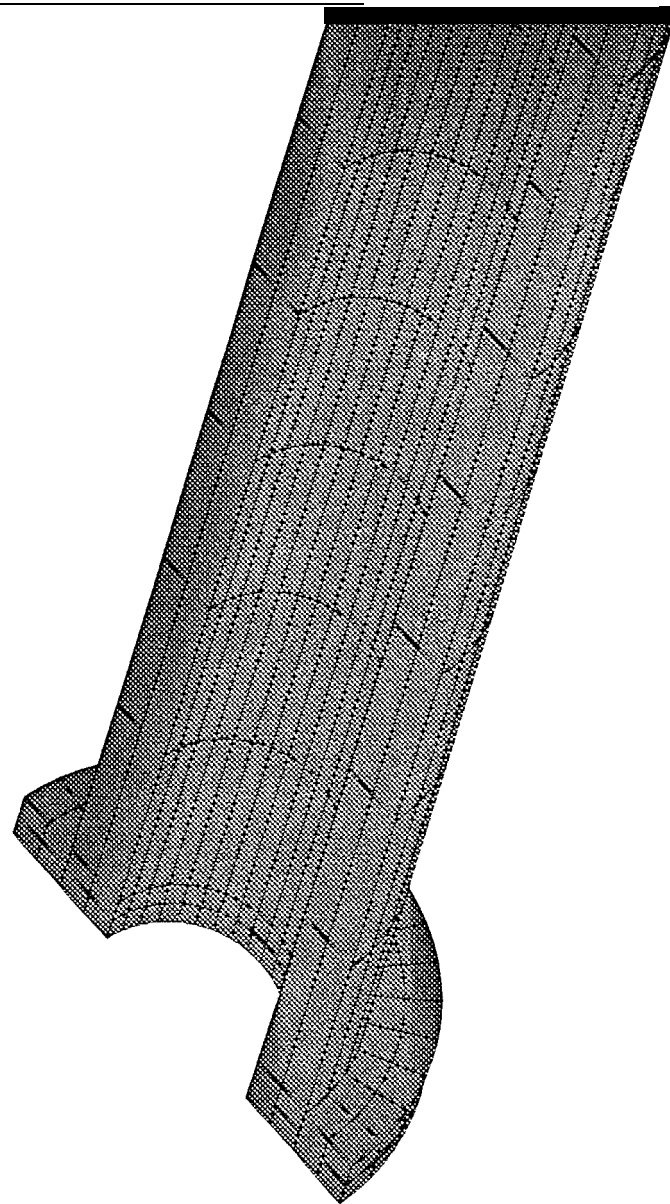
Fig. 4 Blow up of the model (Filter) near the neck with element meshing

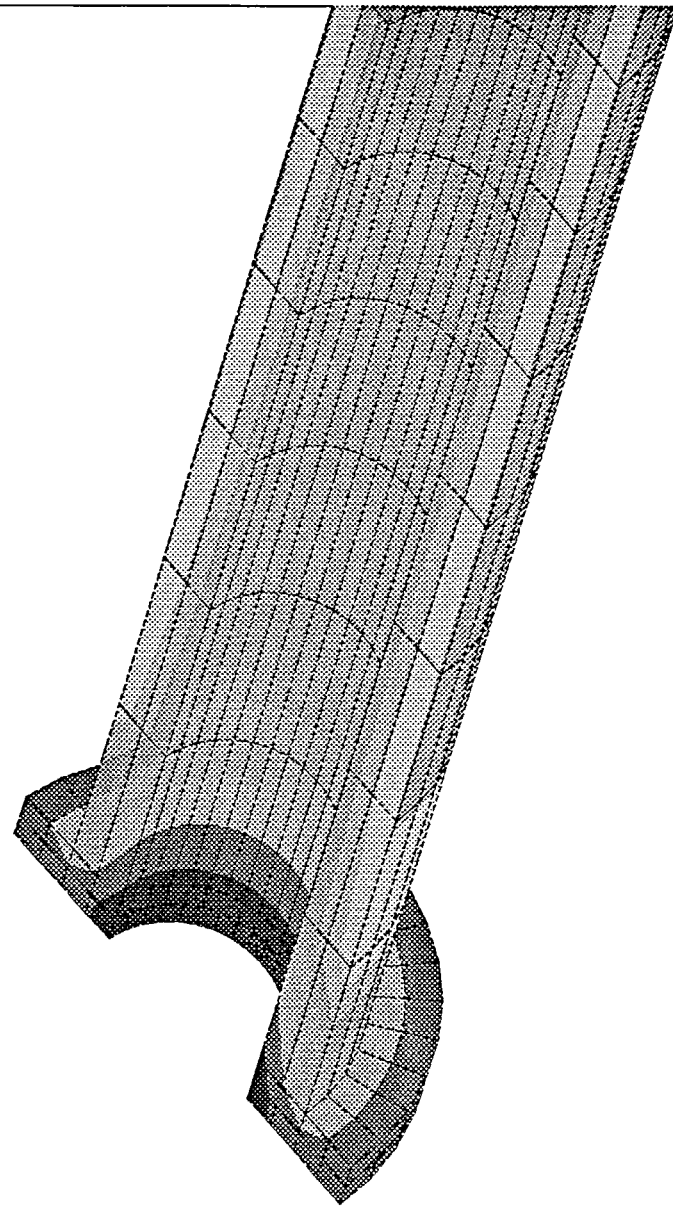
Fig. 5 Temperature contour from FEM ANALYSIS

The convective heat transfer coefficients were obtained using correlation for forced flow. the thermal conductivity for the **filter** was taken as 87-86 W/mK, a value for silicon carbide. The convective heat transfer coefficients used were 1105W/mK and 992 W/mK for inside and outside surface respectively. Figure 3 shows the model of the entire half filter with exact scale factor. Figure 4 shows a blow-up of the filter near the flange neck. The figure also depicts the meshing of the elements. Figure 5 shows the temperature contour plots. The highest temperatures were on the outside surface close to the middle of the filter. The lowest temperature was on the inner surface close to the neck, The temperature variation ranges from about 567 degree C to about 405 degree C.

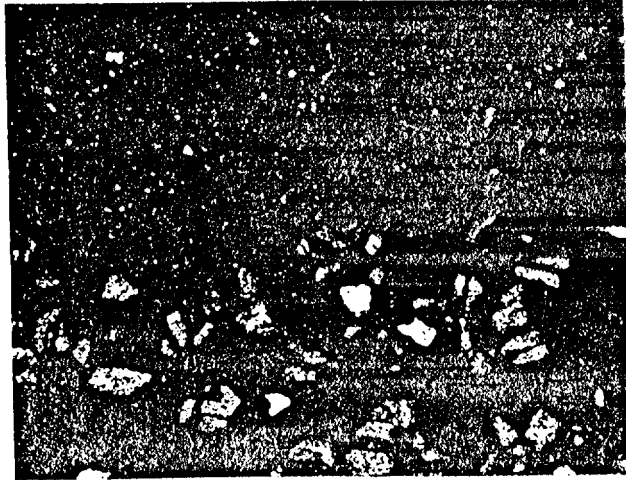
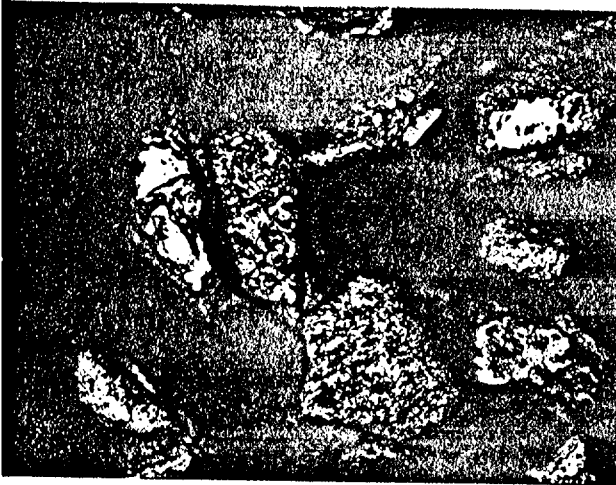
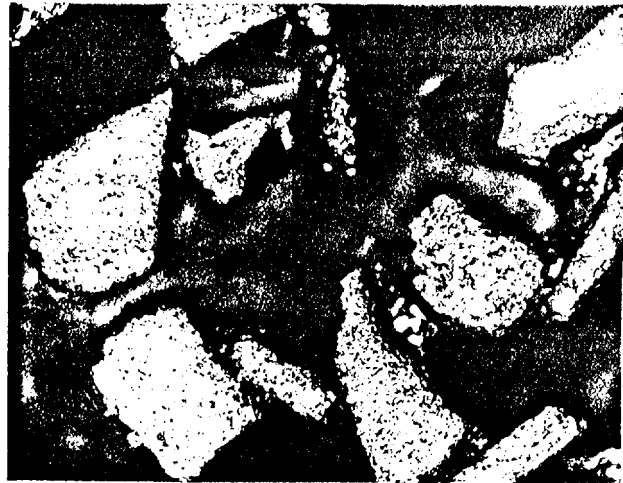
Figure 6 (a) Metallographic photo of the unused ceramic filter showing the double layer structure, x80, (b) Microstructure of the inner layer of unused and (c) used ceramic filters, x200.

Figure 6, 7, 8 and 9 show some results of related investigation. It shows that the unused ceramic filter is a double-layer porous candle with gray color. The broken used filter samples were in dark yellow color. The yellow color surface layer is the product of emission particle deposition and the chemical reactions between emission gases and filter material. The composition of this layer are mainly SiO₂, Al₂O₃ and Al₂Si₄O₁₀ according to the XRD analysis (Figure 7). This layer would reduce the **efficiency** of ceramic filters.

The observation and analysis also indicates that there is no significant difference in morphological characteristics between used and unused ceramic filters. it seems to indicate that no obvious change in microstructure occurred **after** usage. But, the XRD spectrashowed that **after** usage the crystal structure of the main composition SiC has been changed. The crystal plan spaces of the SiC in the outer layer were increased, For the inner layer, not only has SiC changed the crystal plane spaces, but also its grain orientation, The preferred orientation along (1034) of SiC in the inner layer of the used ceramic filter can be seen clearly in Figure 9. The growing and change in microstructure of the grain caused by thermal cycle may result in great stress inside the filter, The thermal induced stresses may promote the nucleation and the propagation of **microcracks** leading to the **final** fatigue fracture failure of the ceramic filters,

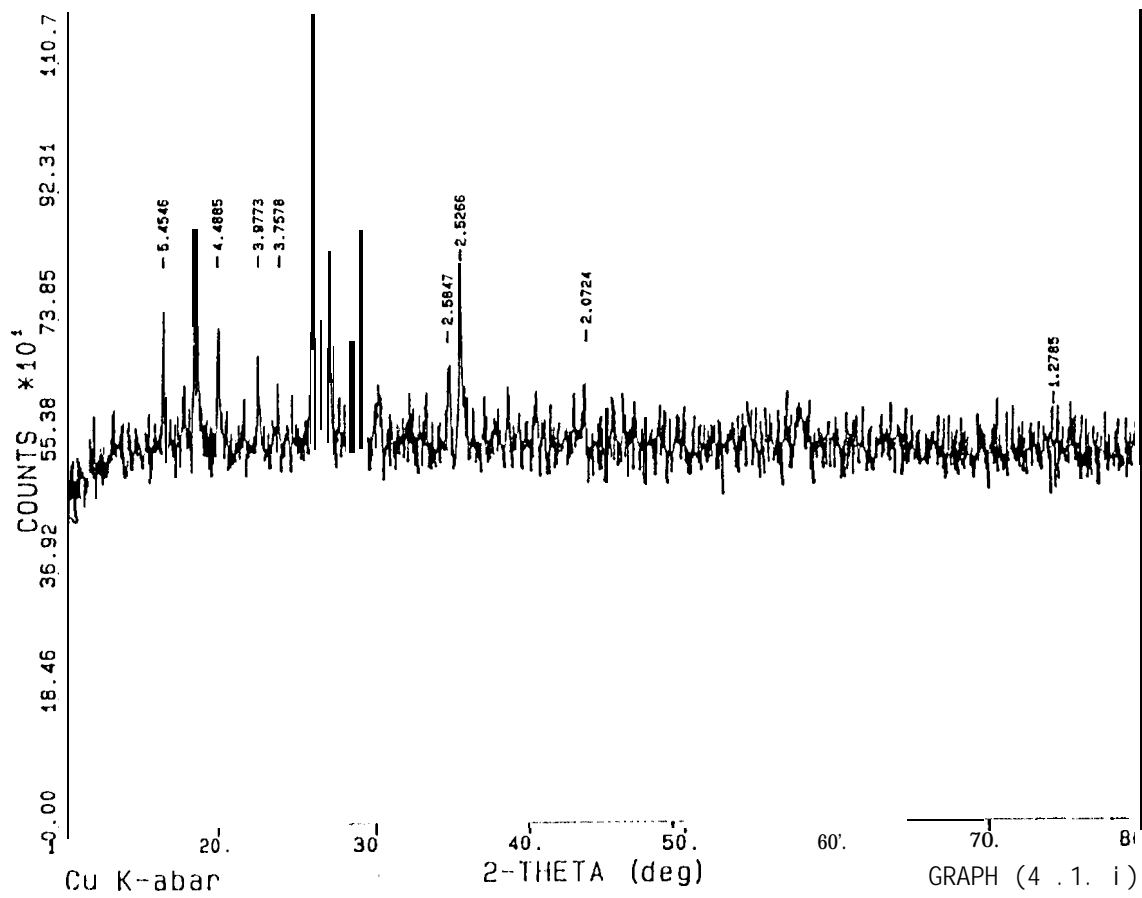
Figure 7 XRD spectrum of the deposition and reaction layer on the surface of the used ceramic filter,

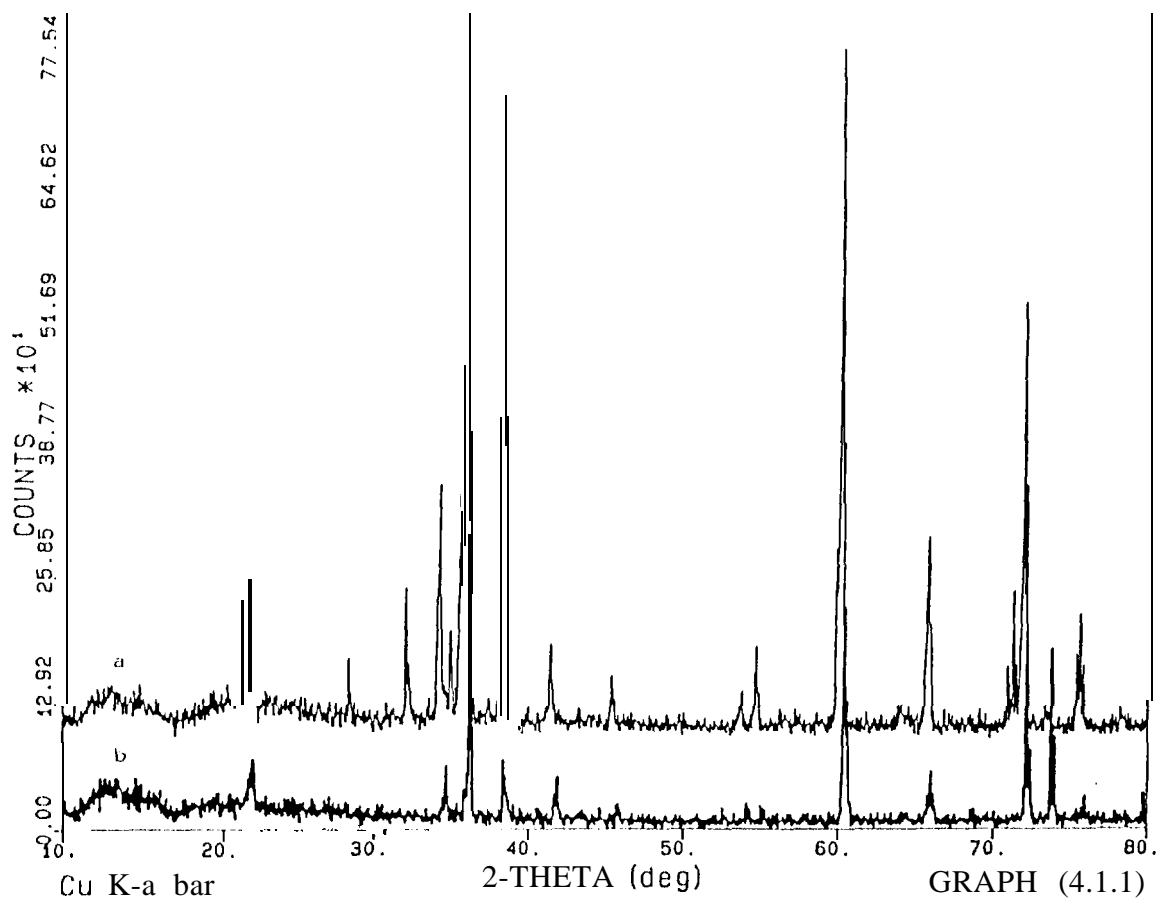
Figure 8 XRD spectra of the outer layers of (a) the used and (b) the unused ceramic filters, showing changes in crystal plane spaces after usage.

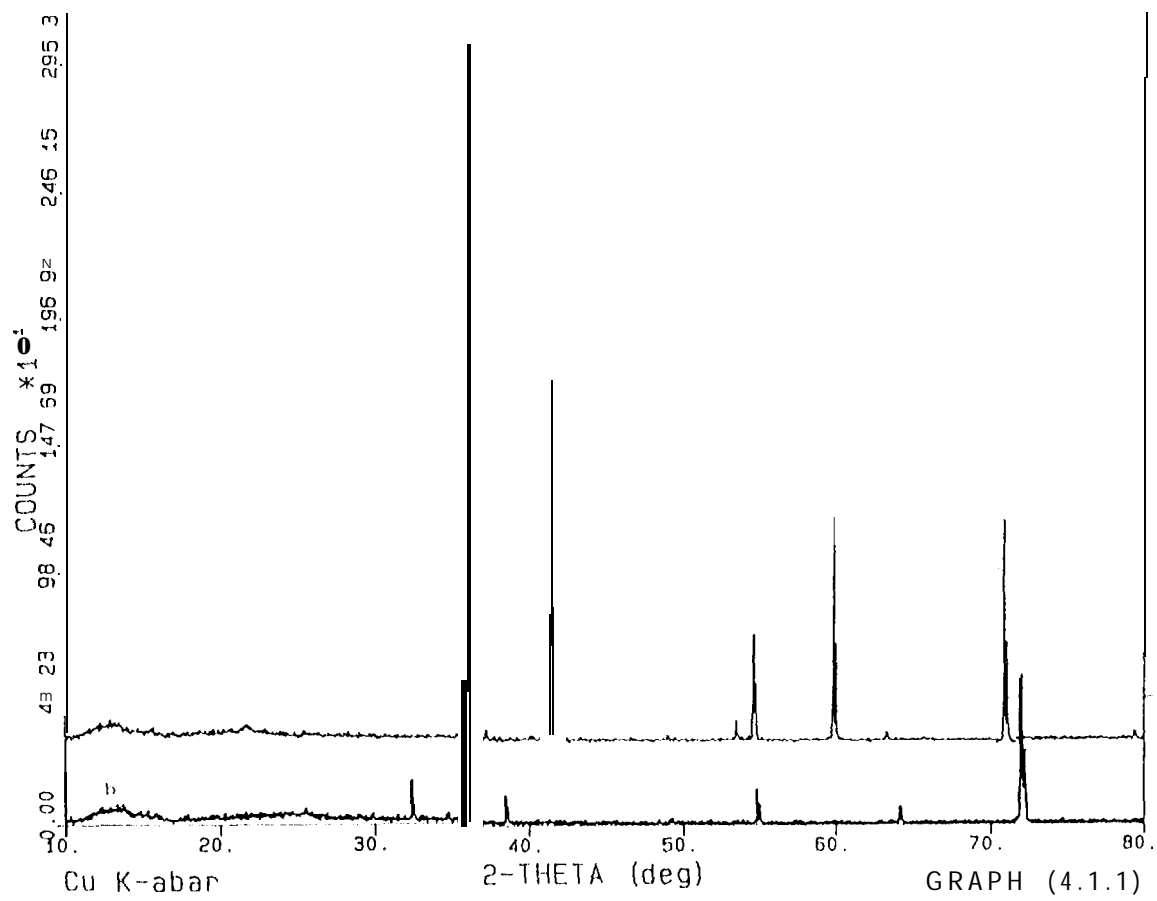
Figure 9 XRD spectra of the inner layers of (a) the used and (b) the unused ceramic filters, showing changes in crystal plane spaces and orientation after usage.

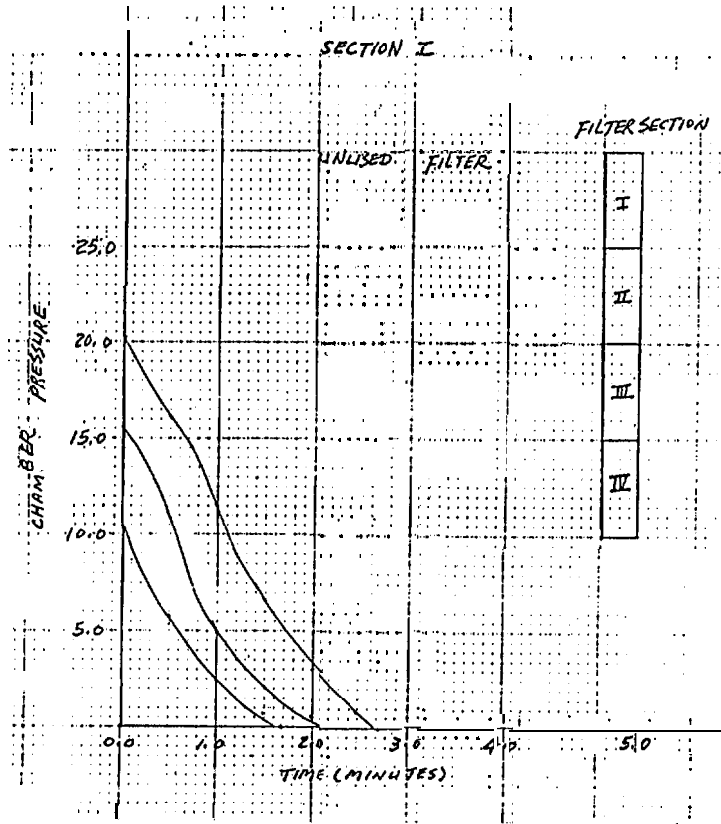
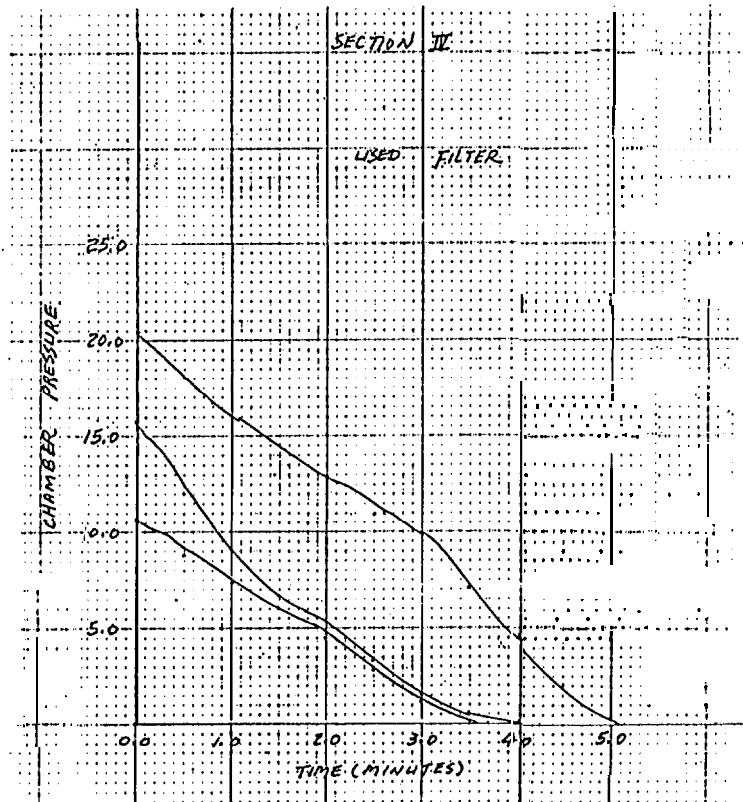
Figure 10: Filter permeability variations of used filter compared to unused filter

The test data indicated that the unused **filter** is characterized with a fairly uniform permeability distribution along its axis. The permeability distributions of the four sections along the filter axis are almost the same, However, the used filter displayed a random and nonuniform permeability distribution along filter axis and its perimeter, when both type of filters were tested under the same environment with the same test setup. The used filter displays the same or better permeability in section 111 area. But the filter permeability at area section IV area is much less than that of the unused filter **as shown in figure 10**. Along the filter chamber wall, area section 111 always display a lower pressure field and that of area IV displayed a higher pressure field. Reverse gas flows were also monitored during the gas stream **flowing** process at a **range** of pressure level close to filter section area 111, These observations were consistent with different chamber pressure levels. This indicates that the pressure field in the **filter** chamber can not be assumed with a **laminar** flow or a steady state flow for flow process simulation.
