Energy Systems Environmental Restoration Program
**Source Document for Waste Area Groupings
at Oak Ridge National Laboratory,
Oak Ridge, Tennessee**

Date Issued—September 1996

Environmental Management Activities at
OAK RIDGE NATIONAL LABORATORY
Oak Ridge, Tennessee 37831-6285
managed by
LOCKHEED MARTIN ENERGY SYSTEMS, INC.
for the
U.S. DEPARTMENT OF ENERGY
under contract DE-AC05-84OR21400

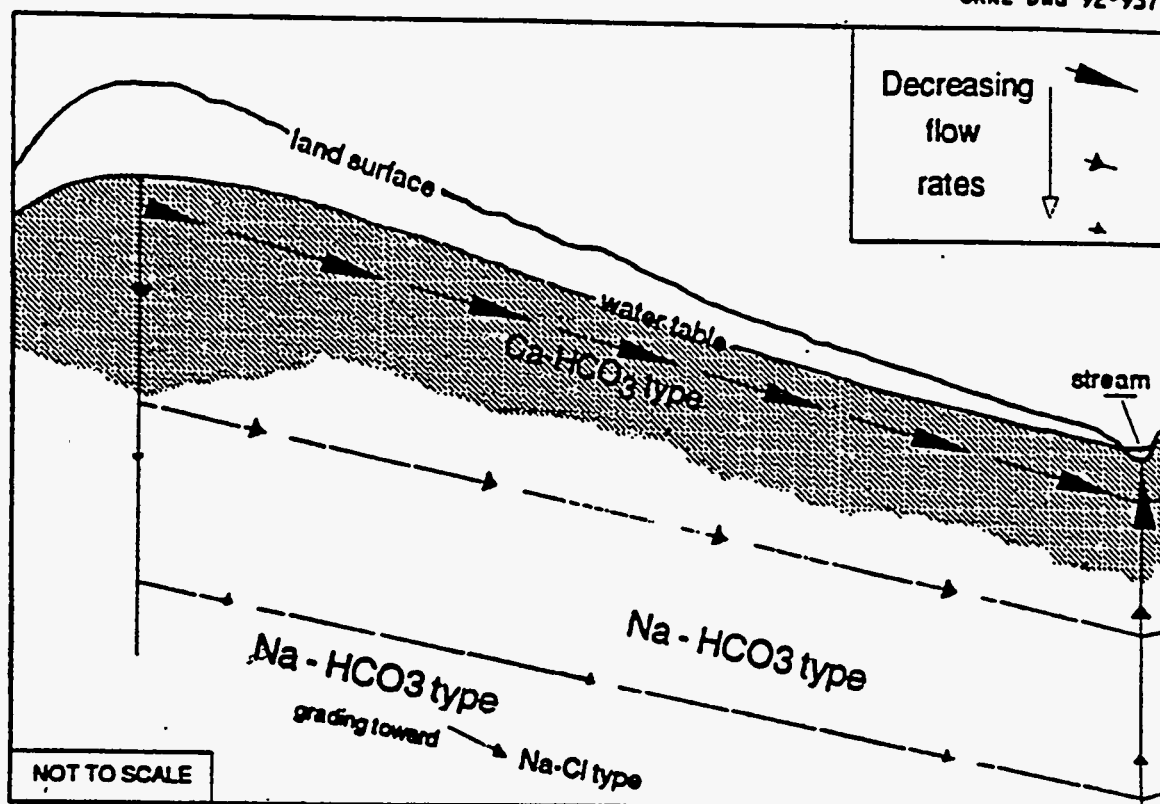
Fig. 5.10. Schematic cross section showing very generalized flow paths, related geochemical evolution, and relative flow rates. Source: Clapp 1992

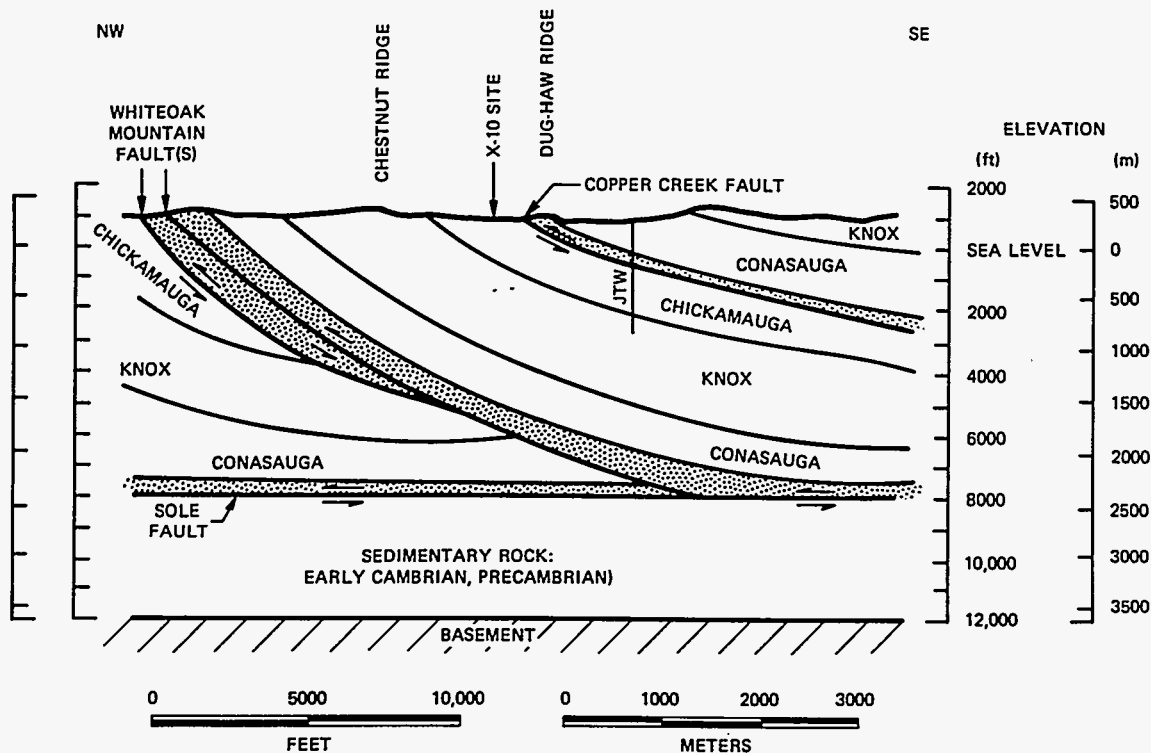
Fig. 6.2. Geologic cross-section beneath WAG 1 through ORR. Source: Bechtel 1989

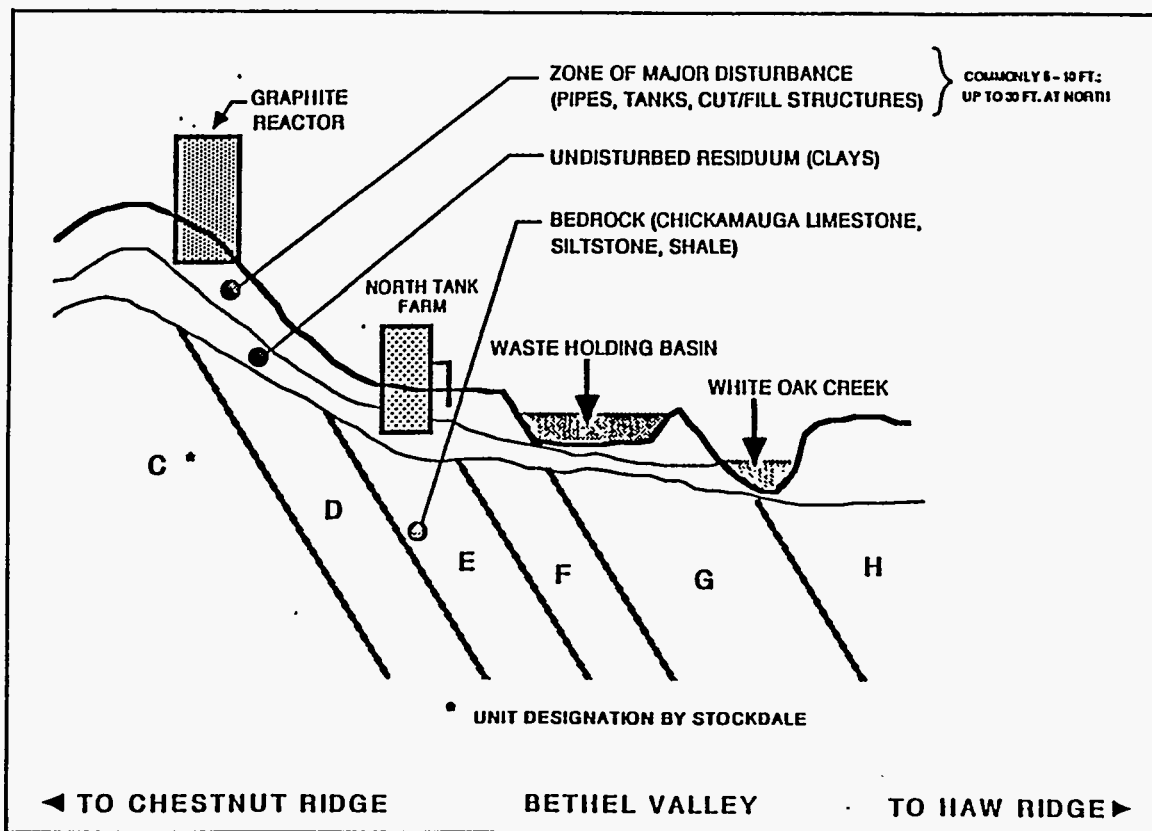
Fig. 6.4. Geologic cross-section through the main plant area. Source: Bechtel 1989

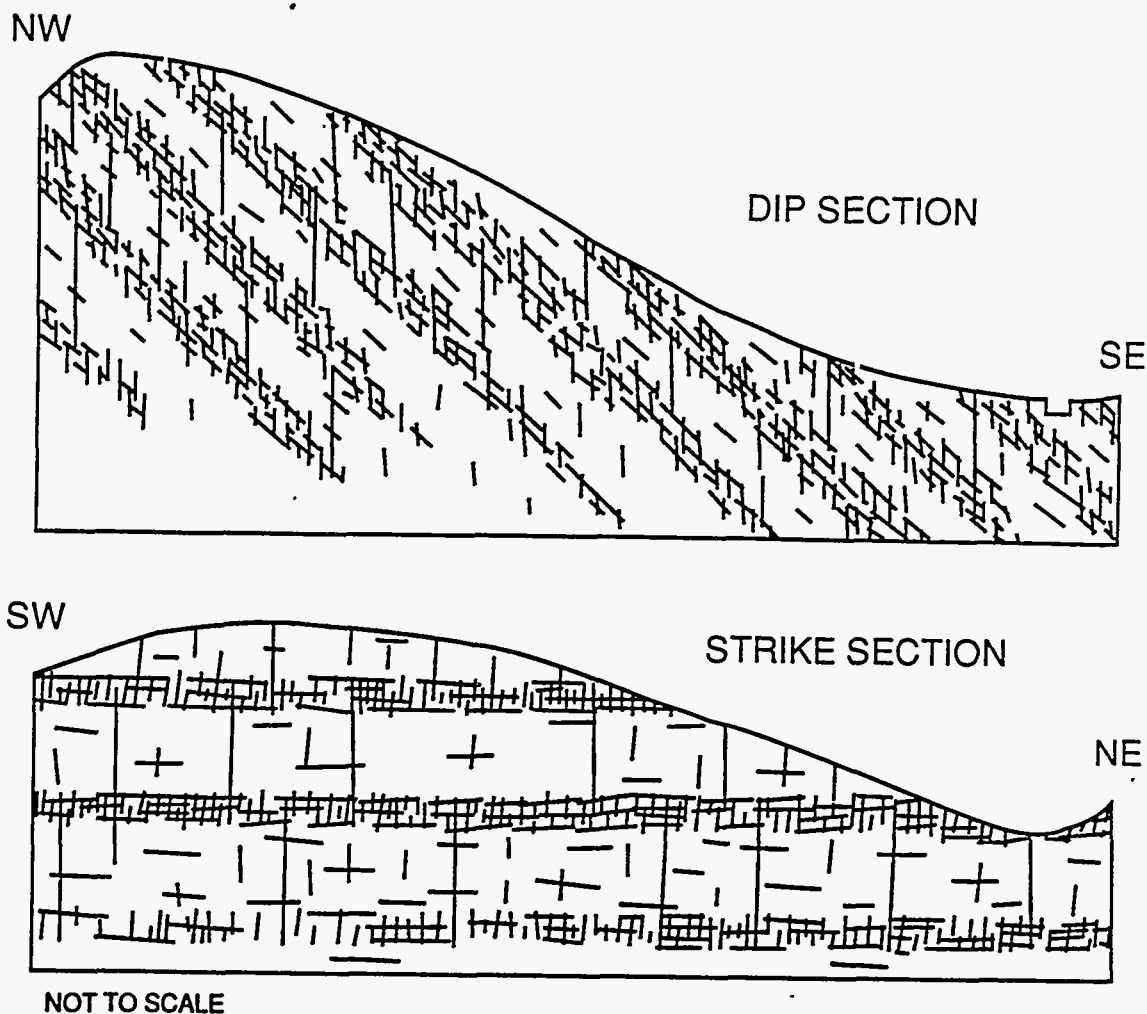
Fig. 7.7. A conceptual model showing differences in the trends and densities of open fractures to explain anisotropy in the groundwater zone of Melton Valley. A third fracture in each section is represented by the plane of this paper. Source: Energy Systems 1990a

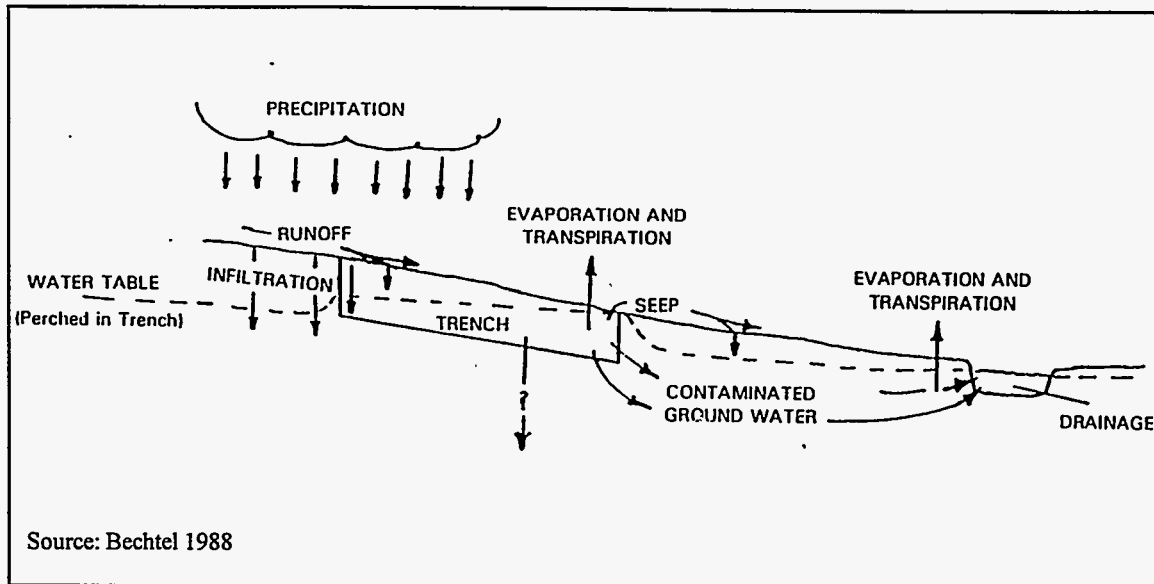
Fig. 10.7. Diagram of groundwater and radionuclide contaminant movement from a hypothetical trench to the surface environment.

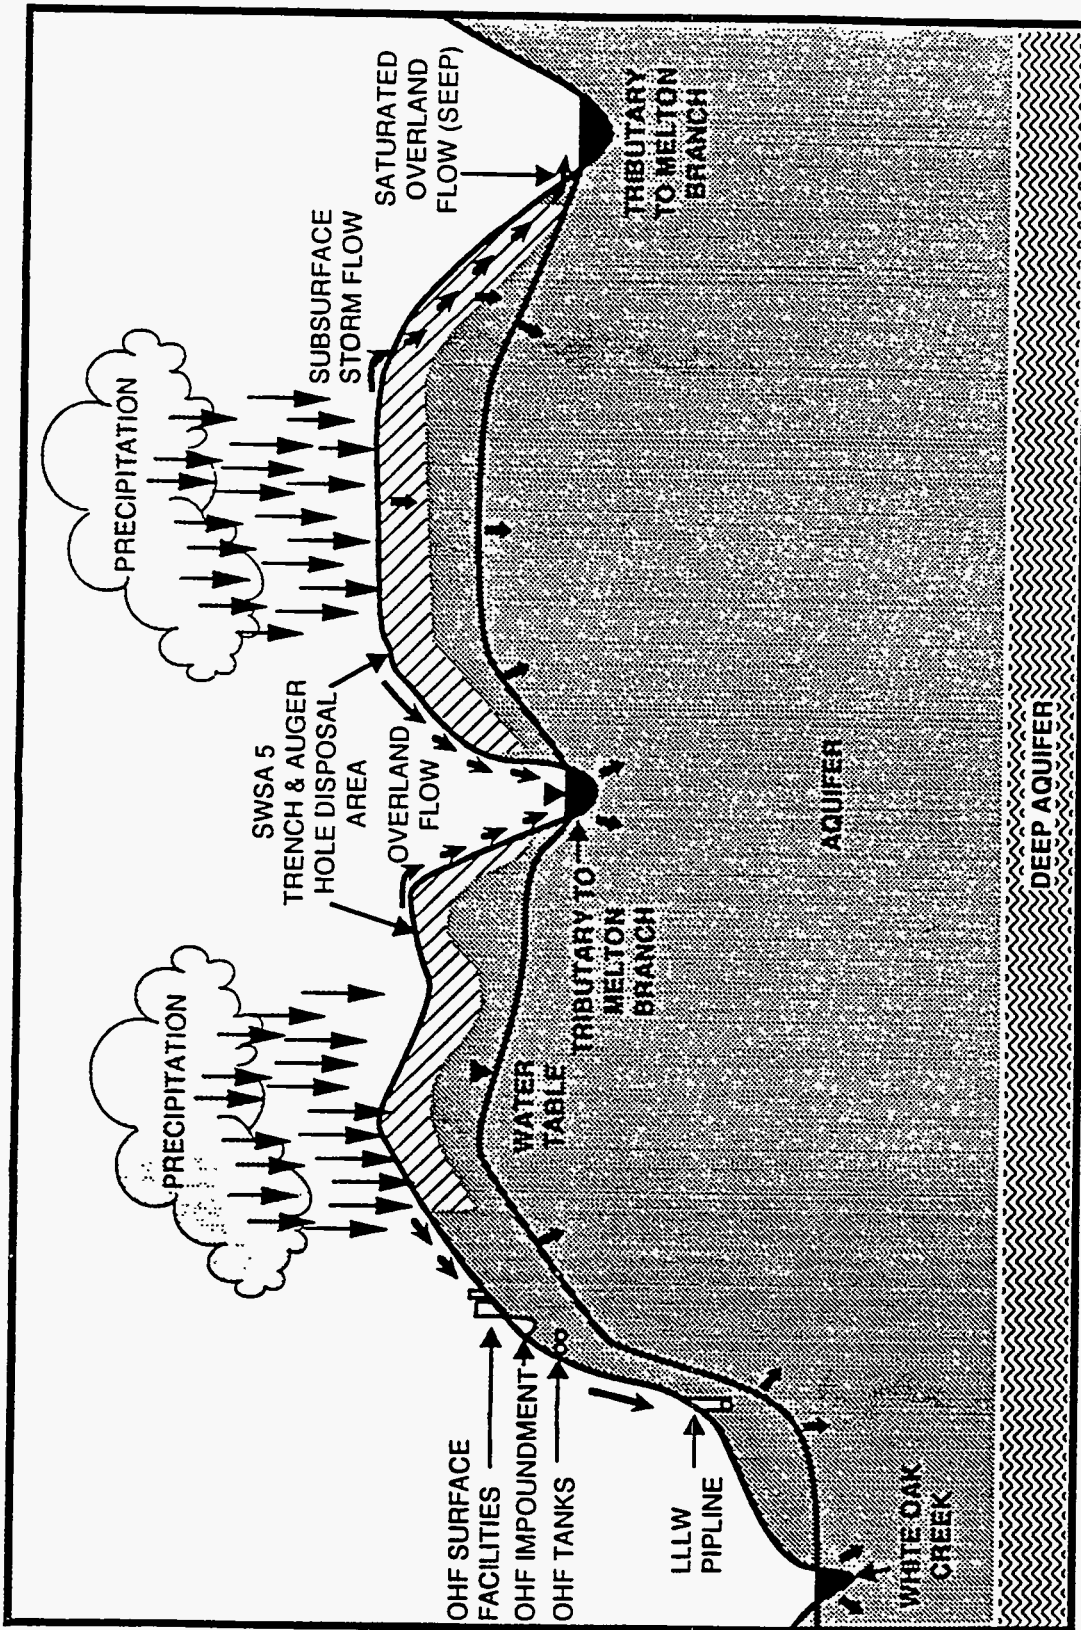
Fig. 10.9. WAG 5 conceptual flow paths.

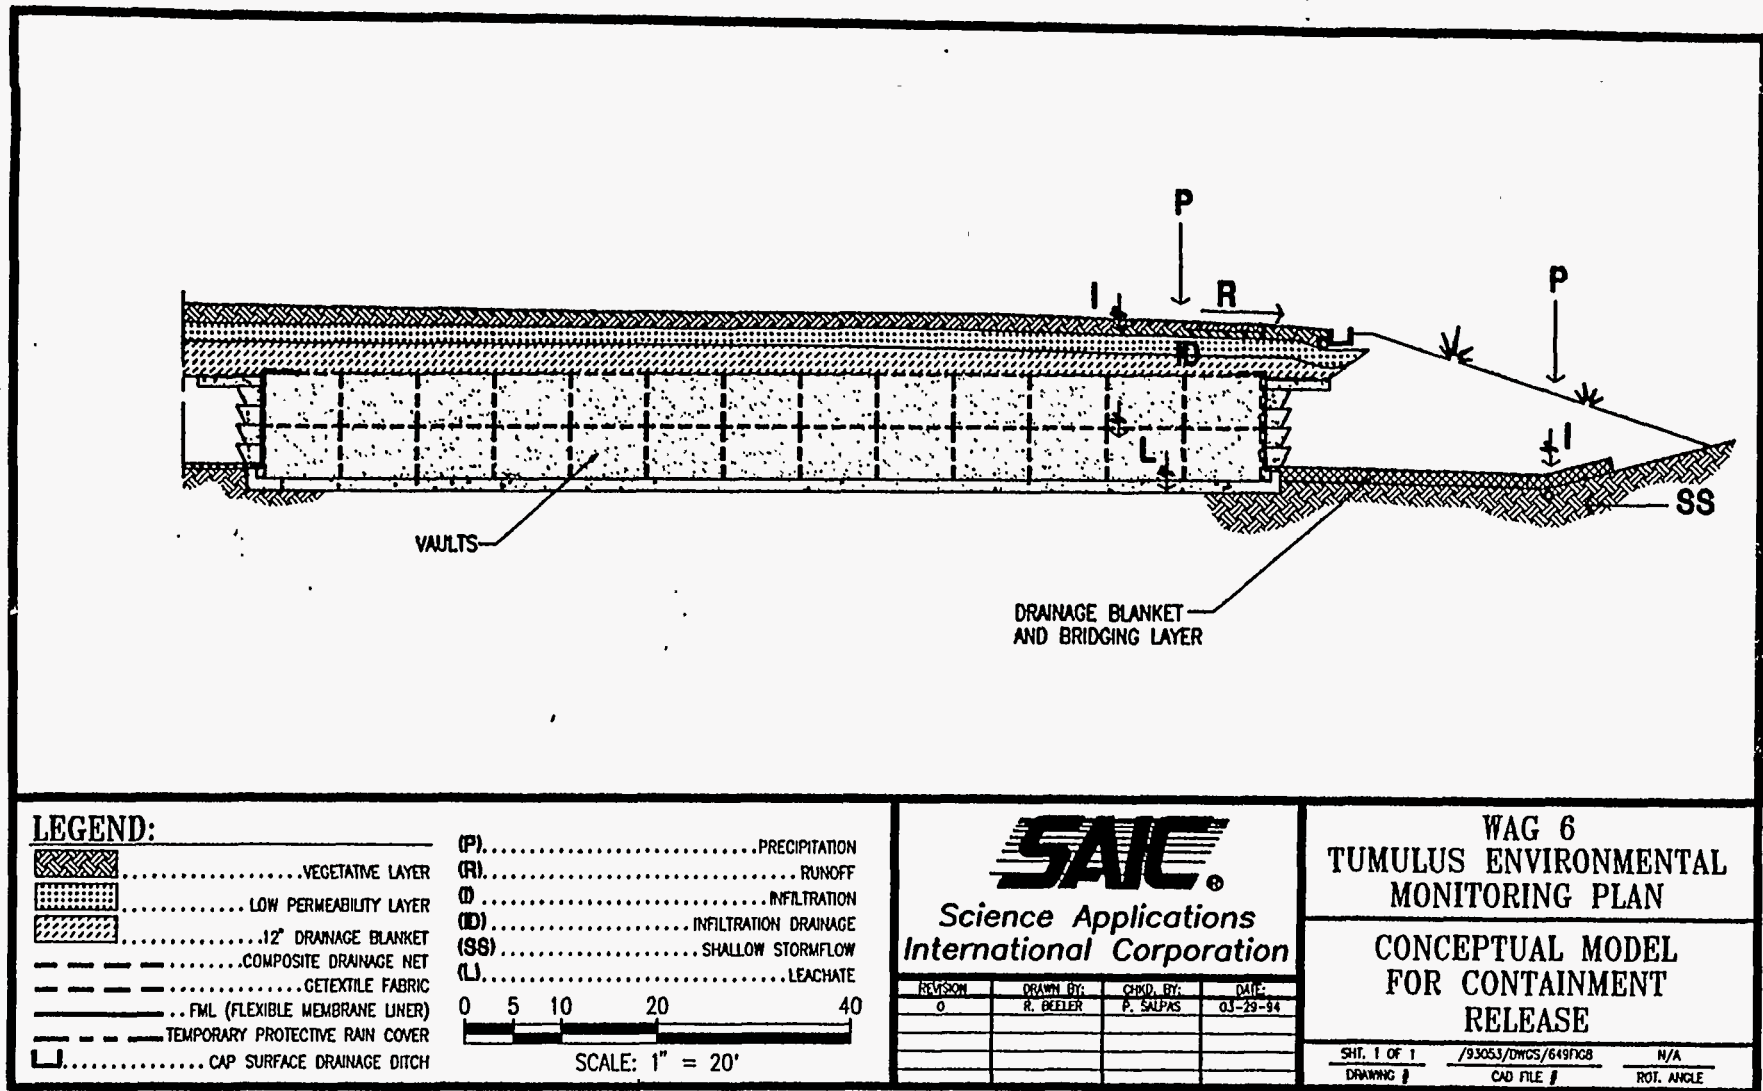
Fig. 11.9. Conceptual drawing of a tumulus structure showing its major components and primary water pathways under expected conditions (P, R, I) and under the condition of cap leakage (L). Source: SAIC 1994

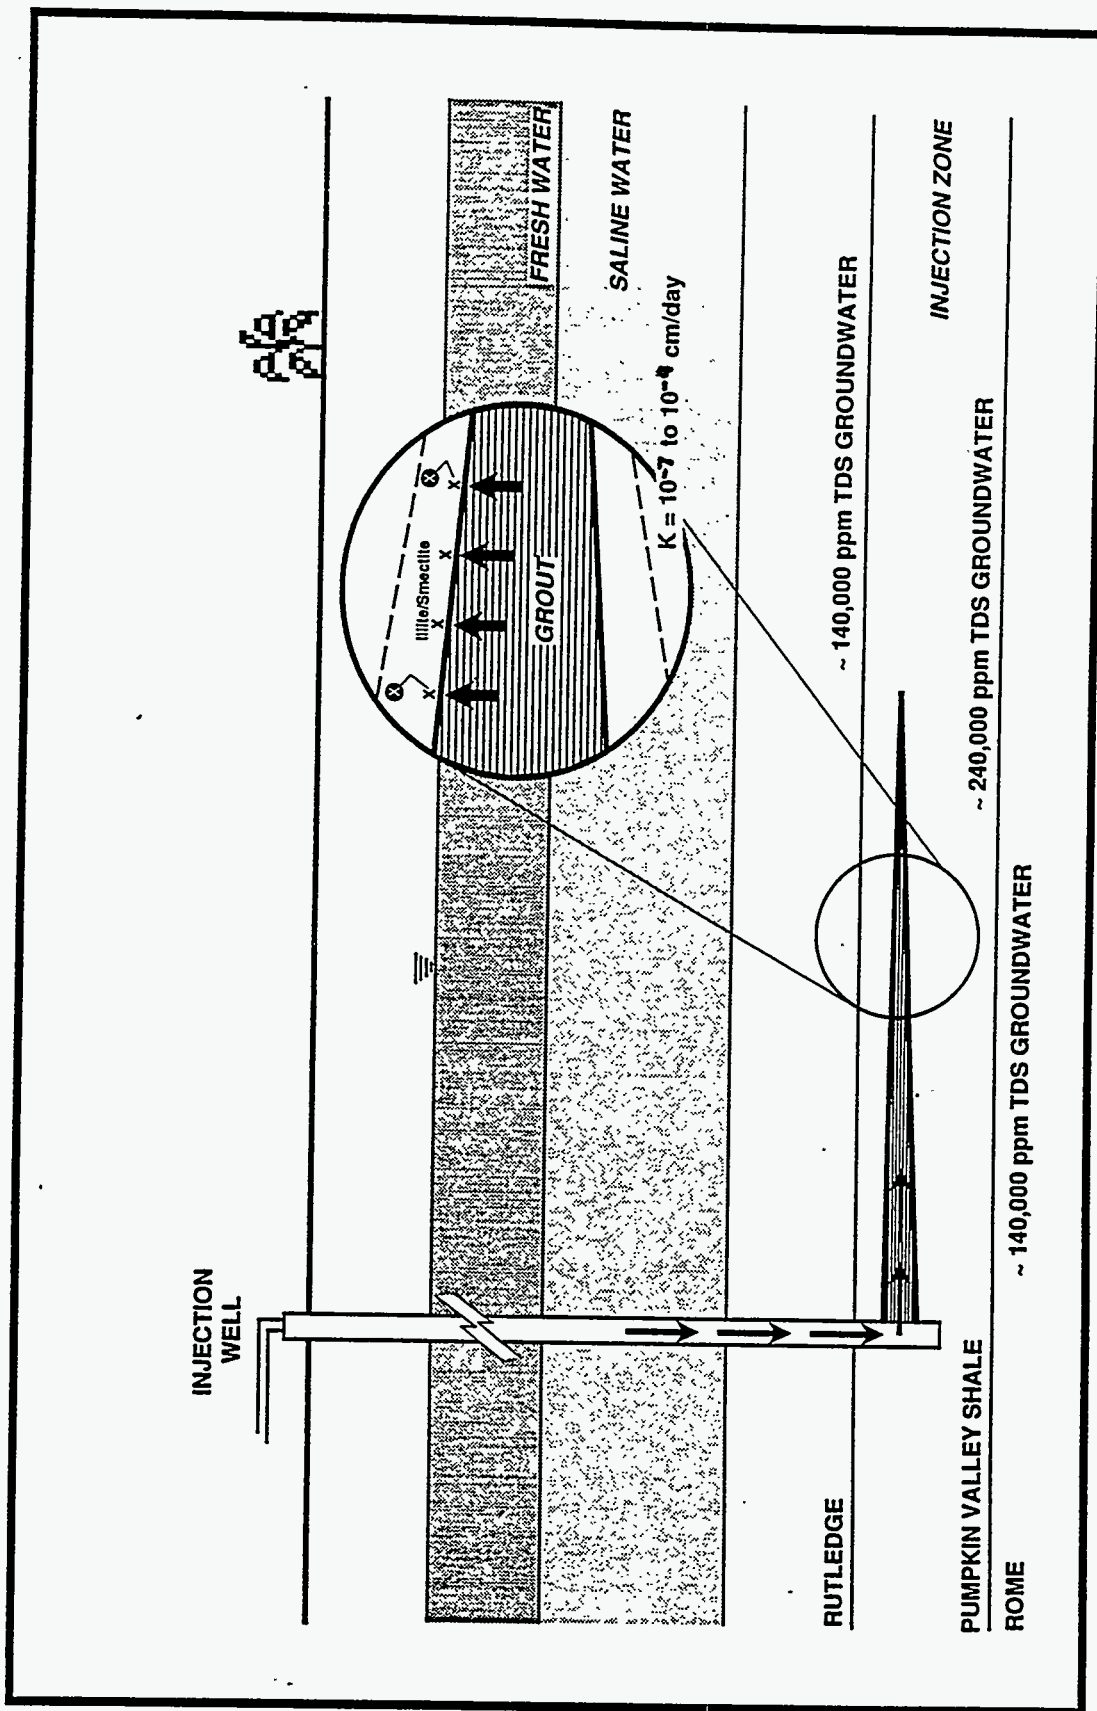
Fig. 15.2. Schematic representation of hydrofracture injection process. Source: Bechtel 1990
