Field-Scale Permeation Testing of Jet-Grouted Buried Waste Sites

Guy G. Loomis
Idaho National Engineering Laboratory
P.O. Box 1625
Idaho Falls, Idaho 83415-3710

ABSTRACT

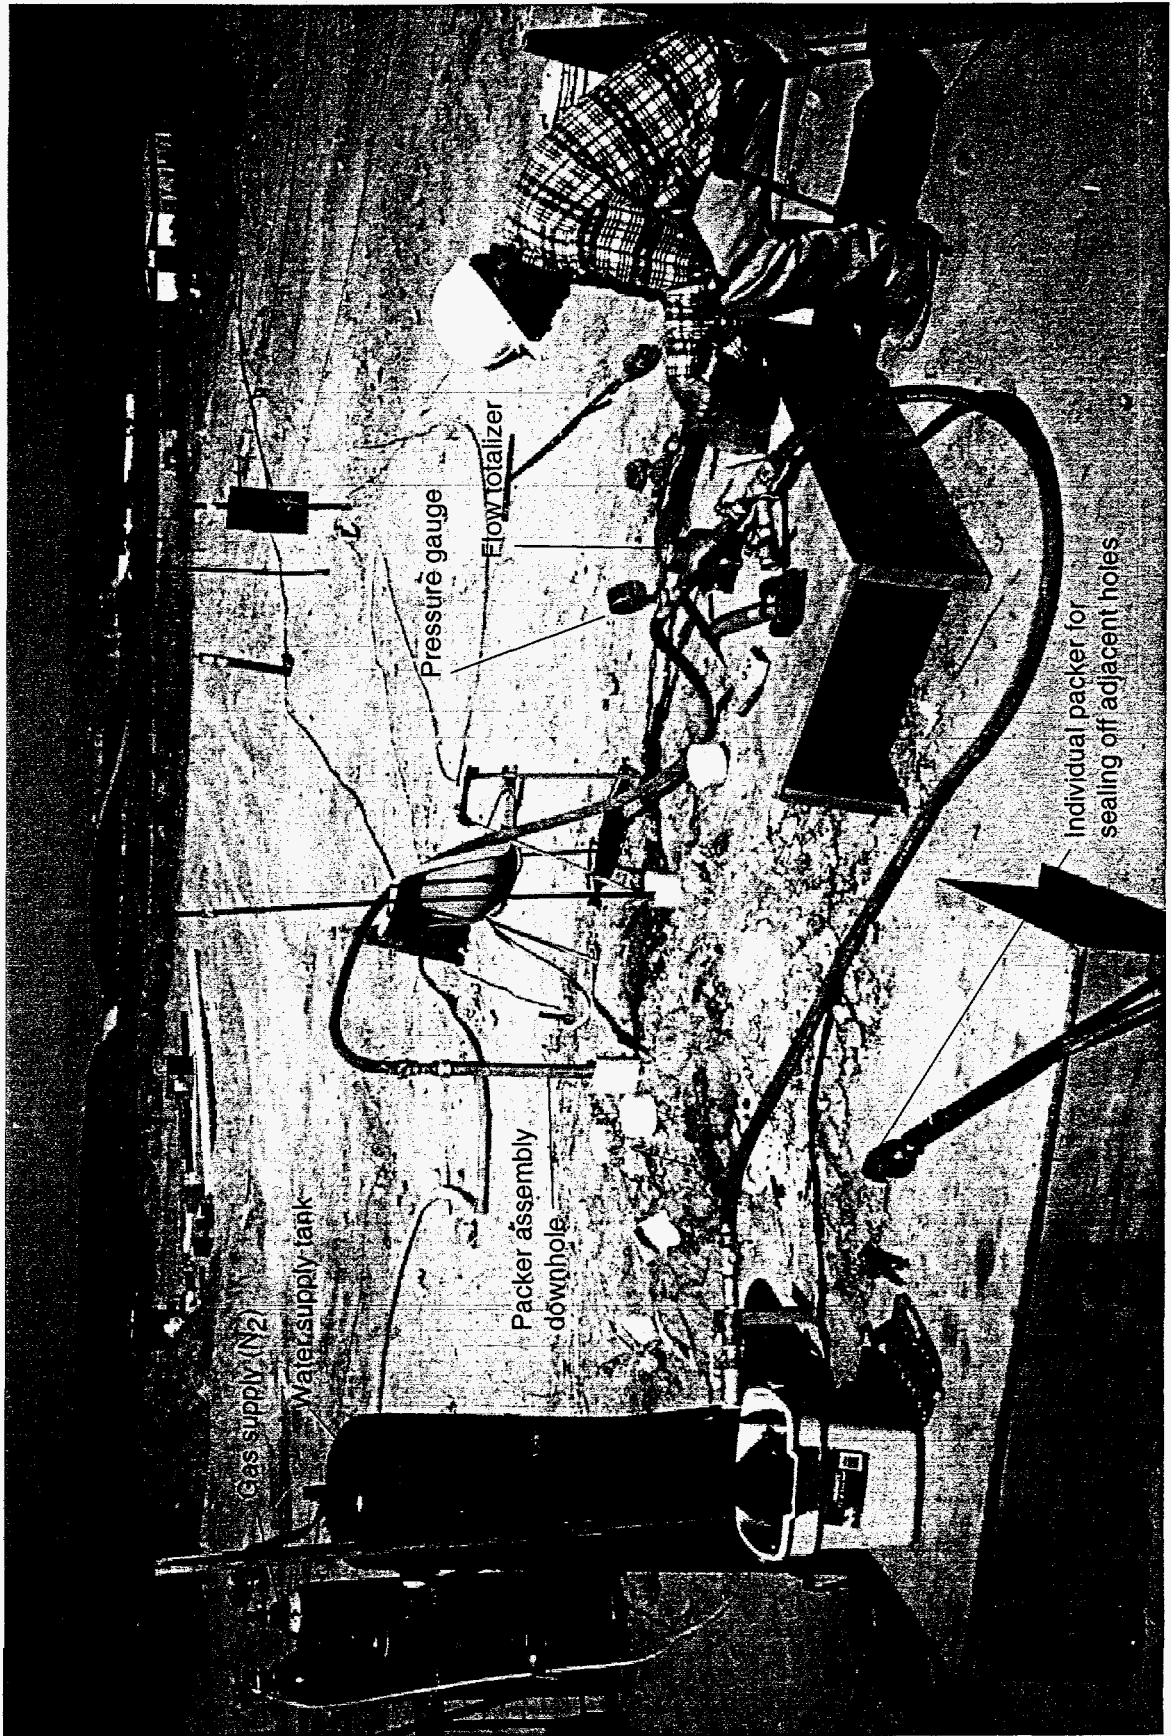
Fig. 1. Packer testing of south culvert (INEL Graphic M96 0452).

Packer tests were performed in the grouted permeameter and pits grouted with TECT, paraffin, and high-sulfate-resistant Portland cement using the 9.1-cm core holes. In these tests, the isotropic hydraulic conductivity was measured at several axial positions by using an inflatable bellows system to isolate regions in the core. The packer tests were conducted using both single- and dual-bellows packer systems. Fig. 1 shows the packer apparatus during testing, including water supply tank, nitrogen pressure supply tank, flow meter, packer assembly, and associated equipment.

Gas supply (N₂)

Water supply tank

Packer assembly
downhole

Pressure gauge

Flow totalizer

Individual packer for
sealing off adjacent holes

The packer test was performed according to standard practice wherein the packer was placed into the core hole at the desired depth, the packer bellows were inflated, and the resultant flow of water into the packed off hole for a variety of pressures (0-158 kPa) was noted. The flow of water was recorded for both ascending and descending pressure values. If, for instance, there was no measurable flow for 10 minutes at a pressure of 158 kPa, the local hydraulic conductivity was less than 10^{-7} cm/s. This is based on standards for packer testing⁴ and on the use of the uncertainty in the flow totalizer of 0.076 L delivered in any interval of 10 minutes. In actual practice, there was no measurable flow registered for many of the core holes tested. Therefore, using the reading error of the flow totalizer gives a conservative estimate of the hydraulic conductivity. The equation⁴ used in these calculations is:

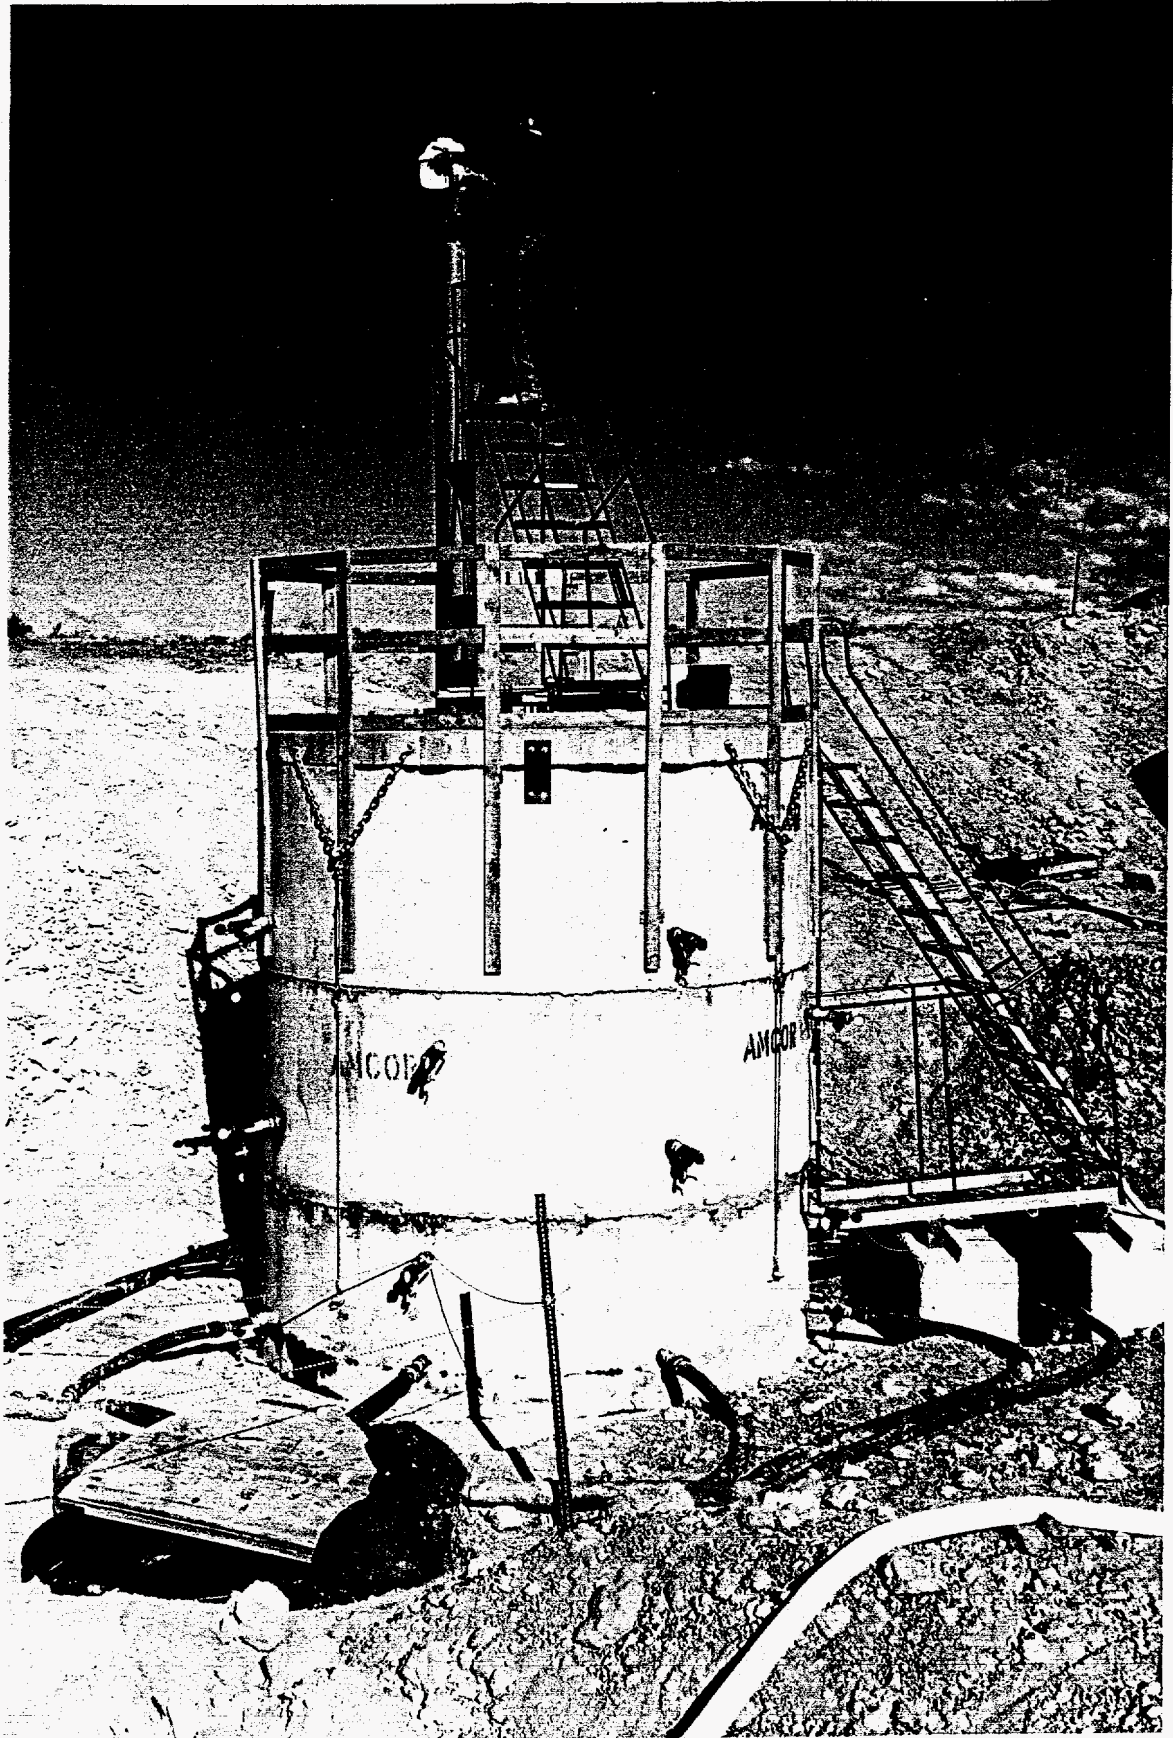
Fig. 2. Completed baseline culvert with lid tie-downs; worker shown introducing water into the head pipe (INEL Photo 96-658-2-30).

Fig. 2 shows the baseline ungrouted permeameter with head pipe and associated collection system for water effluent out the bottom. The head pipe had a site glass to monitor the fall of water each day. Once installed, the bottom eight valves were attached to a covered water collection system to produce the mass balance of water into and out of the matrix. Once emplaced, water was introduced into the head pipe, and the system was allowed to fully saturate. Saturation was achieved when added water did not flow into the system with the bottom valves closed. Once saturated, the falling head method was employed. This involved filling the head pipe and noting how much volume drop in water occurred over various intervals, nominally 8-24 hours. A calibration head pipe with a semiclosed system (top vent but no bottom drain) was used to adjust the head pipes for changes in atmospheric conditions.

Following the gross saturation, a specially constructed lid was installed on the top of the culvert that included a 3-m-high head pipe to provide an additional head of water to accelerate the time required to obtain the hydraulic conductivity measurement.

After several attempts at sealing from the outside, it was discovered that the leakage was attributed to the lid actually lifting at the exact pound-force exerted by the water head (about 10 cm of head up the head pipe) applied over the entire surface area of the lid. The decision was made to apply a new seal of the tar-like material and to tie the lid to the culvert rings using both steel plate and a turnbuckle system. These tie-downs are shown in Fig. 2.
