Emerging NDE Technology for Aging Aircraft

David G. Moore Richard L. Perry
Sandia National Laboratories - Federal Aviation Administration
Airworthiness Assurance NDI Validation Center
Albuquerque, New Mexico 87185
(505) 844-7095 (505) 284-4296

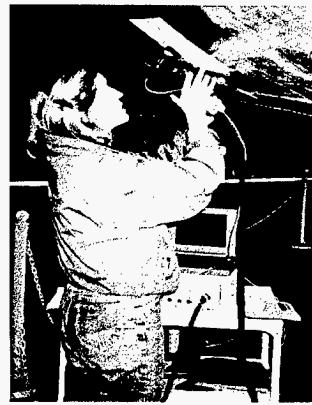
Figure 2. Working maintenance environment which represents inspection difficulties that influence reliability.

The main goal of the validation center is to promote the efficient development and timely transfer of technology to its customers. To support this goal, the AANC has a 28,000 square foot hangar at the Albuquerque International Airport (Figure 1). The hangar facility replicates a working maintenance environment by incorporating both the physical inspection difficulties as well as the environmental factors which influence inspection reliability (Figure 2). The principal intent of the Center is to validate enhanced inspection techniques for transport and commuter aircraft. However, the center has been involved in other activities such as structural test and repair issues, maintenance reliability studies, responding to aircraft Certification Office requests, and hosting of various FAA and industry groups.

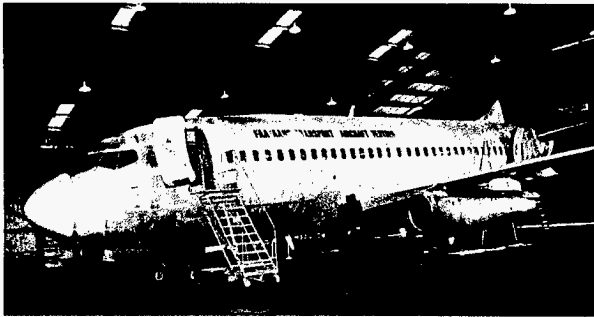
Figure 3. Boeing 737-200 testbed used for inspection deployment issues.

Over the first seven operating years, the center has built a vast library of test specimens. Each specimen is categorized by the type of defect it represents. The major categories are surface cracks, interlayer cracks, corrosion, and composite defects. AANC has acquired two aircraft testbeds; a Boeing 737-200 and a Fairchild Metro II (Figures 3, 4).
