**INTEGRATED RADWASTE TREATMENT SYSTEM  
FINAL REPORT**

Topical Report

By  
M. N. Baker  
H. M. Houston

October, 1997

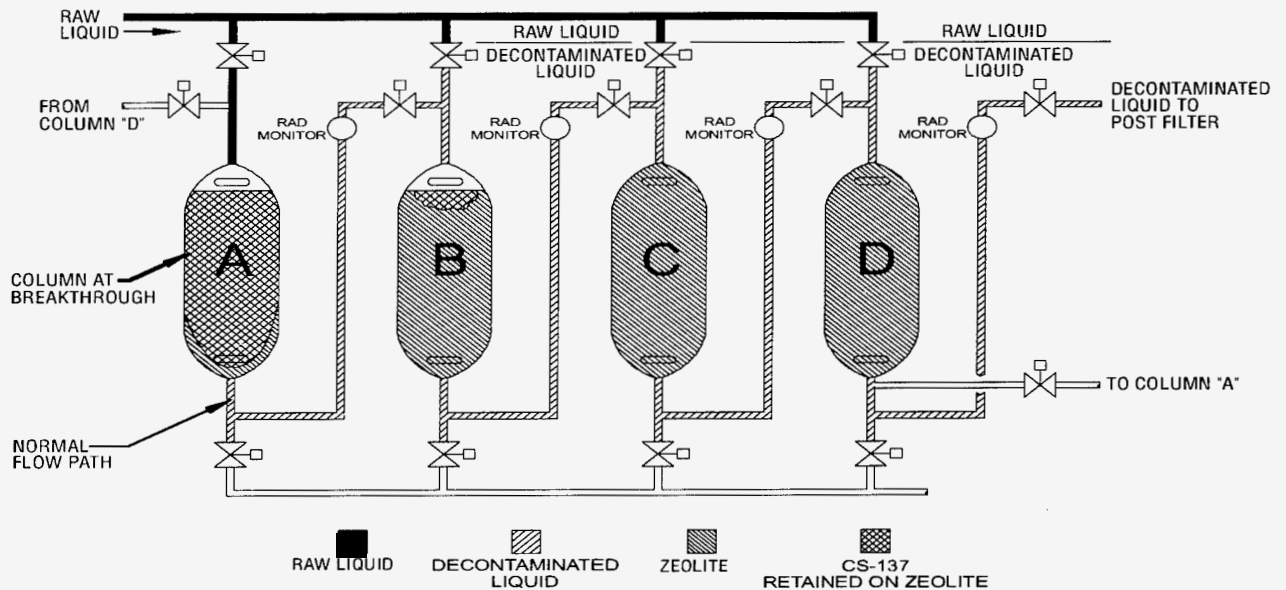
Figure 3.1 STS Ion-Exchange Columns

As process knowledge developed, it became evident that radiation monitors installed on the effluent piping of the ion-exchange columns were not reliable for on-line process control. [See Figure 3.1] High system decontamination factors (DFs), low monitor readings, and awkward conversion from counts per minute on the monitors to microcuries per milliliter in the liquid affected data accuracy. Batch sampling and on-line sampling of the tanks and ion-exchange columns proved to be a better source of primary data for process control.

There was no particular benefit in filling the ion-exchange columns to the point of “breakthrough” because Cs-137 that was not being retained by the lead column was being captured by the second column. [See Figure 3.1] This meant that a high-volume campaign would be followed by a reduced-volume campaign, that a low-volume campaign would be followed by a high-volume campaign, and so on.
