River Corridor Closure Contract

618-10 Burial Ground Trench Remediation and 618-10 and 618-11 Burial Ground Nonintrusive Characterization of Vertical Pipe Units Lessons Learned

Washington Closure Hanford

WCH-543
Rev. 0

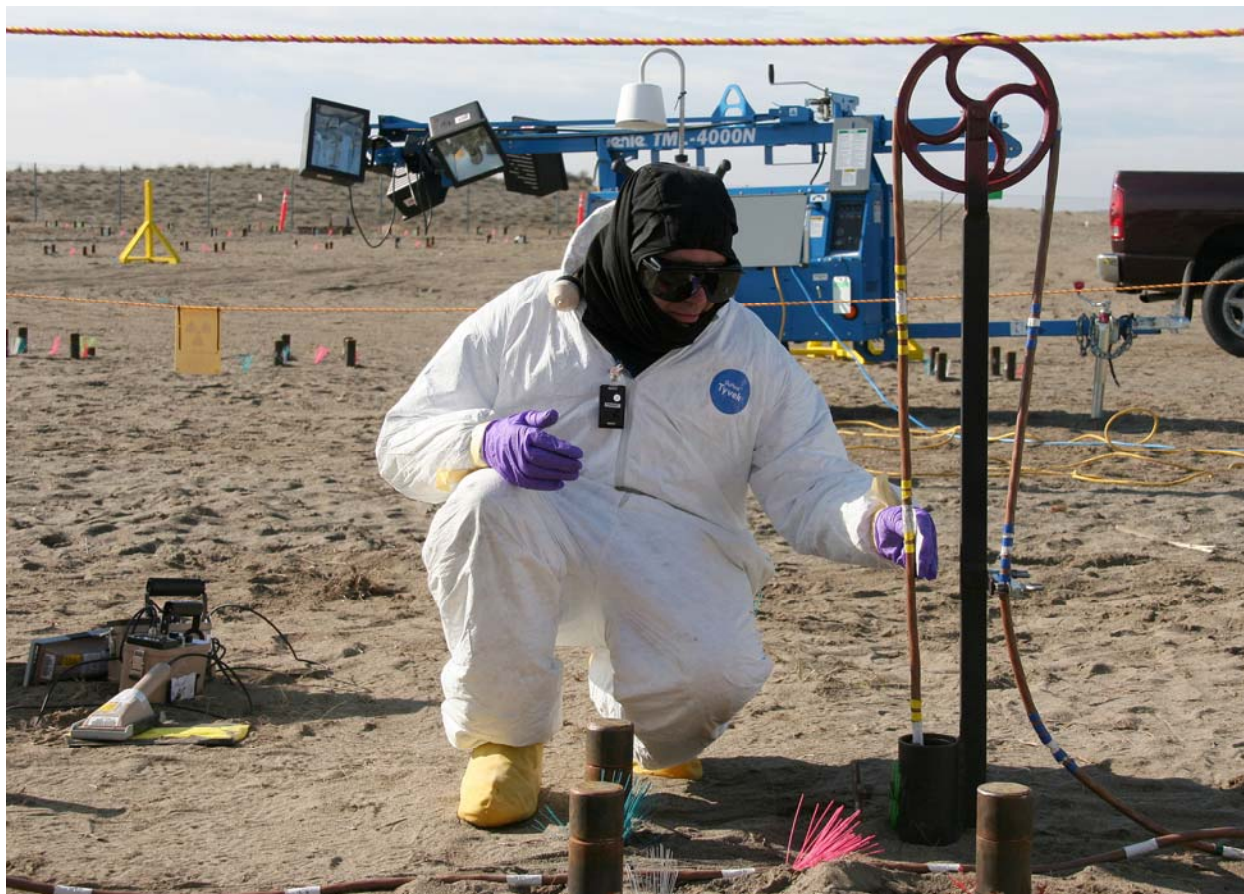
Figure 1. Insertion of the Multi-Detector Probe at the 618-10 Burial Ground.

- **Maintain due diligence regarding the establishment of radiological controls even though radiological contamination is not expected:** Radiological surveys were being conducted using a test gauge lowered into the cone penetrometers, to determine if any contamination was present within the recently installed cone penetrometers. The surveys were being conducted as part of the cone penetrometer installation activities adjacent to the vertical pipe units (VPUs) in support of nonintrusive characterization activities. Each VPU had four cone penetrometers installed to test depth in support of future radiological characterization of each VPU. Upon discovery of contamination during the survey of the test gauge, all work activities were stopped at the 618-10 work site. No contamination source could be determined. As a result, the work process was revised to control all cone penetrometers as High Contamination Areas (HCA) with PPE required for placing and removing items from inside the cone penetrometers. This work process was successfully implemented for the remaining 618-10 characterization and employed at 618-11.

A U.S. Department of Energy (DOE), Richland Operations Office (RL) surveillance (S-10-SED-WCH-026; DOE-RL 2010) was conducted to investigate the design, operation, and performance of the characterization equipment. A corrective action plan (WCH 2010) was prepared to address the findings of the surveillance regarding the adequacy of instrument capabilities, data collection, reporting, and documentation. A workshop was conducted in December 2010 (WCH-434, *618-10 Burial Ground VPU Nonintrusive Characterization Process and Data Collection Work Shop*) with RL and the EPA to review the results of the characterization effort and determine the path forward. The results are

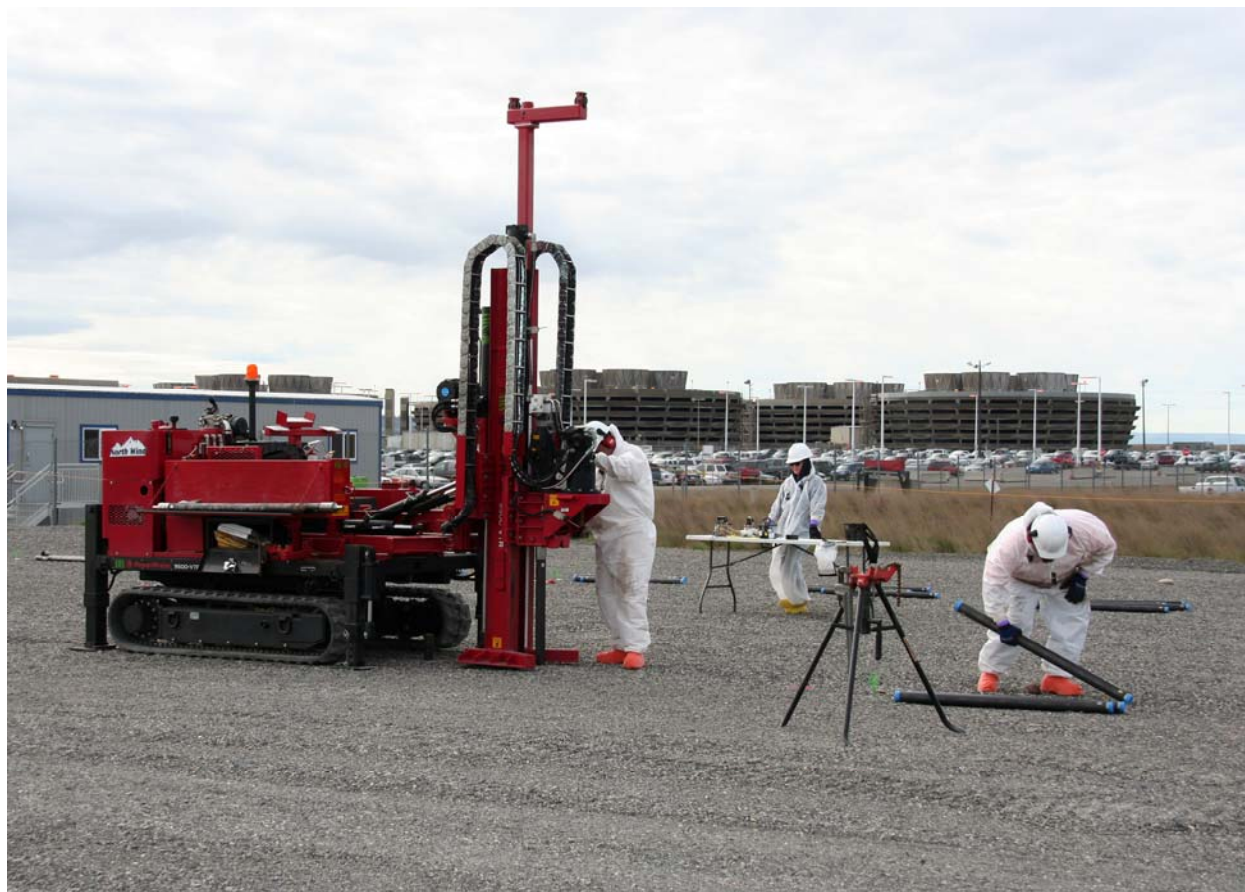
Figure 2. Installation of the Cone Penetrometers at the 618-11 Burial Ground.

- Because it was learned from the results obtained during the 618-10 characterization effort that meaningful data could be obtained using only two cone penetrometers versus four (as used at 618-10), the 618-11 VPU characterization effort was revised to collect data using two cone penetrometers adjacent to each VPU.

- During review of the 618-10 characterization data it was recognized that only the gross gamma dose rate instrument would be utilized to collect data from each cone penetrometer location using an energy-compensated Geiger-Mueller detector with a sensitivity range from a few mR/hr to about 500 R/hr.

- During characterization activities at 618-10, soil samples were collected adjacent to and below each VPU. The results concluded that no contamination was detected and soil sampling was eliminated from the characterization work scope. As a result, the cone penetrometers were driven to approximately 6 ft below the believed bottom of each to determine if significant levels of contamination were present. The results concluded no significant levels of contamination beneath the VPUs.
