# SANDIA REPORT

SAND2013-5916  
Unlimited Release  
Printed July 2013

## Series and Parallel Arc-Fault Circuit Interrupter Tests

Jay Johnson, boB Gudgel, Andrew Meares, and Armando Fresquez

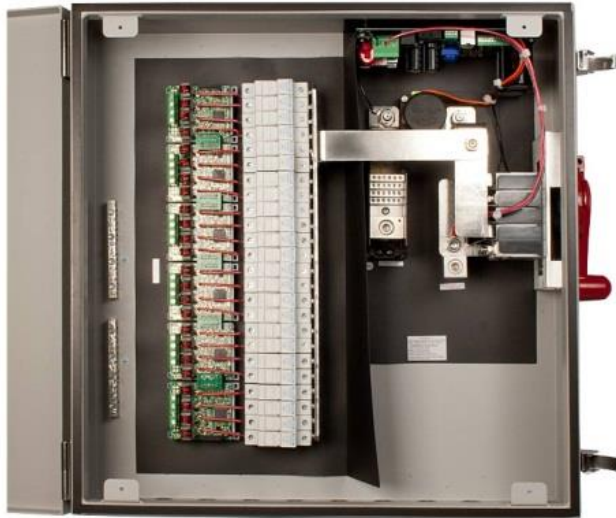
**Figure 1: 24-String MidNite Solar combiner box with string level monitoring that was retrofitted to detect and mitigate series and parallel arc-faults.**

With these challenges solved, a 24-string combiner box, shown in Figure 1, was retrofitted with parallel arc-fault detection circuitry. The schematic of the electrical and communications connections inside the combiner box is shown in Figure 2.

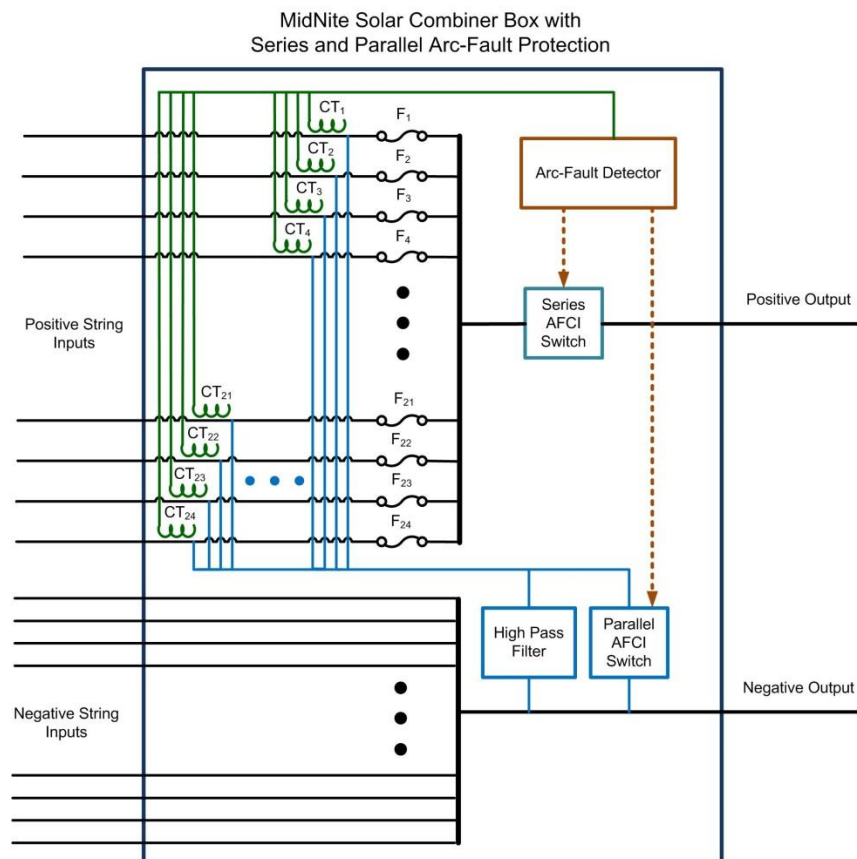
**Figure 2: Schematic of the electrical and communications connections in the AFCI combiner box.**

**Solution 3:** MidNite Solar designed a high frequency bridge across the positive and negative strings so the CTs still receive the high frequency noise when the series switch is opened.

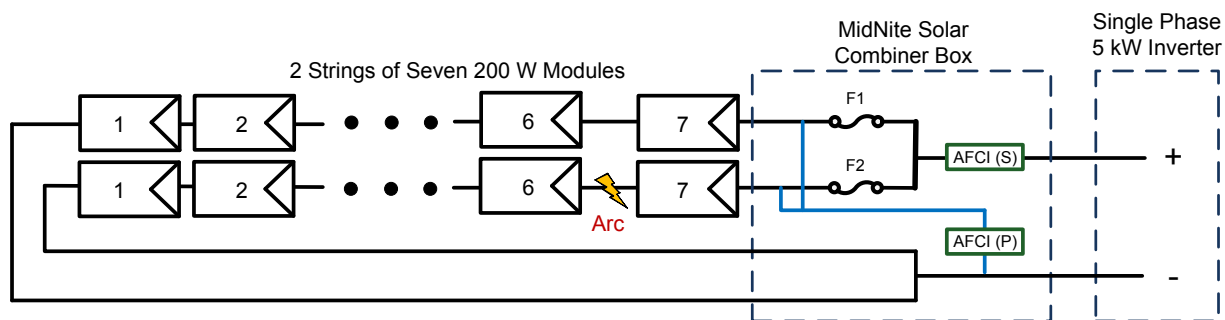
**Figure 3: Combiner box AFCI series arc-fault test.**

Series arc-fault tests were conducted at DETL with the arc current measured with a Tektronix TCP303 clamp-on CT and the arc voltage measured with a Tektronix P5200. These data were collected at a sampling rate of 25 kHz with a Tektronics DPO3014 oscilloscope. The arc current and voltage were recorded to determine the arc-fault power and trip time. Series arc faults create similar arcing noise regardless of their location in the string [1], so the series arc-faults were generated at an arbitrary position (positive side of Module 6 in one of the strings) as shown in Figure 3.

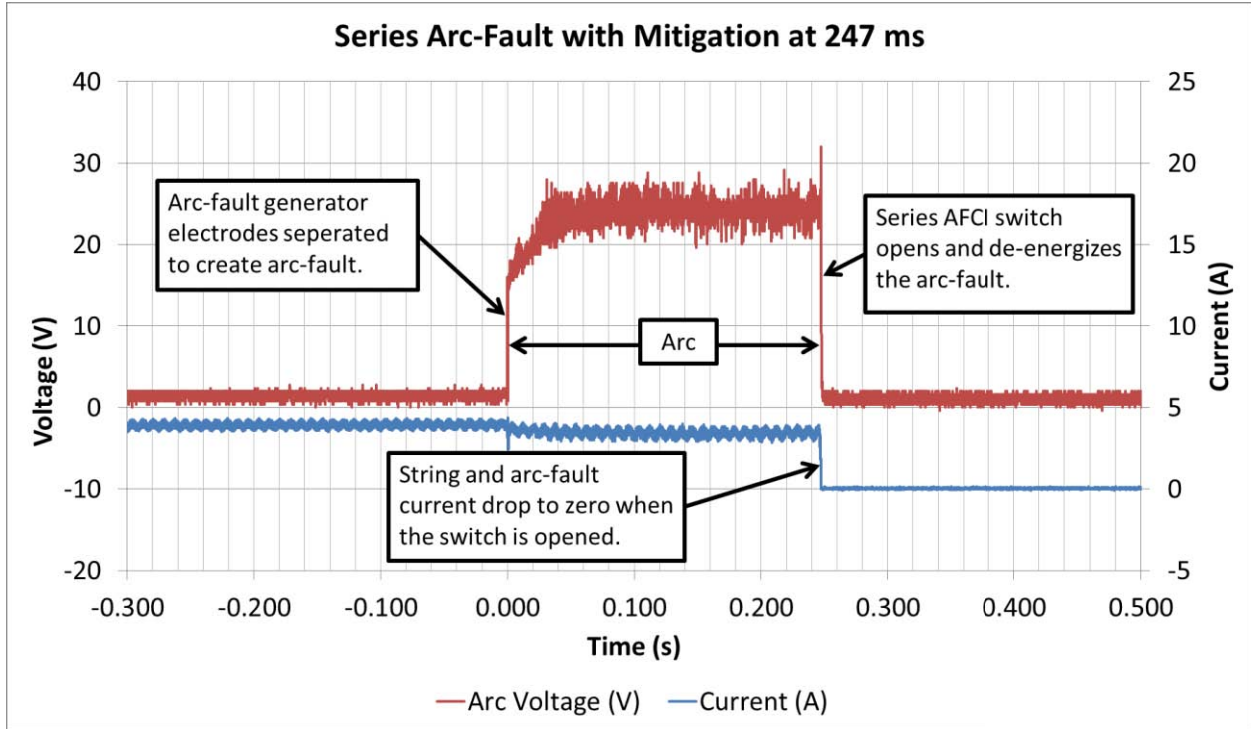
Figure 4: Example series arc-fault test.

An example arc-fault test is shown in Figure 4. The average trip time for ten series arc-faults was 250 ms and is discussed in Section 3.3.

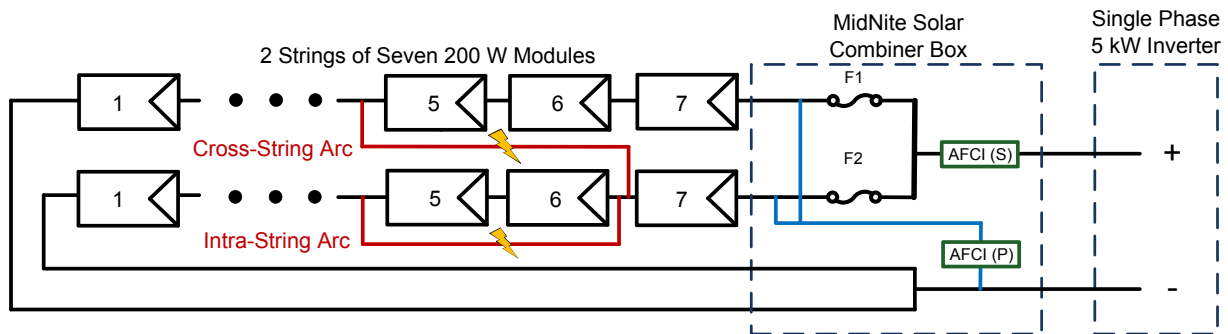
Figure 5: Combiner box AFCI parallel arc-fault tests. Intra-string and cross-string parallel arc-faults are shown.

Parallel arc-faults were created within a single string and across two strings with and without the inverter running because the AFCI must mitigate parallel arc-faults regardless of the operation of the inverter. The difference in intra-string and cross-string parallel arc-faults is shown in Figure 5. The instrumentation setup was the same as the series arc-fault tests and arc-fault current and voltage were recorded to determine the arc power and trip times. Example intra-string and cross-string parallel arc-faults are shown in Figure 6 and Figure 7. Typical trip times for parallel arc-faults are discussed in Section 3.3.

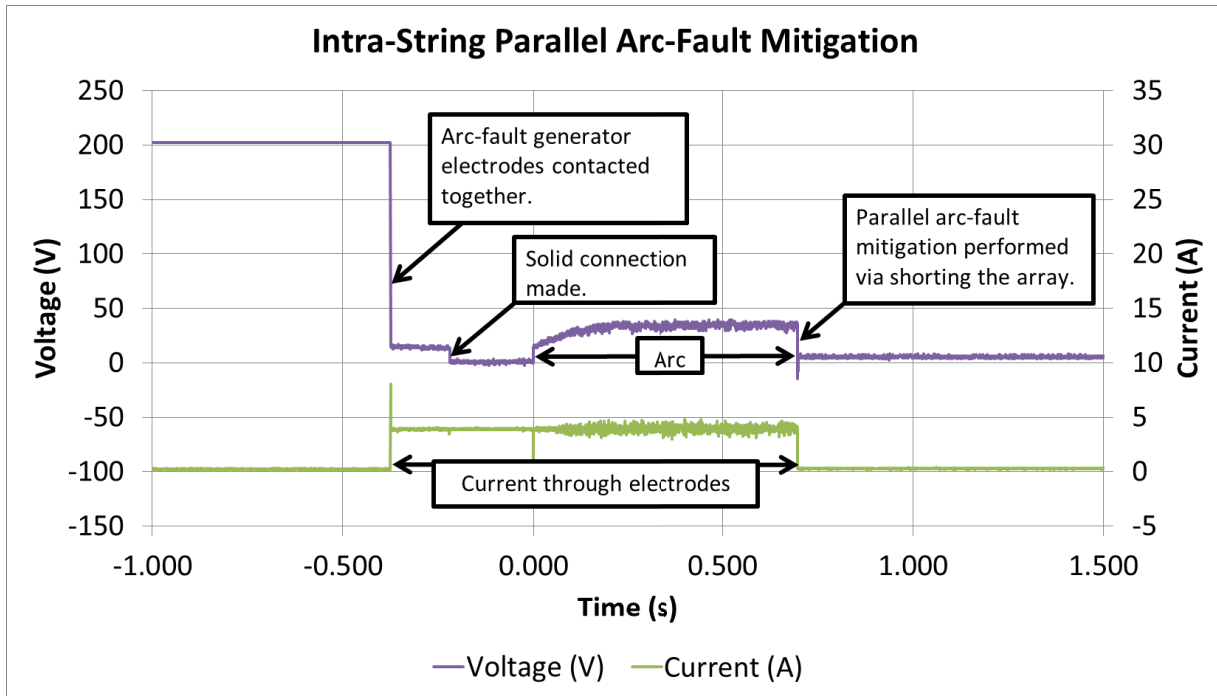
Figure 6: Example parallel intra-string arc-fault test with the inverter running. Detection time was 697 ms for the arc from the positive side of Module 1 to the positive side of Module 6.

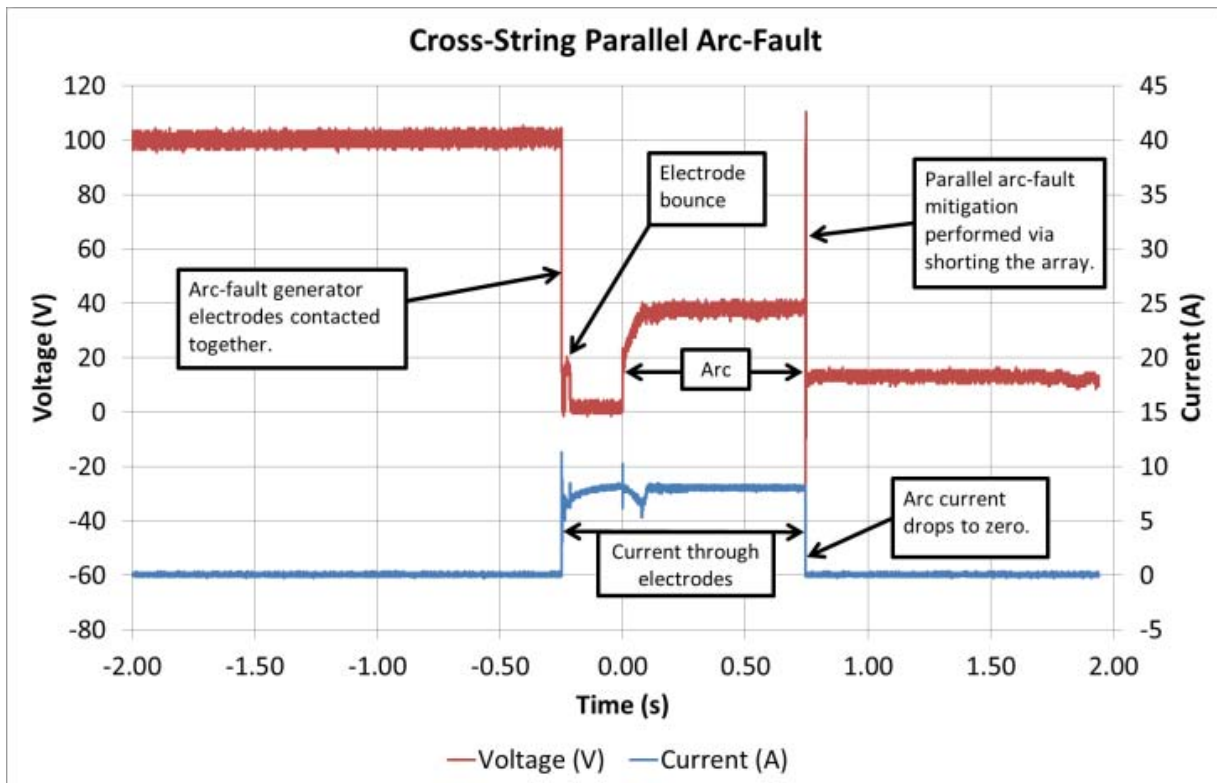
Figure 7: Example parallel cross-string arc-fault test with the inverter running. Detection time was 747 ms for the arc from the positive side of Module 4 to the positive side of Module 6 on the other string.

Ten series arc-faults and ten cross-string arc-faults were created with and without the inverter running to determine the average trip times for different arc-fault types. The series arc power was approximately ~90 W and the parallel arc-fault power was ~300 W. The series arc-faults were detected in an average of 250 ms, and the parallel arc-faults were detected on average in 726 ms and 754 ms for the inverter running and not running, respectively. At these power levels, UL 1699B allows two or more seconds to de-energize the arc-fault, so all the tests would have passed the UL test standard for a Type 2 (series and parallel) arc-fault circuit interrupter. The longer trip times for the parallel arc-faults are due to the order of switching operations. Since the MidNite AFCI opens the series switch first, series arc-faults are more quickly de-energized. After the series switch has opened, the parallel arc-fault switch is closed if there is still arcing noise on the DC system. As a result, the parallel arc-faults are de-energized nearly ½ second after series arc-faults.

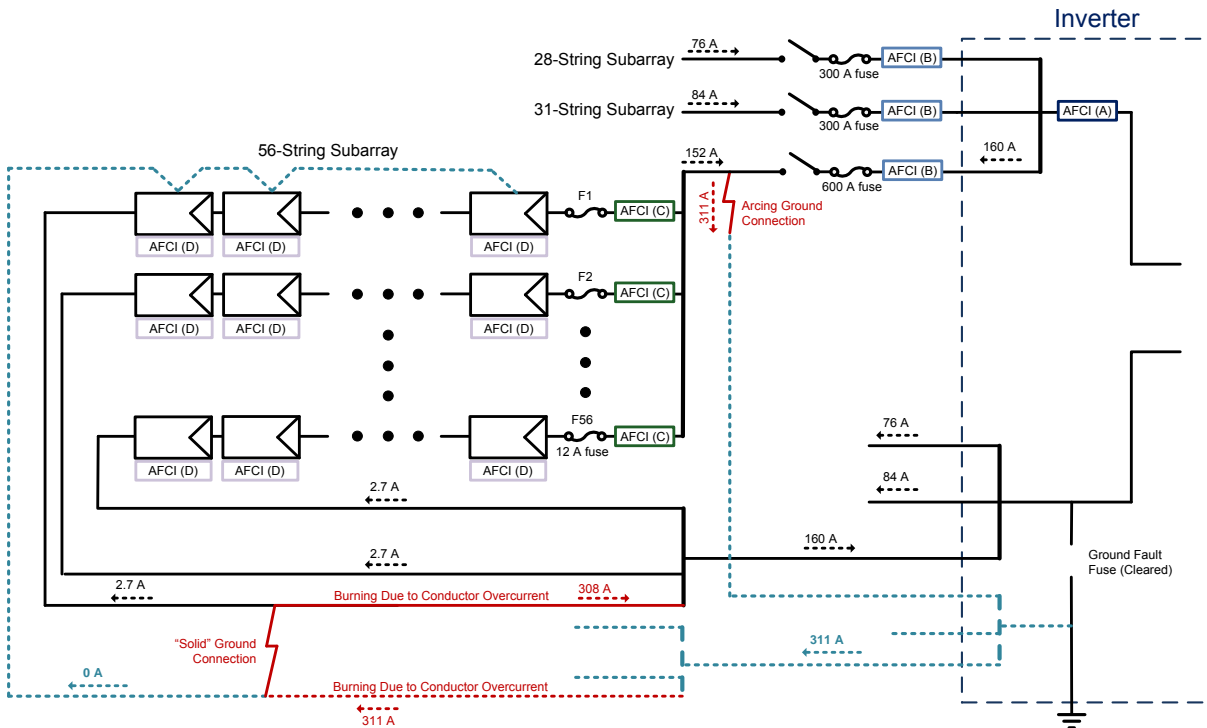
**Figure 8: Different arc-fault circuit interrupter placements in an array with a blind spot ground fault scenario.**

Assuming there is an arc at one of the fault locations or series arcing was present when the conductors began to melt, there would be detectable arcing frequencies present in the PV array and AFCIs would trip. Unfortunately, not all of the AFCI locations would have prevented the Bakersfield fire, shown in Figure 8:

- **Inverter AFCI (A):** The fault current is not interrupted and the fire would continue.
- **Recombiner AFCIs (B):** The 160 A backfed current from the 28- and 31-string subarrays would be interrupted, but the 152 A current from the 56-string subarray would

have still feed the fault path. This series AFCI configuration would not have prevented the incineration of the DC cabling or the fire.

- **Combiner box AFCIs (C):** All the fault current would have been prevented from passing through the fault path and the system would have been safely de-energized.
- **Module AFCIs (D):** The arcing (and ground fault) current would be stopped because all of the modules would be disconnected from the fault path.

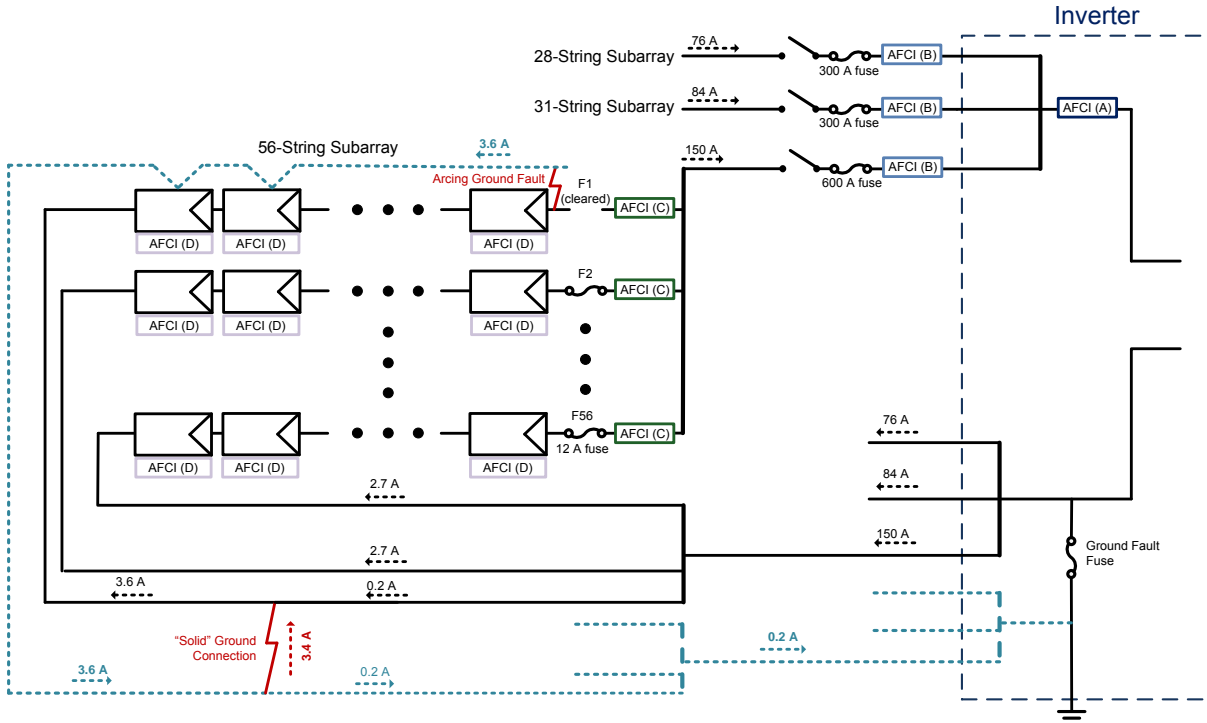
**Figure 9: Locations of different arc-fault circuit interrupter technologies during an arc-fault in a single string in a large PV system.**

In the event that the second ground fault occurs to a current-carrying conductor within the string, shown in Figure 9, there is significant backfed current through the faulted string and the overcurrent fuse clears. At that point, the only current path for the faulted string is through the GFDI or ground fault. The current division will depend on the resistance of the fault and ground fault fuse but it is unlikely to clear the ground fault fuse. In this case, only module-level series AFCIs would be able to prevent the arc-fault to ground.

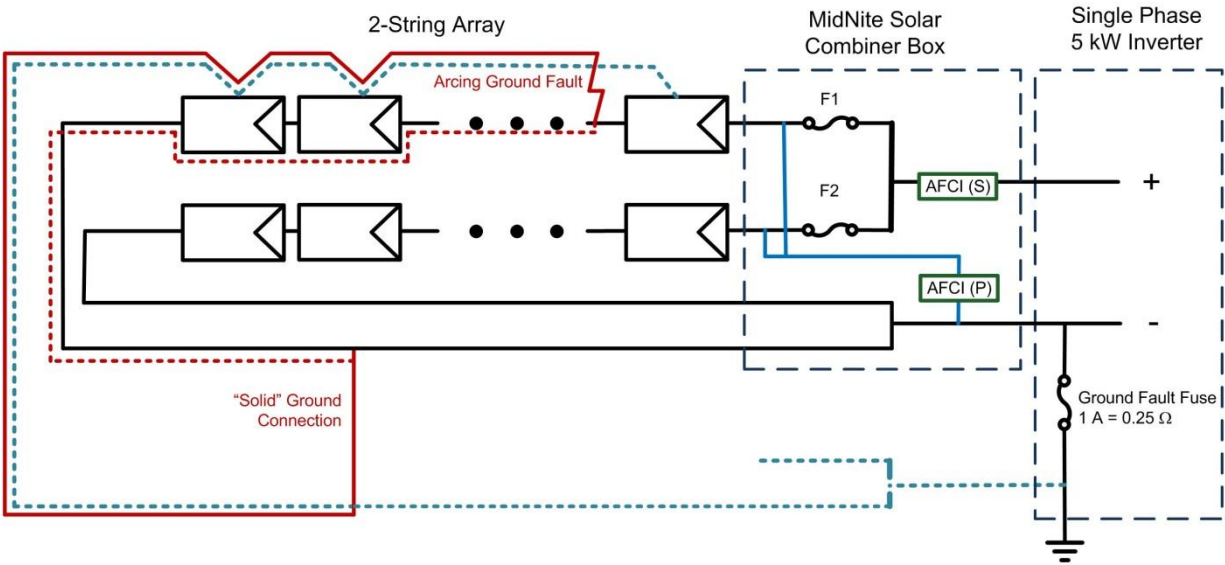
**Figure 10: Blind spot fire recreation at DETL with a parallel AFCI combiner box.**

In order to verify a parallel AFCI would mitigate a “two fault” blind spot ground fault, the sequence of events that cause the Mt. Holly and Bakersfield fires was recreated: first, a solid connection to the grounded current-carrying conductor was established and then an arc-fault was created to the equipment grounding conductor (EGC) from another location in the array. In the test at DETL, shown in Figure 10, the second fault was created from the positive side of the sixth module on one of the strings using a branch MC4 connector, arc-fault generator, and clamp attached to the PV system frame. When the arc-fault was established, the ground fault fuse in the inverter cleared, the series AFCI opened the strings, and then the parallel AFCI shorted the array to de-energize the arc-fault. The GFDI and the series AFCI alone were not sufficient to mitigate the arcing blind spot ground fault.
