***Construction and Development of a  $BF_3$   
Neutron Detector  
at Brookhaven National Laboratory (BNL)***

**C. Czajkowski, C. Finfrock, P. Philipsberg, V. Ghosh**

March 2012

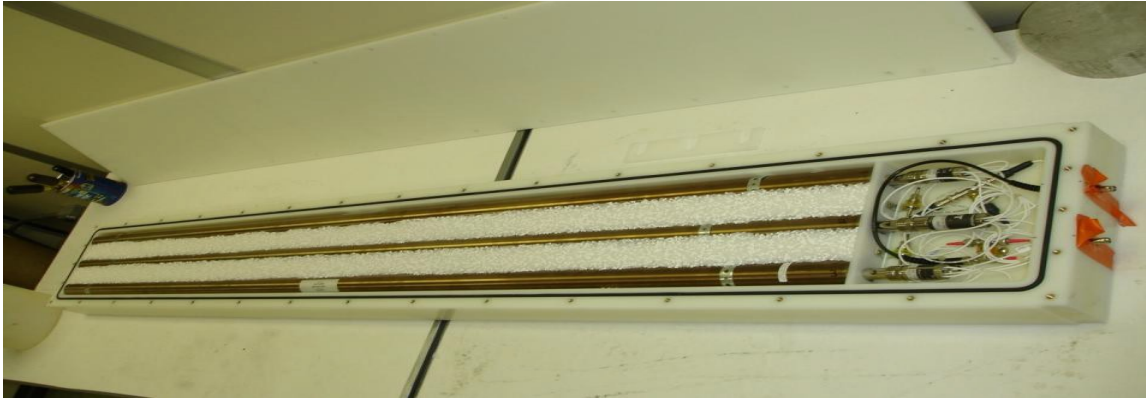
**Figure 1:** This is a photograph of the full assembly, showing the machined one-piece cavity with o-ring seal, the tubes with electronics modules, and the alumina and poly bead blend, just prior to assembly. The top cover can be seen leaning against the wall.

After the tubes were installed in the cavity, the interstitial space was filled with a blend of poly and alumina (Al<sub>2</sub>O<sub>3</sub>) beads. (Figure 1) The alumina provided another level of mitigation for the BF<sub>3</sub> hazard. The alumina reacts irreversibly with the BF<sub>3</sub> and sequesters it, so it is not freely released to the environment. A 3mm bead size was decided on for the materials as a compromise between providing a large bed surface area and still allowing flow of gas to permeate the bed without requiring significant driving pressure. The alumina and poly beads were mixed 50/50% by weight, and the space between the tubes was completely filled with the blend. The poly beads added slightly to the neutron moderation, and were taken into account in the MCNPX modeling.

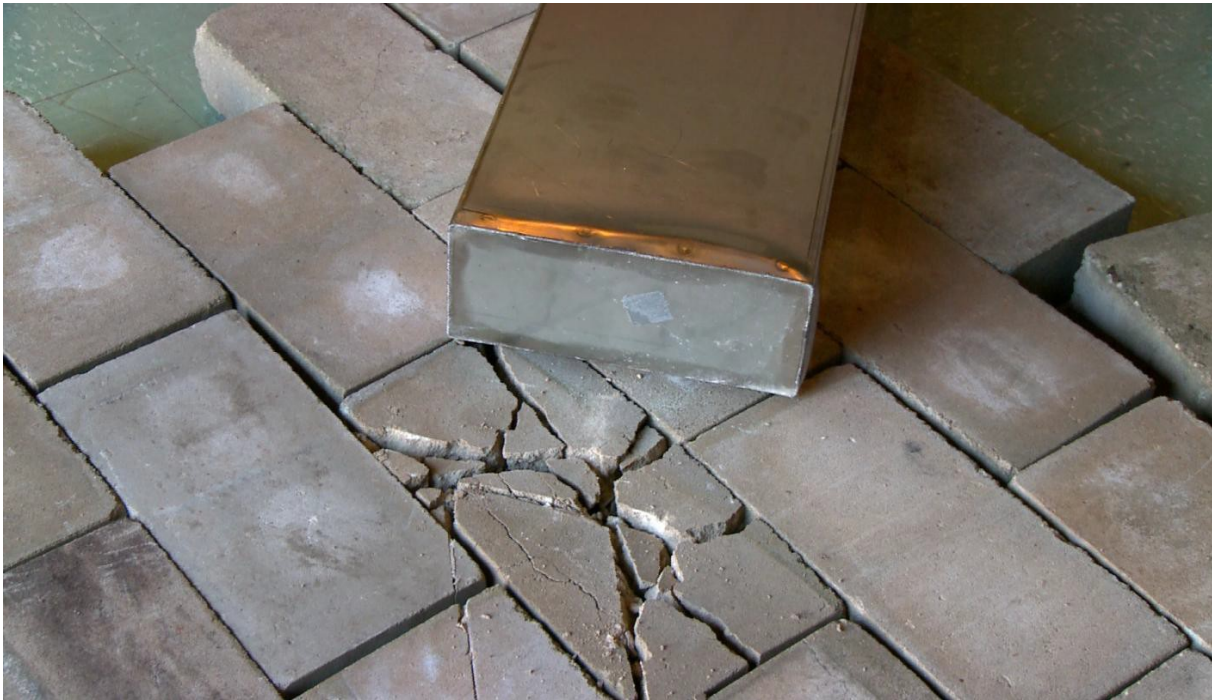
**Figure 2:** This photograph (after impact) depicts the damage to the concrete bricks and the damage to the stainless steel case for the detector assembly. The stainless steel case was not breached.

The drop test was performed in a “high bay” laboratory space equipped with an overhead crane. A layer of solid concrete blocks was arranged on the concrete floor underneath the impact area, primarily to protect the floor tiles from impact damage. The drop test surrogate was also equipped with a lifting eye bolted into the top of the detector such that when suspended from the crane, the detector hung vertically, with the bottom face parallel to the floor. A “special effects” quick release device was used between the surrogate detector and the crane to initiate a free-fall drop of the surrogate from the test elevation of 15 feet above the floor. The drop test surrogate was observed to bounce upward after impact with the concrete floor, to a height of about 29 inches, estimated from video taken during the drop test. The calculated velocity at impact ( $v=\sqrt{2gd}$ , where  $g= -9.8 \text{ m/sec}^2$ ) is  $-9.47 \text{ m/sec}$ , or  $-21.1\text{mph}$ . Measurements made by scaling the displacement of the detector in progressive frames of video resulted in measurements of velocity ranging from  $-18.5$  to  $-21 \text{ mph}$ . After impact, visible deformation of the outer stainless steel envelope is evident at the lower edge, as can be seen in Figure 2. Upon inspection, no breach of the stainless steel envelope was detected. The drop test surrogate actually bounced on its end twice before falling over on its side.

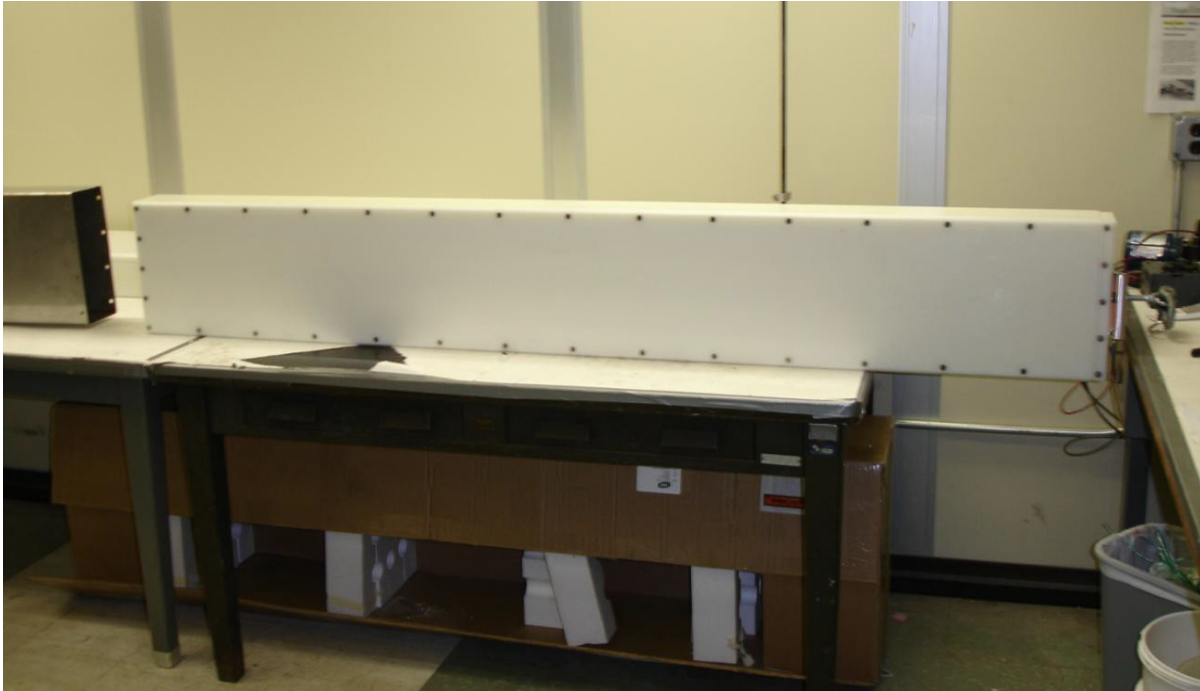
**Figure 3:** The polyethylene cavity after being slid out of the stainless steel envelope.

The drop test surrogate was recovered and disassembled. The deformation of the outer stainless steel envelope was mild enough that the envelope could still be slid off of the sealed polyethylene cavity by having two people pull in opposite directions. The polyethylene cavity can be seen in figure 3. When the screws were removed from the polyethylene cover, it was observed that several of the brass threaded inserts installed in the plastic had been slightly lifted out of the plastic. This was not sufficient to allow any of the polyethylene beads inside the cavity to fall out. Inspection of the three surrogate tubes revealed that differing amounts of damage had occurred. Tube number one suffered almost no discernible damage. Tube number two suffered some mushrooming distortion near the bottom end, similar a the bare-tube drop test conducted earlier. Tube three suffered similar damage, but slightly larger in magnitude. The tubes can be seen in figure 4. Each of the tubes from the drop-test surrogate were evacuated to roughing pump vacuum and then valved off for periods of time ranging from 24 to 72 hours. None of the three tubes that were used in the drop test surrogate experienced any change in pressure over the time that they were evacuated, indicating that none of the tubes had been breached.

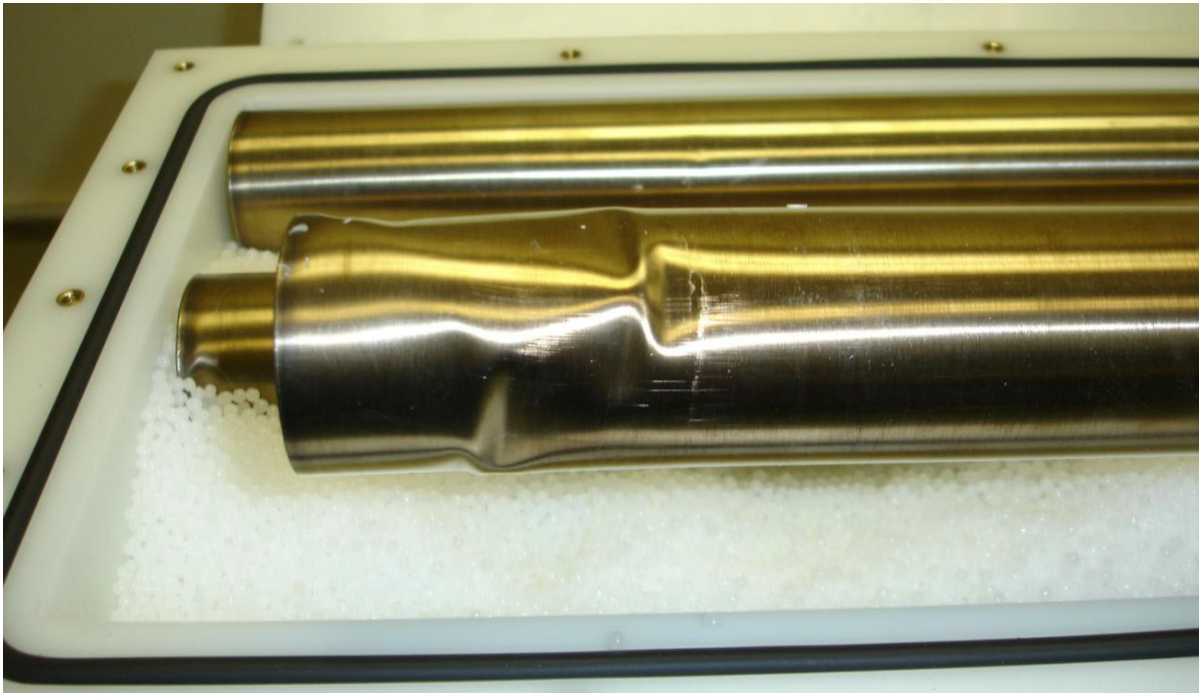
**Figure 4:** A close-up view of the most damaged tube from the drop test mock-up. While wrinkled, the tube has not been breached. The tube is being held above its installed position in the mockup for this photo.
