U.S. Department of Energy
Idaho Operations Office

Final Removal Action Report for the CPP-603A Basin Facility

January 2007

DOE/ID-11306
Revision 1

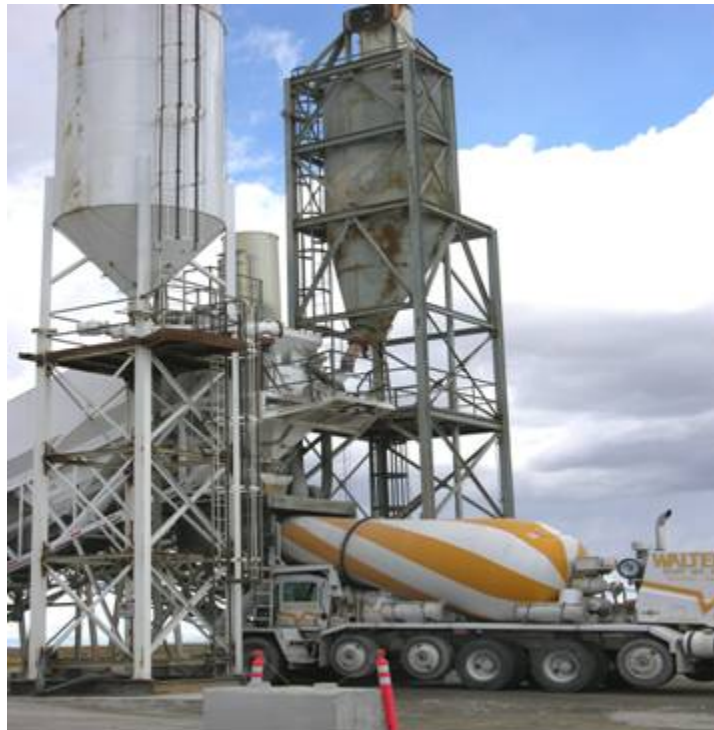
Figure 1. Grout Batch Plant.

To support the CPP-603A basin dewatering and grout/CLSM placement as well as other projects at INTEC, including Tank Farm Closure, a subcontract was executed to establish a cement batch plant east of INTEC outside of the security fence. The batch plant was capable of producing custom grout mixes at a rate to support grout/CLSM placement at CPP-603A. Grout/CLSM was delivered from the batch plant to CPP-603A in cement trucks with a capacity of 10 yd³.

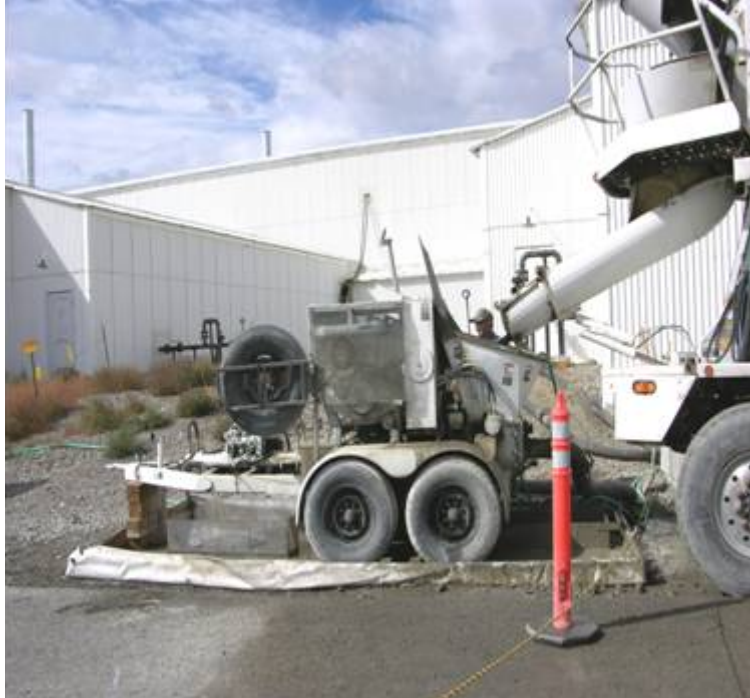
Figure 2. Grout/CLSM Pump.

Grout/CLSM was pumped into the CPP-603 basin system as described in Section 2.4 of the Removal Action Work Plan. Two grout/CLSM mixture recipes were utilized in the basin system. Mix 1 was specifically designed to be very flowable and self-leveling. Mix 1 was used for the initial pours to encapsulate any residual sludge that may have remained in the basins and debris on the bottom of the basins. However, some of the pipes and hoses left in the basins, as well as debris piles, were configured in such a way that could trap water in the pipe or hose sections. As a result, it is possible that small volumes of water were not completely displaced by the grout/CLSM and could be encountered during future remediation. The water is fully encapsulated now, but future workers should be aware that it may exist. Mix 2 contained a large fraction of sand and smaller amounts of fly ash and cement. Due to the composition of materials in Mix 2, it was less flowable. Because it contained less fly ash, Mix 2 tended not to increase the water pH as drastically as Mix 1. Mix 2 was used to fill the majority of the void space in the basin system.

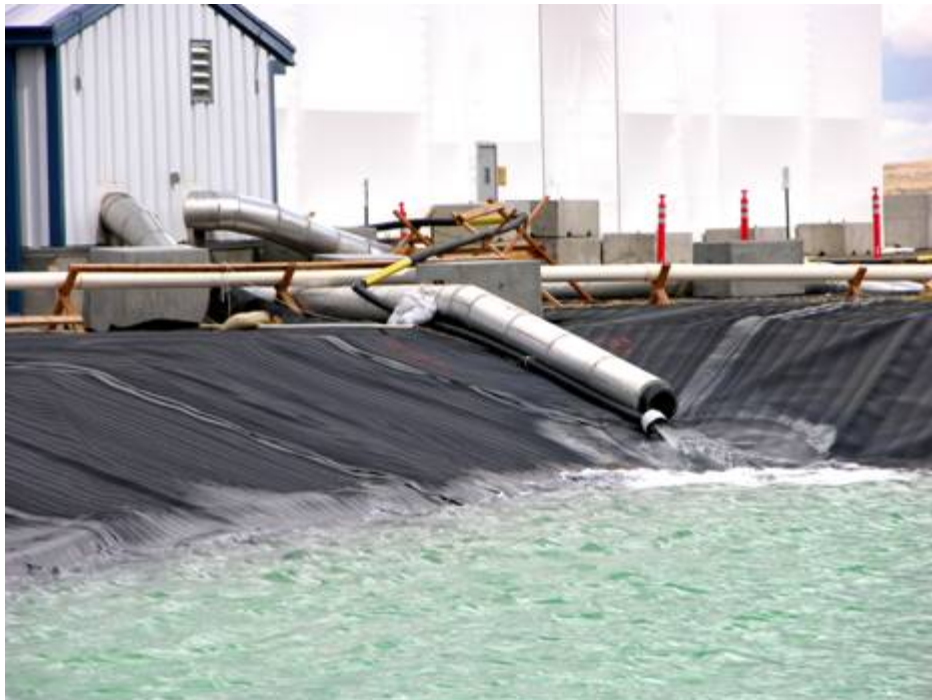
Figure 3. Basin Water Discharge to ICDF Evaporation Pond.

On August 22, 2006, the first basin water was pumped to ICDF. The first grout/CLSM was placed in the North Basin on August 23, 2006. Basin water pumping continued on a 5-day/week, 10-hour/day schedule during routine operation. The last of the basin water was pumped to the ICDF evaporation ponds on November 3, 2006. Basin water was pumped from below the water surface in the overflow pit through carbon steel pipe with duplex filters and totalizing flow meter in line. Outside of CPP-603, the transfer piping transitioned to 3-inch high density polyethylene (HDPE) through the remaining route to the ICDF evaporation ponds as described in Section 2.4.4, *Water Removal System Design* in the Removal Action Work Plan.

A total volume of 1,191,842 gal of basin water was pumped from CPP-603A to the ICDF evaporation ponds. The discrepancy between the volume of water actually pumped and the 1,519,000 gal estimated in the Removal Action Work Plan is due to: (1) the estimates in the Removal Action Work Plan did not exclude the volume already filled by beams, columns, and debris within the basin system, and (2) some unmeasured volume of basin water was incorporated into the grout/CLSM mixture as it was placed into the basin system and solidified.

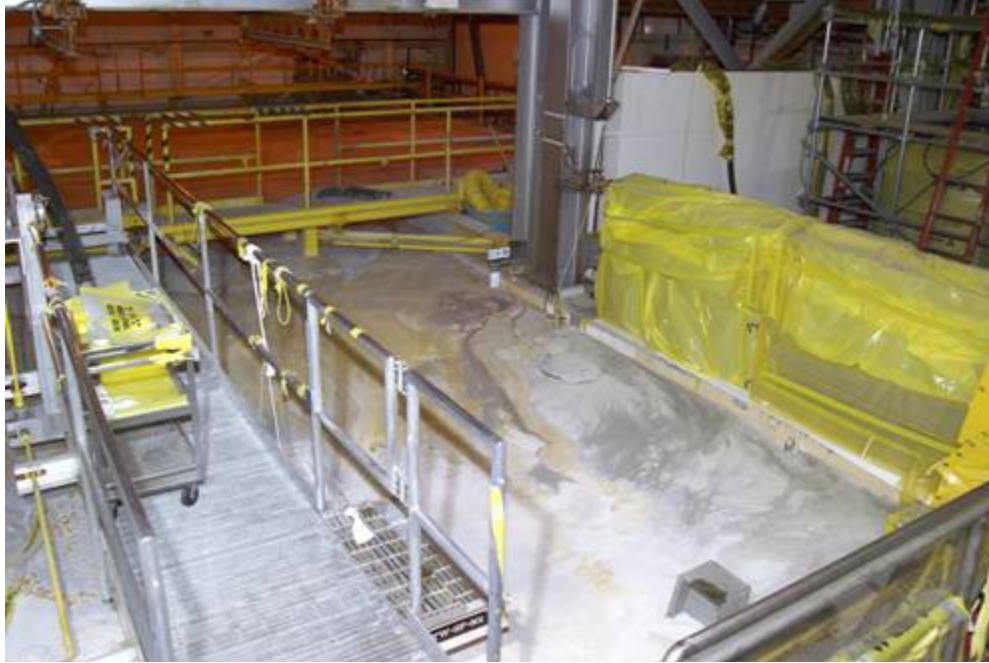
Figure 4. Grouted South Unloading Pit.

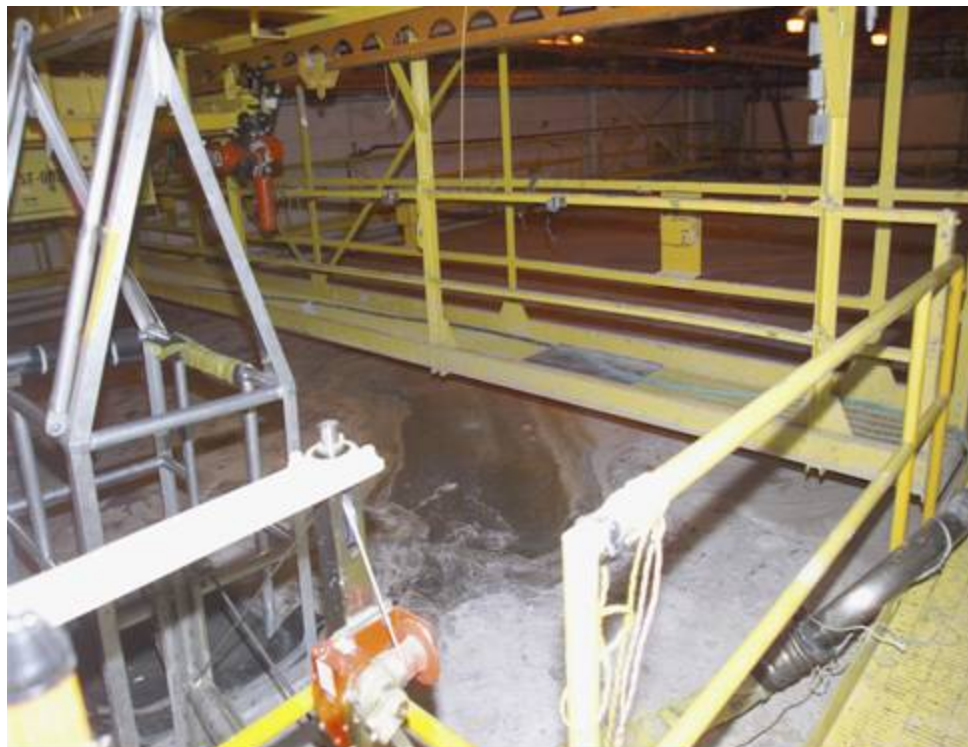
Figure 5. Grouted South Basin.

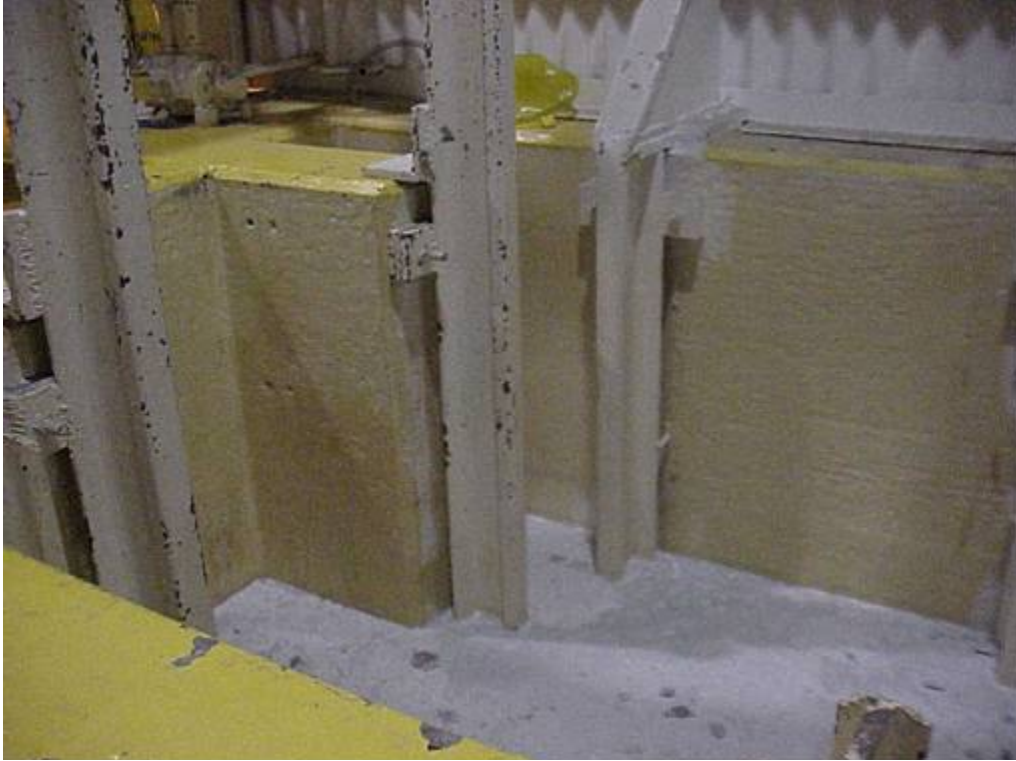
Figure 6. Grouted North Unloading Pit.
