Electrochemical Testing of Gas Tungsten Arc Welded and Reduced Pressure Electron Beam Welded Alloy 22

S. D. Day, F. M. G. Wong, S. R. Gordon, L. L.
Wong, R. B. Rebak

February 7, 2006

2006 ASME Pressure Vessels and Piping Conference
Vancouver, Canada
July 23, 2006 through July 27, 2006

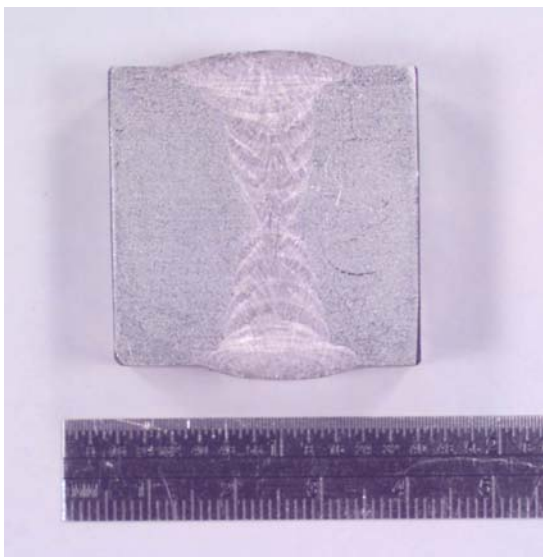
Figure 1 shows a macrograph of the cross section of a 1.5-inch thick Alloy 22 plate that was welded using the GTAW technique. This was a double V welding that consisted of at least nine passes on each side of the plate. Figure 1 shows that the width of the weld seam was up to 20 mm in the outside surface and approximately 10 mm wide in the middle section of each V (at one fourth of the plate thickness). Figure 2 shows a macrograph of the cross section of a 1.5-inch thick plate that was welded using the RPEB technique. This was a single pass autogenous weld, with a maximum width at the surface of 10 mm and a rather constant weld seam width through the

Figure 1. Macrograph of a GTAW welded Alloy 22 plate

thickness of the plate of 3 mm. Comparing Figures 1 and 2, it is obvious that the RPEB plate contains less amount of weld material than the GTAW plate.

Figures 17 and 18 show the macro appearance of the corroded RPEB and GTAW specimens after the galvanostatic tests for the 1 mA/cm² applied current density. Figures 17 and 18 show that both weld seams were preferentially etched. Figure 17 shows that the weld seam in the RPEB welded specimen was much narrower than the weld seam in the GTAW specimen (Figure 18). This agrees with the macro-etch appearances of the cross section of the weld (Figures 1 and 2).

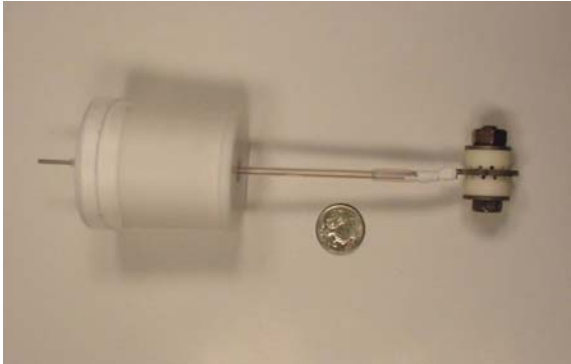
Most of the test specimens were discs designed to test for general corrosion and passivity according to ASTM G 5 guidelines. The MCA specimens were assembled using a Teflon-coated ceramic washer for crevice forming as described in ASTM G 48 [5] (Figure 3). The tested surface area of the disc specimens was approximately 0.7 cm² and the exposed MCA specimen area was about 5.6 cm². The test specimens were given a 600 grit silicon carbide abrasive paper finish approximately one hour prior to testing. They were then ultrasonicated in distilled water for 5 minutes and then degreased with acetone, isopropyl alcohol, and distilled water.

Figure 3. MCA Specimen for Crevice Corrosion Testing

Lawrence Livermore National Laboratory (LLNL). There were two type of specimens, discs (per ASTM G 5) [5] and standard MCA (multiple crevice assembly) specimens. The discs were prepared from five cores taken through the weld plate from the beam or arc side to the opposite surface. Four discs were sliced from each core, one from the top surface (A) and one from the bottom surface (D), and two from locations one-third (B) and two-thirds (C) the distance between these surfaces. The specimens used in this study were from the top surface (A) and the one-third depth level (B) beneath it. The GTAW weld specimen series was designated GXXX and the RPEM weld series 15XXX. Separate Alloy 22 base metal disks in the mill-annealed (MA) condition that were not taken from this welded plates were labeled DEAXXXX. The MCA specimens lie in the plate plane with the weld seams cutting across the loop end, perpendicular to the stem direction (Figure 3). The MCA specimens were taken from the same sampling levels (A through D) as the disks.

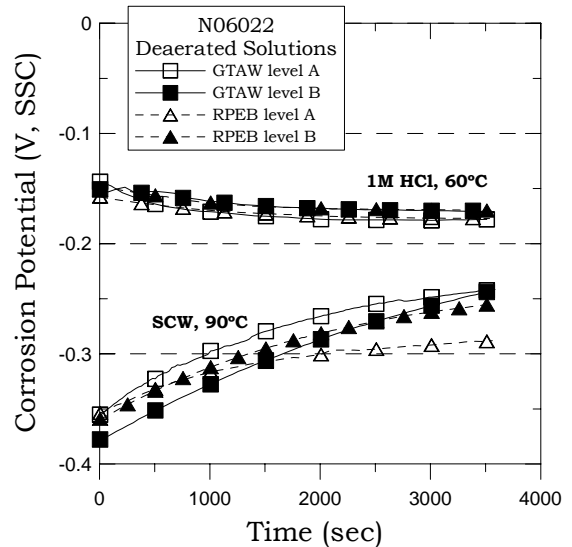
Figure 4 shows the evolution of E_{corr} for GTAW and RPEB welded material discs in SCW and 1 M HCl solution. A one-hour interval may not be sufficient for the corrosion potential to reach a steady state value. A full comparison of the E_{corr} evolution between solution and solution is not possible since 1 M HCl was at 60°C and the other two (NaCl and SCW) were at 90°C. In general, E_{corr} initially increased in the SCW and 1 M NaCl solution (not shown), and decreased in the 1 M HCl solution. The amount of change was more pronounced in the SCW and 1 M NaCl solution. These two latter solutions are not as corrosive as the 1 M HCl solution and therefore, E_{corr} increased as a protective oxide film was forming on the surface of the specimens. Figure 4 shows that the E_{corr} values are highly reproducible between run and run, especially for the 1 M HCl solution.

Figure 4 also shows the E_{corr} for each type of weld at the two different levels tested. Level A corresponded to the outermost layer of the plate and level B was the following level. Since the SCW solution is not as corrosive, there was not a clear trend on the values of E_{corr} based on the type of weld. Similarly, there was not a specific trend on the E_{corr} based on the level (A or B) the specimen was removed from in each weld condition (GTAW and RPEB). Figure 4 also shows that in the HCl solution, it appears that the level A specimens (both for GTAW and RPEB) were slightly more active than the level B specimens. However, there is not a clear trend between the two types of weld.

Figure 4. Short-term evolution of E_{corr} in time

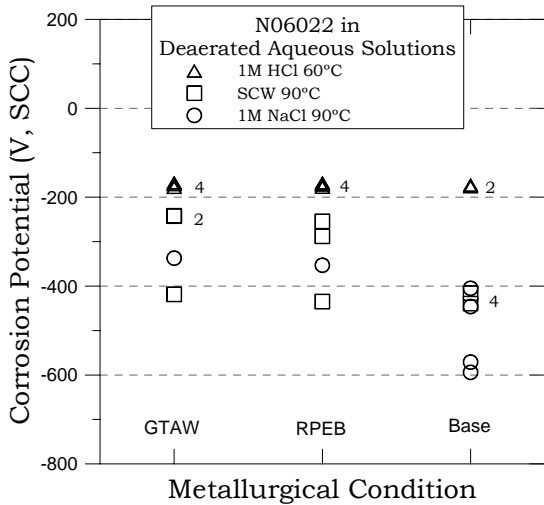
Table 3 and Figure 5 show the E_{corr} values after a 1 h immersion for discs (in HCl and SCW) and MCA specimens (in NaCl). The E_{corr} for the base MCA are for 24 h immersion. The E_{corr} for Alloy 22 in HCl solution are highly reproducible and non-dependent on the type of material (GTAW, RPEB or Base). For the SCW and NaCl solutions, the values of E_{corr} were less reproducible (because the solutions are less aggressive); however, it appears that the welds were more noble (higher E_{corr}) than the base material. The corrosion potentials given in Figure 5 and Table 3 are short-term and in deaerated solutions. They are not meant to represent the long-term corrosion potential of Alloy 22 in aerated environments.

Figure 5. E_{corr} after 1 h (SCW and HCl) and 24-h (NaCl) immersion for all the studied materials (numbers indicate data points)

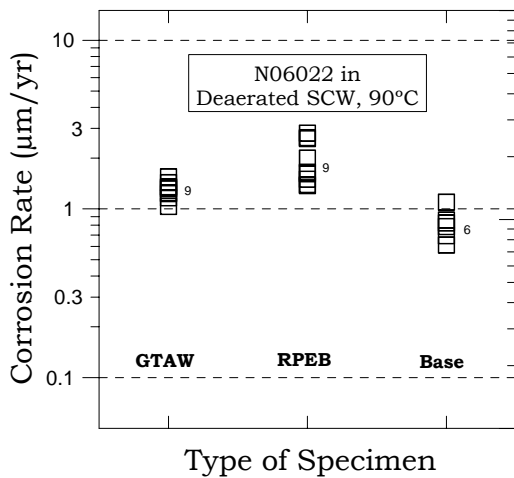
Table 3 shows corrosion rates as a function of the type of material in SCW at 90°C, 1 M HCl at 60°C and 1 M NaCl at 90°C solutions. These are short term corrosion rates for comparative purposes between material and material. The corrosion rates do not represent the long-term behavior of Alloy 22 in the given solutions. Figure 6 shows the corrosion rates for the three types of material (GTAW, RPEB and Base discs) in SCW at 90°C (Table 3). Figure 6 shows that the lowest corrosion rate corresponded to the base metal with an average value of 0.8 $\mu\text{m}/\text{year}$. The second lowest corrosion rate corresponded to the GTAW material with an average value of 1.3 $\mu\text{m}/\text{year}$ and the highest corrosion rate corresponded to the RPEB material with an average corrosion rate of 2 $\mu\text{m}/\text{year}$.

Figure 6. Corrosion rate for the three type of specimens in 90°C SCW. Numbers indicate data points in each cluster. Data from Table 3

Figures 6-8 show that the corrosion rate in the 1 M HCl solution was approximately two orders of magnitude higher than in the other two less aggressive solutions. The overall

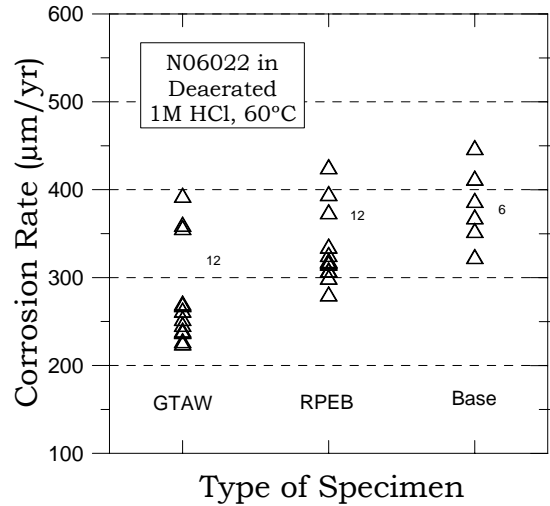
Figure 7 shows the corrosion rates for the three types of material (GTAW, RPEB and Base discs) in 1 M HCl at 60°C (Table 3). In this aggressive environment, the lowest corrosion rate corresponded to GTAW with an average value of 280 $\mu\text{m}/\text{year}$. The second lowest corrosion rate corresponded to the RPEB material with an average value of 335 $\mu\text{m}/\text{year}$ and the highest corrosion rate corresponded to the base metal with an average value of 380 $\mu\text{m}/\text{year}$. This behavior was totally unpredictable since it was initially assumed that the welds would corrode faster in this acidic solution.

Figure 7. Corrosion rate for the three type of specimens in 1 M HCl at 60°C. Numbers indicate data points in each cluster. Data from Table 3

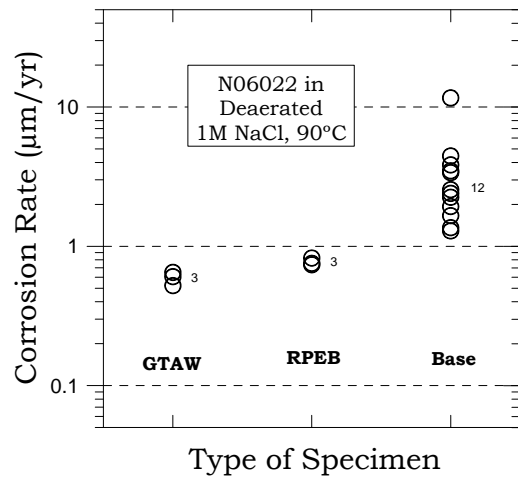
Figure 8 shows the corrosion rates for the three types of material (GTAW, RPEB and Base MCA specimens) in 1 M

NaCl at 90°C (Table 3). In this saline solution the lowest corrosion rate also corresponded to the GTAW material with an average value of 0.6 $\mu\text{m}/\text{year}$. The second lowest corrosion rate was for the RPEB material with an average value of 0.8 $\mu\text{m}/\text{year}$ and the highest corrosion rate was for the base material with an average value of 1.9 $\mu\text{m}/\text{year}$.

Figure 8. Corrosion rate for the three type of specimens in 1 M NaCl at 90°C. Numbers indicate data points in each cluster. Data from Table 3

lowest corrosion rates were for the 1 M NaCl solution on MCA (creviced) specimens.

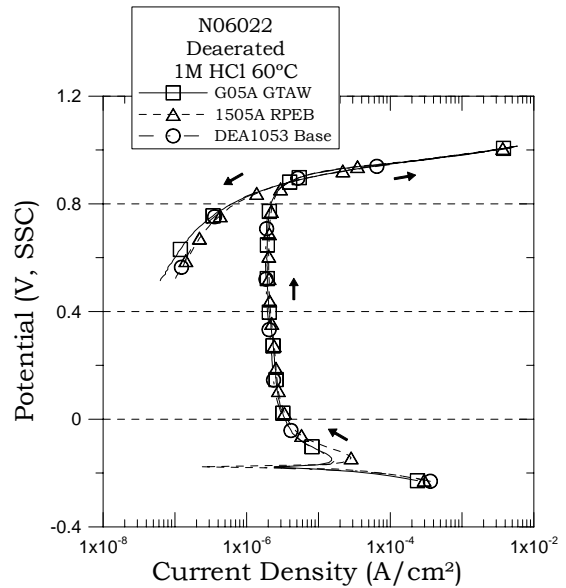
Figure 10 shows that the cyclic polarization curves for the three materials in 1 M HCl at 60°C almost completely overlap. The largest current density for the anodic peak above the corrosion potential corresponded to the RPEB material (Figure 10). The breakdown potentials (E20 and E200 in Table 3) in 1 M HCl were almost identical for all three materials and well above +0.9 V SSC. None of the materials showed localized corrosion (pitting corrosion) after the potentiodynamic tests despite they were polarized to high anodic potentials in a 1 M chloride solution of pH = 0.

Figure 10. CPP for Three Different Alloy 22 Specimens in 1 M HCl solution at 60°C

Figures 9-11 show the cyclic polarization behavior of Alloy 22 GTAW, RPEB, and base metal specimens in deaerated SCW at 90°C, 1 M HCl at 60°C, and 1 M NaCl at 90°C solutions, respectively. For each solution, the cyclic polarization curves appear almost undistinguishable from each other for the three types of material (GTAW, RPEB and base). Figure 9 shows that for the SCW at 90°C solution, the cyclic polarization curves for all the materials show an anodic peak on the forward sweep at a potential of approximately 250 mV (SSC) with a current density between 350 to 550 μA/cm². The highest current density was for the base material and the lowest for the GTAW specimen. The origin of these peaks is still unknown. There is also some noise in the final portion of the reverse scan where it crosses the forward passive region. The origin of this noise is also not known. Even though Figure 9 shows a small hysteresis in the reverse potential scanning, none of the materials tested in SCW at 90°C showed localized corrosion.

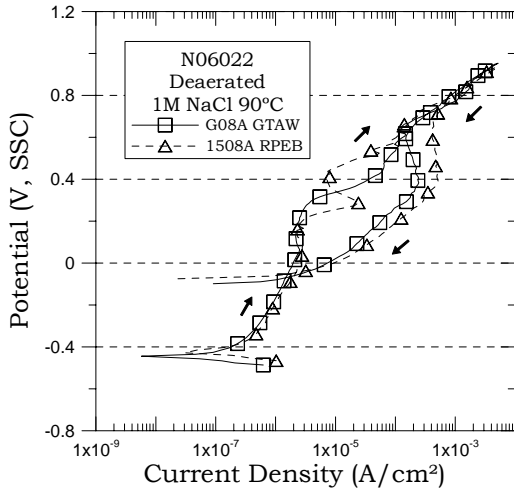
Figure 11 shows the cyclic polarization curves for GTAW and RPEB materials in 1 M NaCl at 90°C. Both curves were similar to each other and exhibited a reverse scan hysteresis loop that intersected the passive current line at -50 to -75 mV SSC. Microscopy of the specimens after the tests showed that both types of welded materials suffered crevice corrosion under the crevice formers. There was only one test for each welding condition so it is difficult to rank these two materials regarding their relative resistance to localized corrosion. In both types of materials the crevice corrosion nucleated and developed both in the welded part of the specimen and also in the base metal. This was easier to observe in the RPEB material since the weld seam was narrower.

Figure 11. CPP for Two Welded and Creviced Alloy 22 Specimens in 1 M NaCl solution at 90°C

In polarization curves (e.g. Figure 11) several specific potential values can be measured. These characteristic potentials are listed in Table 3. They can be divided between breakdown potentials (E_{20} and E_{200}) and repassivation potentials (ER_{10} and ER_1) (see Table 3 for description).

(Figures 11 and 15) would be needed for localized corrosion to nucleate and propagate.

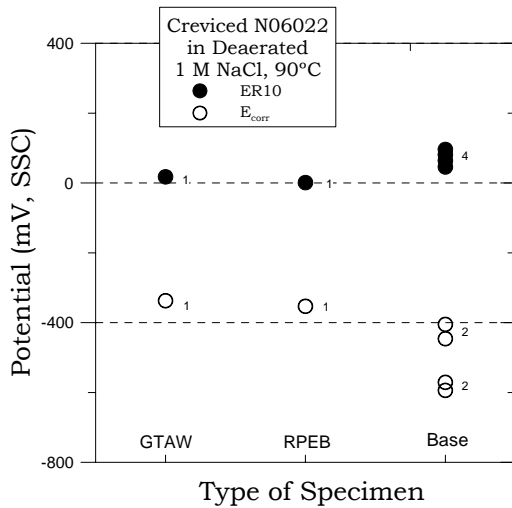
The analysis of the parameters from the polarization curves will be done just for the 1 M NaCl solution since this was the only solution that promoted localized corrosion. Figure 15 shows the E_{corr} and ER_{10} (Table 3) in 1 M NaCl at 90°C. Figure 15 shows that the margin between E_{corr} and the repassivation potential is large for all three materials. The larger this difference the less prone the material will be to localized corrosion in the environment of testing. Both welded materials (GTAW and RPEB) had similar values of ΔE ; however, these values correspond to only one tested specimen of each welded material. These preliminary results indicate that crevice corrosion would not occur in Alloy 22 base and welded at the corrosion potential. A polarization of several hundred mV

Figure 15. E_{corr} and ER10 for Alloy 22 in 1 M NaCl at 90°C

Galvanostatic studies were carried on to etch the weld seam in GTAW and RPEB specimens. Two sets of experiments were carried out in 1 M HCl solution at 60°C. In the first set, a current density of 0.1 mA/cm² was applied to the specimens for 3 h. In the second set, a ten times higher current density of 1 mA/cm² was applied for the same period. Figure 16 shows the potential output plots for the two applied constant current density tests. Both types of weld show the same applied potential for each applied current density. At the higher applied current density, the output potential was slightly higher (~ 30 mV) for both types of welds (Figure 25). The values of output potential are the same as in the polarization curve (Figure 15).

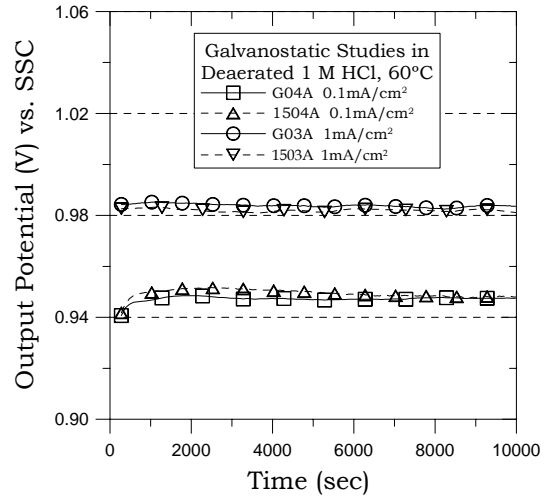
Figure 16. Galvanostatic Treatment under two applied currents for welded specimens in 1 M HCl at 60°C

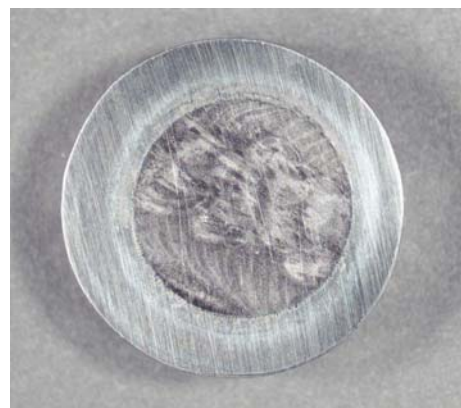
Figure 18. Specimen G03A (GTAW) after galvanostatic treatment of 1 mA/cm² for 3 h in 1 M HCl at 60°C
