In-situ Monitoring of Corrosion during a Laboratory Simulation of Oxalic Acid Chemical Cleaning

B. J. Wiersma, J. I. Mickalonis, D. C. Beam, M. R. Poirier, D. T. Herman, S. D. Fink, J. M. Pareizs, and F. F. Fondeur

Savannah River National Laboratory
Aiken, SC, 29808

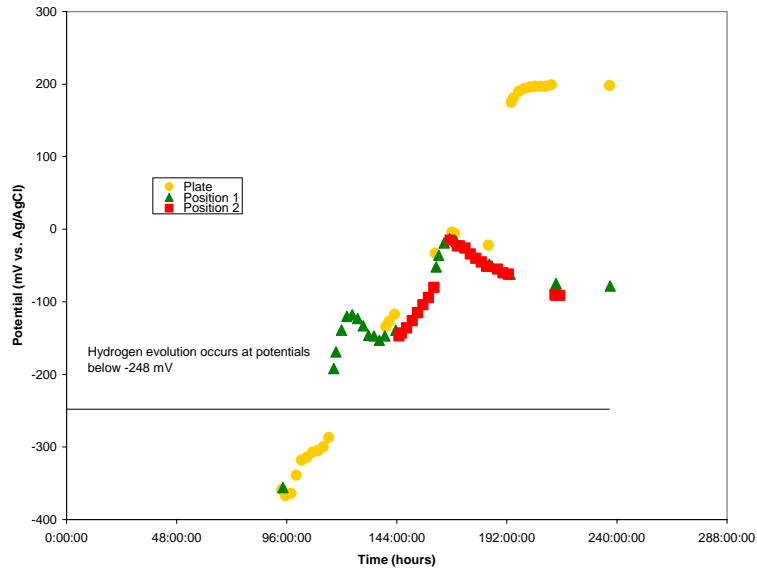
Figure 4. E_{corr} measurements for Test 2 (mixed at 75 °C): polished coupons.

The behavior of E_{corr} at the 50 and 75 °C was similar (see Figure 3, Figure 4, Figure 6 and Figure 7). At 50 °C and 75 °C, E_{corr} for the plate and Position 1 coupons initiated at potentials below E_{H_2} and increased to potentials 150 to 200 mV greater than E_{H_2} . The low initial E_{corr} was likely due to two factors: lack of mixing and surface condition. The lack of mixing left the metal in direct contact with oxalic acid for a period of time, rather than in contact with oxalic acid containing dissolved sludge. Visual observations of these two coupons during the test indicated that, at this stage of the test, the metal surface remained in a pristine (i.e., no iron oxides present) condition. Separate tests on pristine coupon in pure oxalic acid also resulted in E_{corr} values within this range. At these conditions, hydrogen evolution is the preferred cathodic reaction due to the limited amount of dissolved sludge present in the solution. The subsequent increase in potential is likely associated with the increase of ferric ion in solution as the sludge dissolves. Thus, the preferred cathodic reaction becomes ferric ion reduction. The E_{corr} for coupons in Positions 2 and 3, in contrast, initiated at values 100 to 200 mV greater than E_{H_2} and remained at these values for the duration of the test. The higher E_{corr} values are likely due to the presence of sufficient ferric ion in solution which contacted the coupons initially.

The effect of mixing is also evident as shown in Figures 6 and 7. These tests yielded a greater difference in the values of E_{corr} than observed for the mixing tests. This result suggests that diffusion of the ferric ion limited the rate of the cathodic reaction. With mixing the concentration of the dissolved species remained more uniform and, thus, E_{corr} for all the coupons approached a similar value (see Figures 3 and 4).

The highest, or most noble, value of E_{corr} occurred during the 75 °C tests (see Figure 4). The E_{corr} for the horizontal plate shifted almost 250 mV after approximately 110 hours of exposure. These higher potentials typically indicate a shift into a passive region where corrosion rates are low. No such shift occurred in any other tests.

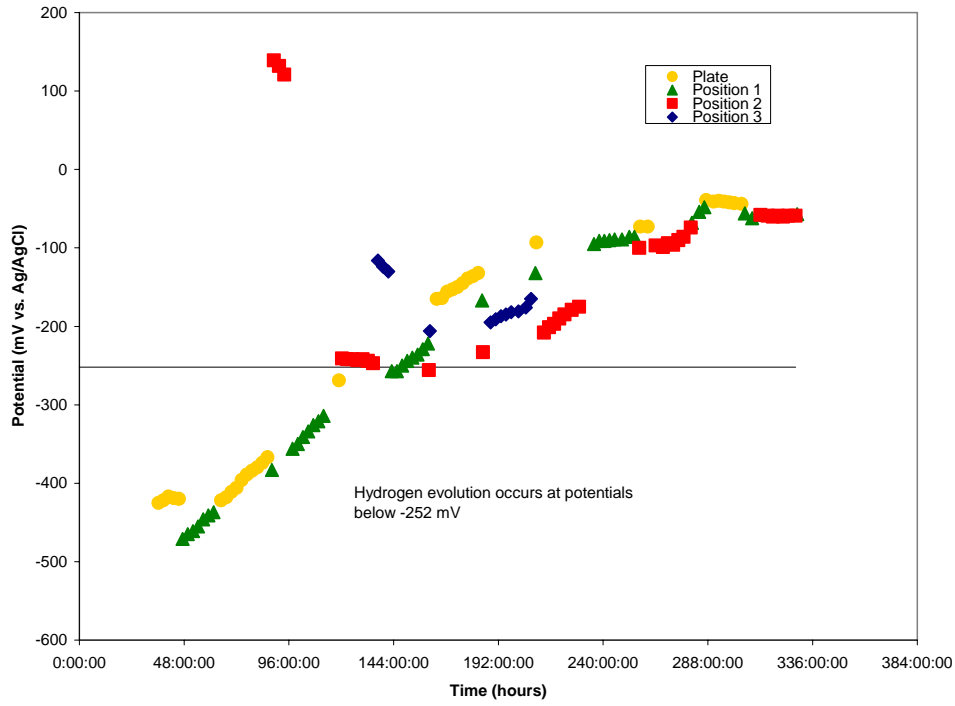
Figure 6. E_{corr} measurements for Test 4 (unmixed at 50 °C): mill-scale coupons.

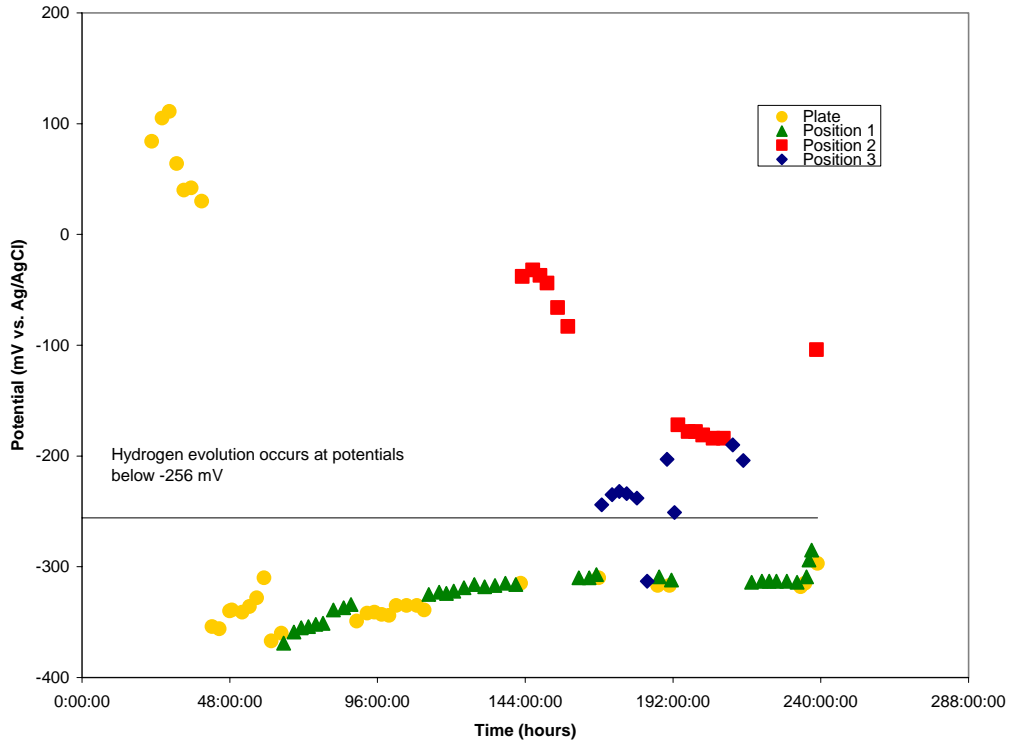
Figure 8. E_{corr} measurements for Test 6 (unmixed at 25 °C): mill-scale coupons.

The behavior at the lower temperature (25 °C) was also controlled by the cathodic reaction (see Figures 5 and 8). However, in this case the two competing reactions were oxygen reduction and hydrogen evolution. Unlike the higher temperature tests, we believe the concentration of ferric ion remained too low to affect the corrosion reaction. The effect of mixing is also apparent. In tests with mixing, shown in Figure 5, both the plate and position coupon were exposed to unmixed conditions for the first ~30 hours they were immersed – complete immersion of these coupons did not occur until 30 or 40 hours after oxalic acid addition began and mixing did not begin until after 70 hours. Initially, the potential for the plate coupon was less than E_{H_2} . We believe sufficient sludge dissolution had occurred in the lower regions of the vessel to limit oxygen solubility near the plate coupon and thus hydrogen evolution was the favored cathodic reaction. However, the coupon in Position 1, behaved as though it were controlled by oxygen reduction initially. We believe this behavior occurred because at this point the sludge species had not yet diffused to the upper region of the solution. The availability of oxygen near the interface also favored the oxygen reduction reaction. As the species from the dissolved sludge solution diffused to the top of the liquid, E_{corr} for the coupon in Position 1 decayed as the solubility of oxygen decreased. At initiation of agitation, the plate and coupons in Positions 1 and 2 were immersed. The initial effect was that E_{corr} for all three coupons increased. This behavior indicates that oxygen reduction is a more significant participant in the cathodic reaction. However, after approximately 50 hours (i.e., the 120 hour mark of the test), E_{corr} for all three coupons began to decay to values below E_{H_2} . We hypothesize the presence of other species from the dissolved sludge in the solution limited the availability of oxygen to these coupons. Thus hydrogen evolution became the controlling reaction. When the coupon in Position 3 became immersed approximately 90 hours after mixing initiated, the initial E_{corr} was less than E_{H_2} . This trend suggests that the solution was saturated with species from the dissolved sludge at this time and thus the availability of oxygen was limited thereby hydrogen evolution became the preferred cathodic reaction at this location.

For the non-mixing test at low temperature, shown in Figure 8, E_{corr} for the plate and the coupon in Position 1 remained less than E_{H_2} for most of the test. In contrast, E_{corr} for the coupons in Position 2 and 3 initiated at values 25 to 200 mV above E_{H_2} and decayed slightly for the remainder of the test. It is speculated that a concentration gradient existed for the dissolved species in the sludge. The sludge dissolves at the bottom of the vessel and hence the concentration of dissolved species is greater at this location. The presence of these dissolved species in solution limits the availability of oxygen for the cathodic reaction. Thus, hydrogen evolution occurs at the plate and the coupon at Position 1. The concentration of the dissolved sludge species at the top of the liquid is less because these species have not yet diffused to this location. Thus, oxygen is more soluble and hence available to participate in the cathodic reaction at for coupons at Positions 2 and 3. The decay may reflect diffusion of the dissolved species toward the top of the liquid and hence a decreasing availability of oxygen.

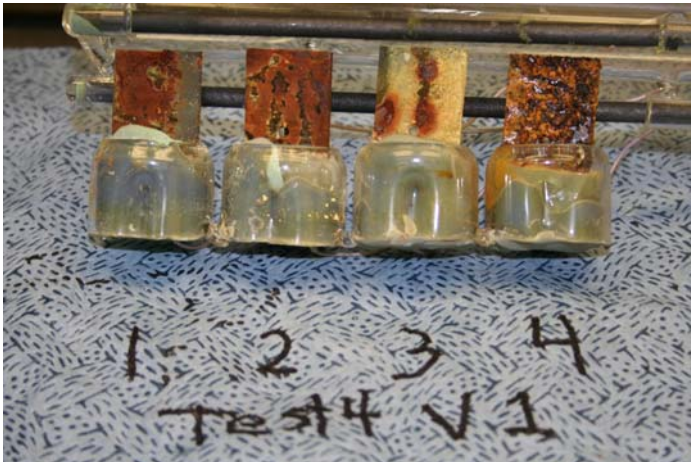
Figure 11. Post-test photo of vertical coupons from Test 4 (50 °C, unmixed). Note goethite and humboldtine on first three coupons.
