Primer on Durability of Nuclear Power Plant Reinforced Concrete Structures - A Review of Pertinent Factors

NUREG/CR-6927
ORNL/TM-2006/529

Prepared by
D.J. Naus

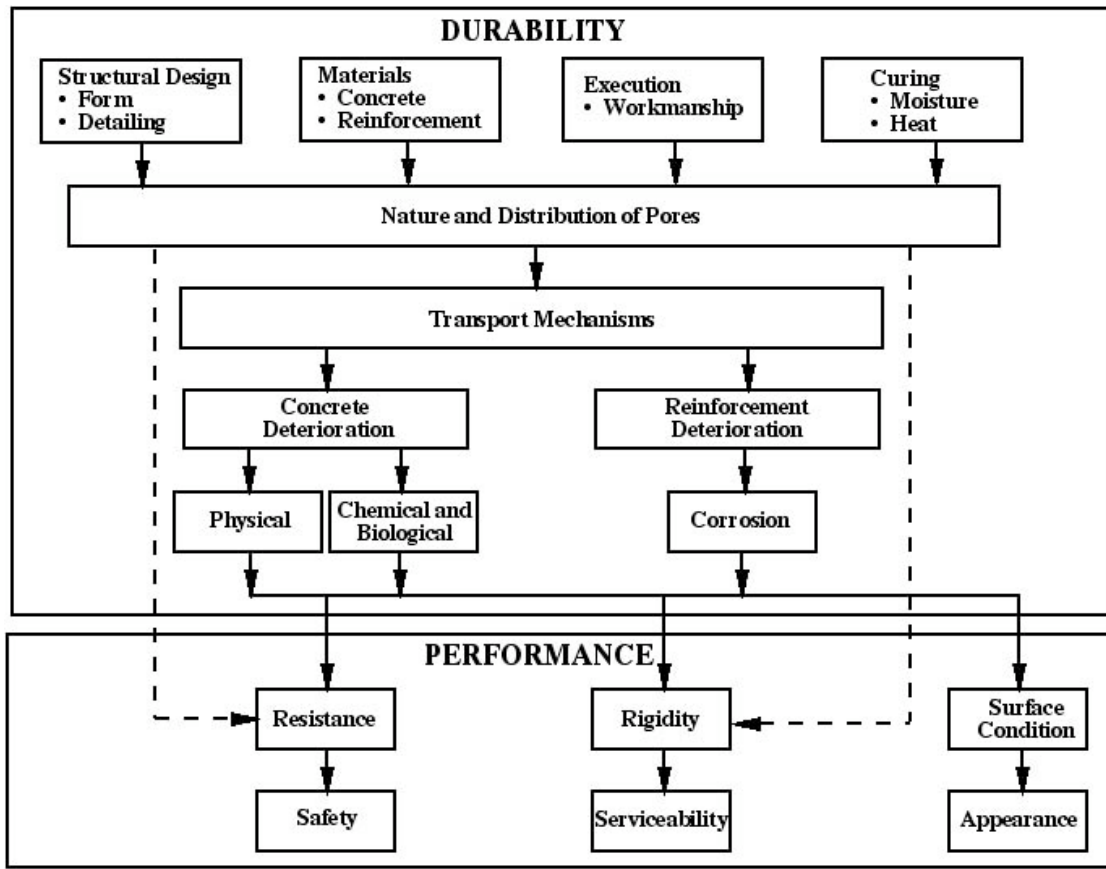
Figure 1.1 Relationship between the concepts of concrete durability and performance.

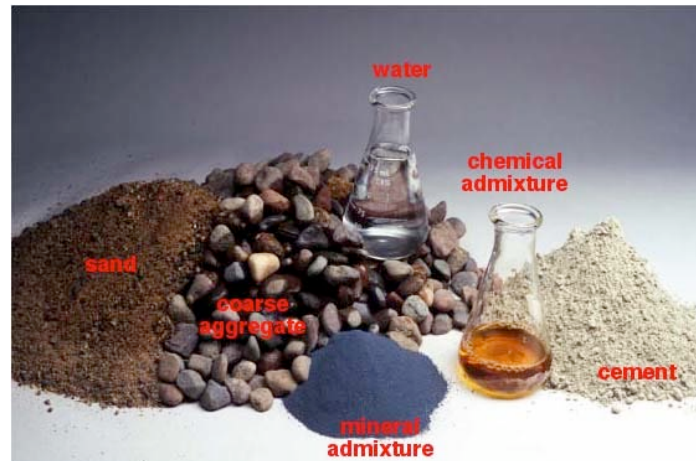
Figure 3.1 Basic concrete constituent materials

ultra-lightweight (e.g., vermiculite and perlite) to lightweight (e.g., expanded clay shale or slate-crushed brick) to normal weight (e.g., crushed limestone or river gravel) to heavy-weight (e.g., steel or iron shot). Sometimes chemical or mineral admixtures are added during the mixing process to enhance durability (air entrainment), improve workability (enhanced placement and compaction), modify hardening and setting characteristics, aid in curing, reduce heat evolution, or provide other property improvements.³⁰ Basic concrete constituent materials are identified in Figure 3.1.

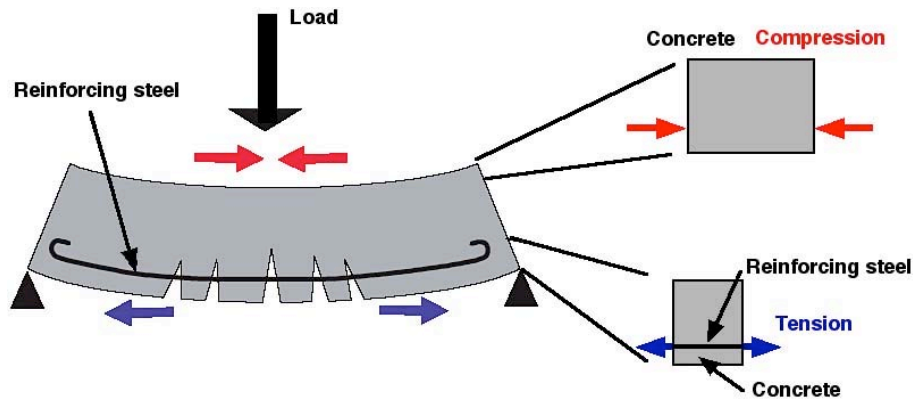
Figure 3.2 Principle of reinforced concrete.

Concrete tensile strength is about one-tenth to one-fifth its compressive strength so concrete can not be relied upon to withstand very high tensile stresses. This limitation is overcome by embedding steel reinforcement in the concrete. The concrete and steel thus work in concert, Fig. 3.2. In addition to resisting tensile loads, the bonded steel reinforcement is used to control the extent and width of cracks,

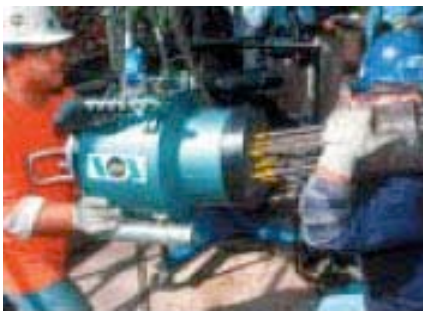
Figure 3.3 Example of a multistrand tendon.

The tendons are installed within preplaced ducts in the containment structure and post-tensioned from one or both ends after the concrete has achieved sufficient strength. After tensioning, the tendons are anchored by buttonheads, wedges, or nuts. Corrosion protection is provided by filling the ducts with wax or corrosion-inhibiting grease (unbonded), or portland cement grout (bonded). Supplemental conventional reinforcing is also used to minimize shrinkage or temperature effects and to provide local load-carrying capacity or load transfer. With the exception of Robinson 2 (bar tendons) and Three Mile Island 2 (strand tendons), plants that have post-tensioned containments utilize unbonded tendons so that the tendons can be inspected and replaced (if necessary). Bellefonte and Ginna each have grouted tendons (rock anchors) to which tendons are attached. Figure 3.3 presents an example of a multistrand tendon for a general civil engineering application.

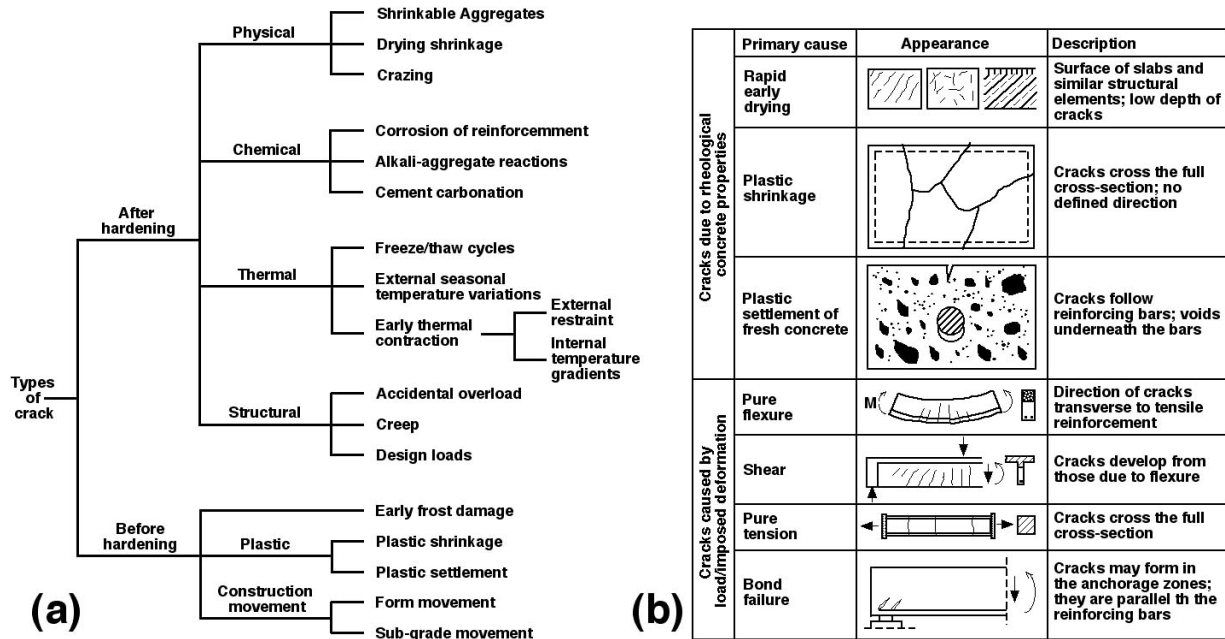
Figure 4.1 Relationship between primary causes and types of cracks in concrete.

capacity). Figure 4.1a provides information on the types of cracks that can form in concrete structures⁷ and Figure 4.1b provides a description and appearance of several of the crack forms.⁵⁷

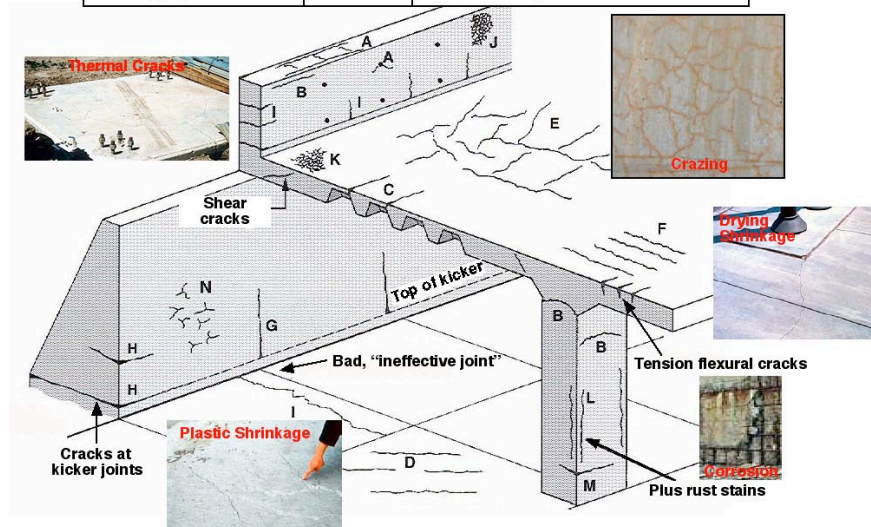
Figure 4.2 Examples of intrinsic cracks in a hypothetical structure.

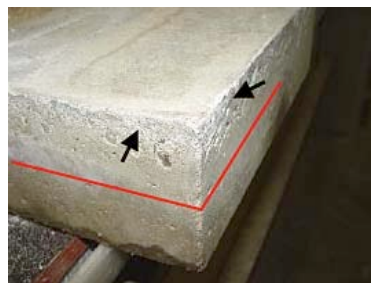
Figure 4.3 Concrete slab experiencing deterioration due to salt crystallization.
(Arrows indicate concrete surface deterioration and lines the level of solution in wetting cycle.)

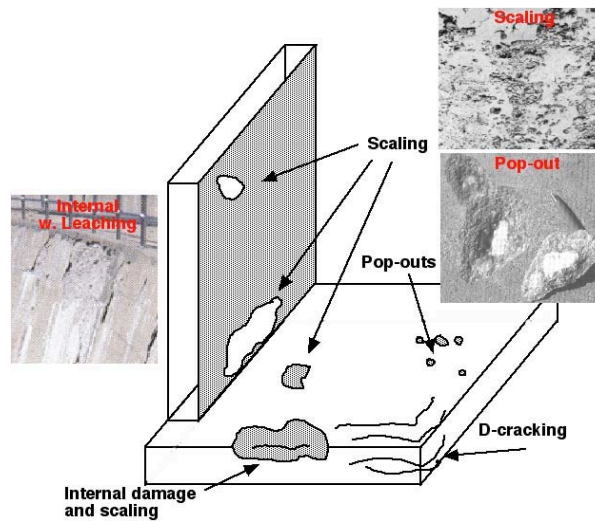
Figure 4.4 Types of freeze-thaw damage.

Damage to concrete resulting from freezing and thawing attack can take several forms:⁺ expansion, internal cracking, and spalling; scaling associated with application of salt; and pop-outs.^{61,62} Internal damage is confined primarily to the mortar and is associated with freeze-thaw damage of young concrete or mature cement paste that does not have a pore structure capable of resisting stresses that develop due to freeze-thaw occurrence. Scaling is delamination of the concrete surface. Weakness may exist at the surface due to an inherent weakness of the concrete due to excessive water, excess mortar, or treatment during construction. The surface layer may become detached if the stresses occurring exceed the tensile or bond strength holding the layer to the substrate. Scaling may develop from a shallow surface feature into internal damage. It often is associated with application of de-icing chemicals that cause the temperature of the concrete surface to change rapidly which induces a thermal shock that can cause cracking and surface scaling. Also, if salts are present in the pore solution the osmotic pressure is increased since moisture tends to move toward zones of higher salt concentrations. A pop-out is a small volume of concrete that has separated from the body of the concrete to leave a roughly conical depression. The most common cause of pop-outs is stress resulting from freeze-thaw action within the coarse aggregate particle that causes cracking of the particle and simultaneous fracture of the concrete between the particle and nearest concrete face. Aggregates that produce pop-outs are generally sedimentary (e.g., cherts, sandstones, shales, and limestones), but can be calcareous or siliceous or gravel or crushed rock, and have a high porosity.⁶³ Internal damage occurs in the form of cracking, is confined to mortar, and is associated with freeze-thaw damage to cement paste that does not have a pore structure capable of resisting the stresses that develop. Figure 4.4 presents a schematic of the types of freeze-thaw damage as well as examples.⁶¹

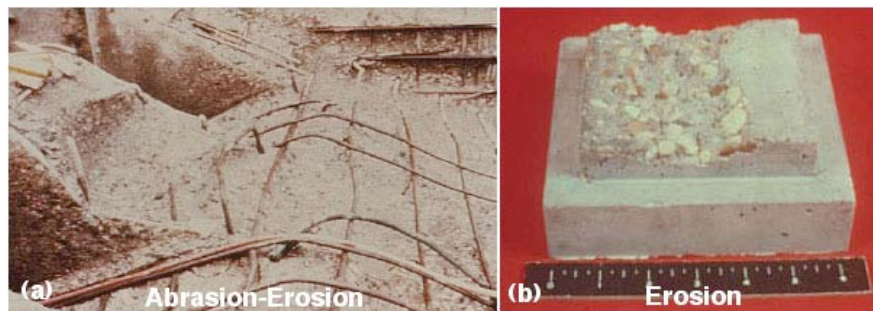
Figure 4.5 Abrasion-erosion of concrete: (a) abrasion-erosion damage in a concrete stilling basin and (b) erosion of conventional concrete.

Abrasion/Erosion/Cavitation Progressive loss of material at the concrete surface can occur due to abrasion, erosion, or cavitation. Abrasion generally refers to dry attrition due to rubbing or grinding of aggregate or other debris on the concrete surface, while erosion is normally used to describe wear by the abrasive action of fluids containing solid particles in suspension. Mechanical abrasion is usually characterized by long shallow grooves in the concrete surface and spalling along monolithic joints. Concrete surfaces abraded by water-borne debris are generally smooth and may contain localized depressions. Cavitation is the formation of bubbles or cavities in a liquid. In hydraulic structures, the liquid is water, and the cavities are filled with water vapor and air. The cavities form where the local pressure drops to a value that will cause the water to vaporize at the prevailing water temperature. Formation of these cavities is usually triggered by concrete surface irregularities that are subjected to high-velocity water flow. Cavitation bubbles will grow and travel with the flowing water to an area where the pressure field will cause collapse. When a bubble collapses or implodes close to or against a solid surface, an extremely high pressure is generated, which acts on an infinitesimal area of the surface for a very short time. A succession of these high-energy impacts will damage almost any solid material.⁶⁶ Figure 4.5 presents examples of concrete abrasion-erosion.^{66,67}

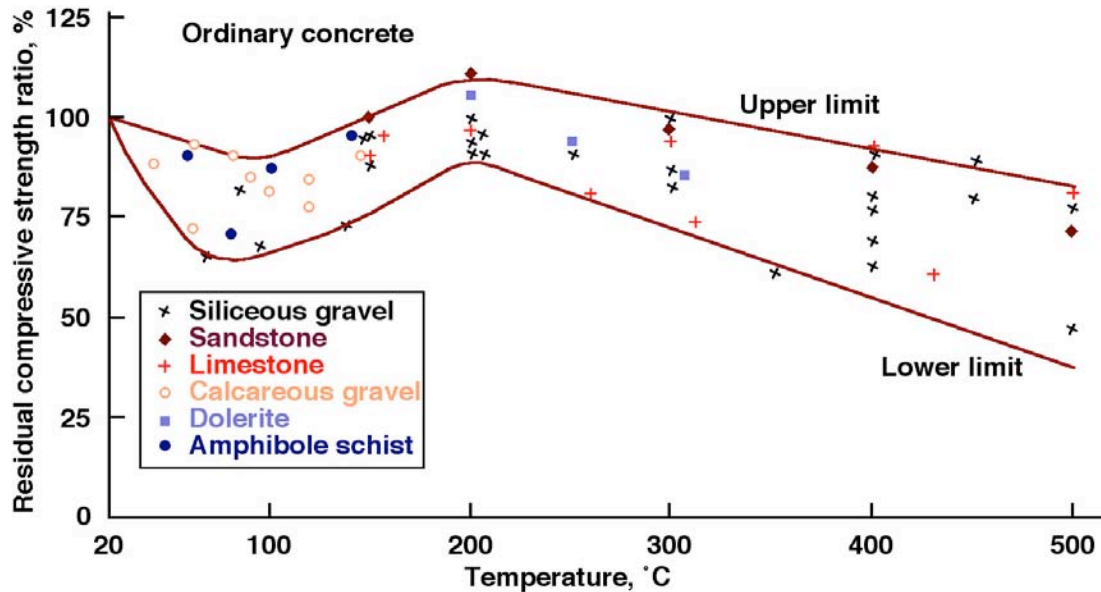
Figure 4.6 Effect of temperature on residual compressive strength: unsealed specimens.

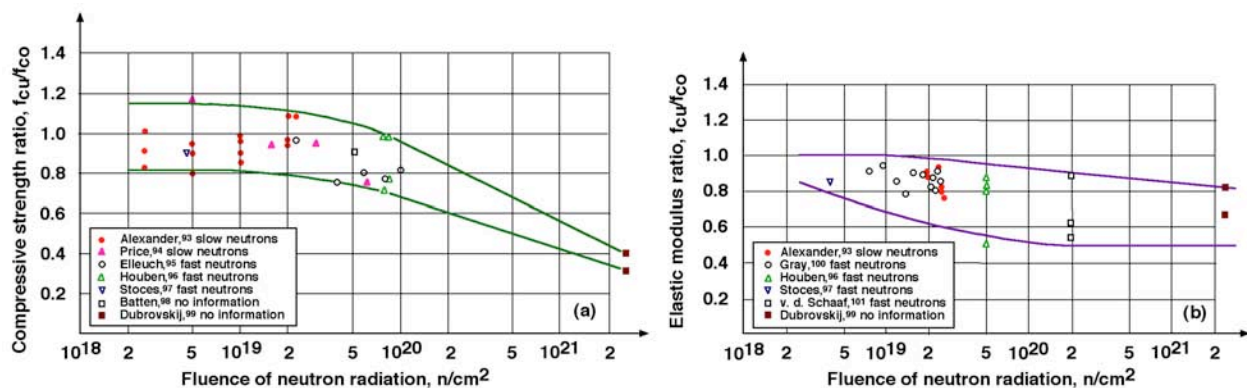
Figure 4.7 Effect of neutron radiation on concrete compressive strength and modulus of elasticity relative to unirradiated and unheated control specimen results.

Prolonged exposure of concrete to irradiation can result in decreases in tensile and compressive strengths and modulus of elasticity. Figure 4.7 presents a summary of the effects of neutron radiation on the compressive strength and modulus of elasticity of several concretes.⁹⁰ Results in the literature⁹⁰ indicate that: (1) for some concretes, neutron radiation of more than 1×10^{19} neutrons/cm² or 10^{10} rads of dose for

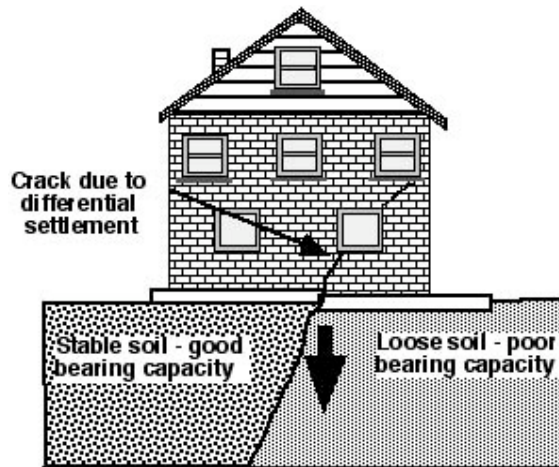
Figure 4.8 Example of differential settlement cracking in a building structure due to inadequate foundation design.

Uniform settlement will not normally cause structural distress, although if excessive it can result in damage or misalignment of connecting services or structures. Differential settlement is more of a concern as it can cause misalignment of equipment and lead to overstress conditions in structures (e.g., cracking such as illustrated in a building structure in Fig. 4.8). The amount of settlement is dependent on the physical properties of the foundation material at the site, which may range from bedrock (minimal settlement expected) to compacted soil (some settlement expected). Settlement is generally allowed for in the design of the structures and is not expected to be significant. When a structure such as a nuclear power plant is sited on soils, the potential for settlement is acknowledged and monitoring programs may be implemented to confirm that design allowables are not exceeded.

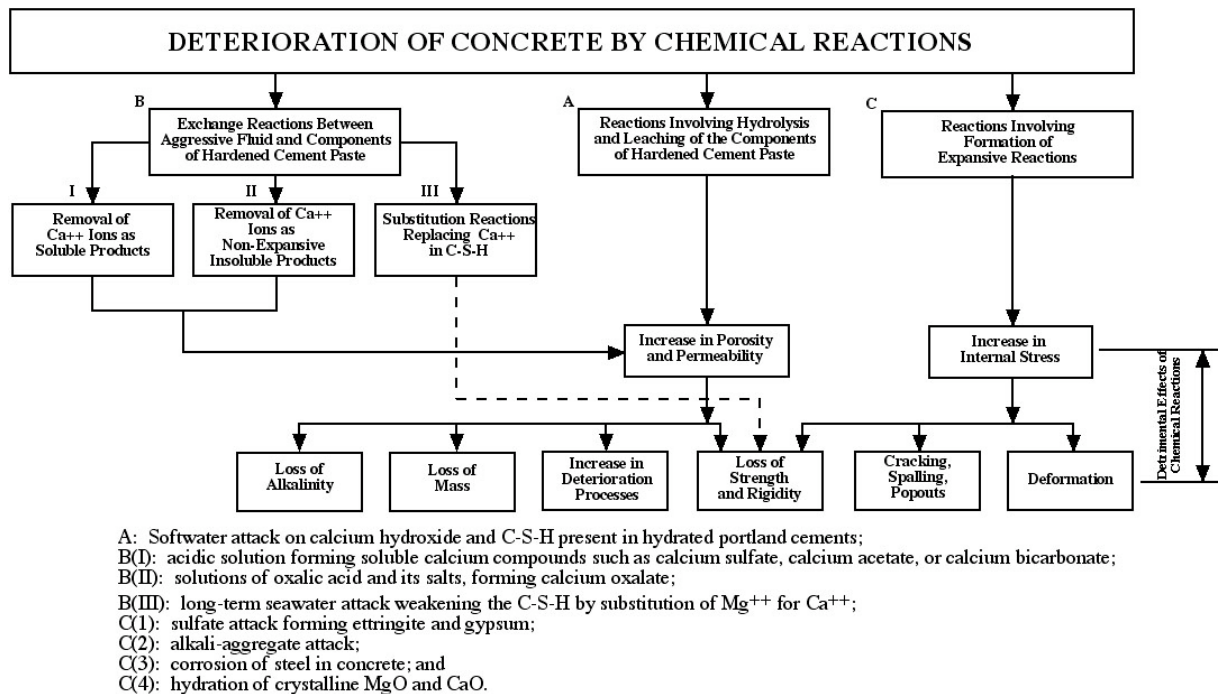
Figure 4.9 Types of chemical reactions responsible for concrete deterioration.

Chemical attack involves the alteration of concrete through chemical reaction with either the cement paste or coarse aggregate, or embedded steel reinforcement.** Generally, the attack occurs on the exposed surface region of the concrete (cover concrete), but with the presence of cracks or prolonged exposure, chemical attack can affect entire structural cross sections. Chemical causes of deterioration can be grouped into three categories: (1) hydrolysis of cement paste components by soft water; (2) cation exchange reactions between aggressive fluids and the cement paste; and (3) reactions leading to formation of expansion products.¹⁰⁹ Figure 4.9 presents a summary of the types of chemical reactions responsible for concrete deterioration and the detrimental effects that can occur.¹¹⁰ Chemical attack of concrete may occur in several different forms as highlighted in the following sections.

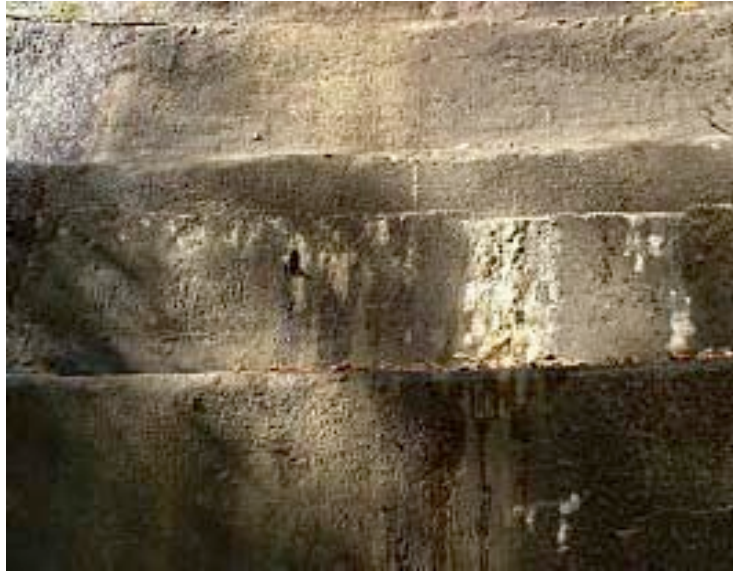
Figure 4.10 Efflorescence in water structure.

concrete or at its surfaces in contact with sulfates in the surrounding soil.¹¹¹ Typically, however, efflorescence is primarily an aesthetic problem rather than affecting the concrete mechanical properties or durability. In rare cases, excessive efflorescence deposits can occur within the surface pores of the concrete causing expansion that may disrupt the surface.¹¹² Figure 4.10 presents an example of efflorescence in a water structure.

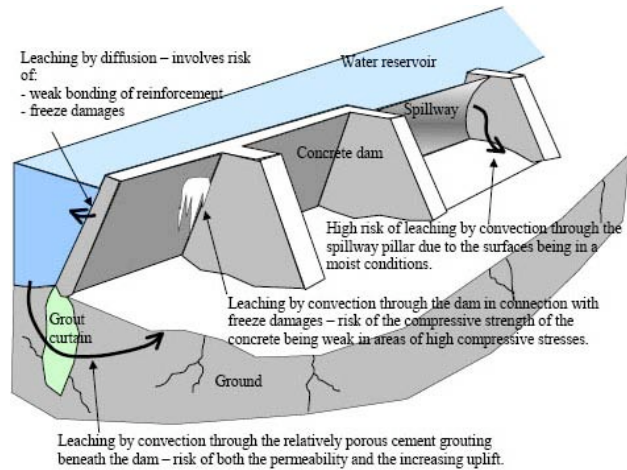
Figure 4.11 Typical leaching types observed in concrete hydraulic structures such as a dam.

Leaching of cementitious materials mainly involves the transportation of ions from the interior of the material through its pore system outwards into the surroundings. In the leaching process solid compounds in the concrete are dissolved by water that has penetrated and are transported away either by diffusion based on the concentration gradients or convection through the flow of water. Pure water that contains little or no calcium ions, or acidic ground water present in the form of dissolved carbon dioxide gas, carbonic acid, or bicarbonate ion, tends to hydrolyze or dissolve the alkali oxides and calcium-containing products. Water with a pH less than 12.5 is aggressive toward concrete since it destabilizes the cementitious hydration products. The rate of leaching is dependent on the amount of dissolved salts contained in the percolating fluid, rate of permeation of the fluid through the cement paste matrix, and temperature. Extensive leaching causes an increase in porosity and permeability thus lowering the strength of the concrete and making it more vulnerable to hostile environments (e.g., water saturation and frost damage, or chloride penetration and corrosion of embedded steel). Figure 4.11 shows a schematic of different types of leaching found in concrete hydraulic structures.¹¹³ Examples of leaching in a concrete dam and a tendon gallery of a nuclear power plant are shown in Figure 4.12. Concrete leaching is basically of three types: (1) leaching at free surfaces of the concrete, (2) leaching from the interior of concrete, and (3) leaching at surfaces of cracks in concrete.¹¹⁴ Figure 4.13 presents conceptual models for each of the leaching types. Of these types, (a) is generally of little importance, (b) is serious and can result in serious damage, and (c) is difficult to deal with and complicated to assess. Concretes produced using low water-cement ratios, adequate cement content, and proper compaction and curing are most resistant to leaching.

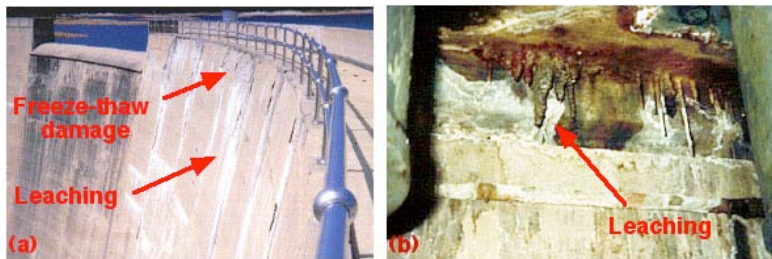
Figure 4.12 Examples of leaching of concrete: (a) dam with freeze-thaw damage and leaching, (b) nuclear power plant tendon gallery leaching.

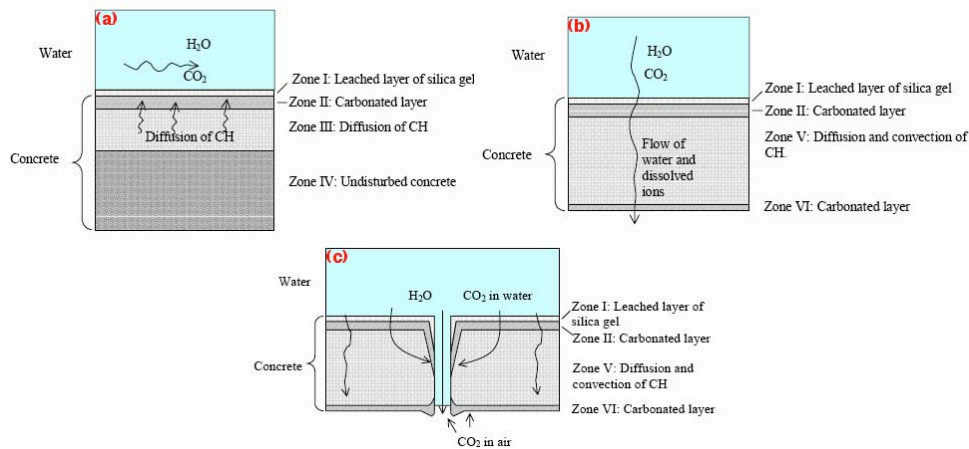
Figure 4.13 Conceptual models for concrete leaching mechanisms: (a) leaching from free surfaces, (b) homogeneous percolation through porous concrete, and (c) leaching from surfaces of cracks. CH = calcium hydroxide.

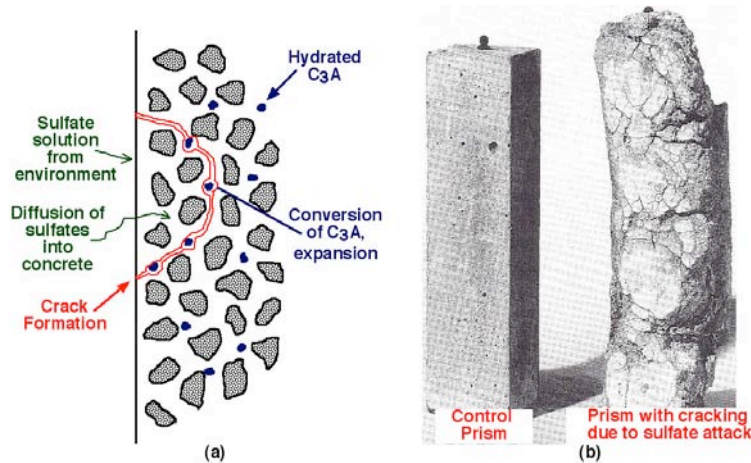
Figure 4.14 Concrete cracking due to sulfate attack: (a) mechanism, (b) example of concrete cracking due to sulfate attack.

Sulfate Attack All sulfates are potentially harmful to concrete. Sulfate attack of concrete is caused by exposure of concrete products or structures to an excessive amount of sulfate from internal or external sources. Internal sulfate attack results when a soluble source of sulfates is incorporated into the concrete at the time of mixing through the hydraulic cement, presence of natural gypsum or pyrite in the aggregate, and admixtures. External sulfate attack is most common and typically occurs when water containing dissolved sulfates penetrates the concrete. Magnesium, sodium, calcium, and potassium sulfates present in soils, ground water, and sea water react with the calcium hydroxide and if enough water is present, result in expansion and irregular cracking of the concrete that can lead to progressive loss of strength and mass. The degree of sulfate attack depends on water penetration, the sulfate salt and its concentration and type, the means by which the salt develops in the concrete (e.g., is it rising and drying causing crystallization), and the chemistry of the binder present in the concrete. Sulfate attack of hardened concrete generally appears in two forms: expansive formation of ettringite and gypsum in the hardened concrete causing cracking and exfoliation, and softening and dissolution of the hydrated cementing compounds due to direct attack on these compounds by sulfate or by their decomposition when calcium hydroxide reacts with the sulfates and is removed.⁴⁷ The end result of sulfate attack can be excessive expansion, delamination, cracking, and loss of strength. Figure 4.14 illustrates the mechanism of sulfate (sodium) attack and presents an example of cracking resulting from sulfate attack. It has been reported that at a concentration of about 0.2% sulfate content in ground water concrete may suffer sulfate attack, magnesium sulfate can be more aggressive than sodium sulfate, and there are three key chemical reactions between sulfate ions and hardened cement pastes: (1) recrystallization of ettringite, (2) formation of calcium sulfoaluminate (ettringite), and (3) decalcification of the main cementitious phase (calcium silicate hydrate).¹¹⁵

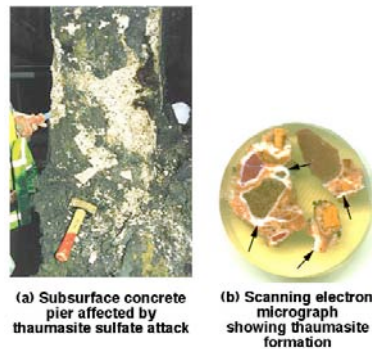
Figure 4.15 Thaumasite sulfate attack.

A rare form of sulfate attack is through formation of thaumasite as a result of the reaction between the calcium silicates in the cement, calcium carbonate from limestone aggregates or fillers, and sulfates, usually from external sources.⁵⁶ Coincident factors for thaumasite sulfate attack in susceptible concrete include: source of sulfates, presence of mobile ground water, source of calcium silicate hydrate, presence of carbonate, and a low temperature (<10°C).¹²⁰ Thaumasite sulfate attack forms slowly and can destroy a significant part of the calcium silicate hydrate that eventually results in a soft, white, pulpy mass that causes total disintegration of the concrete and exposes the steel reinforcement. Figure 4.15 presents a subsurface concrete pier affected by thaumasite sulfate attack in the United Kingdom. However, serious damage to concrete or masonry due to thaumasite formation has not been a common occurrence.

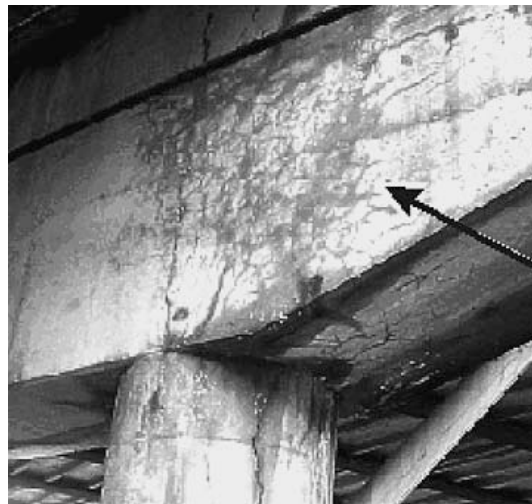
Figure 4.16 Cracking damage in a concrete structure due to DEF.

Delayed Ettringite Formation Ettringite formation by reaction of internal or external sulfate with anhydrous or hydrated calcium aluminates has an expansive character. When it occurs within several hours in a fresh concrete mixture, there is no destructive expansion. However, when ettringite forms at later ages (e.g., months or years) in a hardened concrete, delayed ettringite formation (DEF) can exhibit expansion and cracking. The distress often is attributed to improper heat-treatment of concrete in which the ettringite formation is prevented or the ettringite that is normally formed during the early hydration of portland cement decomposes ($T > 70^{\circ}\text{C}$). Use of cements having high sulfate contents in which the sulfate has very low solubility also can lead to DEF. In this case, the sulfate concentrations in the pore liquid are high for an unusually long period of time in the hardened concrete. Eventually the sulfate will react with the calcium- and aluminum-containing phases of the cement paste and the cement paste expands forming cracks around the aggregate particles. In one case where this has been reported, it was thought that the occurrence of DEF was due to the sulfate formed in the clinker of the cement being present as anhydrite and as a component of the silicate phases that are slowly soluble.¹²¹ If structures susceptible to DEF are later exposed to water, ettringite can reform in the paste as a massive development of needle-like crystals, causing expansive forces that result in cracking. The extent of development of DEF is dependent on the amount of sulfate available for late ettringite development in the particular concrete and on the presence of water during the service life. Elevated temperatures also increase the potential for damage due to DEF. Prevention or minimization of DEF can be accomplished by lowering the curing temperature, limiting clinker sulfate levels, avoiding excessive curing for potentially critical sulfate to aluminate ratios, preventing exposure to substantial water in service, and using proper air entrainment. Neither the mechanisms involved in DEF nor their potential consequences relative to concrete durability are completely understood. DEF leads to a degradation in concrete mechanical properties such as compressive strength, and can promote increased permeability. A detailed review of over 300 publications dealing with DEF is available.¹²² Figure 4.16 presents an example of cracking damage in a concrete structure due to delayed ettringite formation.

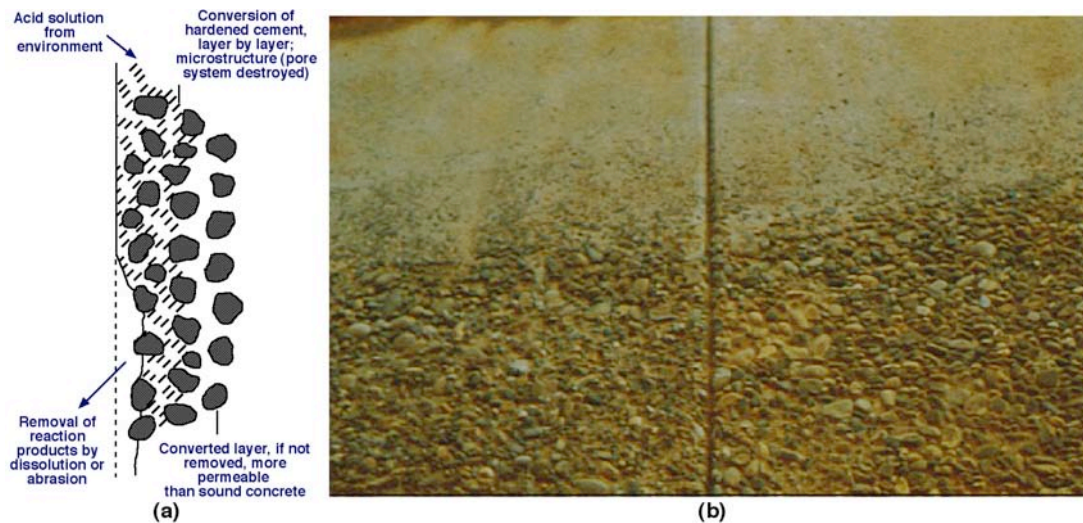
Figure 4.17 Surface loss due to acid attack: (a) mechanism, (b) example of acid attack on concrete wall.

so much the aggressiveness of the attacking acid, but more the solubility of the resulting calcium salt. The rate of deterioration is also accelerated if the aggressive chemical solution is flowing. Since under acid attack there is a conversion of the hardened cement, the concrete permeability is not as important as for other types of chemical attack (e.g., leaching and sulfate attack). Nitric, hydrochloric, and sulfuric acids are very aggressive as their calcium salts are readily soluble and removed from the acid front. Organic acids such as formic, acetic, and lactic are also corrosive to portland cement concrete. Other acids such as phosphoric, carbonic, tannic, and humic are less harmful as their calcium salts have low solubility and inhibit the attack by blocking the pathways within the concrete. Oxalic acids have negligible affect on portland cement concretes. Carbonic, humic, and sulfuric acids are the acids most commonly encountered by concrete since they are found in natural ground waters. Visual examination of concrete undergoing acid attack will show disintegration of the concrete in the form of loss of cement paste and aggregate from the matrix. Due to the large buffering capacity of concrete and the relatively small amount of acid contained in rain, acid rain will convert only an insignificant amount of the concrete.⁵⁷ Acid rain is even a smaller threat to nuclear power plant structures than general civil engineering concrete structures because of their massive cross sections. Surface coatings and a dense concrete with a low water-cement ratio provide improved resistance to acid environments. Figure 4.17 illustrates the mechanism of acid attack and presents an example of acid attack on a concrete wall.

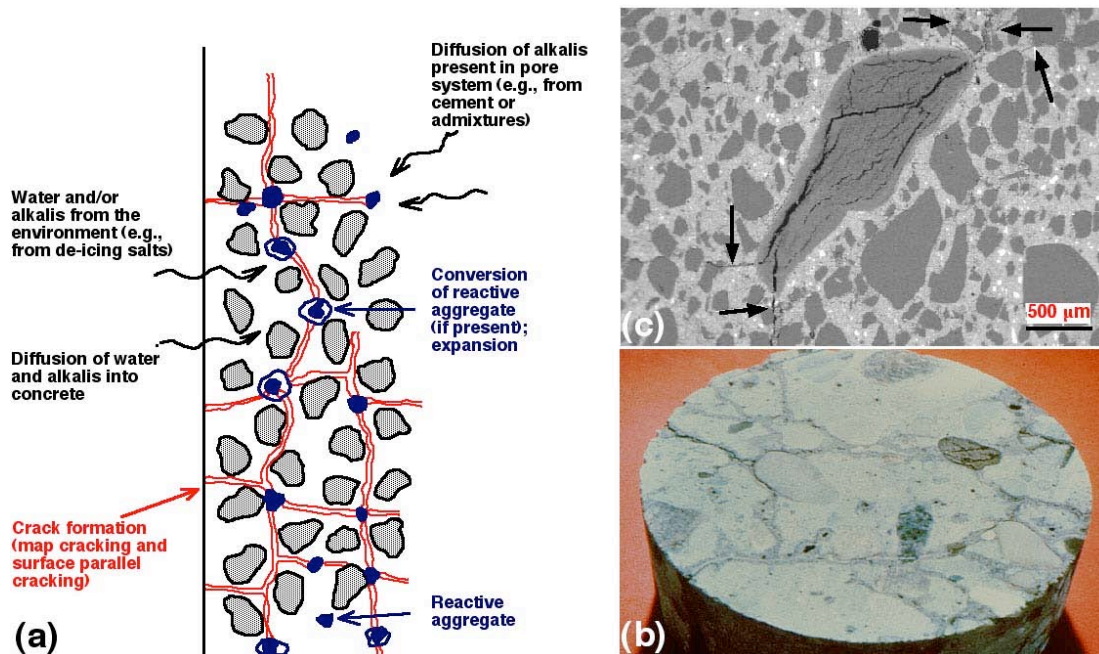
Figure 4.18 Concrete cracking due to alkali-silica reaction: (a) mechanism, (b) resulting gel that causes expansion and cracking, (c) polished section of concrete showing chert particle with extensive internal cracks extending from aggregate as noted by arrows.

the alkali-silicate ions and expands, which can disrupt the concrete.* Figure 4.18 presents the mechanism of alkali-silica reaction (ASR) and the gel resulting from alkali-aggregate reaction that causes expansion

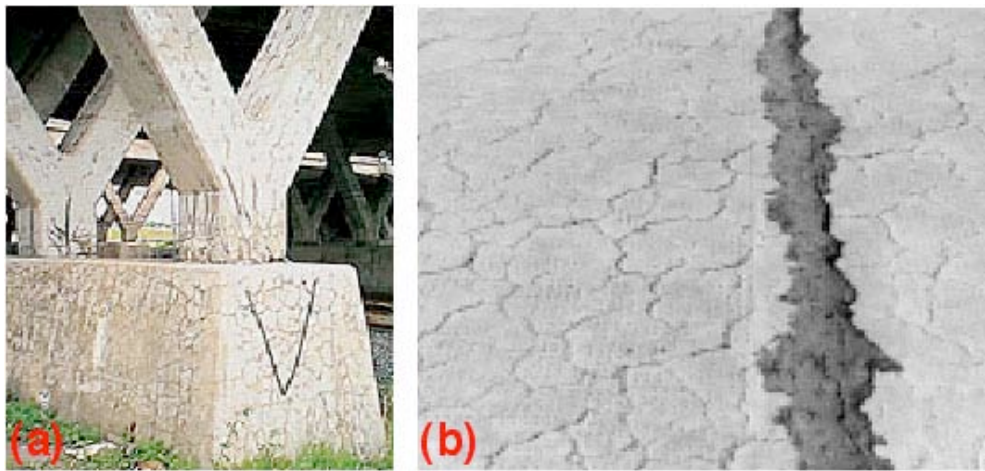
Figure 4.19 Examples of concrete cracking: (a) alkali-silica reaction in bridge pier, (b) alkali-carbonate reaction in sidewalk with exudation of joint material.

strength in excess of 50% with losses for smooth bars greater than for ribbed bars.^{135,136} Prestress developed by the ASR expansion can enhance the shear strength and stiffness of beams.¹³⁷ Figure 4.19 presents examples of alkali-aggregate reactions in concrete structures.

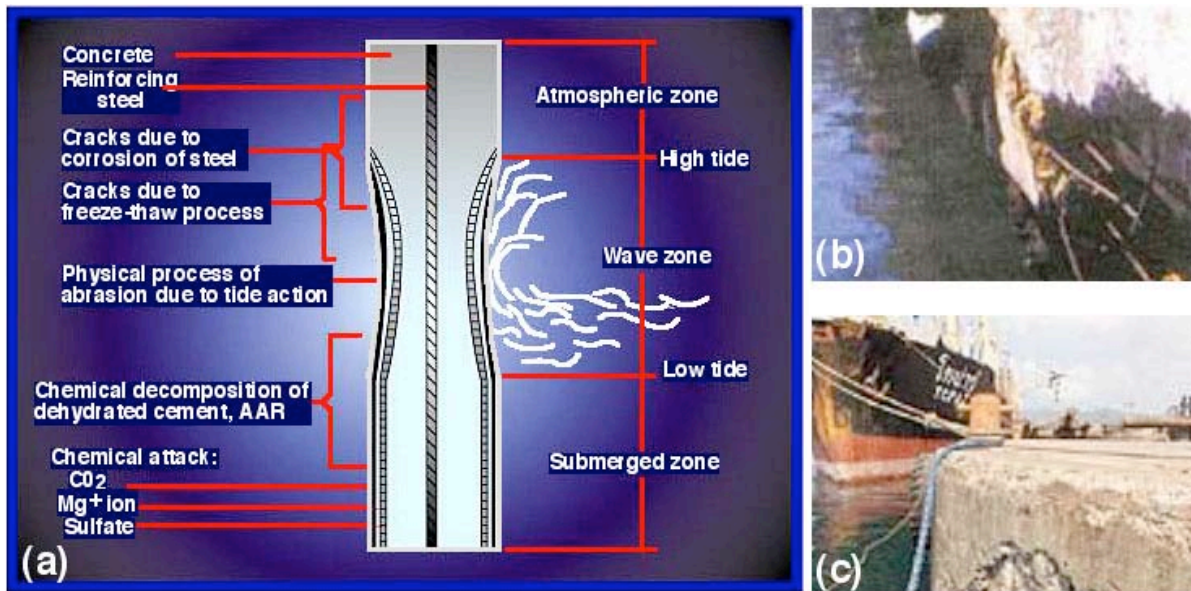
Figure 4.20 Sea water attack of concrete: (a) mechanism, (b) and (c) examples of attack.

Aggressive Water Attack# Concrete in service may be exposed to aggressive waters, with the most common deleterious ion being sulfate.¹⁴³ In other waters, acids and chemical by-products from industrial processes may be present. Some locations have sea water or brackish water in contact with concrete. Most sea waters have a pH of 7.5 to 8.4, are fairly uniform in chemical composition, contain about 3.5% soluble salts by weight, with Na^+ and Cl^- having the highest ionic concentrations, but Mg^{2+} and SO_4^{2-} are also present.¹⁰⁹ Reaction of magnesium sulfate with the cement hydration products leads to formation of ettringite, calcium sulfate, and insoluble magnesium hydroxide (brucite) that reduces the rate of attack of dense concrete. The rate of attack is further reduced by the formation of aragonite (calcium carbonate) which forms more readily in the tidal zone than the surface layers of a completely immersed element.⁴⁶ Concrete exposed to a marine environment may deteriorate as a result of combined effects of chemical action of sea water constituents on cement hydration products, alkali-aggregate expansion if reactive aggregates are present, crystallization pressure of salts within concrete if one face of the structure is subject to wetting and others to drying conditions, frost action in cold climates, corrosion of embedded steel reinforcement, and physical erosion due to wave action or floating objects. Figure 4.20 presents a diagrammatic representation of deterioration of concrete exposed to sea water as well as examples of sea water attack.

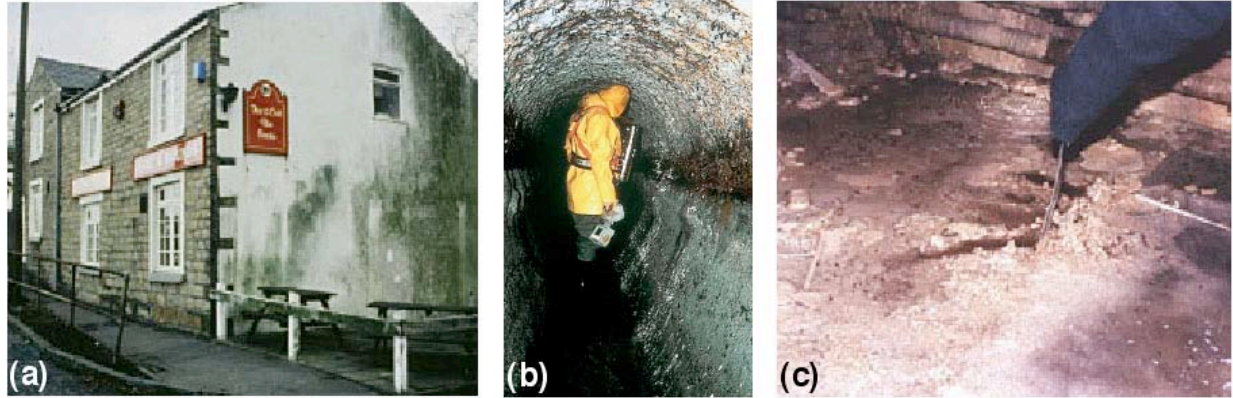
Figure 4.21 Concrete biological attack: (a) algae growth on outside wall of house, (b) biogenic sulfuric acid attack in sewer system, (c) decaying concrete floor in flooded cellar.

Formation of capillaries within the concrete during the hydration process and the capillary action of water provide a means for penetration of microorganisms into concrete. The metabolism of microorganisms results in the excretion of sulfuric or nitric acid that can contribute substantially to the degradation of cementitious materials. A number of organisms are capable of causing the dissolution of concrete through leaching of calcium and other alkaline binding materials.¹⁴⁶ These organisms are known to cause serious damage to sewer lines, buildings, and monuments. In environments where reduced sulfur compounds are present, such as sewers, the production of sulfuric acid by sulfur oxidizing bacteria (thiobacilli) forms a corrosive layer that causes extensive cement degradation. The sulfuric acid reacts with the free lime [$\text{Ca}(\text{OH})_2$] to form gypsum ($\text{CaSO}_4 \cdot 2\text{H}_2\text{O}$) that produces a corroding layer on the concrete surface that penetrates into the concrete. The newly formed gypsum crystals react with calcium aluminate in the cement to produce ettringite that further contributes to the degradation of concrete by increasing the internal pressure leading to formation of cracks that, in turn, provide a larger surface area for the corrosion process.¹⁴⁷ In environments where reduced sulfur compounds are limiting, such as on buildings, nitric acid-producing nitrifying bacteria have been found to play a role in concrete degradation.¹⁴⁸ The action of nitric acid on the calcareous components of concrete results in the production of calcium nitrate (soluble salt) that is either lost from the concrete resulting in formation of corrosion pits or remains to add salt to the pore water. The sulfate-reducing bacteria are primarily responsible for degradation of concrete above ground and the nitrifying bacteria for degradation below ground.¹⁴⁹ Microbes have extremely diverse modes of metabolism, are natural inhabitants of soil, and can survive extreme environments such as the inner wall of a geothermal cooling tower.¹⁵⁰ Concrete can also be corroded by gluconic, malic, and oxalic acids produced by fermentative bacteria that are natural soil inhabitants.¹⁵¹ Figure 4.21 presents examples of biological attack of concrete and Table 4.8 provides a summary of the effects of microorganisms on building materials.

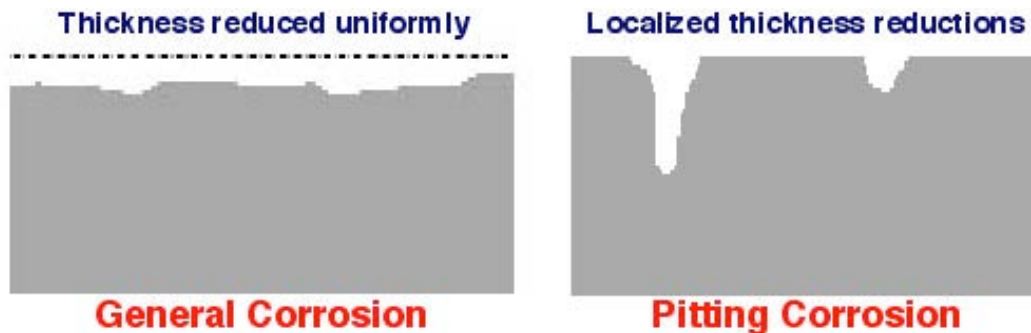
Figure 4.22 Illustrations of general and pitting corrosion of a metal surface.

Corrosion of conventional steel in concrete is an electrochemical process that can assume the form of either general or pitting corrosion. General corrosion refers to a relatively uniform reduction of thickness over the surface of a corroding material. It is relatively easy to measure and monitor. Pitting corrosion is a localized form of corrosion in which the bulk of the surface remains unattacked. Pitting corrosion is often found at locations where resistance against general corrosion provided by passive surface films has broken down. Figure 4.22 presents schematics illustrating general and pitting corrosion.

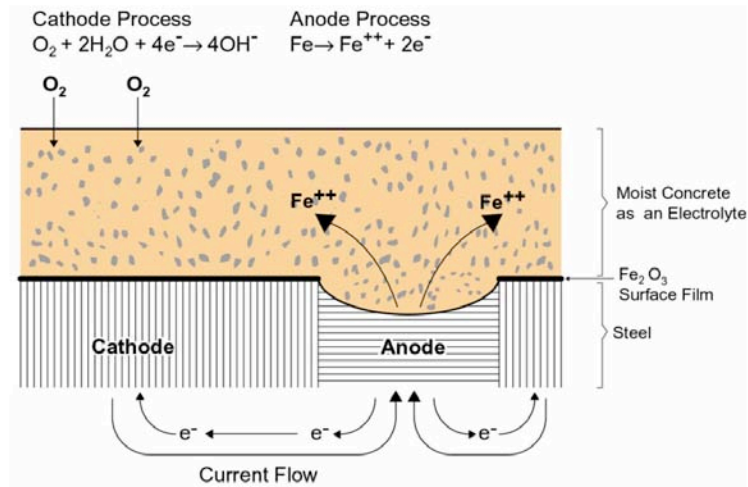
Figure 4.23 Electrochemical reaction illustrating corrosion of steel in concrete.

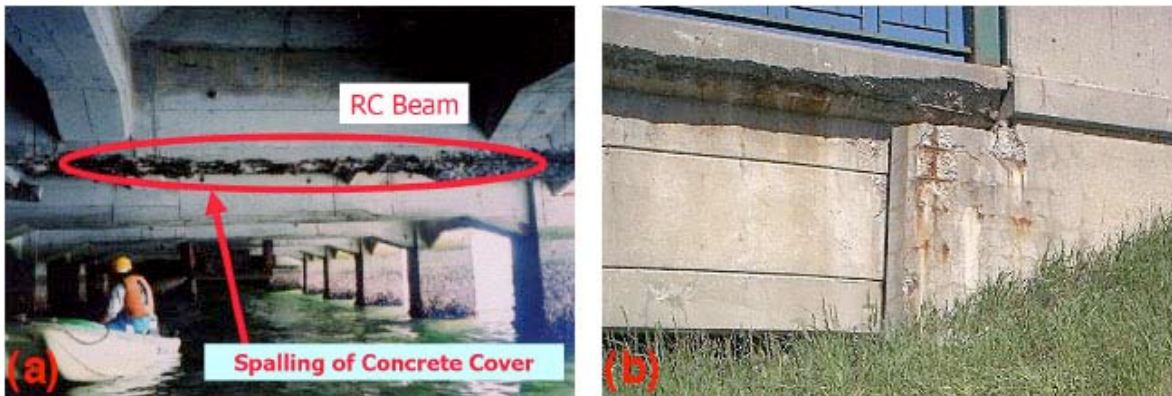
Figure 4.24 Corrosion of reinforced concrete: (a) sea water structure, (b) bridge structure.

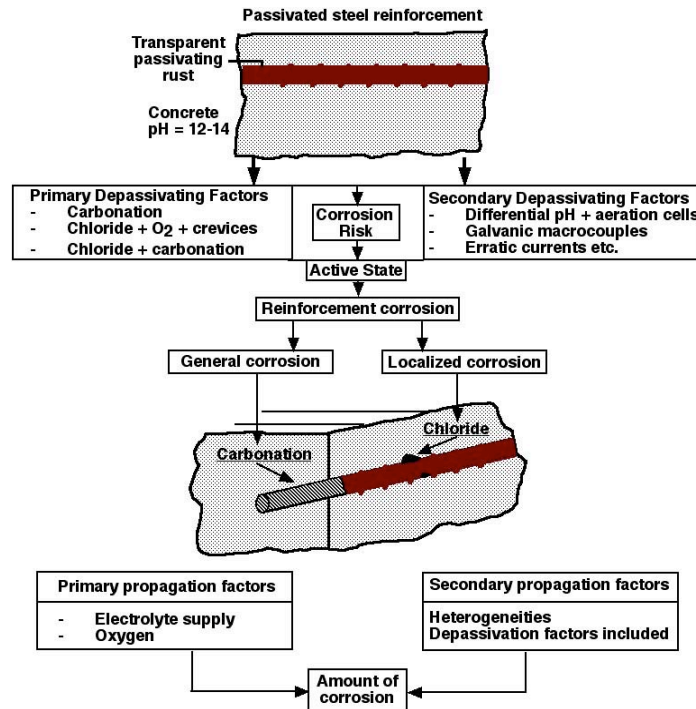
Figure 4.25 Factors leading to depassivation of steel in concrete.

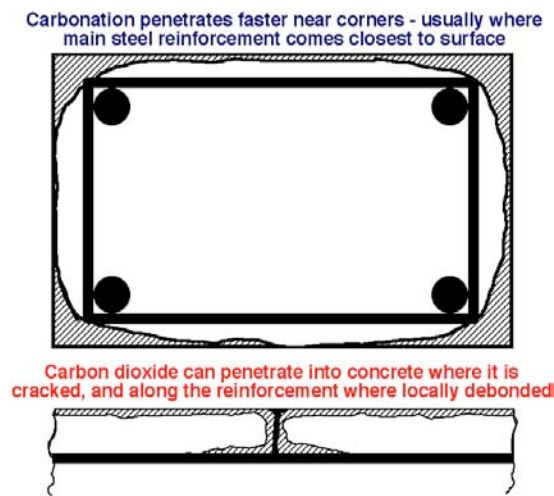
Figure 4.26 Carbonation penetration.

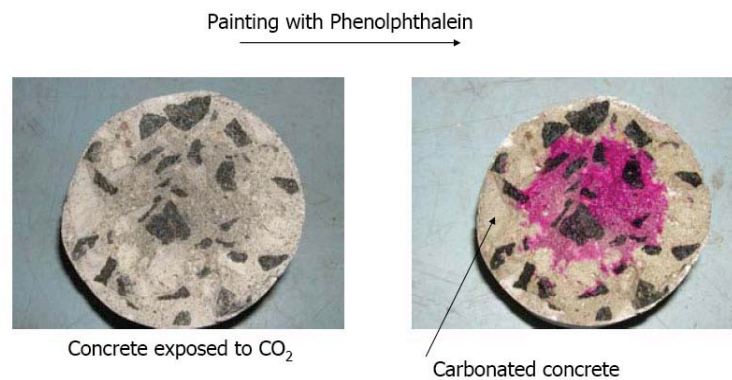
Figure 4.27 Use of phenolphthalein to identify carbonated concrete.

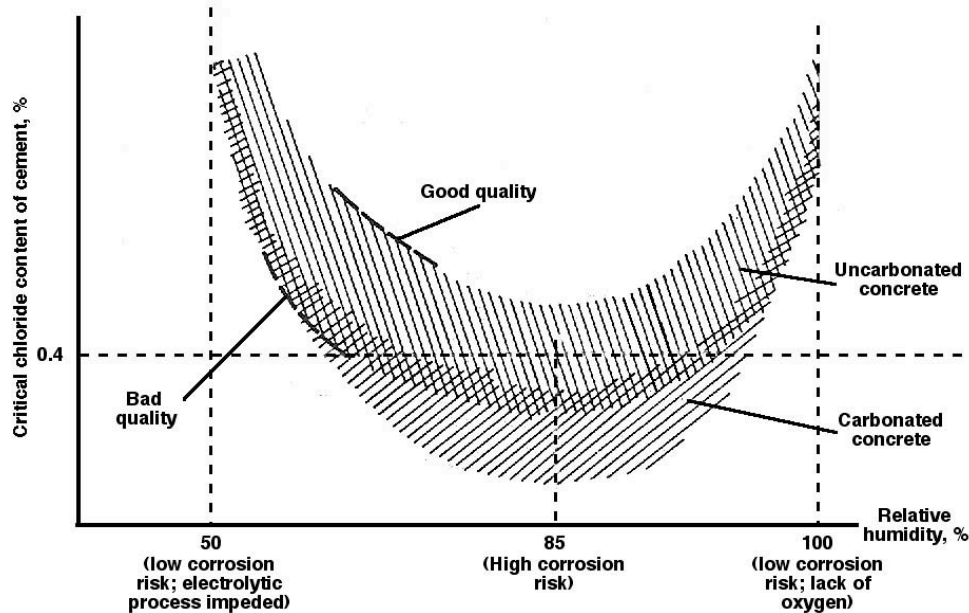
Figure 4.28 Variation of critical chloride content with environment.

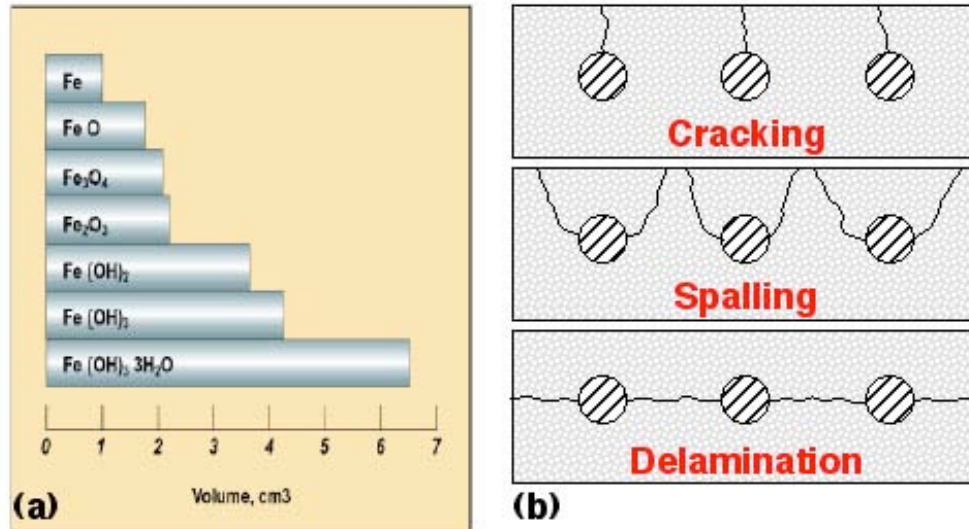
Figure 4.29 Oxidation states of iron and representations of visible forms of corrosion.

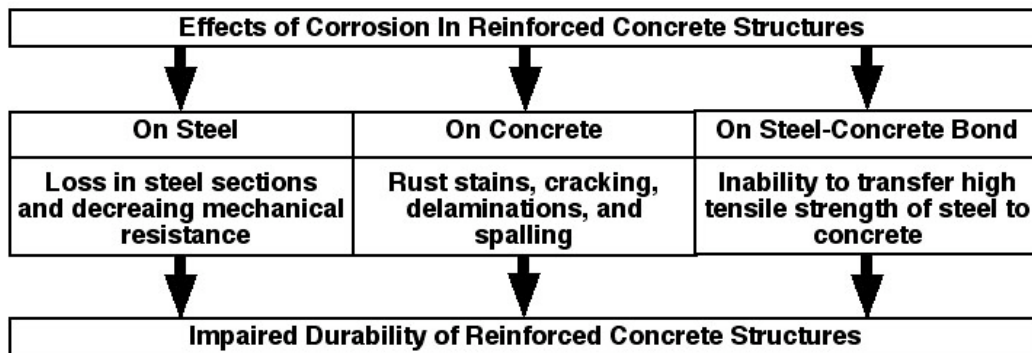
Figure 4.30 Effects of corrosion on reinforced concrete structures.

deterioration at the concrete surface is apparent. Figure 4.30 summarizes the effects of corrosion on reinforced concrete structures.¹⁵³
