Primer on Durability of Nuclear Power Plant Reinforced Concrete Structures - A Review of Pertinent Factors

NUREG/CR-6927
ORNL/TM-2006/529

Prepared by
D.J. Naus

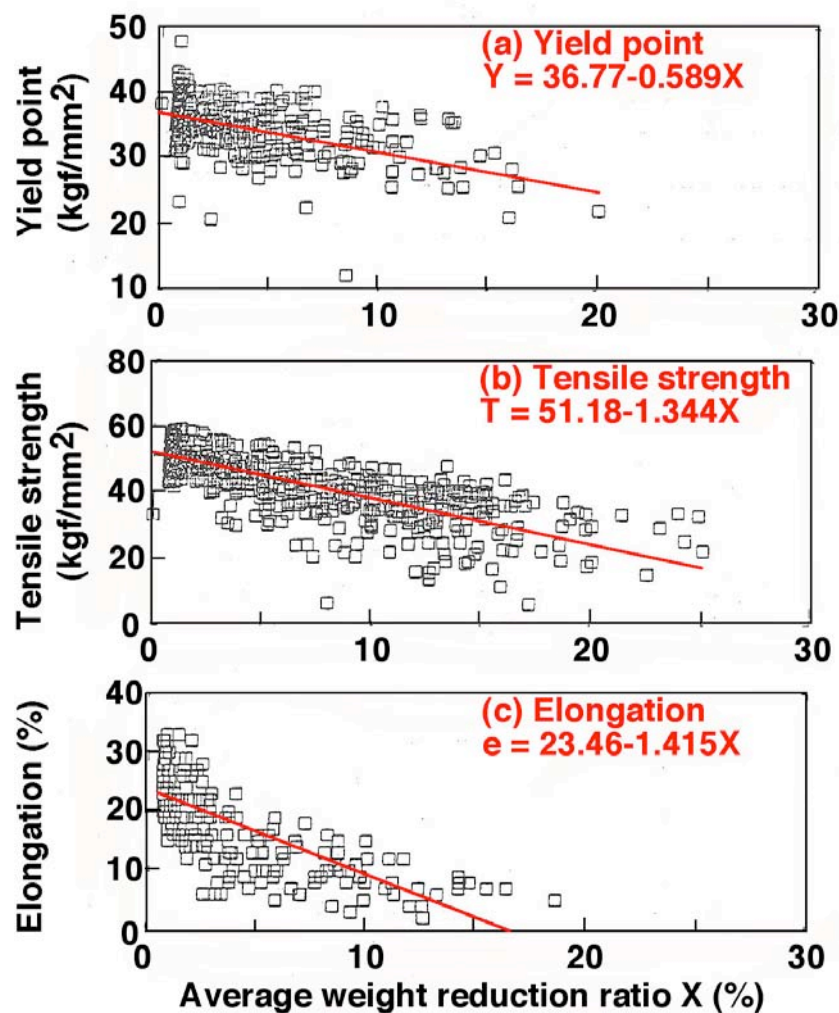
Figure 4.31 Properties of corroded steel reinforcement.

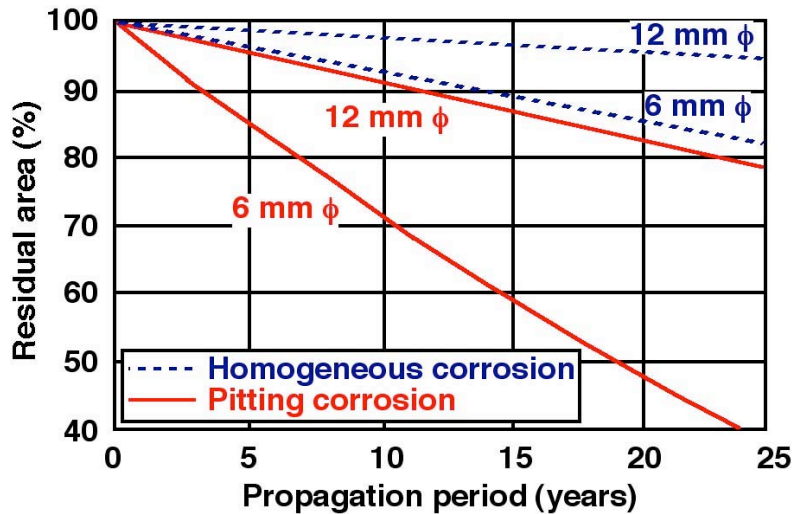
Figure 4.32 Residual cross-sectional area of steel reinforcement as a function of type and longevity of corrosion.

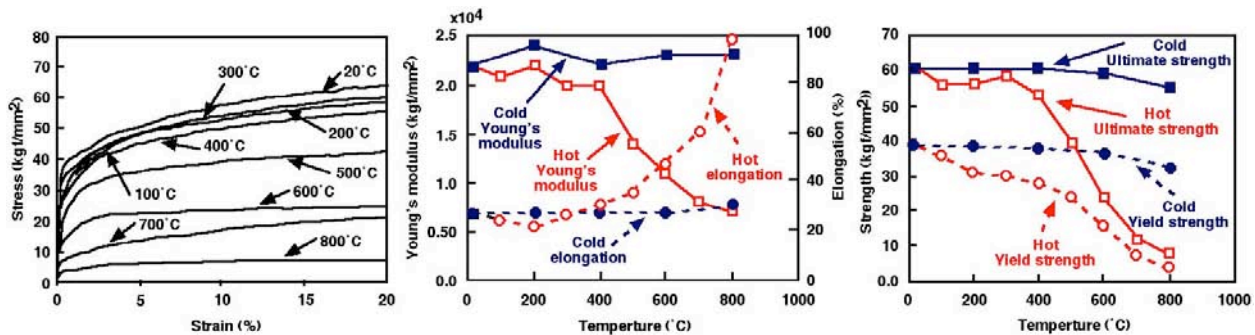
Figure 4.33 Effect of temperature on properties of a 3,500 kgf/cm² minimum specified yield strength steel bar.

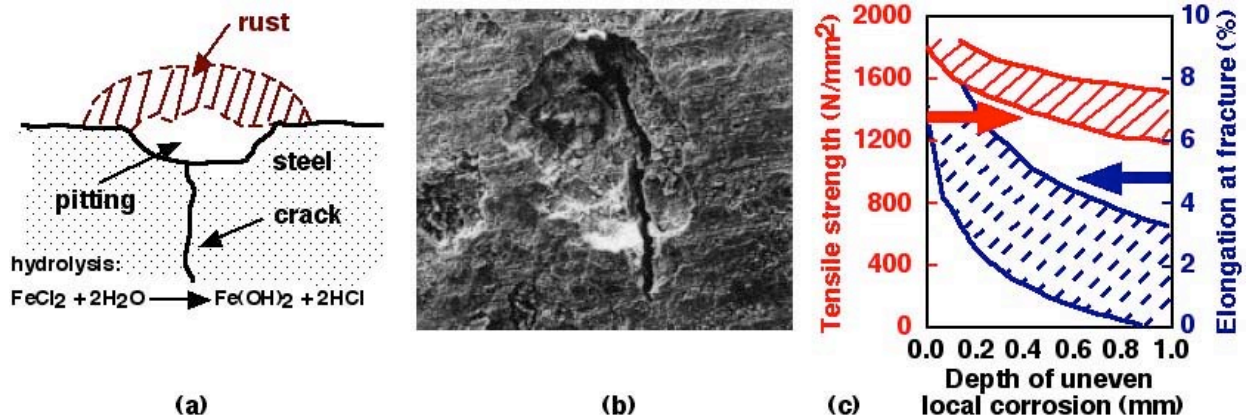
Figure 4.34 Pitting corrosion of prestressing steel: (a) mechanism, (b) pitting-induced stress-corrosion cracking, (c) effect of pit depth on tensile strength and elongation.

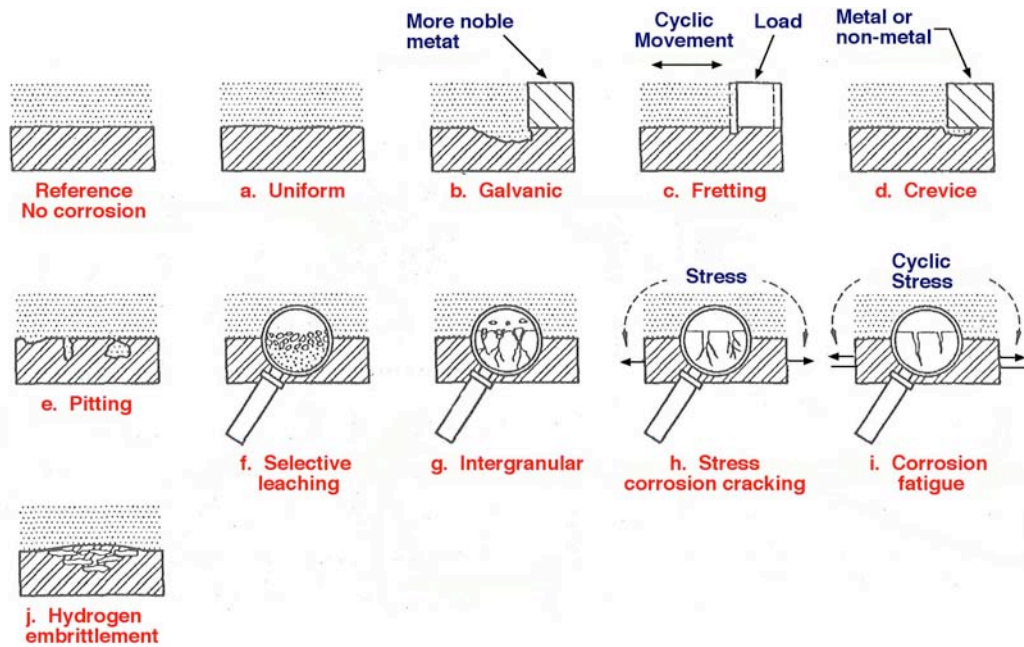
Figure 4.35 Schematic representations of forms of corrosion that may be found in metals.

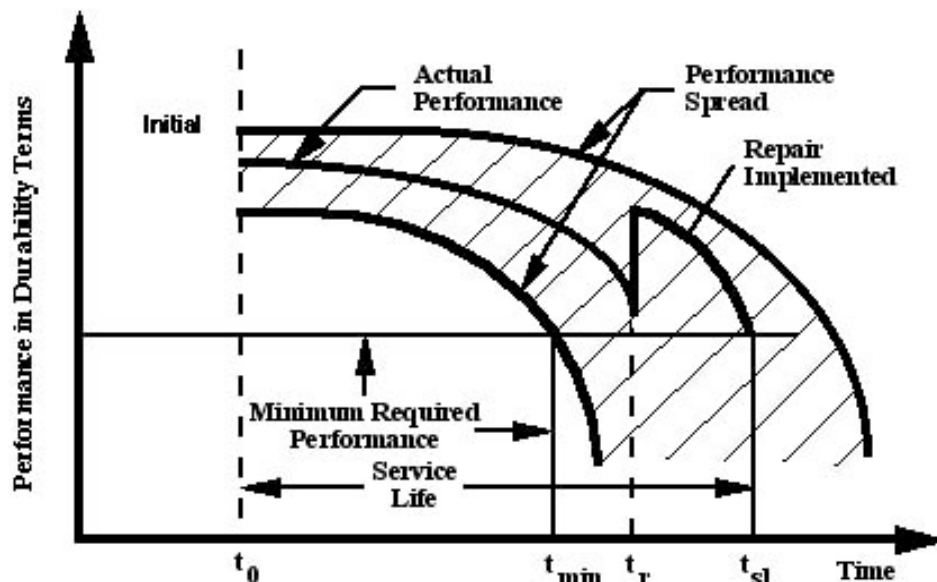
Figure 5.1 Relationship between performance and service life.

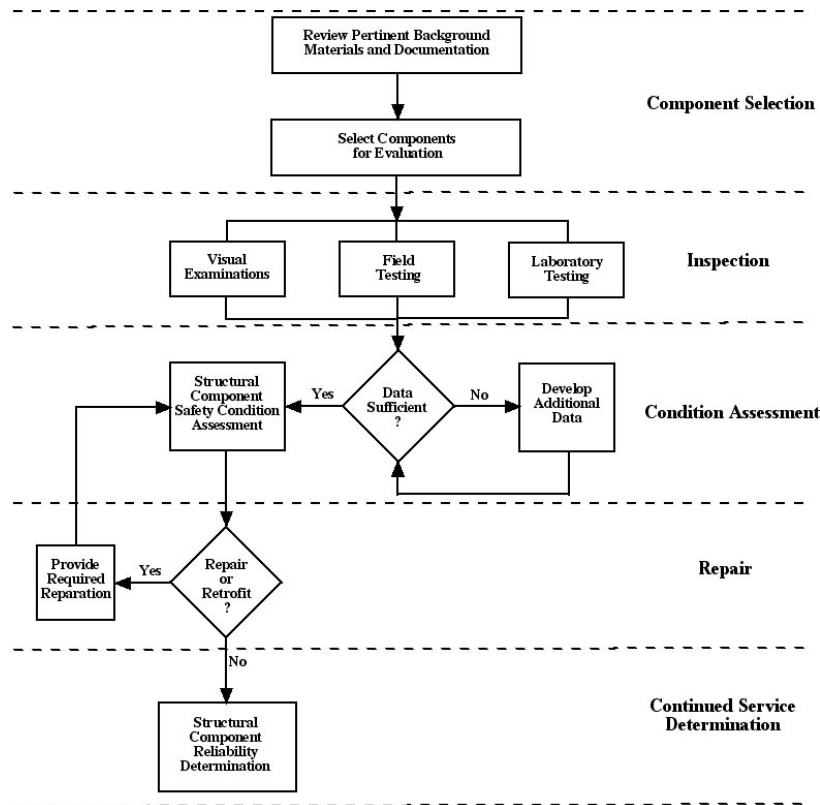
Figure 5.2 Evaluation methodology for nuclear power plant concrete structures.

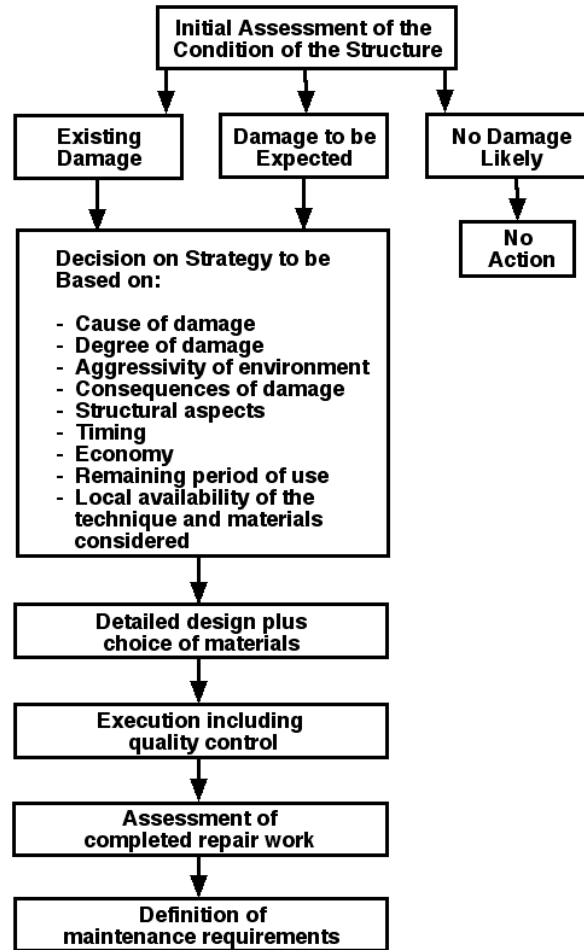
Figure 5.3 Steps to be taken in a repair process.

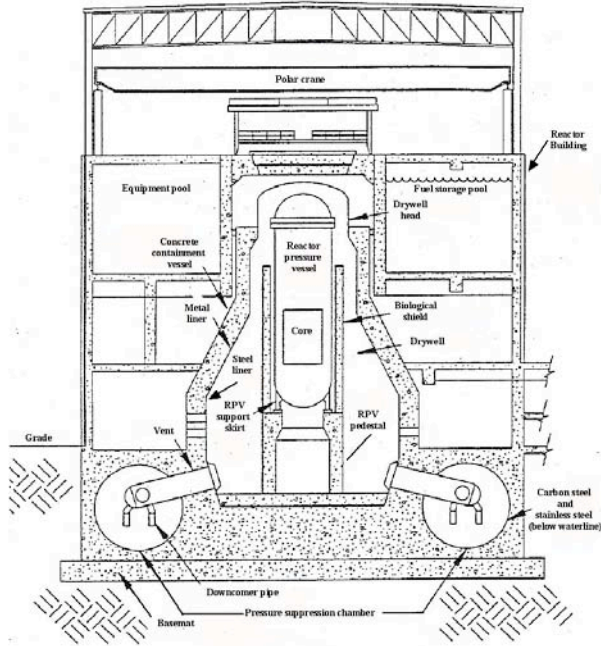
Figure A.1 BWR Mark I type reinforced concrete containment.

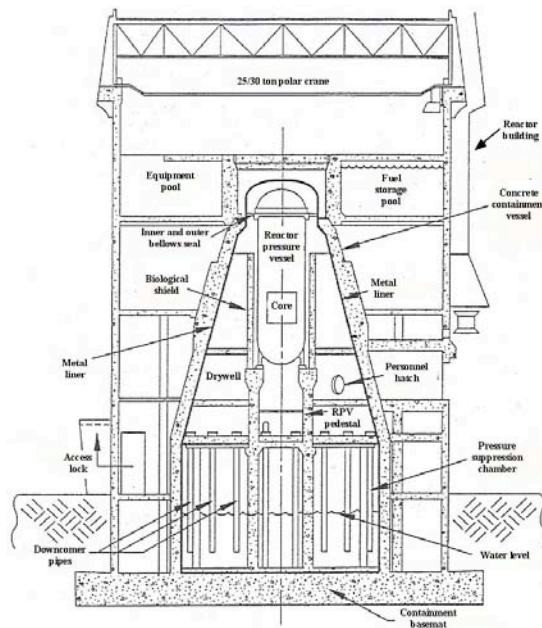
Figure A.2. BWR Mark II type reinforced concrete containment.

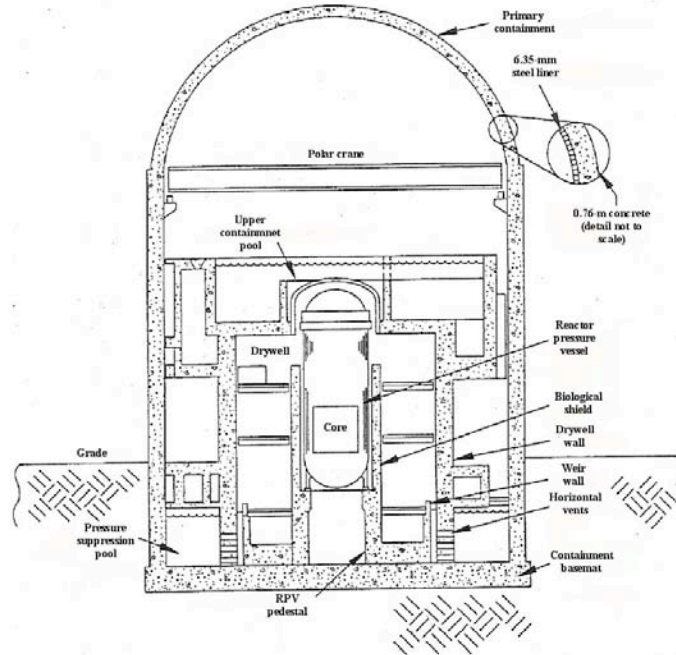
Figure A.3. BWR Mark III type reinforced concrete containment.

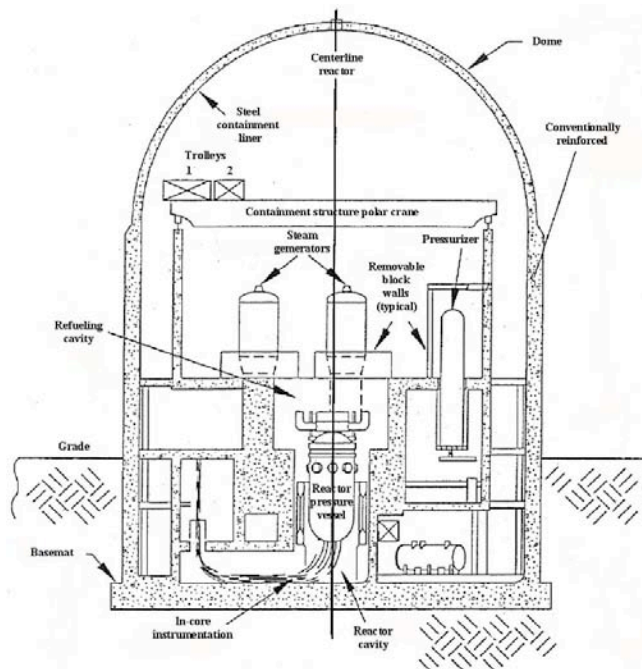
Figure A.4. PWR subatmospheric type reinforced concrete containment.

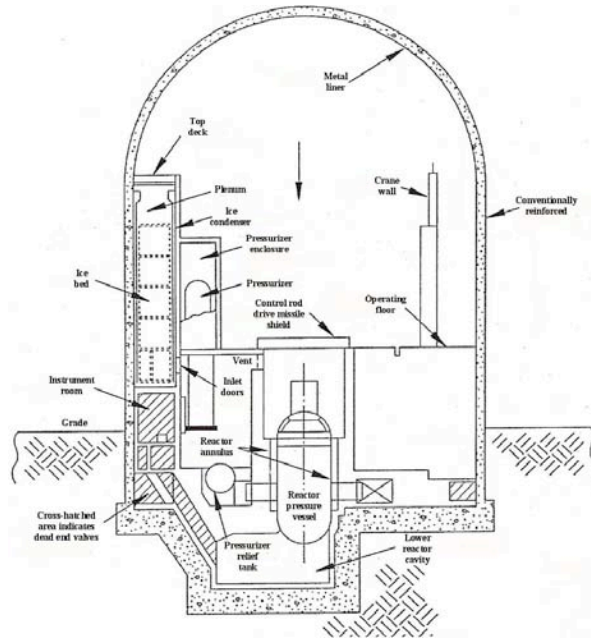
Figure A.5. PWR reinforced concrete containment with ice condenser.

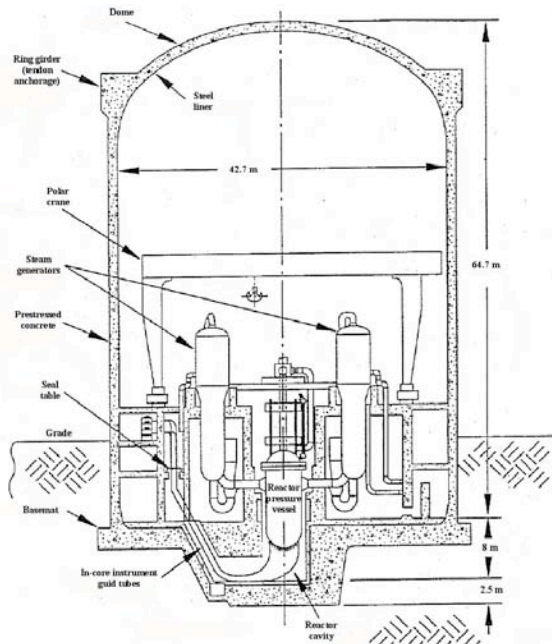
Figure A.6. PWR large dry prestressed concrete containment.

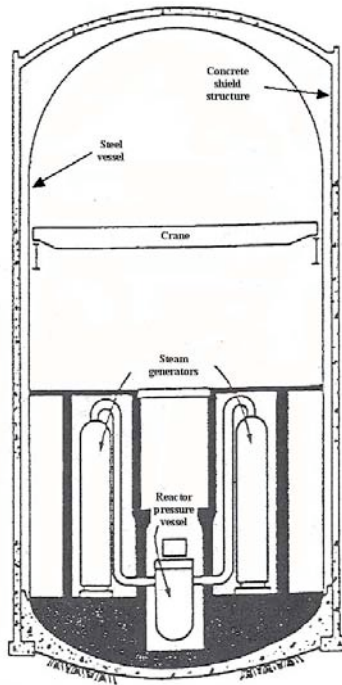
Figure A.7. PWR free-standing steel containment with elliptical bottom.

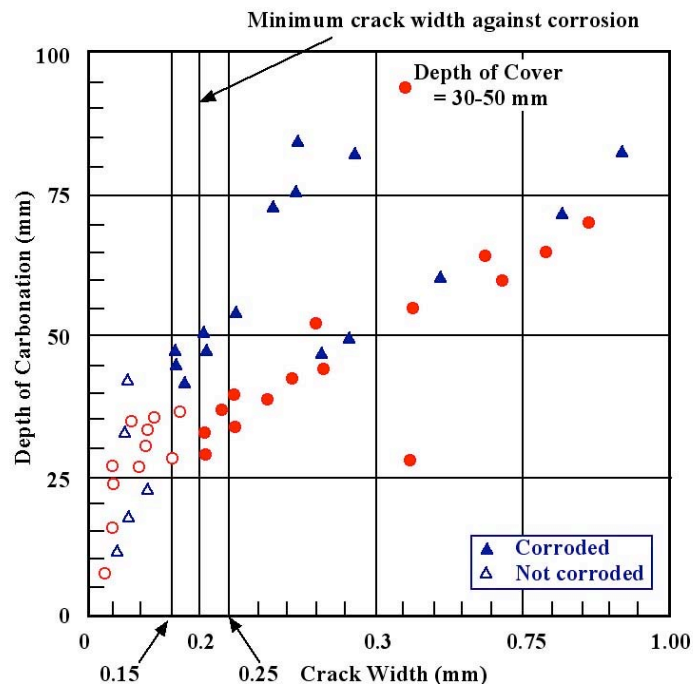
Figure C.1 Surface crack width, carbonation depth, and corrosion.

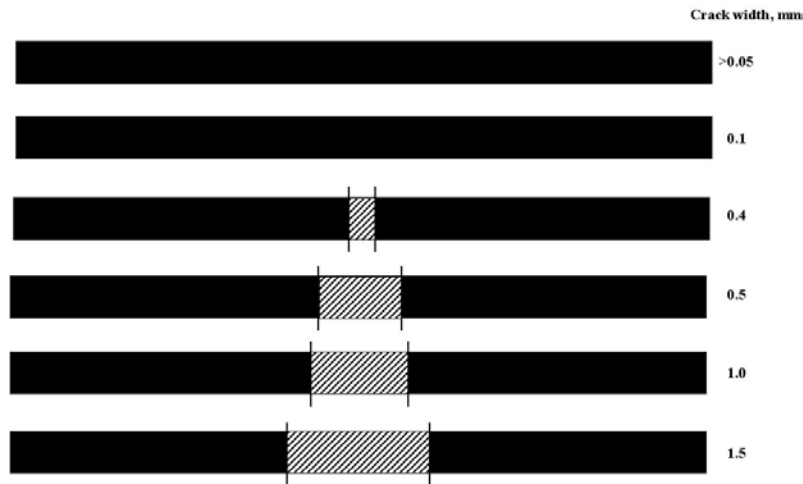
Figure C.2 Effect of crack width on corrosion length.

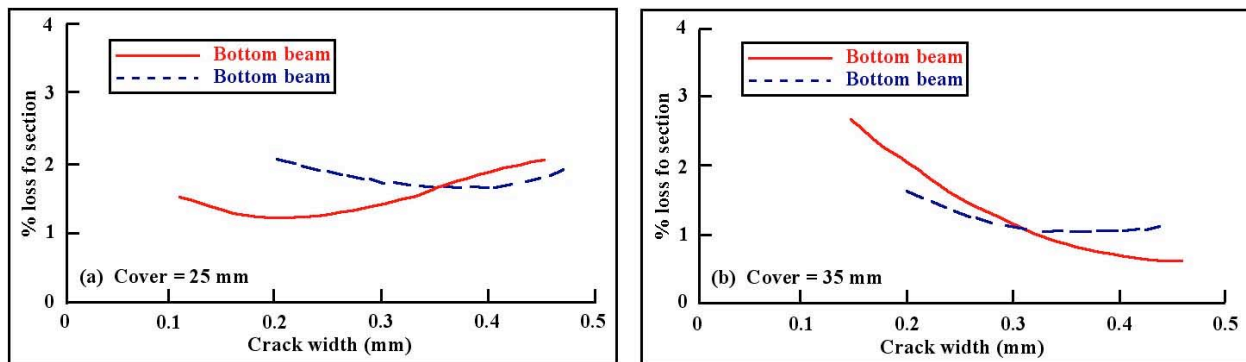
Figure C.3 Crack width and corrosion of 8-mm-diameter bar in marine environment (after 10-year exposure).

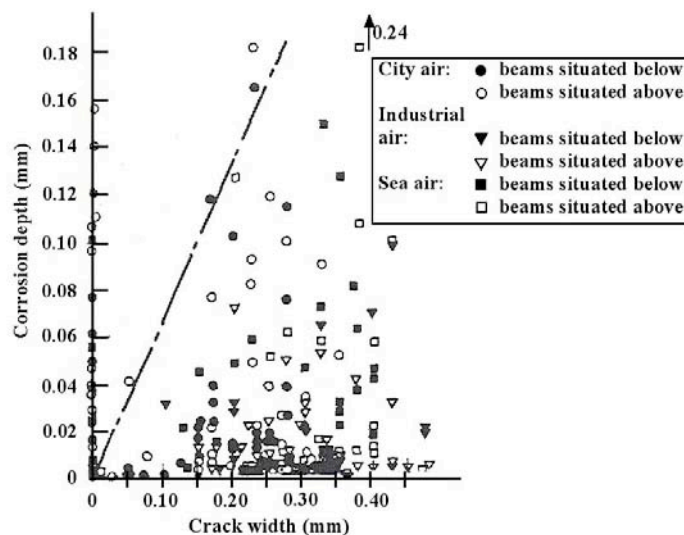
Figure C.4 Corrosion depth versus crack width after 10-year exposure.

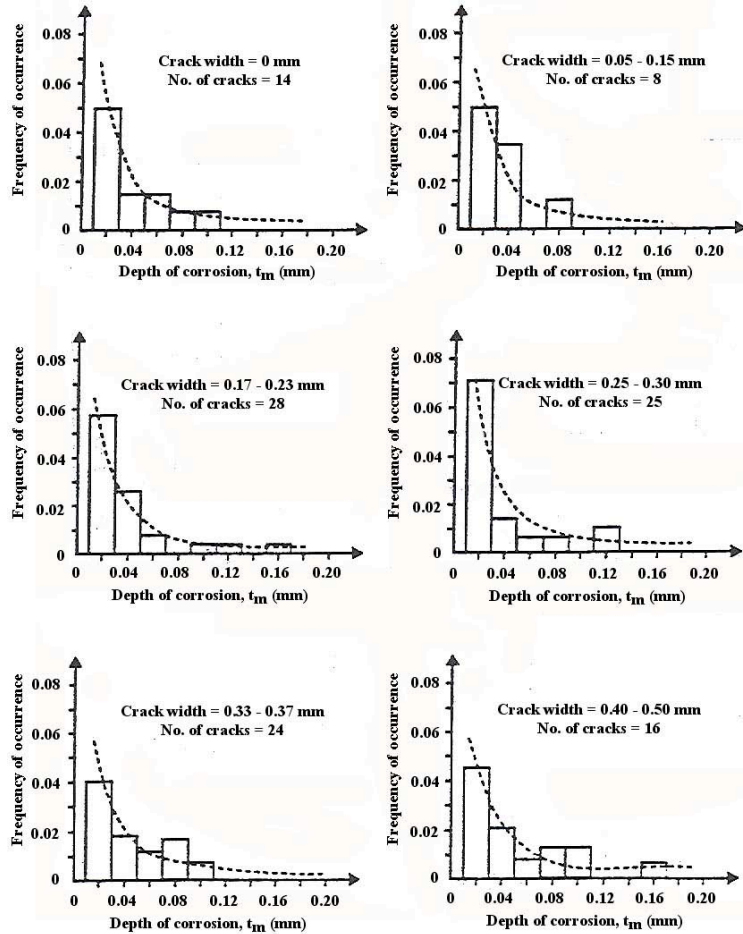
Figure C.5 Distribution of corrosion depths in Figure C.4.

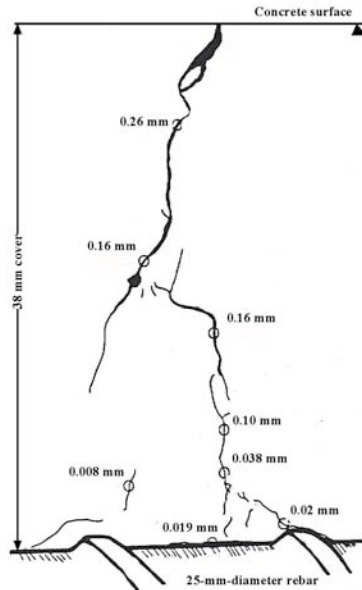
Figure C.6 Variation of crack width with depth.

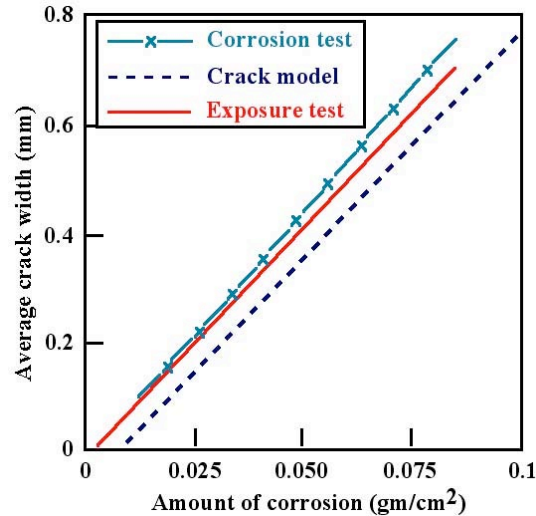
Figure C.7 Crack width versus amount corrosion.
