## PEP-II STATUS\*

### Abstract

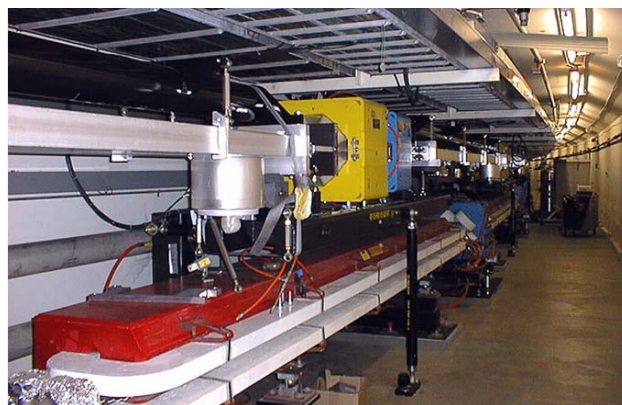
Figure 1. Tunnel layout of the two beam lines. The LER is above the HER.

The PEP-II is an asymmetric-energy double storage ring e+e- accelerator [1]. The rings are housed in a 2.2 km long tunnel with the low-energy ring (LER) above the high-energy ring (HER). The LER has eight RF cavities driven by 4 klystrons and the HER has 11 klystrons driving 28 RF cavities. Each ring contains two transverse bunch-by-bunch feedback systems (X and Y) and one longitudinal bunch-by-bunch feedback system. The beams collided head-on in the middle of the BaBar detector. The head-on collision is achieved through the use of powerful horizontal bending magnets made of permanent magnet (PM) material. The 0.5 m long magnets are positioned 0.21 m from the Interaction Point (IP). Both beams travel through a shared quadrupole, the next magnetic element outboard of the IP. This magnet is also built from PM material [2]. These two magnets the dipole and the quadrupole are inside the 1.5T solenoidal field of the BaBar detector. Table 1 lists some of the design parameters of PEP-II and figure 1 shows the tunnel layout. Figure 2 is an anamorphic layout of the IP showing the beam trajectories as they enter and exit the detector.

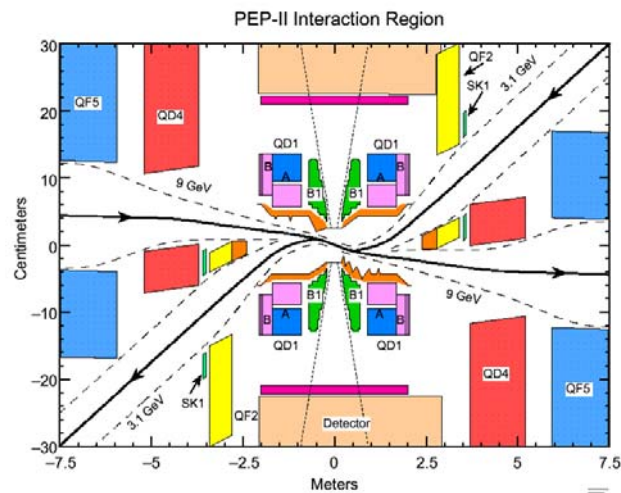
Figure 2. Layout of the beam trajectories at the IP. Note the change in vertical scale. The magnets labeled B1 and QD1 are permanent magnets.

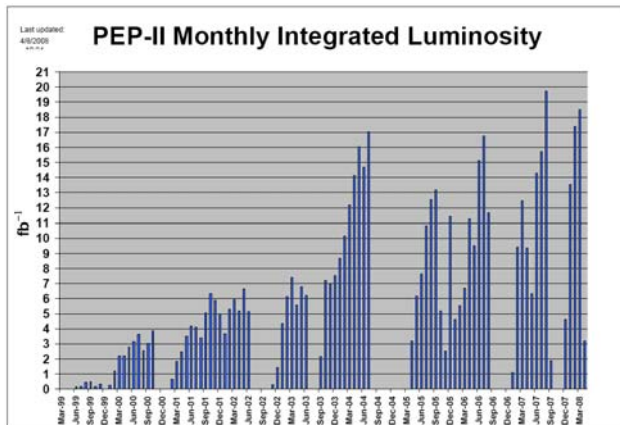
Figure 3. Plot of the monthly integrated luminosity delivered by PEP-II. There is a large increase in performance during the run 4 in 2004. This was the result of employing a continuous top up mode called “trickle-charge”. The improved stability of the machine with fixed beam currents greatly improved efficiency. In addition, luminosity tuning could now be optimized for a single beam current thereby improving peak performance [3].

Figures 3-5 show plots of luminosity performance for PEP-II.

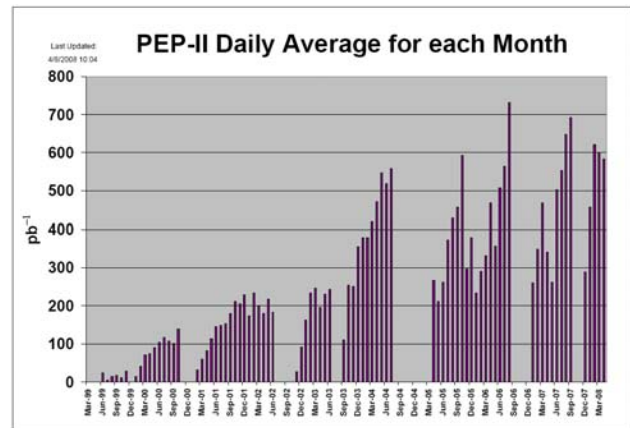
Figure 4. Plot of the average luminosity delivered each day for each month. Note that Aug. 2006, Sep. 2007 and Apr. 2008 were partial months. Aug. 2006 had 18 days of running, Sep. 2007 had 4 days and Apr 2008 had 7 days so the average is over fewer days.  $135 \text{ pb}^{-1}/\text{day}$  is the design performance level. Discounting the partial months, Feb. and Mar. of 2008 are the second and third best months after the month of Aug. 2007.

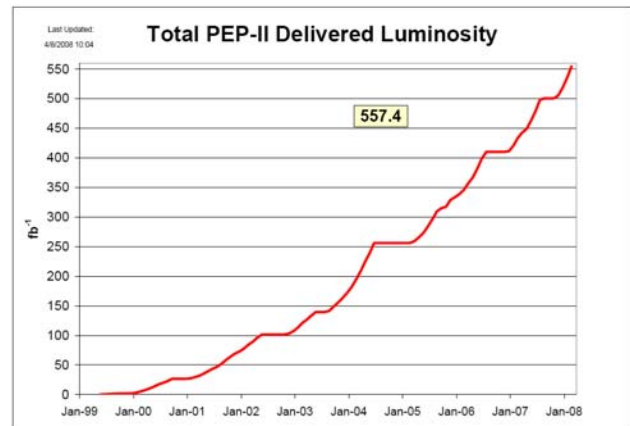
Figure 5. Plot of the total delivered integrated luminosity.

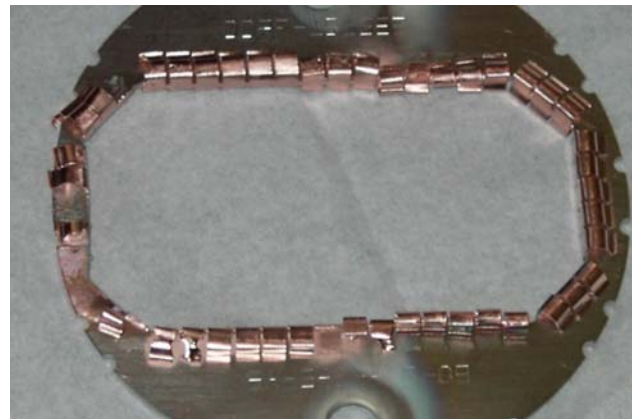
Figure 6. Picture of a damaged HER flex flange RF seal. HOM power getting behind the GlidCop (dispersion strengthened Cu) fingers heated up the stainless steel frame to the melting point of Cu (left side of picture). In addition, one can see signs of arcing where there is Cu deposition on the stainless steel frame top and bottom. The right hand side of the picture shows undamaged fingers.

We did have one problem that was the result of heated vacuum chambers from SR. The 5.5 m long HER dipole chambers were designed to intercept SR power from a beam with 3A of current at 9 GeV. Although well cooled, the dipole chambers still expand (or flex) when SR power strikes the chamber wall. This flexure was taken up by a bellows section on one end of the chamber and by a zero length bellows or flex flange at the other end of the chamber. The zero length bellows had a RF seal to maintain chamber wall continuity across the gap. However, we found that the chamber flexure was large enough to cause the RF fingers in this seal to become over-crushed allowing a gap to form. This gap allowed higher order mode (HOM) power to penetrate behind the RF seal and heat up vacuum components. In addition, the gap permitted arcing at the seal boundary. This problem was uncovered during the summer shutdown in 2006. Initially we thought there were perhaps a handful of RF seals that had failed. We replaced the ones we had found. During run 6 we found out that at least 50% of these shields had failed and we made plans during the shutdown to replace as many as we could. We ended up replacing all of the seals after finding that more than 95% had failed [9]. Figure 6 is a picture of one of the failed RF seals.
