WSRC-STI-2007-00552

Determination Of Corrosion Inhibitor Criteria For Type III/IIIA Tanks During Salt Dissolution Operations – Interim Report

Savannah River National Laboratory
Materials Science and Technology Directorate

Publication Date: December 2007

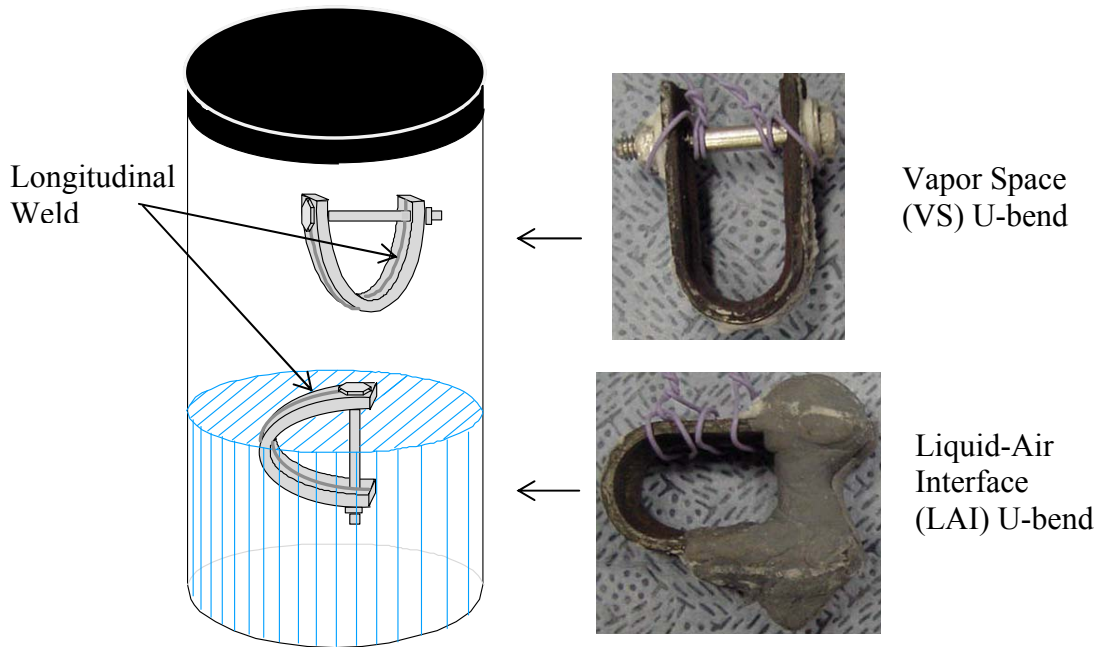
All U-bends were coated with test salt solution and then allowed to dry so that salt crystals formed on the surfaces, to simulate conditions in the vapor space of the waste tanks. Simulant was dropped onto the stressed area of each U-bend using a pipette, and the simulant was dried on the surface using compressed air. The U-bends were then located in their respective positions in the vapor space and at the liquid-air interface in the test vessel. Figure 1 shows the prepared coupons and their respective positions in the test vessel.

Figure 1. Prepared Non-Polarized Coupons, and Positions in Test Vessel

The ongoing non-polarized U-bend testing consists of eight pairs of A537 carbon steel U-bend coupons exposed to three different salt solution chemistries. Four of the pairs were heat-treated to simulate the stress relief given to the Type III/IIIA waste tanks. One U-bend coupon in each pair is exposed completely in the vapor region and one is exposed partially-immersed in the simulated waste solution. The test vessels are wide-mouthed polyethylene bottles filled with approximately 500 ml of solution and placed in an oven to obtain the test temperature of 50 °C. Evaporative losses from the solution are replaced by distilled water.

All U-bends came from the same heat of material as specimens used in the previous work, and they were fabricated in the same manner, with a butt weld traveling in the long transverse-longitudinal orientation [3]. Four of the eight U-bend pairs were heat treated in air. They were heated from ambient to 1100 °F at a rate of 90 °F/hour, followed by a hold at 1100 °F for 60 minutes, and a cooling rate of 115 °F/hr to ambient [3]. Indentations were then placed in the oxide film on the surface of six pairs of the U-bends, with one pair each of the heat-treated and non-heat-treated U-bends left without indentations. A wire was attached to the side of each LAI coupon with conductive silver epoxy and the silver epoxy then coated with inert mounting material. The wire on the LAI coupon allowed for measurement of electrical potential referenced against a silver silver-chloride electrode also immersed in the solution. Stress was applied to each U-bend by tightening the bolt positioned through the ends of the U-bend arms. The arms were tightened until parallel with each other.

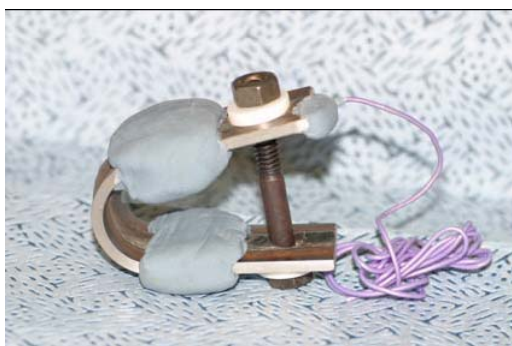
The polarized testing consisted of three A537 carbon steel U-bend coupons exposed to three different salt solution chemistries. All U-bend coupons came from the same heat of material as specimens used in previous work [3]. All coupons had the weld bead on the outside of each U-bend ground flat, and the specimens were then heat-treated to simulate the treatment given to the Type III/IIIA waste tanks prior to their use. Indentations were placed in the oxide film on the surface of the U-bends. A wire was attached to the side of each specimen with conductive silver epoxy, and the silver epoxy then coated with inert mounting material. Stress was applied to the U-bends by tightening the bolt positioned through the ends of the U-bend arms. The arms were tightened until parallel with each other. An example of a prepared specimen is shown in Figure 2. The stressed end of each U-bend was immersed in simulated waste solution and the U-bend was polarized. The test vessels were wide-mouthed polyethylene bottles filled with approximately 500 ml of solution and placed in an oven to obtain the test temperature of 50 °C. Evaporative losses from the solution were replaced by distilled water.

Figure 2. Prepared Polarized U-Bend Specimen, Before Bolt Tightened

Potentiostatic polarization was conducted by applying a constant potential to the working electrode (U-bend) and monitoring the responding current. A potential of zero volts versus the Ag/AgCl reference electrode was chosen to bring each specimen into a possible range for SCC, as determined in the previous phases of testing [3]. Each setup consisted of an Ag/AgCl reference electrode, a graphite counter electrode, and a stressed polarized U-bend. A Gamry electrochemical multiplexer, model ECM8 and a Gamry

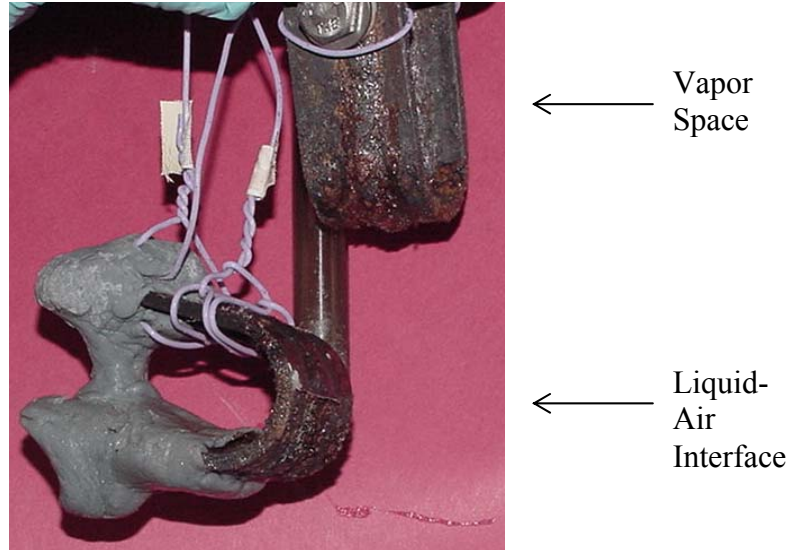
No stress corrosion cracking occurred in the non-polarized U-bend testing during the first 100 days of exposure. Determination of whether SCC occurred was made by visual examination and also by gently squeezing the arms of each U-bend to determine if stress was relieved through cracking. Figure 3 shows the typical appearance of the specimens after 100 days in test. Table 5 in the Appendix contains details from visual examination of the specimens.

Figure 3. Typical Appearance of U-Bend after 100 Days in Simulant

Inhibitor Level	Nitrate (M)	Heat Treatment	U-Bend Appearance	Details
Low	5.5	No	Good	LAI: Some orange corrosion products at interface. Deposits alongside weld.
			Good	VS: Little corrosion on edges. Deposits on and alongside weld.
Low	5.5	Yes	Good	LAI: Orange line at interface. Few deposits above and below interface.
			Very Good	VS: Dried brown stalactite on apex. White dusty crystals covering surfaces.
Low	8.5	No	Very Good	LAI: Nothing on surface below line, deposits above line. White crystalline ear projecting at line. Orange products on edges.
			Good	VS: Even coating of dried deposits and/or red-brown corrosion products.
Low	8.5	Yes	Good	LAI: Some orange corrosion product at interface. Deposits above and on weld below interface. White crystalline ear projecting at line.
			Good	VS: Even coating of dried deposits and/or red-brown corrosion products
Low	8.5	No*	Good	LAI: Little deposits below interface. Small amount brown deposits above. None at line. Salt crystals at line.

Good	VS: Even coating of brown, coating thicker at edges and on weld. Stalactite on apex.
Low	8.5	Yes*	Good	LAI: Broken orange line at interface. Some deposits/spots of corrosion above and below interface.
			Good	VS: Red-brown stalactite on apex. Deposits on and alongside weld.
Medium	8.5	No	Good	LAI: Orange corrosion only on edge at interface line. Nothing below line, some deposits above line alongside and on weld, especially.
			Okay	VS: Thick deposits or corrosion products, especially on, alongside weld.
Medium	8.5	Yes	Good	LAI: No deposits below interface, and even coating at and above interface, with some orange.
			Good	VS: Brown-red deposits on apex.

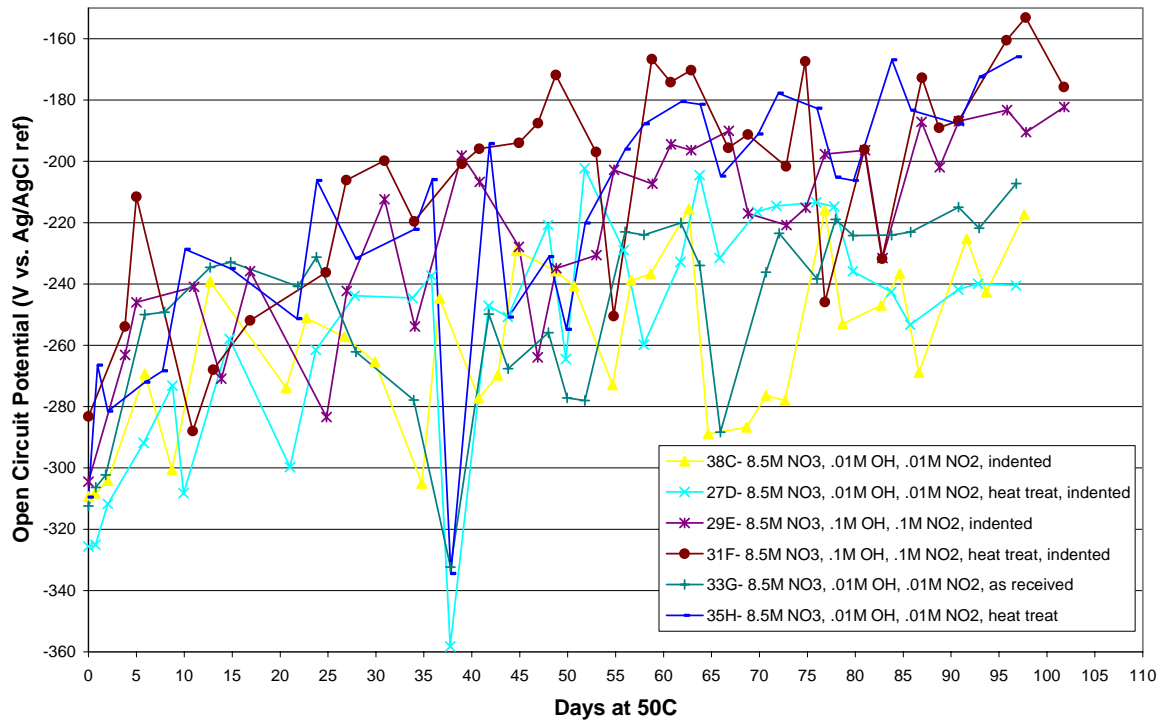
The OCP data for the ongoing tests are being collected for 40 minutes at a time, approximately twice a week. The averages for each 40-minute period during the first 100 days are plotted in Figure 4 and Figure 5.

Figure 4. OCP Data for LAI U-Bends in 8.5 M Nitrate Solution with Reduced Inhibitor Levels

Open-circuit potential (OCP) data was collected twice a week from each of the eight U-bends located at the liquid-air interface of the test solutions. Table 4 contains the initial OCP and the final OCP measured after 100 days of exposure. The OCP increased over time for all eight LAI U-bends, becoming more electropositive. Increases in OCP may indicate that the specimens are reacting to their environment and are entering a region of potential in which they are more susceptible to corrosion, or it could indicate that the chemistry at the surfaces of the coupons is changing. The closer the OCP climbs to the repassivation E_{rp} potential, for instance, the more likely crevice corrosion is, and when the OCP climbs higher than the breakdown potential (E_b), the stressed specimens become susceptible to pitting and stress corrosion cracking.

From previous CPP testing on polished samples and samples immersed for a week in solution [3], it was expected that the initial OCP would not have a dependence on nitrate concentration or inhibitor level. The current data agrees with that conclusion. The initial open circuit potentials range from -283 to -330 V which are similar to initial potentials of U-bends in previous tests which ranged from -325 to -400 V for 8.5 M and 5.5 M tests [3]. The U-bends in the medium inhibitor 8.5 M solution have higher final potentials than the U-bends in the low inhibitor 8.5 M solution, given the same heat treat status. This too is in line with previous CPP data which indicated that the final OCP had a slight dependence on inhibitor level [3]. Figures 4 and 5 reveal no clear difference in OCP between the heat-treated and non-heat-treated U-bends. This was the case for initial OCP measurements of U-bends in previous testing [3].

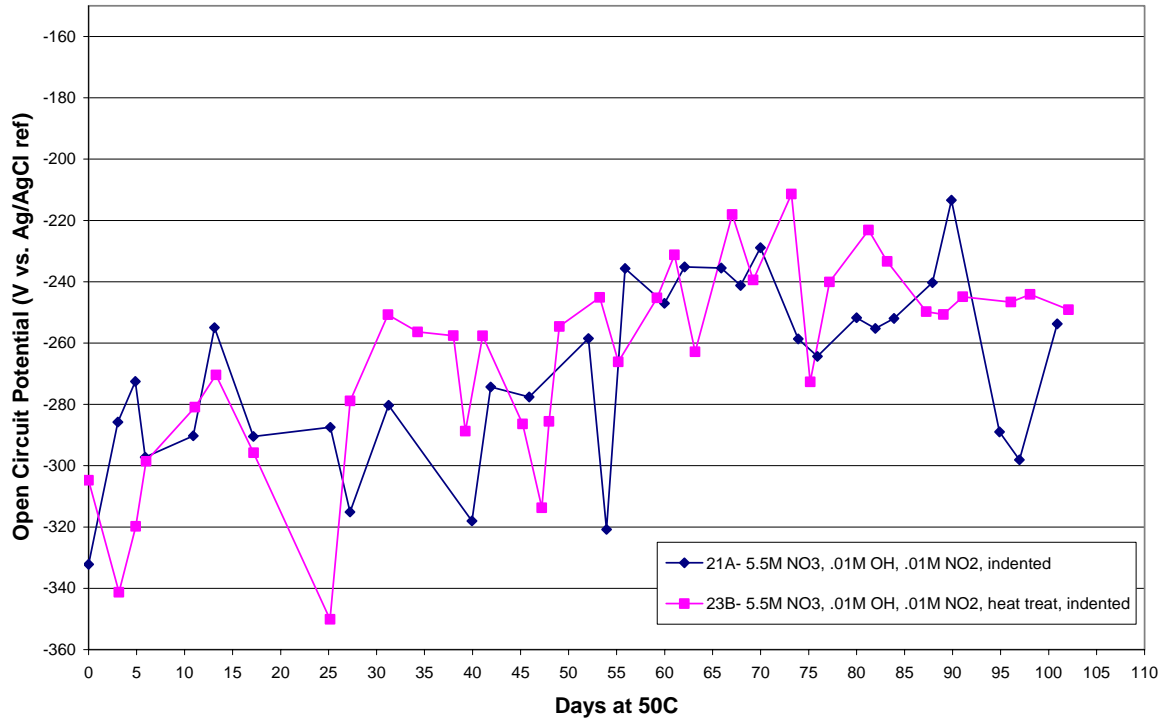
Figure 5. OCP Data for LAI U-Bends in 5.5 M Nitrate Solution with Reduced Inhibitor Levels

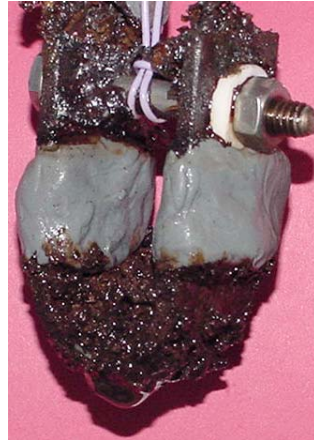
The U-bends quickly acquired thick layers of oxides and corrosion products that obscured the metal surfaces. This occurred within two to three weeks. Figure 6 is a picture of an encrusted U-bend at the end of testing. Figure 7 shows the U-bends after initial cleaning.

Figure 6. Polarized U-Bend After 80 Days in Test

The condition of the U-bends is the result of both the polarization and the galvanic corrosion between the stainless steel bolts and the carbon steel U-bends. The bolt on each U-bend was cathodic to the carbon steel and caused the anodic U-bend to corrode. This corrosion was strongest near the bolts.

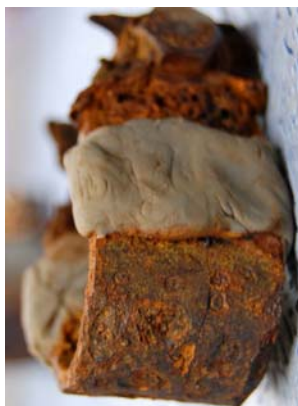
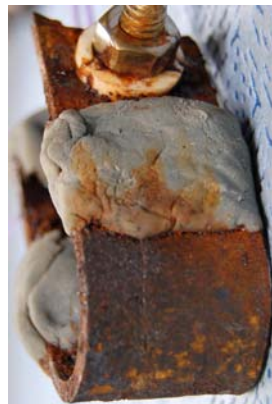
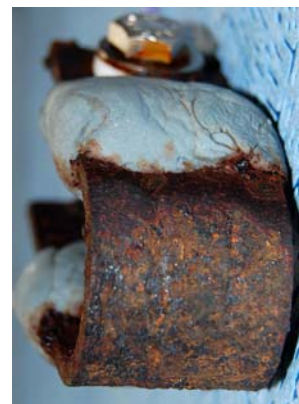
5.5 M Nitrate
Low Inhibitor

7.0 M Nitrate
Low Inhibitor

7.0 M Nitrate
Medium Inhibitor

Figure 7 Polarized U-Bends After Initial Cleaning

Visual examination of the stressed (bent) portions of the U-bends at 10X revealed no stress corrosion cracking. The specimen in the 5.5 M nitrate, low inhibitor solution exhibited severe pitting and general corrosion with significant thinning of the metal. The specimen in the 7.0 M nitrate, low inhibitor solution was in better condition, with no thinning but also had pitting and general corrosion. Lastly, the specimen in the 7.0 M

nitrate, medium inhibitor solution was in the best condition of the three, again with no signs of cracking.

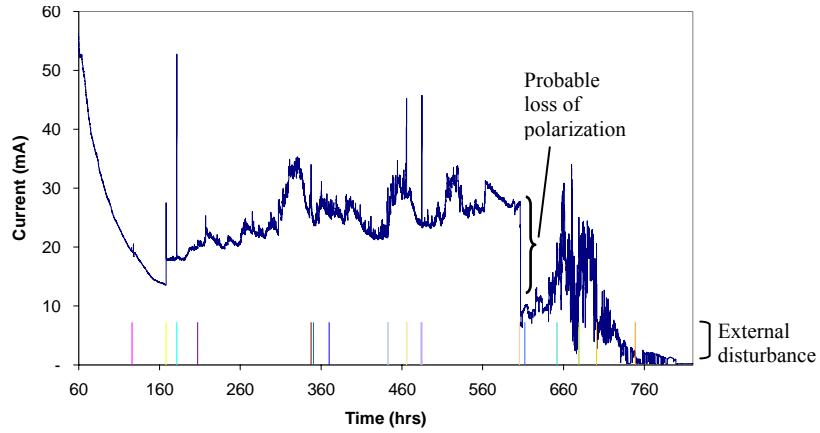
Polarization of the U-bends took place for a period of time, but diminished and eventually stopped as galvanic corrosion products built up under the wire connecting the U-bend to the potentiostat. The current response from each U-bend was recorded during polarization. Graphs of the first month's data for each U-bend are shown in Figures 8-10.

Figure 8. Current Response of Polarized U-bend in 5.5 MNO₃⁻, Low Inhibitors, 50°C

The current response data for the U-bend in the 5.5 M nitrate solution with low inhibitor levels indicates that interference problems were experienced after one week in solution and that loss of contact with the potentiostat may have occurred in the fourth week. The other U-bends, in 7.0 M nitrate solutions with low and medium inhibitor levels, did not appear to lose contact with the potentiostat during the first month of testing. The current response from these specimens did not indicate any significant corrosion events during that time period. Due to the uncertain nature of the tests and the abbreviated data, fresh specimens will be exposed under the same conditions to obtain clearer results. The galvanic current will be eliminated by ensuring no contact between bolt and coupon.

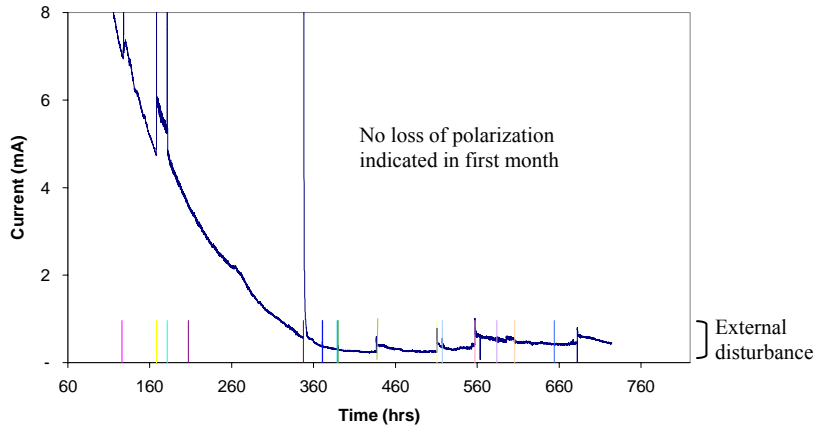
Figure 9. Current Response of Polarized U-bend in 7.0 MNO₃⁻, Low Inhibitors, 50°C

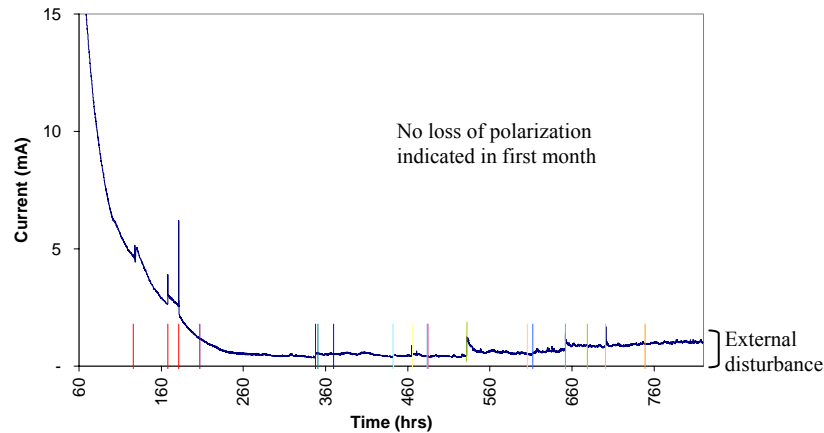
Figure 10. Current Response of Polarized U-bend in 7.0 M NO_3^- , Med. Inhibitors, 50°C
