Chief Joseph Kokanee Enhancement Project

Strobe Light Deterrent Efficacy Test and Fish Behavior Determination at the Grand Coulee Dam Third Powerplant Forebay

Annual Report 2003 - 2004

DOE/BP-00000652-25

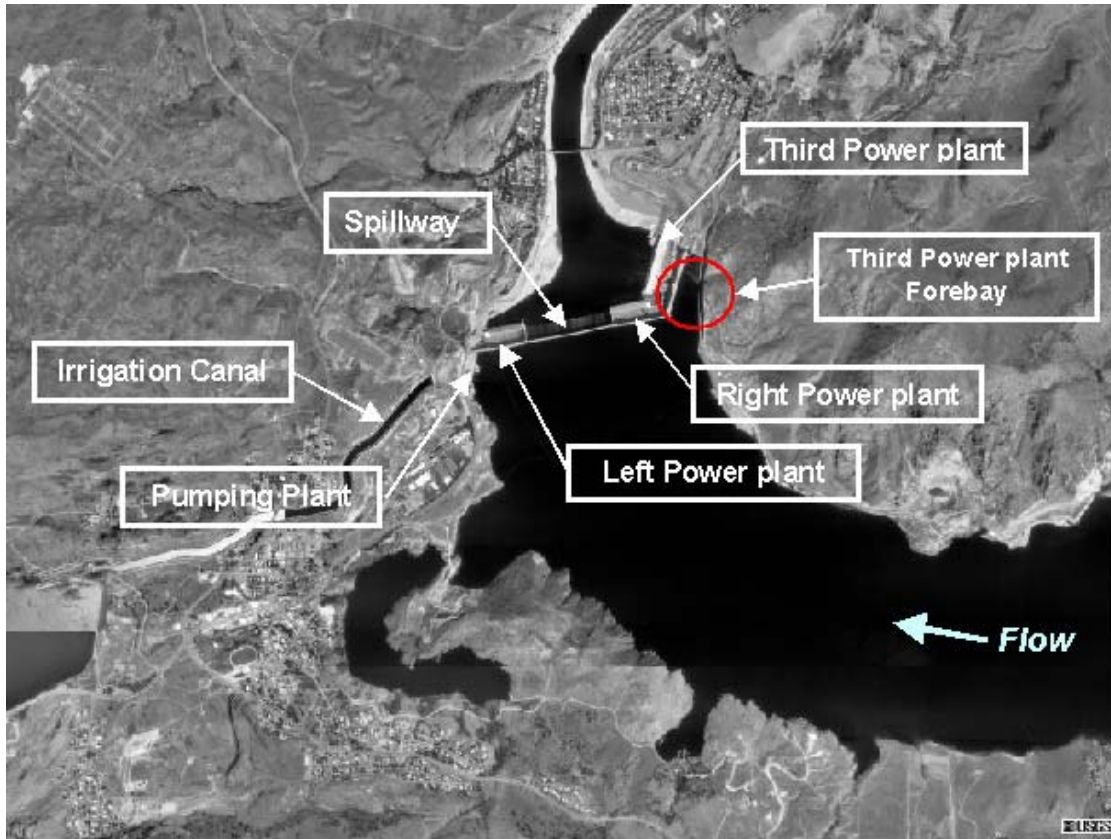
Figure 2.2. Study Site Location (red circle) Near Third Powerplant, Grand Coulee Dam in 2003

Grand Coulee Dam, located at river kilometer 960.1 (mile 596.6) on the Columbia River, is the northernmost of the 11 U.S. dams on the river (Figure 2.1). The dam complex contains four powerplants (pumping plant, left powerplant, right powerplant, and third powerplant) and a spillway (Figure 2.2). Construction of the main dam complex (left and right powerplants and spillway) began in December 1933 and was completed in 1942. Construction of the pumping plant was initiated in 1946 and completed in 1951. Four additional pump/generators were added to the pumping plant in 1983.

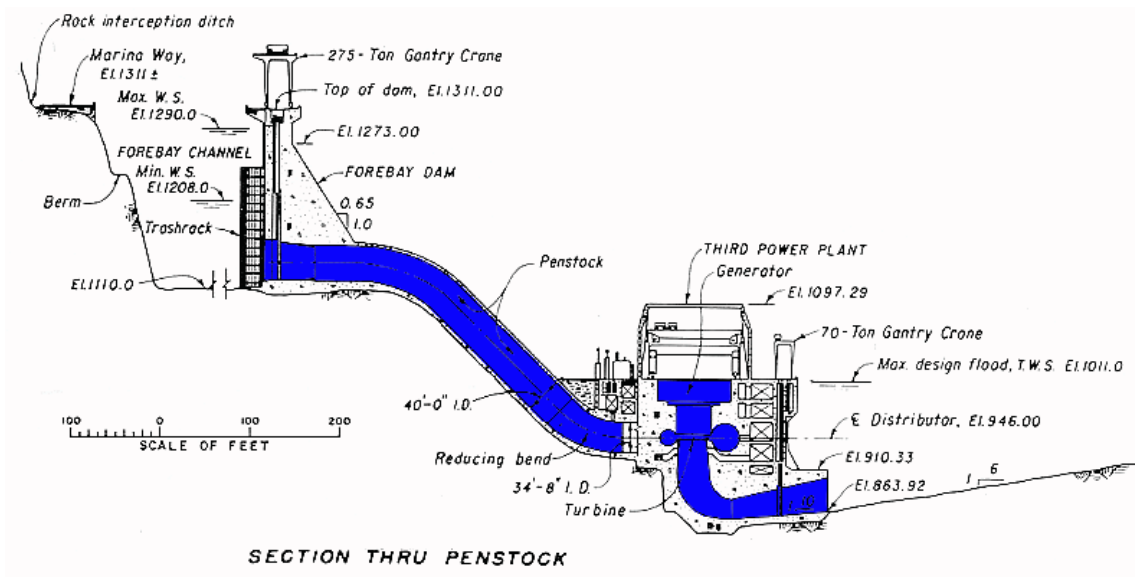
Figure 2.3. Cross Section of Third Powerplant and Forebay Dam at Grand Coulee Dam, Washington (Hubbard 1995)

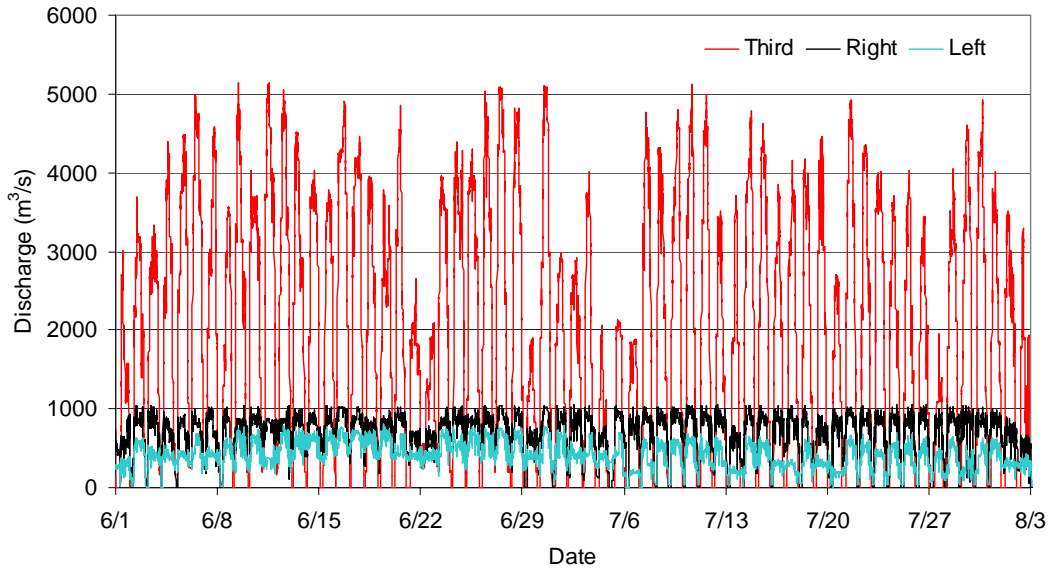
Figure 2.4. Discharge (m^3/s) at Grand Coulee Dam from June 1 Through August 3, 2003. Data for the average discharge for each powerplant are plotted separately.

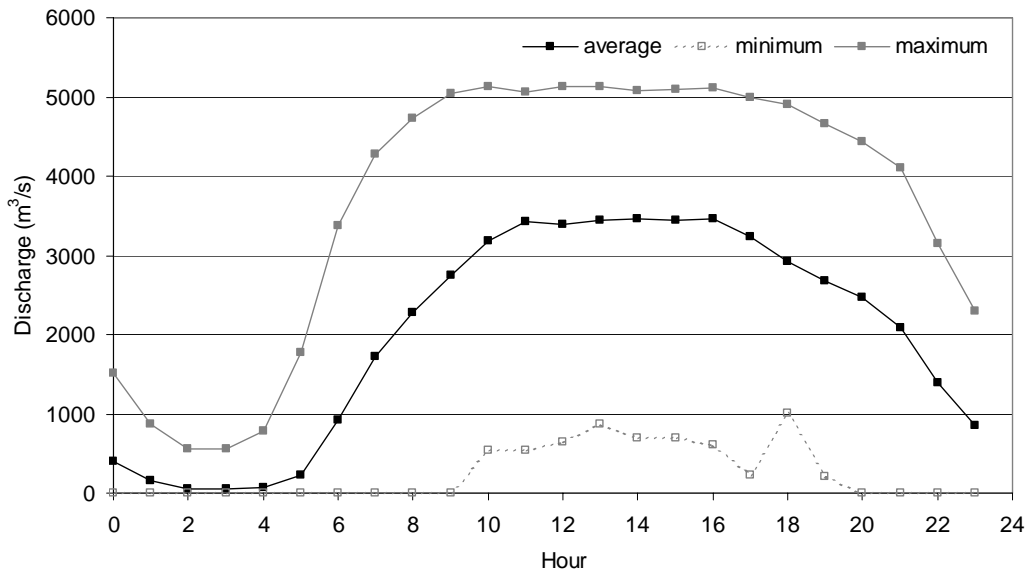
Figure 2.5. Discharge over 24 Hours at Third Powerplant at Grand Coulee Dam. Data were averaged over the period June 1 through August 1, 2003. Zero hour is midnight.

As in 2001 and 2002, daytime discharge levels were higher than those at night (see Figure 2.5), confounding the response to ambient light conditions. Thus, high discharge levels (i.e., > 56 kcfs) occurred during 83% of the daytime sampling period, and 84% of the fish were detected at these levels. Low discharge levels (i.e., < 8 kcfs) occurred only between 6 and 9 a.m. and represented less than 4% of the daytime sample period. At night, low discharge levels occurred primarily between midnight and 6 a.m. and represented 46% of the nighttime sample period. However, 72% of the fish were detected at these discharge levels. Thus, it is unclear whether the predominance of fish at night is reflective of flow conditions or a natural circadian activity pattern.

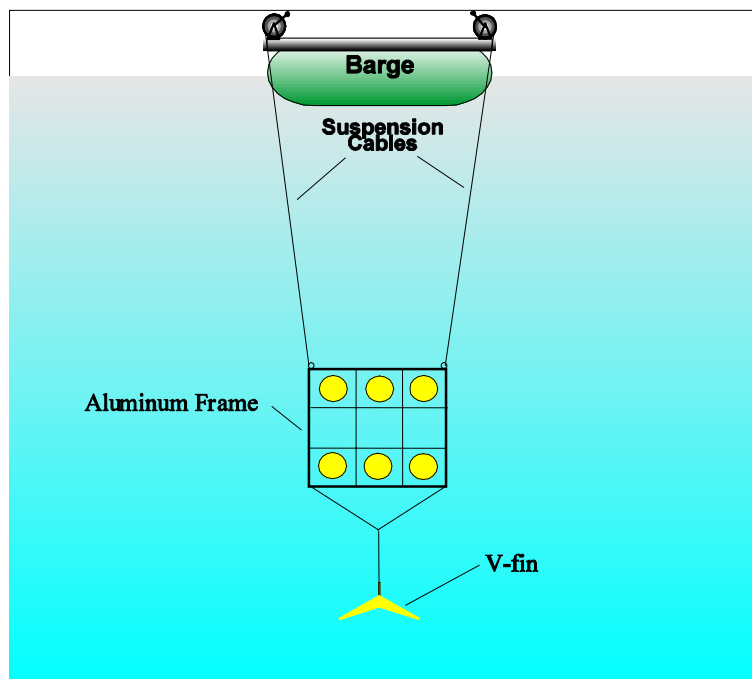
Figure 3.1. Strobe Light Frame Configuration at Grand Coulee Dam, 2003. Front view showing the placement of the strobe lights (yellow circles) and dihedral V-fin depressor.

Six strobe lights, each producing a maximum of 20,000 lumens-s/flash (Flash Technology specification), were mounted across the top and bottom of a 1.3-m² aluminum frame (Figure 3.1). The strobe lights, supplied by Flash Technology, Franklin, Tennessee, were sealed specifically for underwater deployment. The frame was deployed from a barge secured in the center of the entrance to the third powerplant forebay (Figure 3.2). The frame was attached to a system of suspension cables that permitted the frame to be nearly vertical in the water column when flow was minimal but also permitted the frame to move downstream during high flows. The orientation of the frame was stabilized in the flow by a dihedral hydrodynamic tow vehicle (V-fin) attached to a bridle at the base of the frame. The strobe

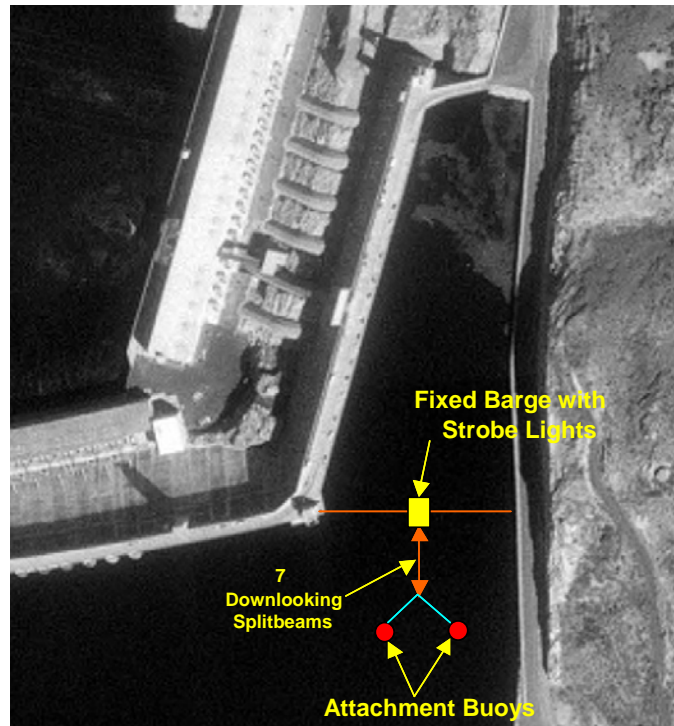
Figure 3.2. Location of Strobe Light Test Site at Third Powerplant Forebay of Grand Coulee Dam

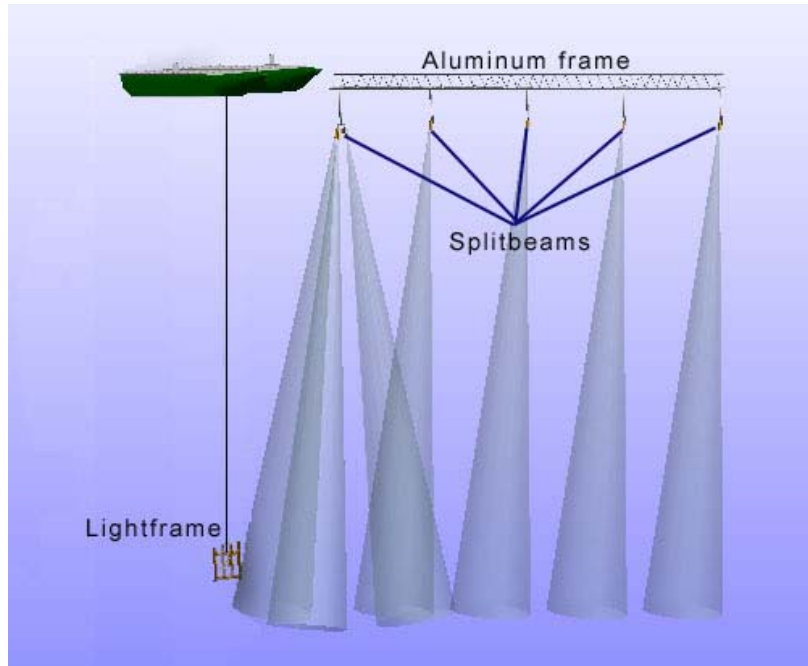
Figure 3.3. Strobe Light and Hydroacoustic Transducer Frame Configuration at Grand Coulee Dam. Side view showing area ensnified (not to scale).

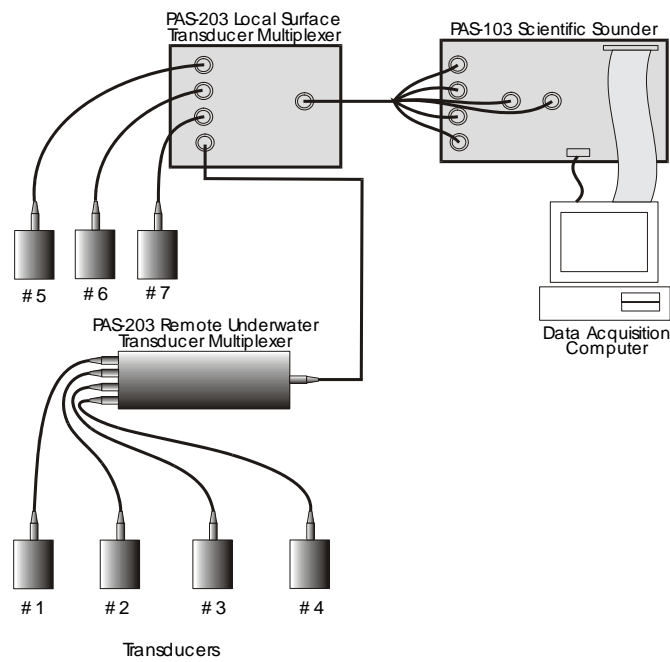
Figure 3.4. Seven-Transducer Multiplexed Splitbeam Hydroacoustic System (Precision Acoustic Systems, Seattle, Washington)

A seven-transducer splitbeam system was used to evaluate the effectiveness of the strobe lights in eliciting a negative phototactic response by fish to the lights. The seven transducers were deployed in a manner to track fish entering and within the region illuminated by the strobe lights. Precision Acoustic Systems (PAS), Seattle, Washington, supplied the splitbeam hydroacoustic system. The system comprised a Model PAS-103 Multimode Scientific Splitbeam Echo Sounder operating at 420 kHz; a Model PAS-203 Remote Underwater Quad Multiplexer; a Model PAS-203 Local Quad Multiplexer; seven 6°, 420-kHz splitbeam transducers lensed to 10°; and associated power and telemetry cables (Figure 3.4). The seven transducers were fast-multiplexed at 20 pings per second (pps). The system was powered

Seven splitbeam transducers were deployed upstream of the strobe lights (Figure 3.4). Five of the transducers were placed perpendicular to the lights and equally spaced from 6 to 22 m. The remaining two transducers ensonified areas to the right and left of the main transducer axis and were at 6 m from the light frame. The main statistical analysis of number of fish tracks is based on data from the five in-line transducers.

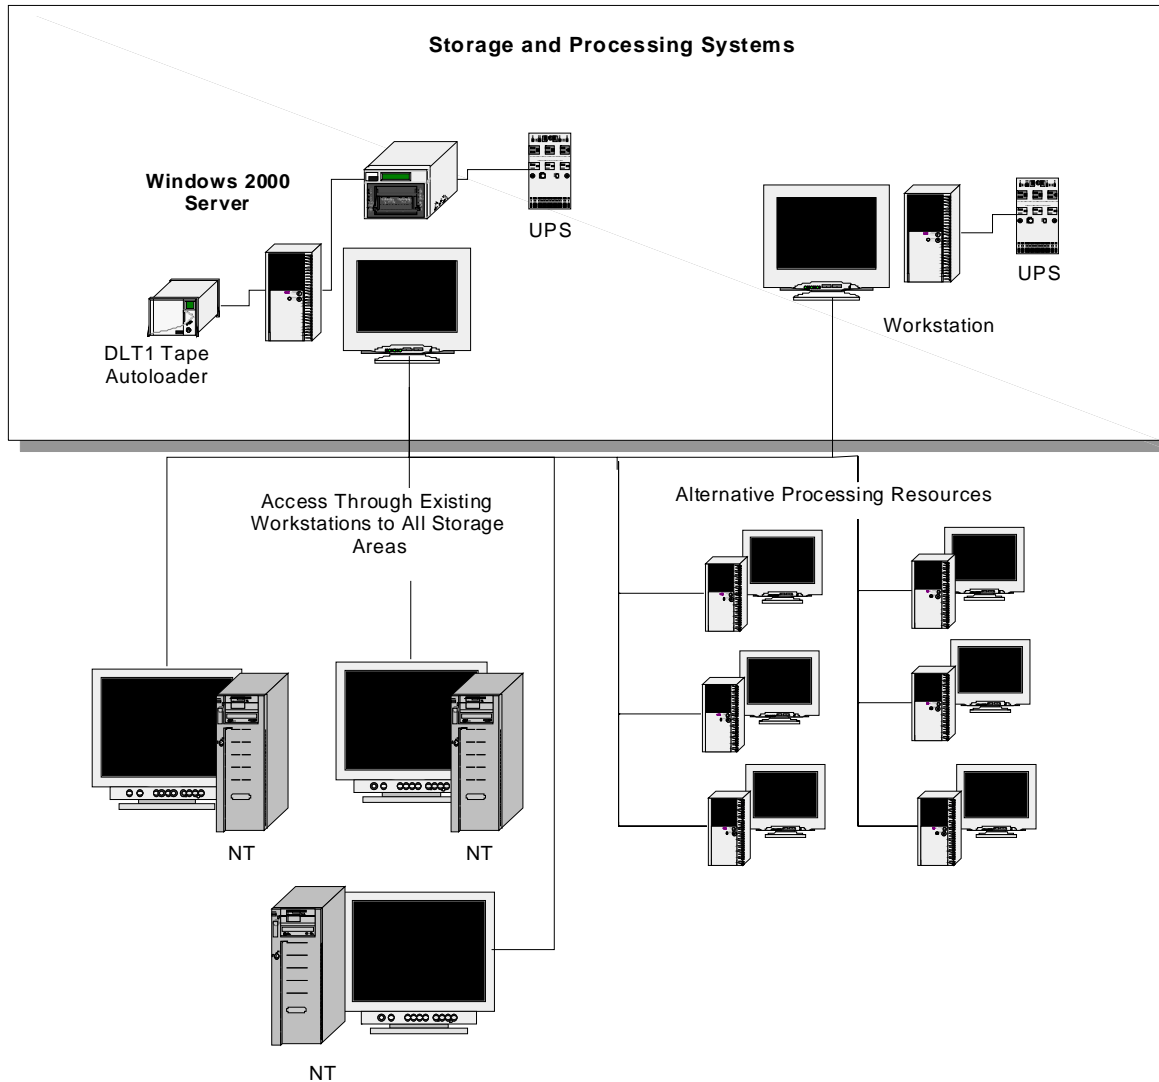
Figure 3.5. Computer Resources Used to Support the Data Processing Tasks at Grand Coulee Dam in 2003

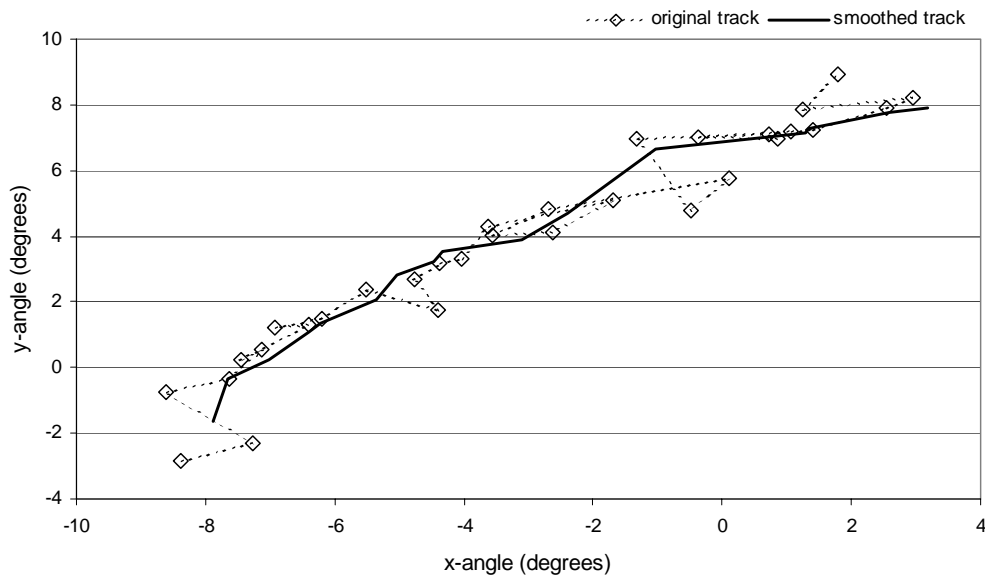
Figure 3.7. Example of Fish Track As Developed by Hydroacoustic Hardware and Software and After Filtering and Smoothing. This view shows the track's projection (image) in the x/y plane, perpendicular to the beam's range axis.

After filtering, the tracks were smoothed by fitting a polynomial as a function of time to the echo locations (for each of the x, y, z coordinates) for each track. Thus, the shape of a fish track was interpreted, at a minimum, as parabolic in its most general form. Usually, fish tracks passing through a narrow splitbeam zone (about a 10° cone) have only slightly curved apparent trajectories. Of course, the track of a fish would be more complicated if it were observed over greater distance and time, and a higher order polynomial description was used when needed. This smoothed description was used to estimate the displacement velocity over the track segments as measured within the splitbeam zone. The accuracy of the polynomial fit was monitored by a joint correlation coefficient calculated for each target. A correlation value can be used to select a target population that does not have ambiguous movement behavior.

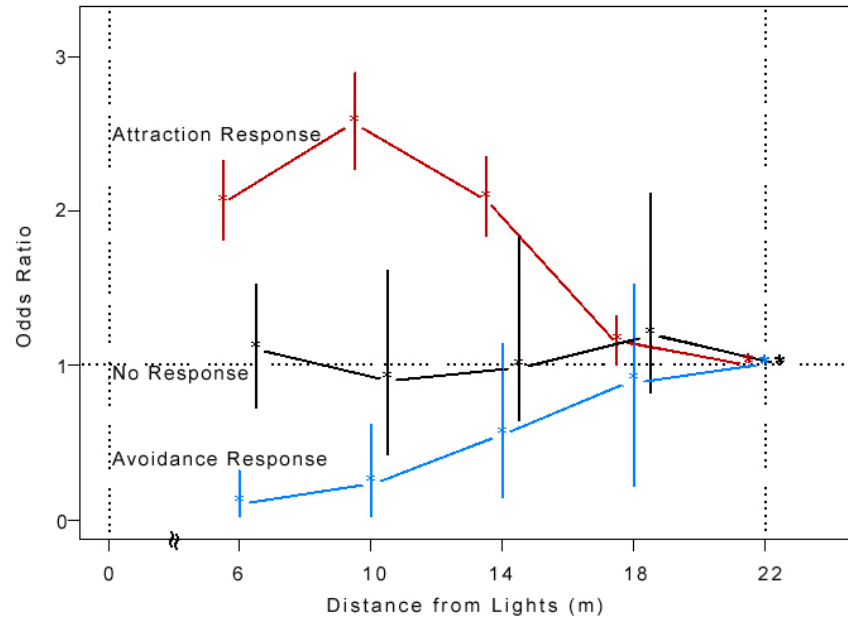
Figure 3.8. Sample Odds Ratio Plot Illustrating the Patterns for Attraction, Avoidance, and No Response

Fitting a log-linear model to data involves setting one of the class levels for each factor as a reference level, with comparisons made to the reference level. Results from the model are point estimates of the relative prevalence of tracks for a factor level when compared to the reference level. These point estimates are called an odds ratio—that is, the ratio of track counts observed at a given location compared to a common reference location. A simulated example of an odds ratio plot is given in Figure 3.8. In the plot, the reference point is at 22 m, farthest from the stimulus source (e.g., lights) and has a value of 1. Each colored line in Figure 3.8 illustrates a different behavioral response to the stimulus. The upper line illustrates an attractive response, with an odds ratio greater than 2, indicating that more than twice as many fish tracks were found at 6, 10, and 14 m than at the reference location. The middle line is

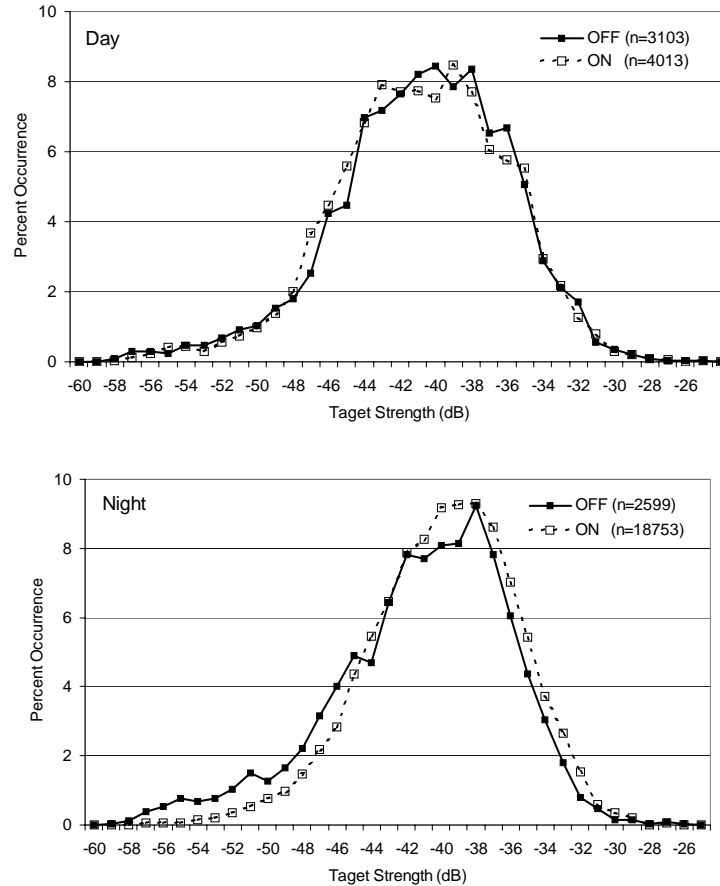
Figure 4.1. Target Strength (dB) for Fish Detected During the Day and at Night for Lights Off and On Treatments in 2003

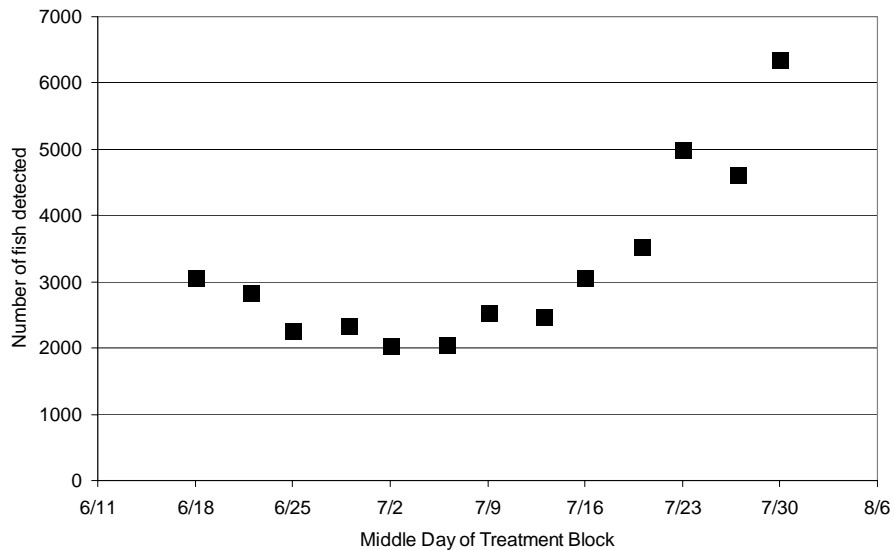
Figure 4.2. Total Number of Fish Detected for Treatment Blocks (2–14) at Grand Coulee in 2003. Block 1 (June 14–16) was incomplete and not included in this comparison. Data from all seven splitbeams.

Overall, the number of fish detected during the study period increased dramatically in late July (Figure 4.2). Numbers started to increase in mid July (Block 10). A similar phenomenon was noted in 2002, when counts for the final treatment block were approximately four times the average count. There also was an increase in the number of detections through the season in 2002, although there was more variability. The reason for this increase currently is unknown but may be related to the time it takes for fish to travel down the reservoir.

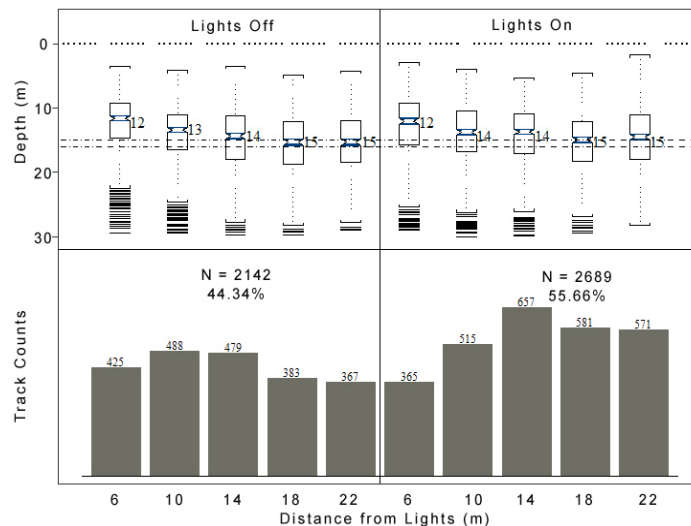
Figure 4.3. Depth Distribution and Number of Fish Detected During the Daytime for the Two 24-hr Light Treatments as a Function of Distance from Strobe Lights for Five Down-looking Transducers (Blocks 2–14). In the upper half of the figure, the box represents the middle 50 percent of the data (25th to 75th percentile); the notch near the center of each box represents the median. Lines bracketing the box are the approximate widths of the 1st to the 99th percentiles. The dotted line at zero represents the water surface, while the lines bracketing 15 m represent the depth of the strobe lights.

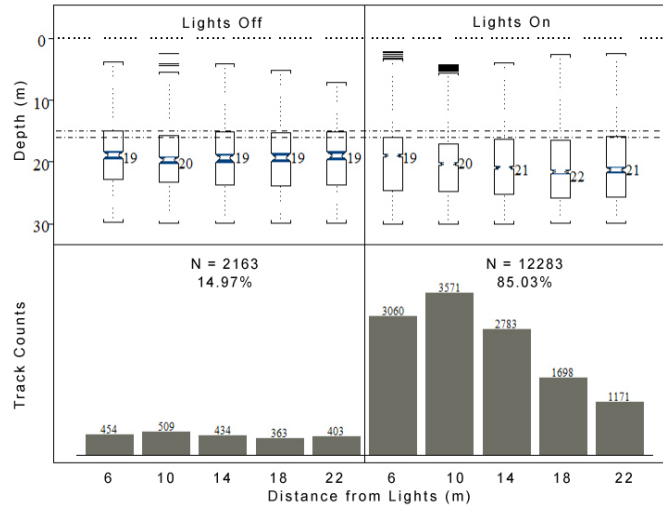
Figure 4.4. Depth Distribution and Number of Fish Detected at Night for the Two 24-hr Light Treatments as a Function of Distance from Strobe Lights for Five Downlooking Transducers (Blocks 2–14). In the upper half of the figure, the box represents the middle 50 percent of the data (25th to 75th percentile); the notch near the center of each box represents the median. Lines bracketing the box are the approximate widths of the 1st to the 99th percentiles. The dotted line at zero represents the water surface, while the lines bracketing 15 m represent the depth of the strobe lights.

At night, fish were distributed deeper compared to daytime (Figure 4.4), around 19 m when the lights were off for 24 hr, and from 19 to 22 m when the lights were on for 24 hr. Similar depths were noted during mobile surveys throughout the forebay (Appendix F). Fish counts were similar to those found in previous years—numbers increased as distance to the lights decreased when the lights were on, and equal numbers of fish were counted at all distances when the lights were off. In addition, 85% of all fish were detected at night when the strobe lights were continuously on for 24 hr.

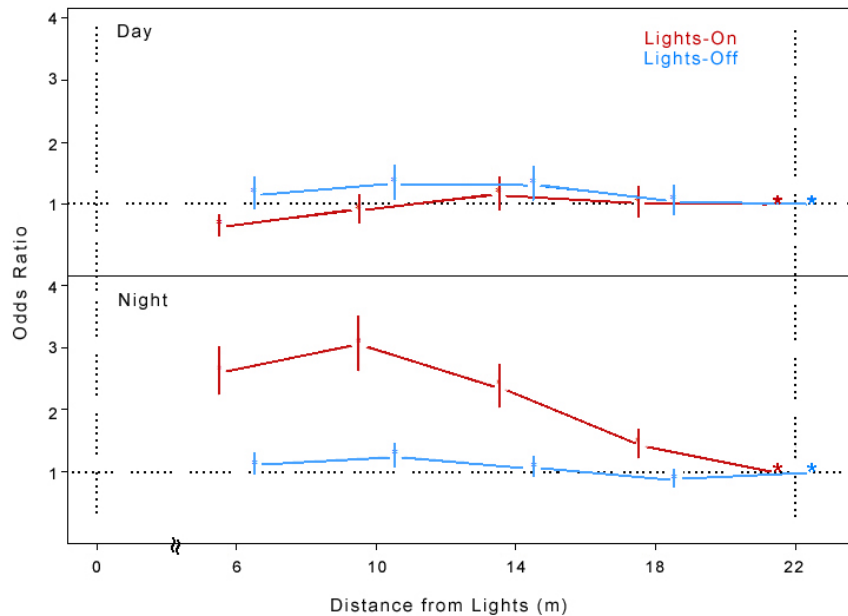
Figure 4.5. Relative Prevalence of Fish Tracks Under Each 24-hr Light Treatment Compared to Common Reference Location at 22 m. Error bars represent 95% confidence intervals based on the χ^2 distribution with 1 degree of freedom. Data represent fish detected by five of the seven downlooking transducers.

A plot of the odds ratio statistic by treatment group and distance from the strobe lights (Figure 4.5) illustrates the statistical analysis of the data in Figures 4.3 and 4.4. Comparisons of the odds ratios (see Figure 3.11 for a discussion of the interpretation of an odds ratio plot) are made to the reference location (22-m range from the strobe lights). Point estimates are statistically significant ($p < 0.05$) if the point estimate of one odds ratio does not overlap the error bar of another.

Based on the analysis displayed in Figure 4.5, the response of fish at night when the lights are on would be categorized as a statistically significant attraction response. Possible interpretations of whether this result is indicative of actual attraction or some other factor such as accumulation are discussed at the end of this section. When the strobe lights were off, either during the daytime or at night, the odds ratio is nearly 1, indicating no response to the lights. During the day, when the strobe lights were on, there was a very weak avoidance response at 6 m (i.e., odds ratio < 1).

Overall Response to Lights	Weak repulsion response (p. 4.5, Fig. 4.5)	Highly significant attraction response (p. 4.5, Fig. 4.5)	Weak attraction response (p. 4.5, Fig. 4.5)	No response (p. 4.5, Fig. 4.5)
Swimming Response with Flow (swimming effort)	High discharge - Swimming effort upstream (p. 4.13, Fig. 4.15, Appendix H)	Low discharge - Swimming effort away from lights laterally (p. 4.13, Fig. 4.16, Appendix H)	High discharge - Swimming effort upstream (p. 4.13, Fig. 4.15, Appendix H)	Low to mid discharge - No preferred swimming direction (p. 4.13, Fig. 4.16, Appendix H)
Arrival Rates (1-hr on/off)	Recruitment fairly constant over time with slight decrease in last half hour (p. 4.9, Fig. 4.10)	Arrival rates increased rapidly (p. 4.9, Fig. 4.10)	Recruitment fairly constant over time (p. 4.9, Fig. 4.10)	Arrival rates decline (p. 4.9, Fig. 4.10)
Arrival Rates (24-hr on/off)	Constant with some fluctuations (p. 4.10, Fig. 4.12, Appendix H)	Increased at night then declines into morning hours (p. 4.10, Fig. 4.12, Appendix H)	Constant with some fluctuations (p.4.10, Fig. 4.12, Appendix H)	Little or no accumulation (p. 4.10, Fig. 4.12, Appendix H)

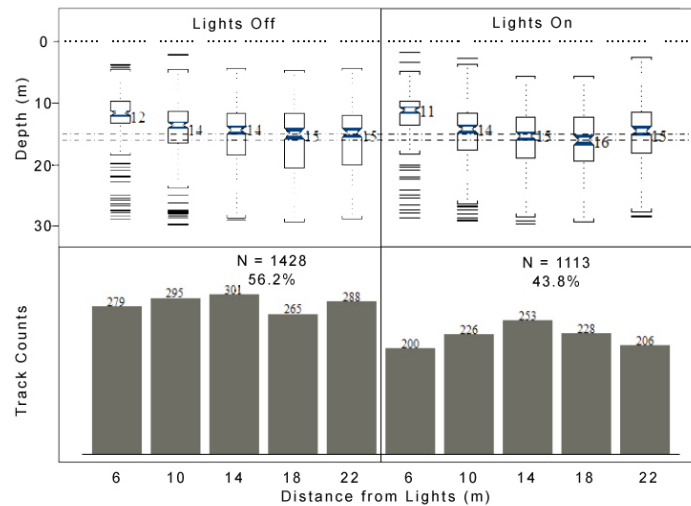
Figure 4.6. Depth Distribution and Number of Fish Detected During the Daytime for the 1-hr Light Treatment as a Function of Distance from Strobe Lights for Five Downlooking Transducers (Blocks 2–14). In the upper half of the figure, the box represents the middle 50 percent of the data (25th to 75th percentile); the notch near the center of each box represents the median. Lines bracketing the box are the approximate widths of the 1st to the 99th percentiles. The dotted line at zero represents the water surface, while the lines bracketing 15 m represent the depth of the strobe lights.

The counts and depth distribution of fish detected during the 1-hr on/off treatment are shown in Figure 4.6 (daytime) and Figure 4.7 (nighttime). The depth distribution was similar to that for the 24-hr treatments, with the fish being at or above the level of the lights during the daytime and below the lights at night. The primary difference between the results for the 1-hr and 24-hr treatments was at night when the difference in the number of fish detected when the lights were on compared to off was 8% for the 1-hr treatments compared to 70% for the 24-hr treatments. The odds ratio for the 1-hr treatments (Figure 4.8) is similar to that for the 24-hr treatments (Figure 4.5).

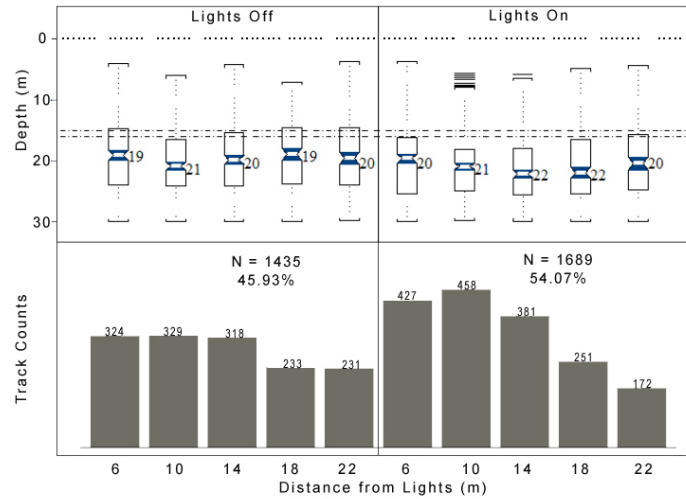
Figure 4.7. Depth Distribution and Number of Fish Detected at Night for the 1-hr Light Treatment as a Function of Distance from Strobe Lights for Five Downlooking Transducers (Blocks 2–14). In the upper half of the figure, the box represents the middle 50 percent of the data (25th to 75th); the notch near the center of each box represents the median. Lines bracketing the box are the approximate widths of the 1st to the 99th percentiles. The dotted line at zero represents the water surface, while the lines bracketing 15 m represent the depth of the strobe lights.

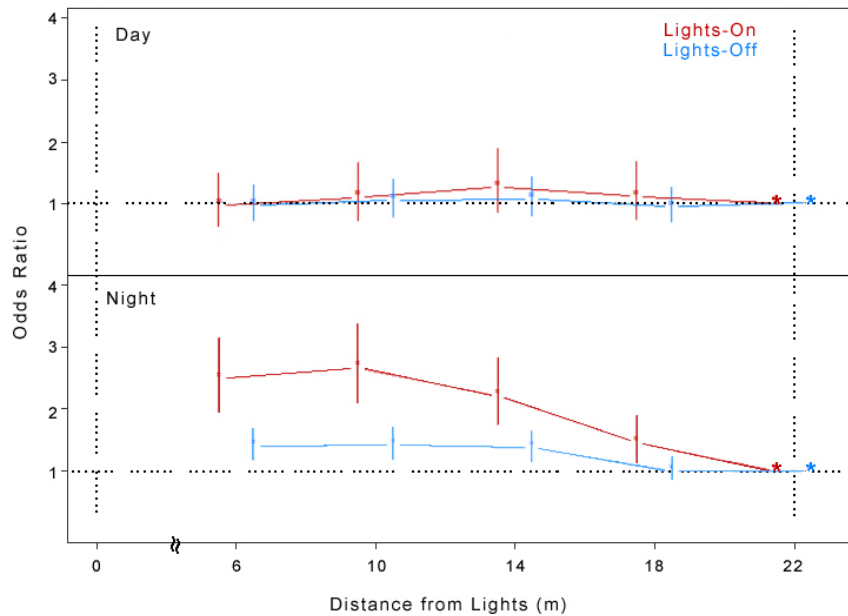
Figure 4.8. Relative Prevalence of Fish Tracks Under the 1-hr Light Treatment Compared to Common Reference Location at 22 m. Error bars represent 95% confidence intervals based on the χ^2 distribution with 1 degree of freedom.

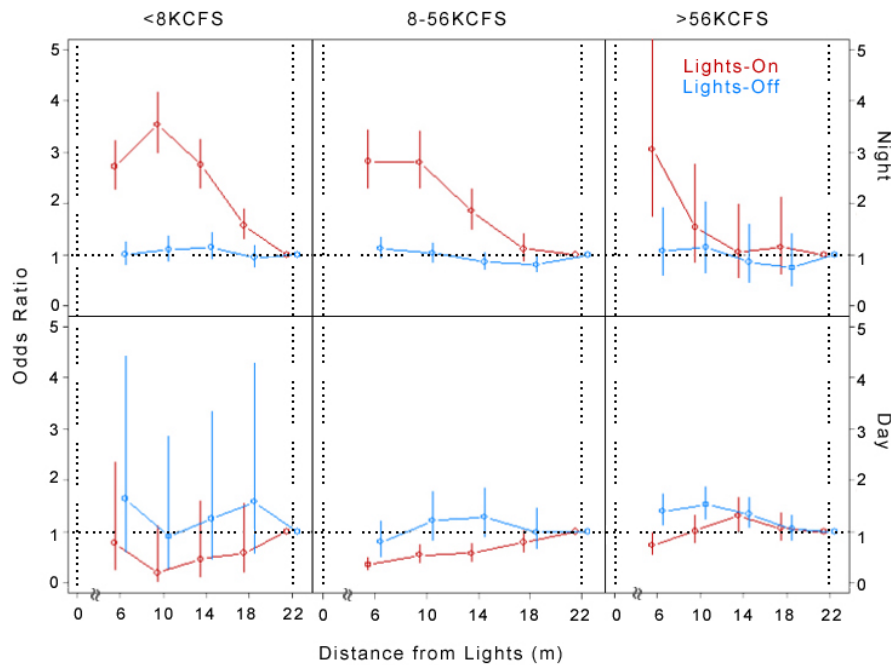
Figure 4.9. Relative Prevalence of Fish Tracks Under Three Discharge Levels, Light Conditions, and Time of Day. Comparisons are made to the reference location at 22 m. Error bars represent 95% confidence intervals based on the χ^2 distribution with 1 degree of freedom. Data represent fish detected by five of the seven downlooking transducers for a 24-hr period.

Results from the analysis of third powerplant discharge on the number of fish present under different light conditions and time of day are presented in Figure 4.9. The odds ratios for fish detected during the day under the three discharge regimes all show a similar mild avoidance response when the lights are on. At the lowest discharge level (< 8 kcfs), the small number of fish targets caused the inconclusive results (i.e., large confidence intervals). Night samples, at all discharge levels, show an attraction response when the lights are on.

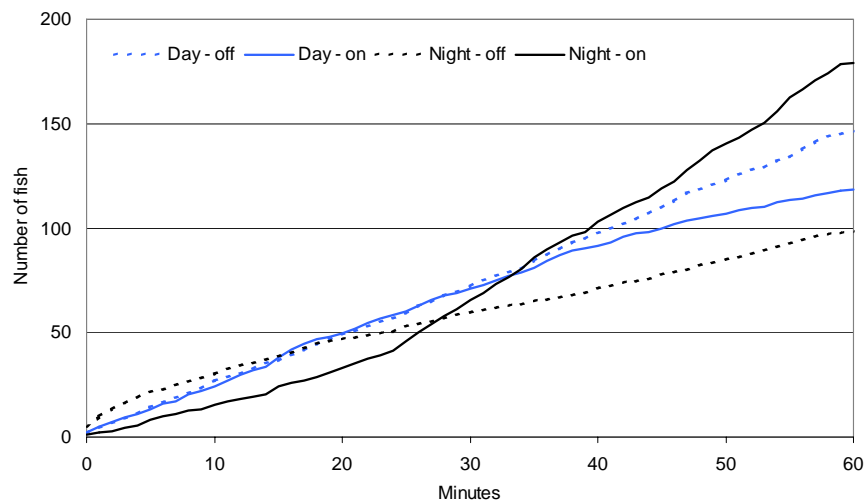
Figure 4.10. Average Cumulative Arrival Rates for Fish Detected During the 1-hr Treatments. Data for all blocks (n = 13).

Figure 4.10 shows the cumulative arrival rates for fish detected during the day and at night for the 1-hr treatments. The rate is the slope of the curve at any particular part of the hour. Arrival rates were definitely variable over the study period, and more fish did not always arrive when the lights were on compared to lights off at night. However, Figure 4.10 shows that at the end of an hour, there were substantially more fish present at night when the lights were on compared to lights off at night. During the day (Figure 4.10), the arrival rates for lights on and off were not substantially different. Figure 4.11 shows the same phenomenon based on the number of fish detected within the lighted zone in 15-min increments.

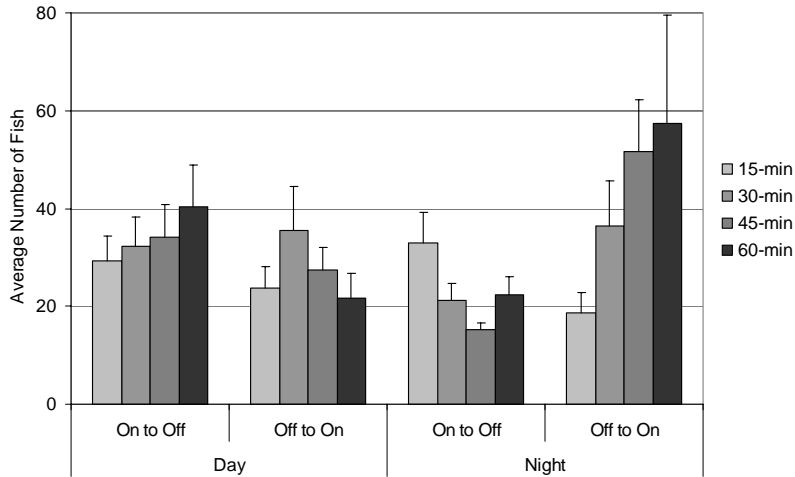
Figure 4.11. Fish Counts at 15-min Intervals After Light Configuration Changed. Results from the 1-hr treatment scenario. Bars are standard errors.

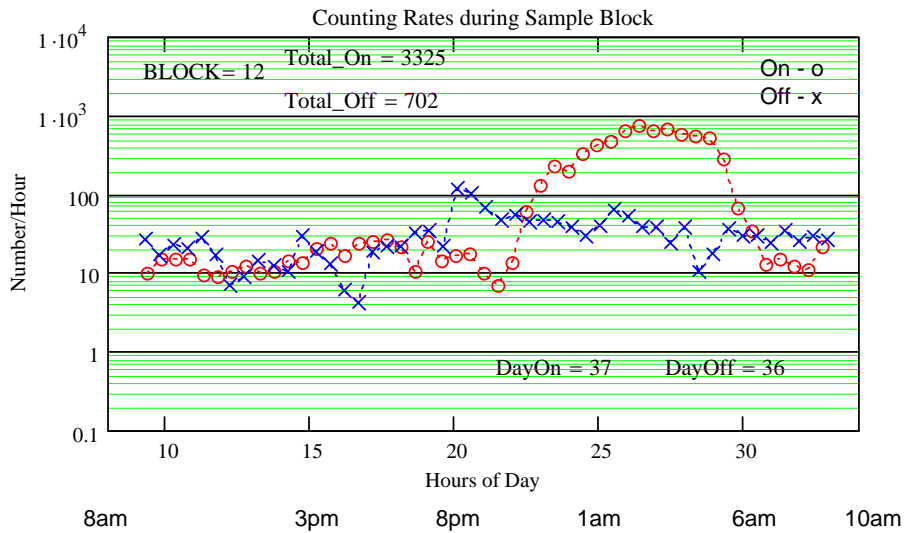
Figure 4.12. Arrival Rate for Fish Detected During 24-hr Light Treatments for Block 12 (July 22 through 24, 2003)

Figure 4.12 is an example of the arrival count rate calculated for the 24-hr treatments (Block 12 - July 22 through 24). Two sequential days are involved because the lights could not be both on or off within the same 24-hr period. The counting in Figure 4.12 begins in the morning and continues to the same time the next day. Plots are provided in Appendix H for all blocks. The important result is that the pattern of all curves was similar, although the total number of fish counted was variable and different for each day. For every treatment block, the rate of arrival began to increase at night when lights were on, reached a steady maximum level at approximately 3 a.m., and then declined into the morning hours before sunrise. The rates remained level with some fluctuations throughout the daylight hours. When the strobe lights

were off, this pattern did not occur. There was often a period after 8 p.m. when the lights-off count rate exceeded that for lights on, but the lights-on rate eventually exceeded the lights-off rate during the night-time for every block. This demonstrates that fish are accumulating at an increasing rate at night when lights are on. Because the rate appears to attain a plateau, it suggests that a certain maximum number of fish produce the track counts at night based on the proximity population. It is noteworthy that counting rates during the day were similar for lights either on or off.

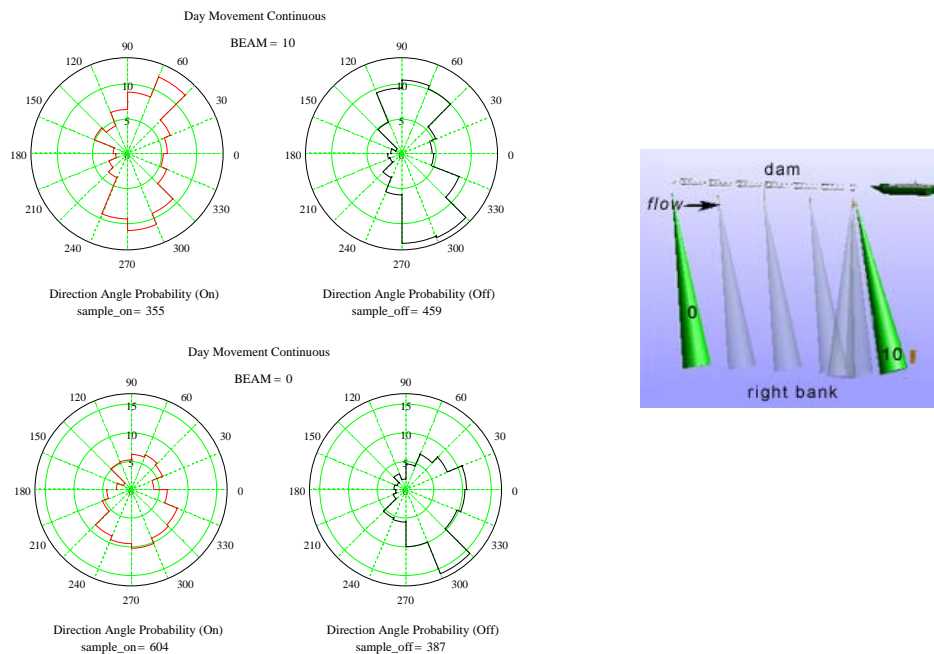
Figure 4.13. Swimming Direction for Fish Detected 6 m (beam = 10) and 22 m (beam = 0) from the Light Frame During the Day When the Lights Are On (red) and Off (black). Zero direction is downstream, 90° is toward the dam.

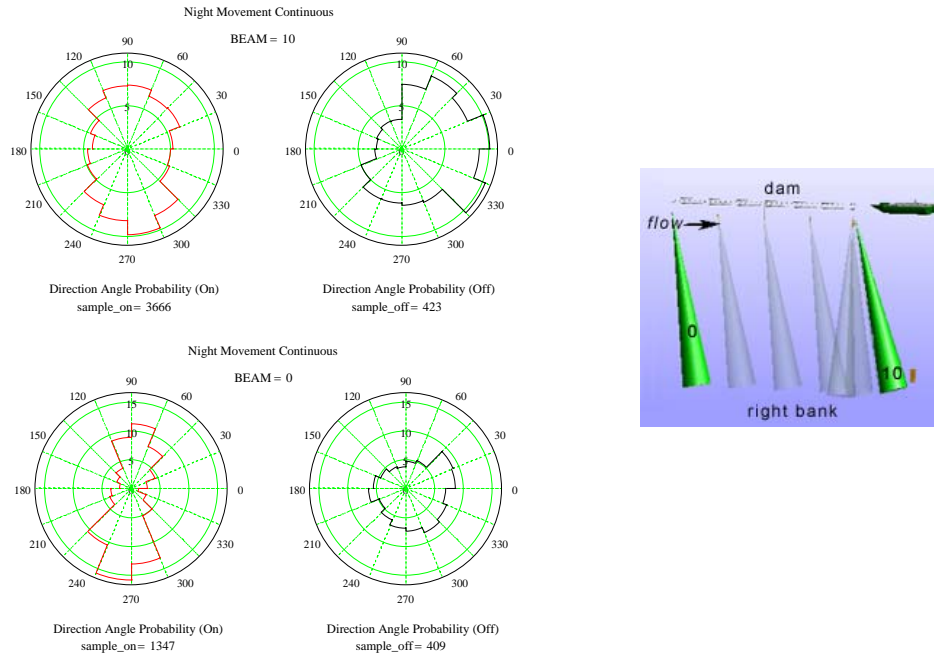
Figure 4.14. Swimming Direction for Fish Detected 6 m (beam = 10) and 22 m (beam = 0) from the Light Frame at Night When the Lights Are On (red) and Off (black). Zero direction is downstream, 90° is toward the dam.

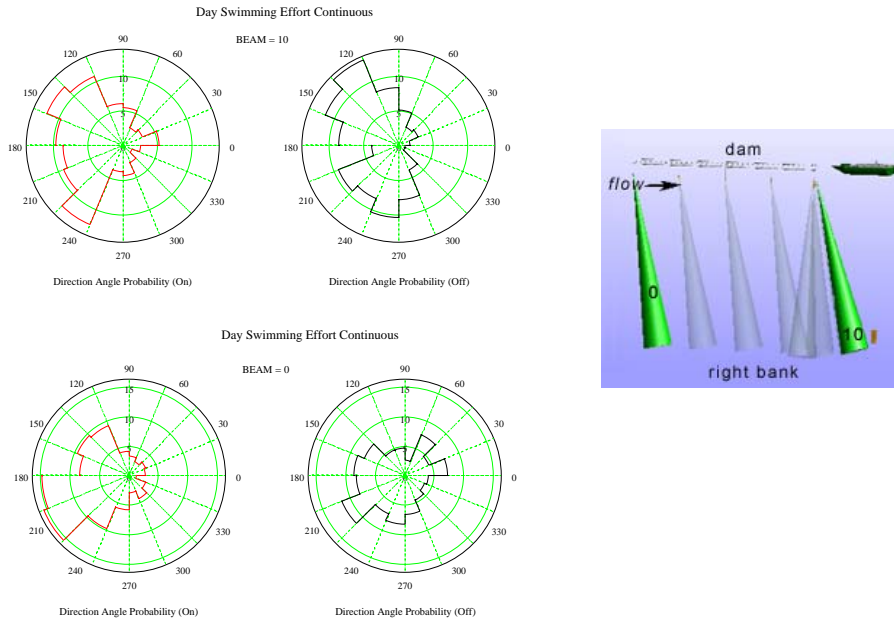
Figure 4.15. Swimming Effort for Fish Detected 6 m (beam = 10) and 22 m (beam = 0) from the Light Frame During the Day When the Lights Are On (red) and Off (black). Zero direction is downstream, 90° is toward the dam.

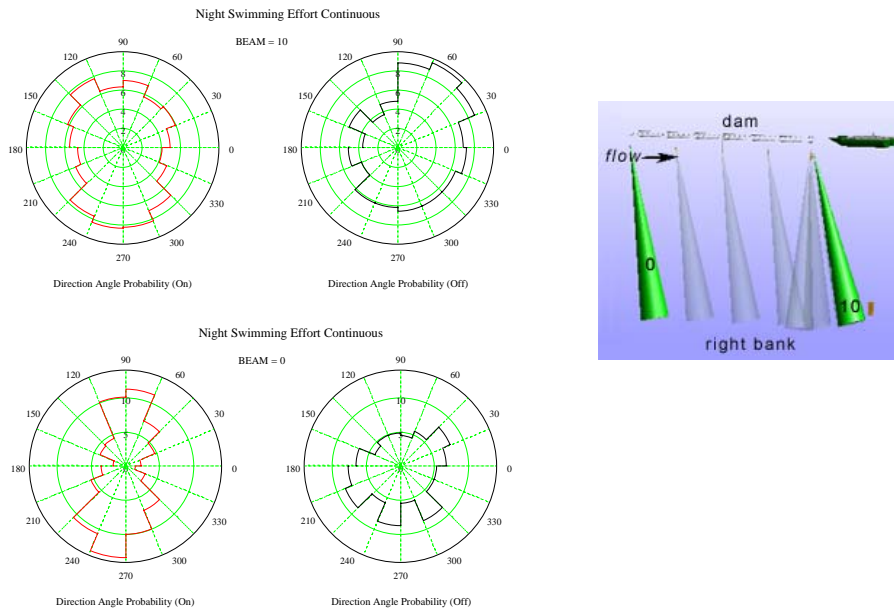
Figure 4.16. Swimming Effort for Fish Detected 6 m (beam = 10) and 22 m (beam = 0) from the Light Frame at Night When the Lights Are On (red) and Off (black). Zero direction is downstream, 90° is toward the dam.

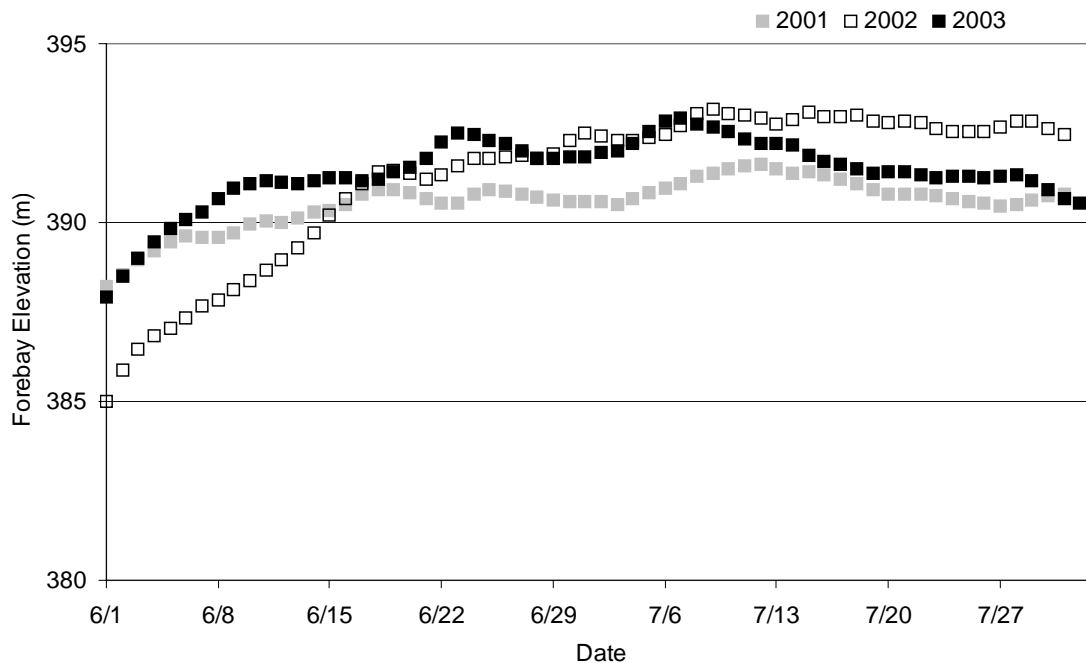
Figure A.1. Forebay Elevation in Front of the Left Powerplant During the Period June 1–August 1 for 2001, 2002, and 2003

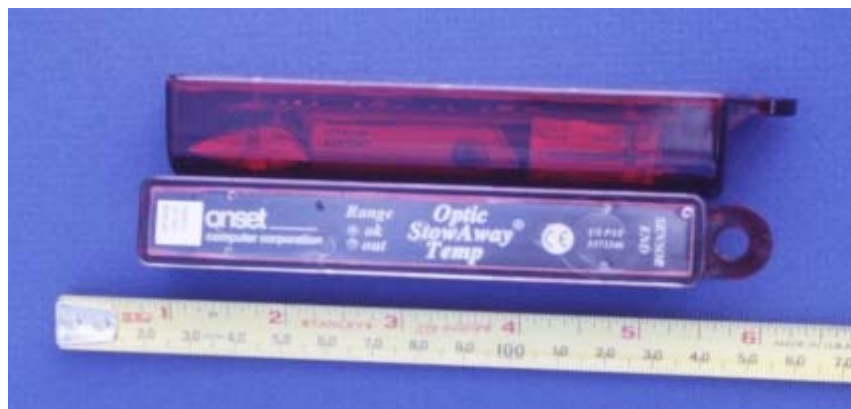
Figure A.2. Self-Contained Temperature Loggers. Loggers are approximately 12 cm in length.

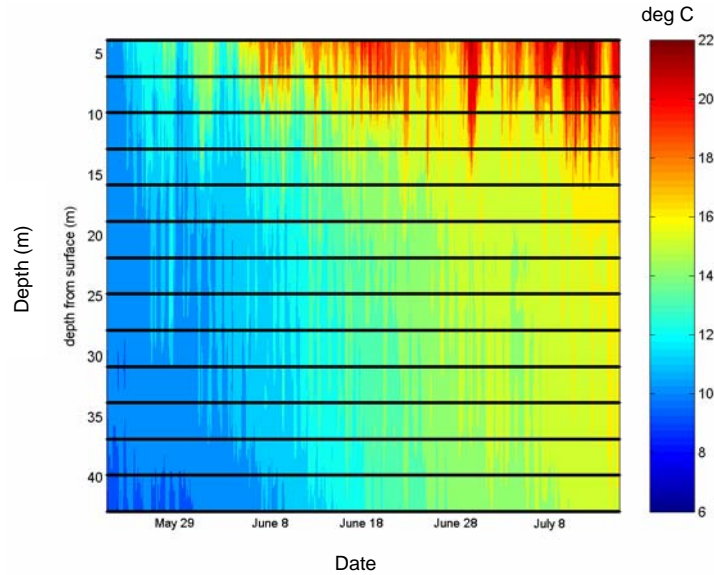
Figure A.3. Water Temperature Contours as a Function of Depth in the Forebay of the Third Powerplant at Grand Coulee Dam in 2003. Black horizontal lines indicate location of temperature loggers.

While light is a well-known stimulus to diel cycles of fish (Thorpe 1978), temperature also has been found to have an effect on their behavioral rhythms (Valdimarsson et al. 1997). For this reason, vertical water temperatures were measured by placing 14 self-contained temperature loggers along a steel cable extending 40 m beneath the water surface. The cable was attached to a buoy anchored upstream of the barge (Figure 3.2) in the forebay. A metal weight was affixed to the bottom of the cable to keep the line vertical throughout the water column. The Onset Optical StowAway[®] temperature loggers (Figure A.2) used during this study have a reported accuracy of $\pm 0.2^{\circ}\text{C}$. All loggers were validated before and after deployment by exposing them to a constant-temperature environment and a high-accuracy thermistor. All loggers were found to measure temperatures at or better than the manufacturer's reported accuracy.

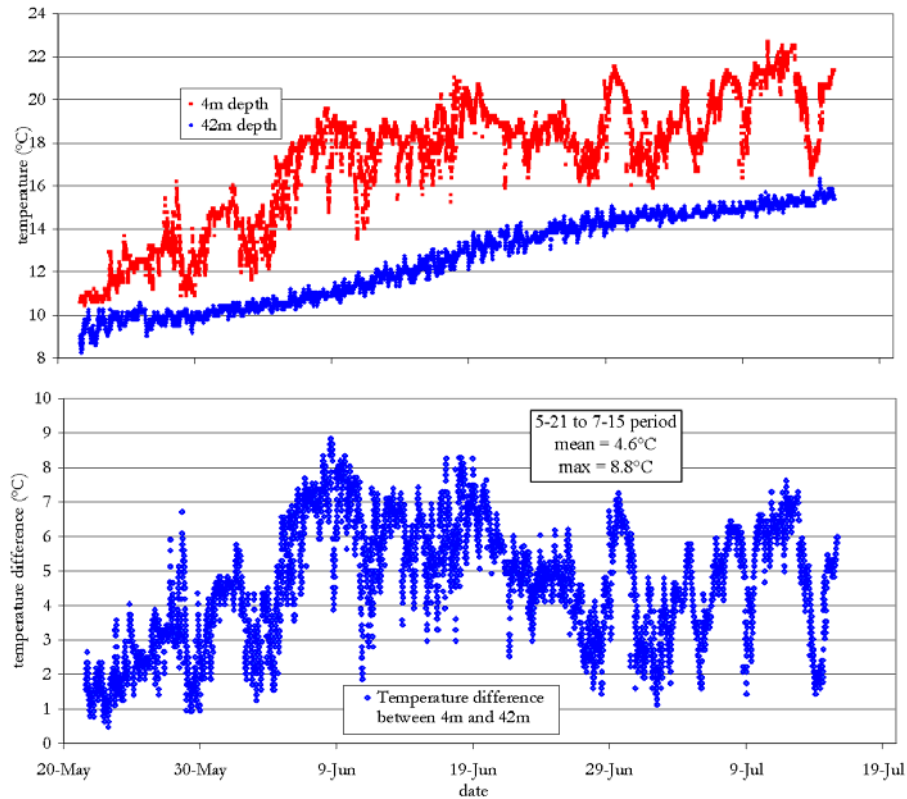
Figure A.4. Temperatures at 4 and 42 m (upper) and Temperature Differences Between 4 and 42 m (lower) During Study Period in 2003 in the Forebay of the Third Powerplant at Grand Coulee Dam
