Chief Joseph Kokanee Enhancement Project

Strobe Light Deterrent Efficacy Test and Fish Behavior Determination at the Grand Coulee Dam Third Powerplant Forebay

Annual Report 2003 - 2004

DOE/BP-00000652-25

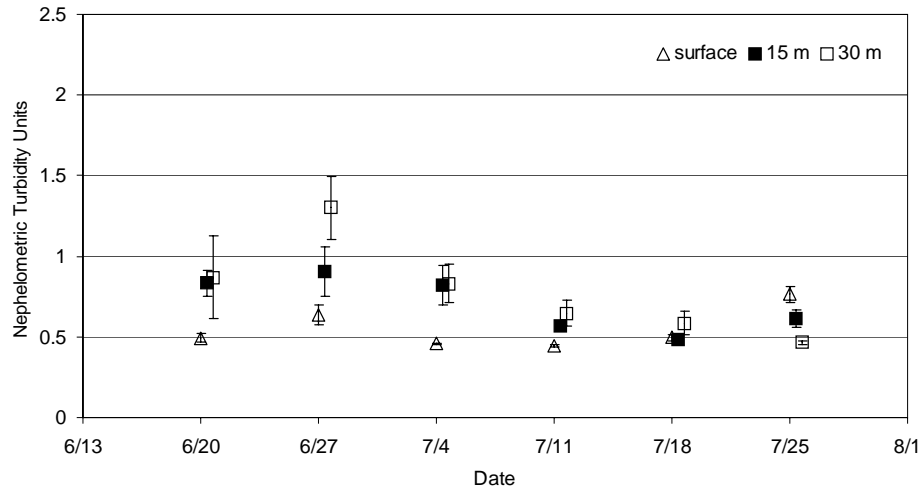
a) Turbidity Levels During 2003 Study Period

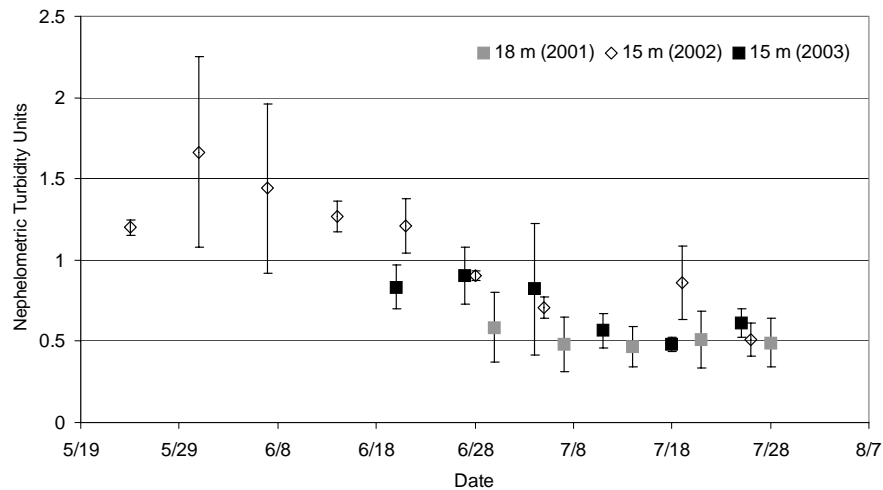
b) Turbidity Levels During Three Study Years

Figure A.5. Turbidity Levels at Grand Coulee Dam in 2003 for Three Depths (surface, 15, and 20 m) and for Three Study Years (June 30 to August 1, 2001; May 24 to July 26, 2002; and June 20 to July 25, 2003). Bars are ± 1 standard deviation ($n = 9$ for 2001; $n = 3$ for 2002; $n = 3$ for 2003).

Turbidity can affect the distribution of fish both vertically and spatially (Swenson 1978; Matthews 1984). Turbidity measurements were taken weekly at three depths (surface, 15 m, and 30 m) at the upstream buoy location closest to the right bank of the reservoir in the forebay of the third powerplant (Figure 3.1). Turbidity measurements were taken with Van Doren bottle grab samples and analyzed using a Hach Model 2100P Portable Turbidimeter.^(a) Three replicates were analyzed at each depth.

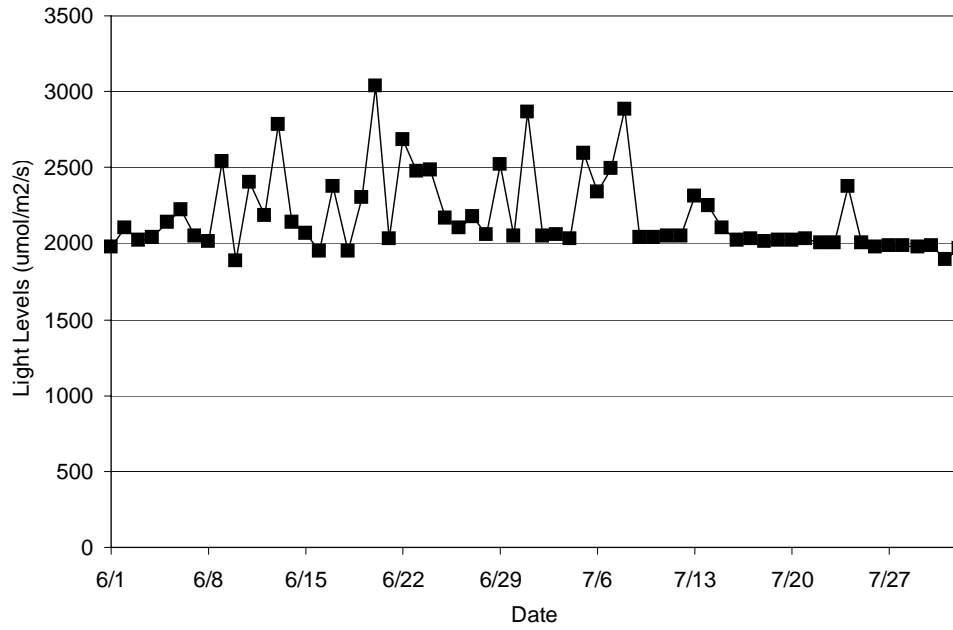
Figure A.6. Maximum Light Levels in Forebay of Third Powerplant at Grand Coulee Dam in 2003

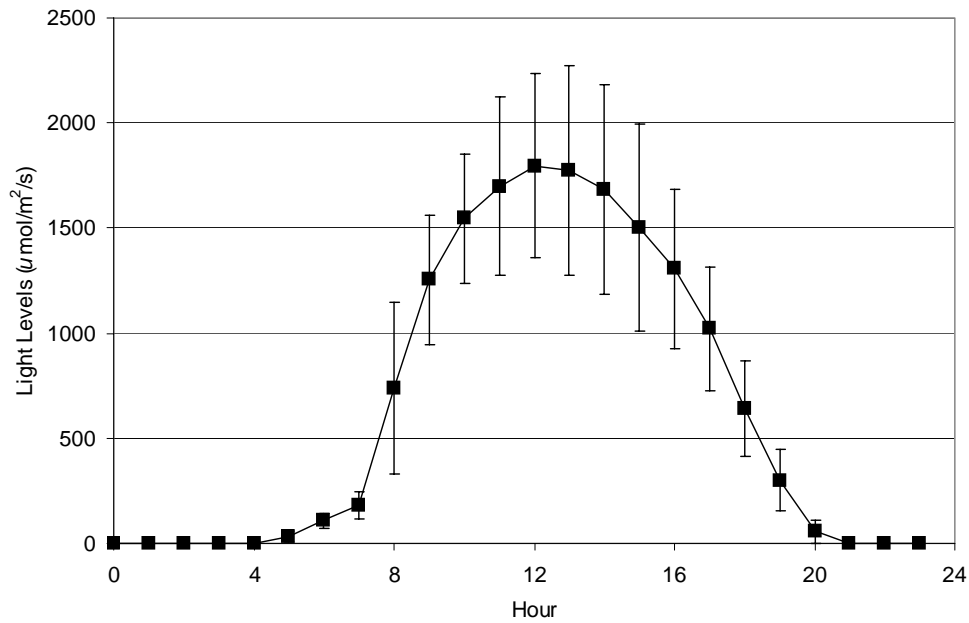
Figure A.7. Hourly Ambient Light Levels Measured at Water Surface Between June 1 and August 1, 2003. Bars are ± 1 standard deviation ($n = 830$) based on 5-min averages. Zero hour is midnight.

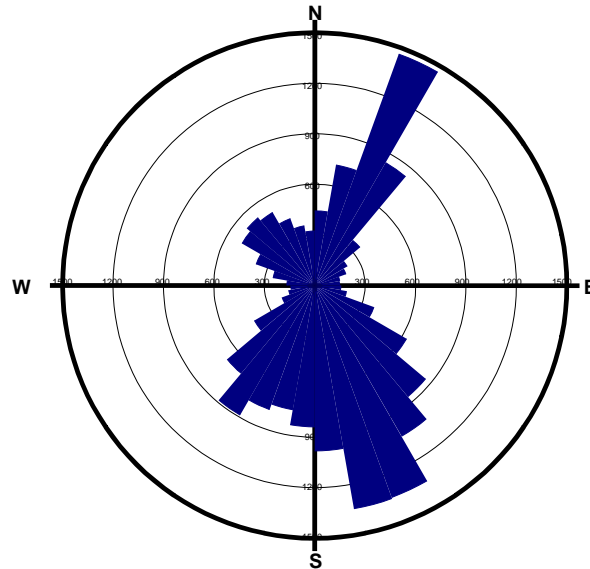
Figure A.8. Wind Rose Showing Predominant Direction from Which Wind Comes in Forebay of Third Powerplant at Grand Coulee Dam in 2003

Wind direction was primarily downstream from the south-southeast (Figure A.8). Wind speed was generally below 20 km/h (12 mph) (Figure A.9). However, on several occasions during the study, gusts were recorded in excess of 25 km/h (15 mph).

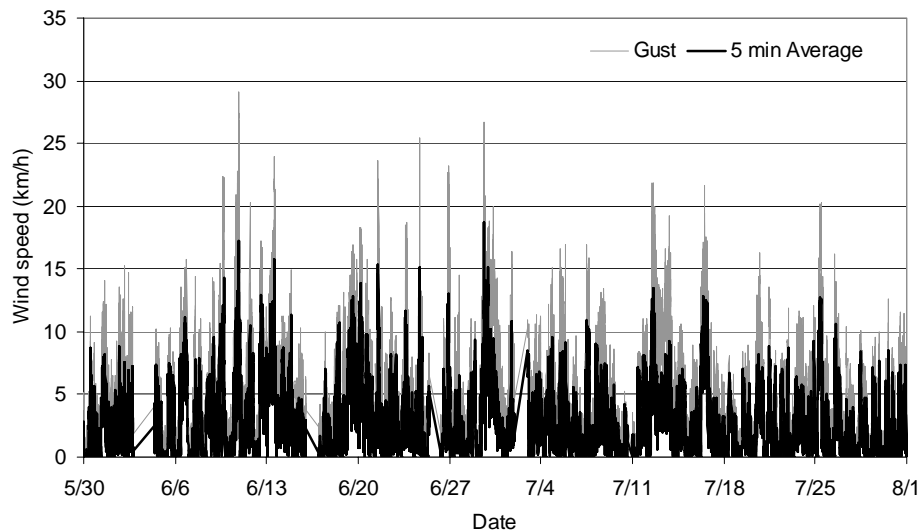
Figure A.9. Wind Speed at Grand Coulee Dam in 2003. Wind speed data represent 5-min averages.

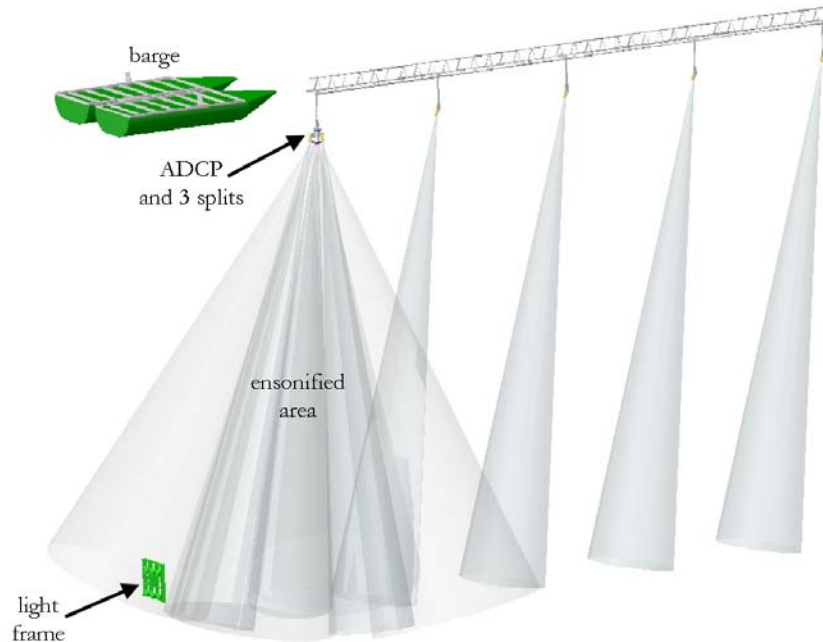
Figure D.1. General Deployment of the Barge, Light Frame, and Acoustic Doppler Current Profiler in the Forebay of the Third Powerplant at Grand Coulee Dam in 2003. The beam swath for the ADCP is approximate (see text for details). The other beams represent the areas ensonified by seven splitbeam transducers.

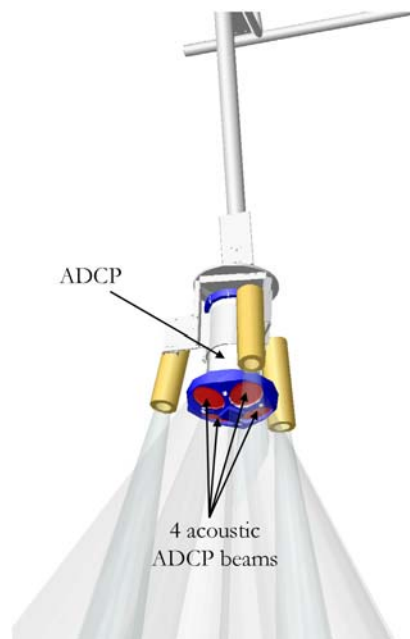
Figure D.2. Close-Up Detail of the Acoustic Doppler Current Profiler Surrounded by the Three Splitbeam Hydroacoustic Transducers. The four ADCP transducer/receivers are shaded red.

The ADCP beams are directional cone shapes that spread out from the 8-cm-diameter transducer head. The width of each beam increases with distance from the head, and the general convention is to cite the radial degree -3 dB down from the peak response at the centerline of the beam. For this specific unit, the -3 -dB level was approximately 1.3° to 1.6° (note: in Figure D.1, which was created for planning purposes, the ADCP beam swath plotted represents the location of the fourth side lobe (-65 dB), which lies at an angle of 9° from the centerline). The ADCP also is equipped with internal sensors to determine the orientation of these beams using pitch, roll, and heading, and to measure the water temperature for adjusting the speed of sound. The uncertainty of these sensors, as stated by RD Instruments, is 1) pitch and roll, $\pm 2^\circ$; 2) heading, $\pm 5^\circ$; and 3) temperature, $\pm 0.4^\circ\text{C}$.

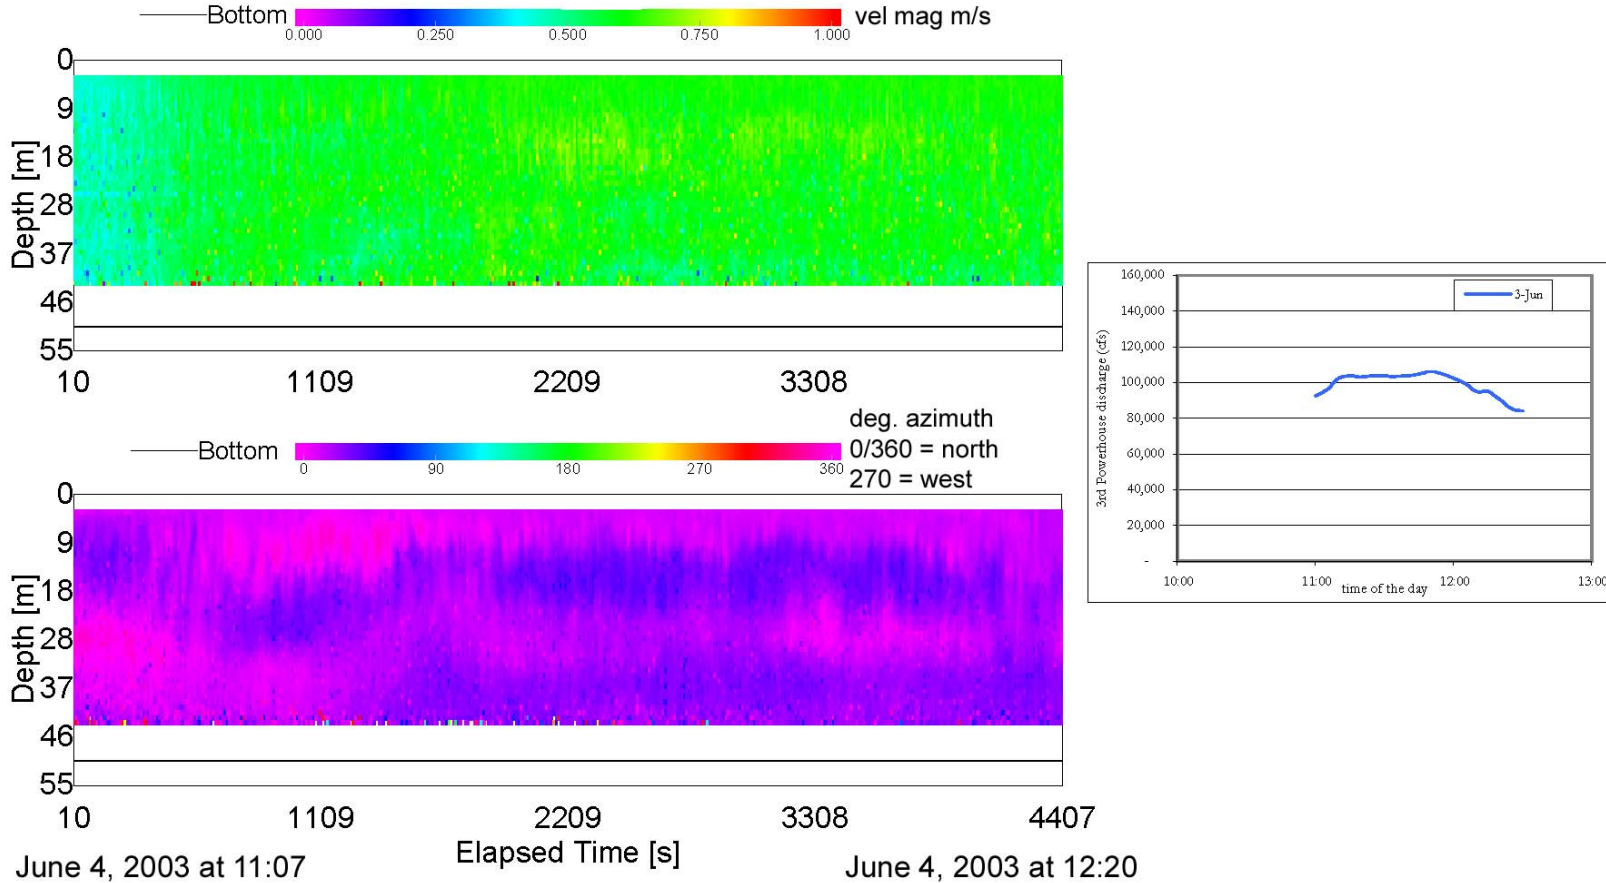
Figure D.3. Circulation Pattern Near the Barge at the Entrance to the Third Powerplant Forebay at Grand Coulee Dam Occurring When Discharge Was High (>80 kcf) (Mode 1) and Thermal Stratification Was Weak (2°C). Top left figure shows the velocity magnitude with depth and time; bottom left, the direction of flow with depth and time; and the figure to the right, the discharge levels through the third powerplant.

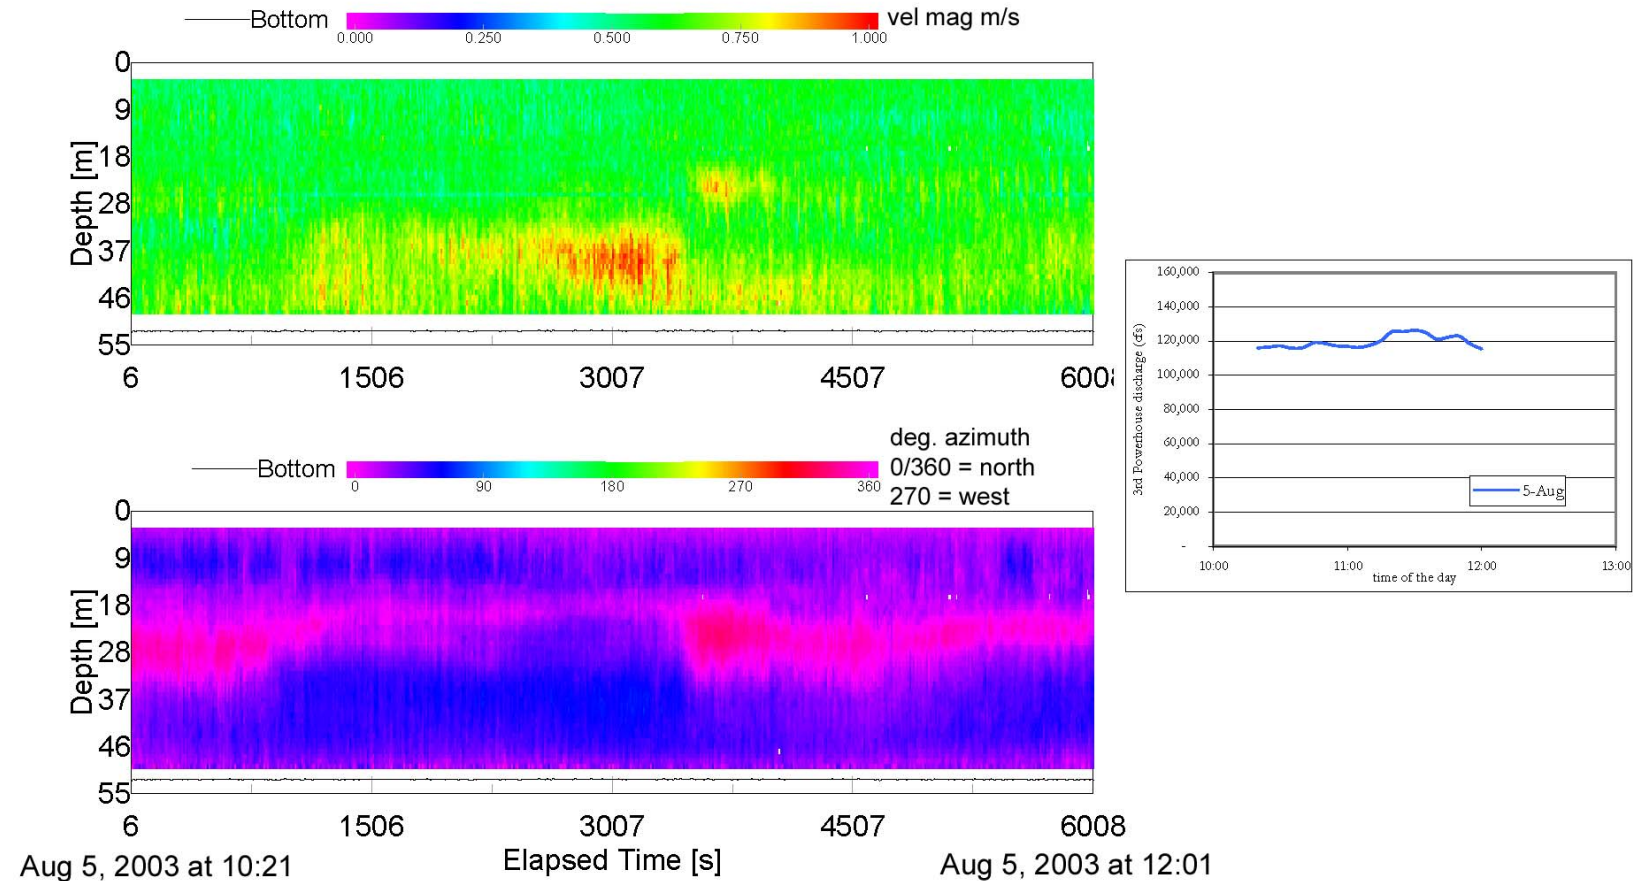
Figure D.4. Circulation Pattern Near the Barge at the Entrance to the Third Powerplant Forebay at Grand Coulee Dam Occurring When Discharge Was High (>80 kcf/s) (Mode 1) and Thermal Stratification Was Strong (>6°C). Top left figure shows the velocity magnitude with depth and time; bottom left, the direction of flow with depth and time; and the figure to the right, the discharge levels through the third powerplant.

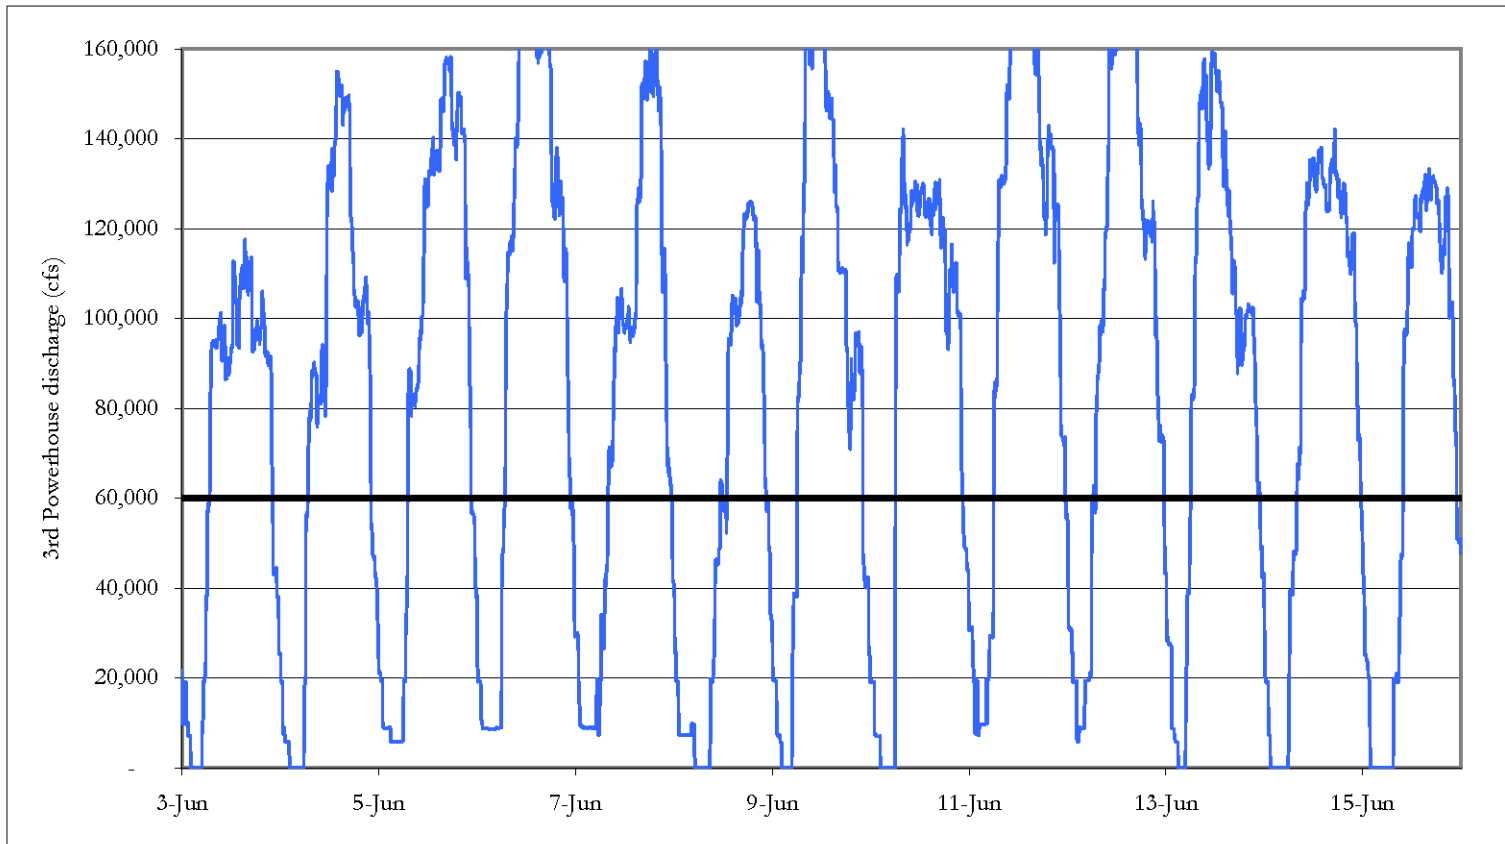
Figure D.5. Discharge Through the Third Powerplant of Grand Coulee Dam Between June 3 and 15, 2003. The line at 60 kcfs is an estimate of the discharge necessary to generate a Mode 2 circulation pattern when thermal stratification is weak. During 2003, discharges were either above or below this threshold.

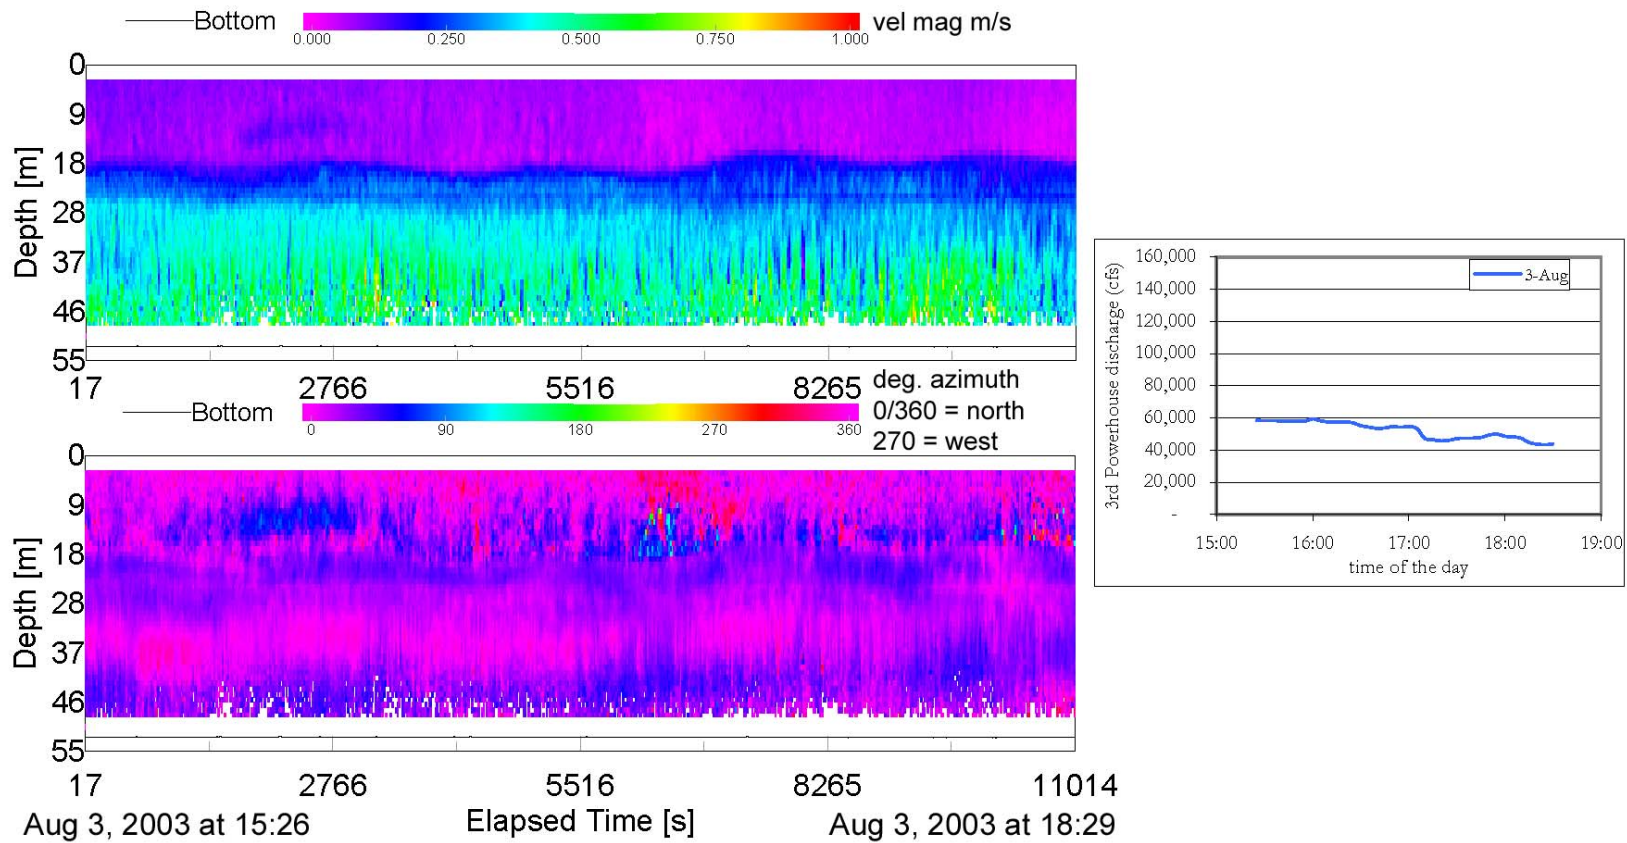
Figure D.6. Circulation Pattern Near the Barge at the Entrance to the Third Powerplant Forebay at Grand Coulee Dam Occurring When Discharge Was Moderate (40 to 80 kcfs) (Mode 2) and Thermal Stratification Was Strong (>6°C). Top left figure shows the velocity magnitude with depth and time; bottom left, the direction of flow with depth and time; and the figure to the right, the discharge levels through the third powerplant.

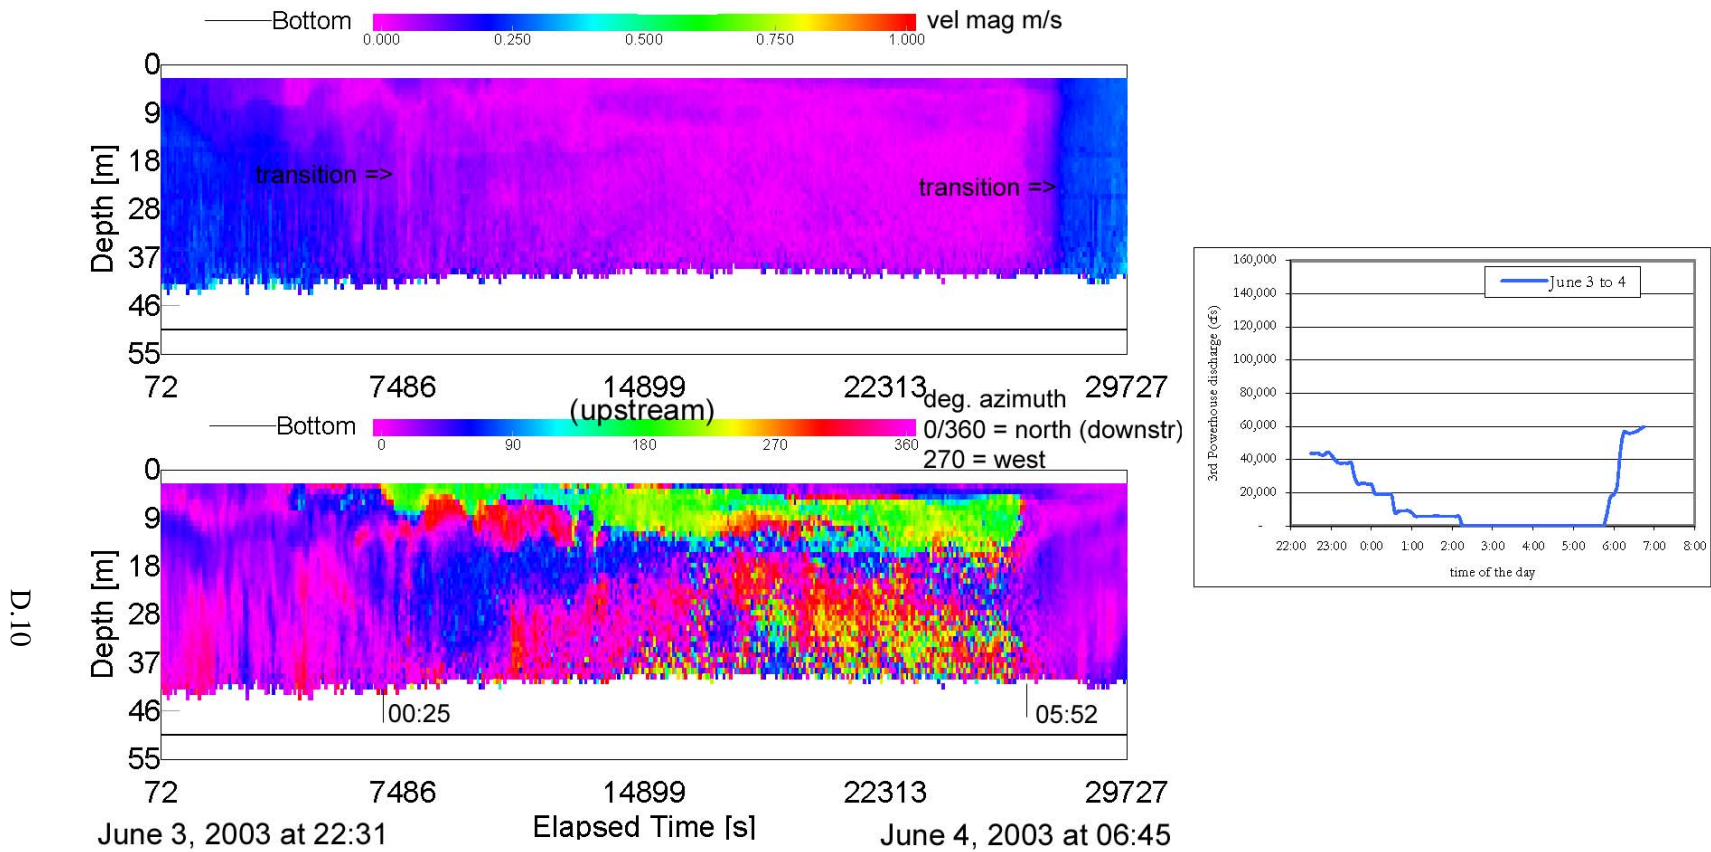
Figure D.7. Circulation Pattern Near the Barge at the Entrance to the Third Powerplant Forebay at Grand Coulee Dam Occurring When Discharge Was Low (<40 kcfs) (Mode 3) and Thermal Stratification Was Weak (2°C). Top left figure shows the velocity magnitude with depth and time; bottom left, the direction of flow with depth and time; and the figure to the right, the discharge levels through the third powerplant.

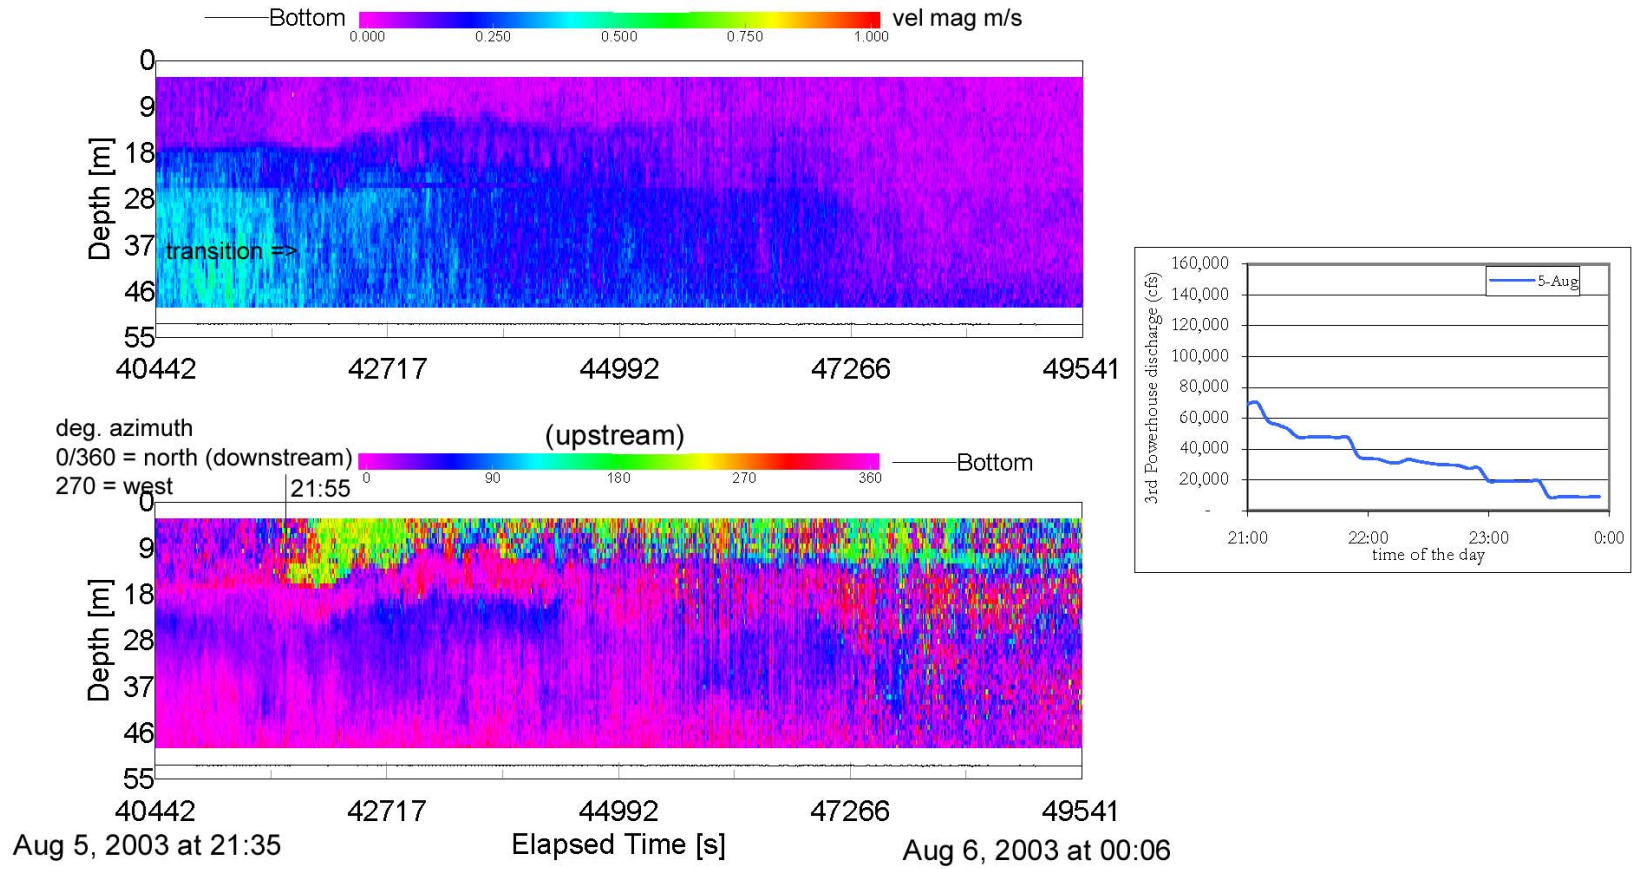
Figure D.8. Circulation Pattern Near the Barge at the Entrance to the Third Powerplant Forebay at Grand Coulee Dam Occurring When Discharge Was Low (<40 kcfs) (Mode 3) and Thermal Stratification Was Strong (>6°C). Top left figure shows the velocity magnitude with depth and time; bottom left, the direction of flow with depth and time; and the figure to the right, the discharge levels through the third powerplant.

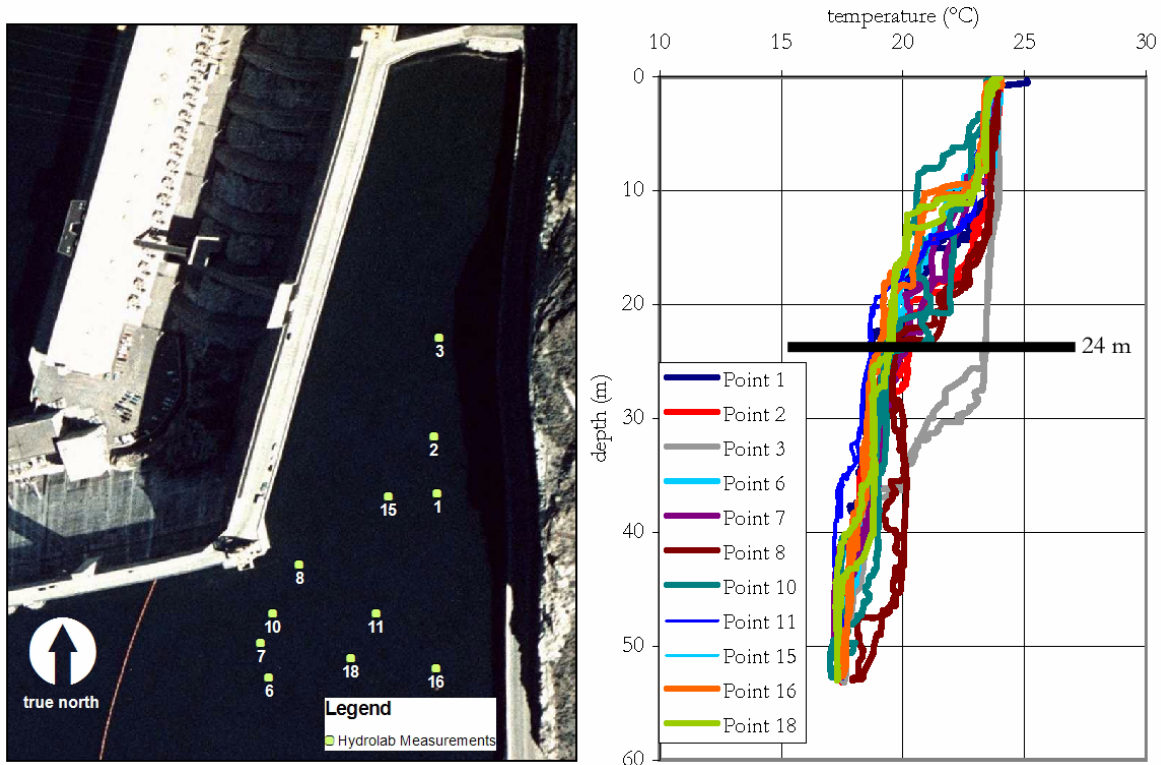
Figure D.9. Water Temperature Measurements Taken Between August 6 and 7, 2003, in the Forebay of the Third Powerplant at Grand Coulee Dam. Locations of water temperature profile measurements are displayed in the left-hand side of the figure. The corresponding data are displayed in the right-hand side. The approximate location of the thermocline for all sites except location 3 was at 24 m.

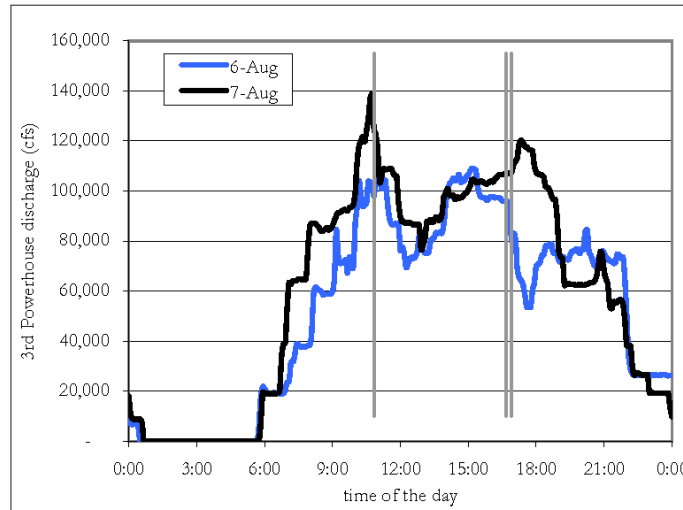
Figure D.10. Discharge Through the Third Powerplant at Grand Coulee Dam During the Mobile Hydrodynamic Characterization Survey on August 6 and 7, 2003. The gray vertical lines indicate the approximate times of the ADCP transects shown in Figure D.11. All mobile ADCP and water temperature surveys were between 10:00 and 19:00 when the powerplant discharge was above 80 kcfs.

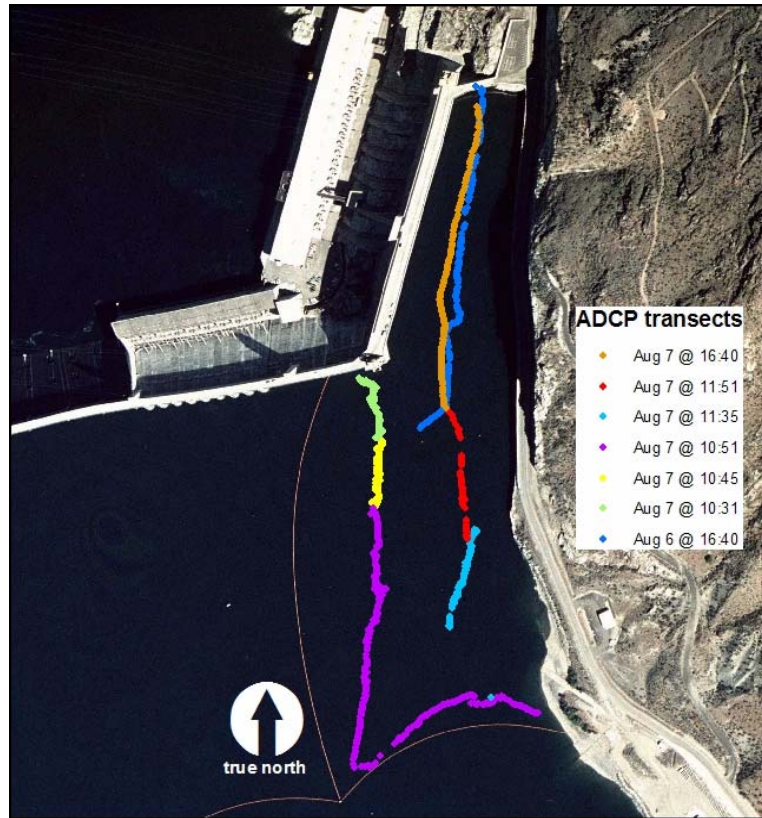
Figure D.11. Location of Mobile ADCP Transects

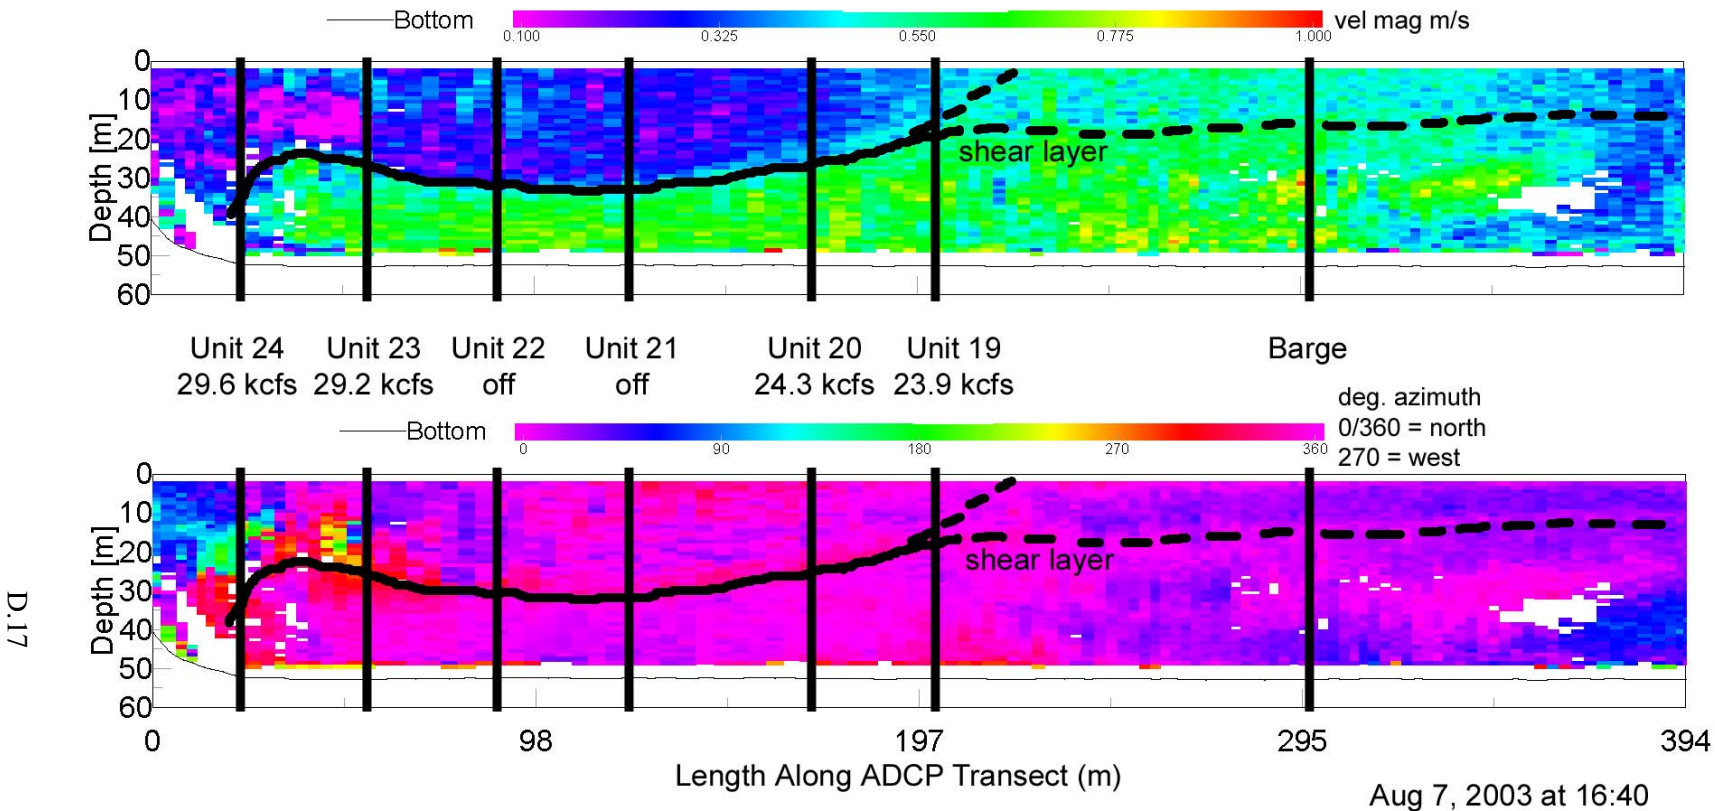
Figure D.12. Water Velocity Magnitude (top), Direction (lower) Collected on August 6, 2002, at 16:48 in the Forebay of the Third Powerplant at Grand Coulee Dam. In the plots, upstream is to the left, downstream to the right. The transect was along the centerline of the forebay (left). The directions in the lower graph are in an earth-referenced coordinate system (middle). Locations of turbine units 19 through 24 are indicated by vertical lines.

shear line separating hypolimnetic and epilimnetic waters was evident in the velocity direction subplot around 20 m; however, it was relatively weak and existed along only the first half of the transect (i.e., before the boat turned toward shore) (Figure D.14). Velocities along the transects outside the cul-de-sac were similar and generally characterized by low water velocities. This is evident also in the first two transects (Figures D.12 and D.13).

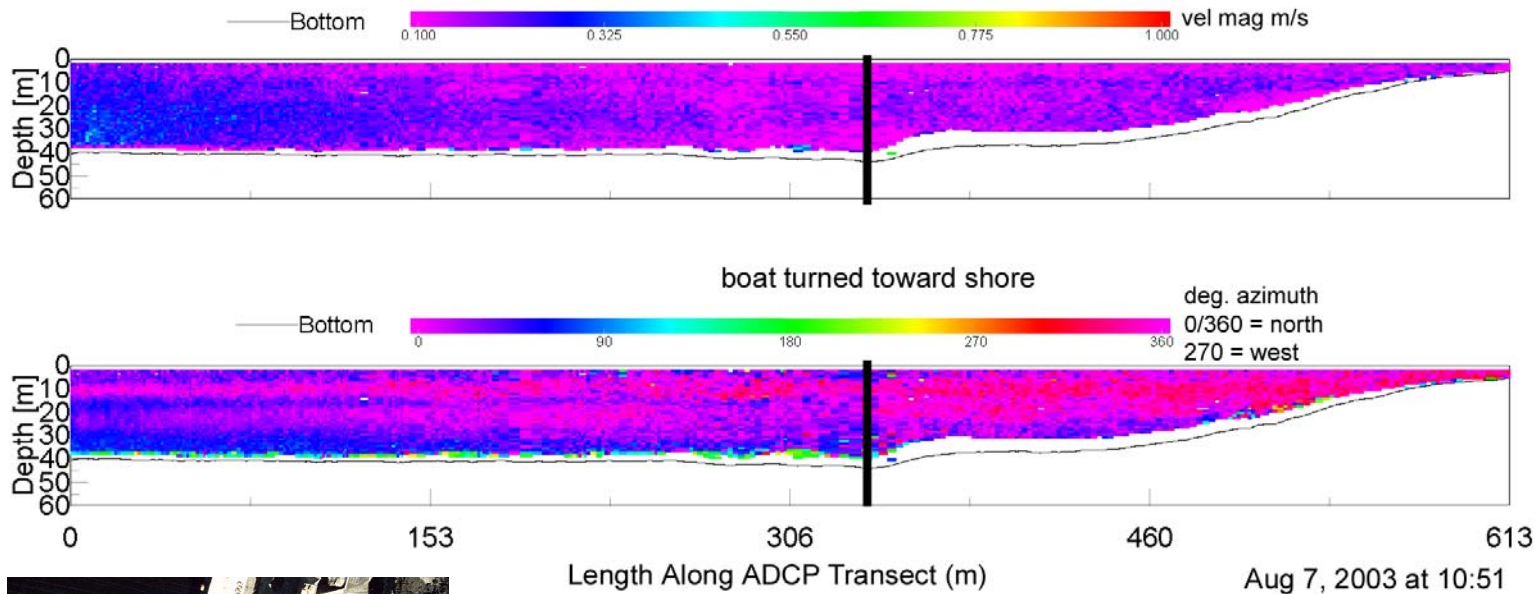
Figure D.13. Water Velocity Magnitude (top), Direction (lower) Collected on August 7, 2002, at 16:40 in the Forebay of the Third Powerplant at Grand Coulee Dam. In the plots, upstream is to the right, downstream to the left. The transect was along the centerline of the forebay (left). The directions in the lower graph are in an earth-referenced coordinate system (middle). Locations of turbine units 19 through 24 are indicated by vertical lines.

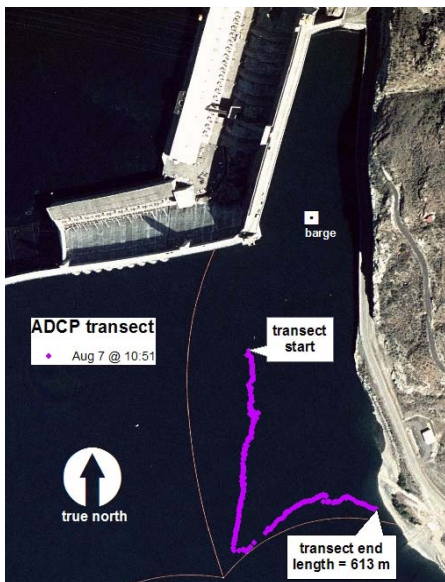
Figure D.14. Water Velocity Magnitude (top), Direction (lower) Collected on August 7, 2002, at 10:51 Along the Log Boom Around the Entrance to the Forebay of the Third Powerplant at Grand Coulee Dam. In the plots, downstream is to the left, upstream to the right. The transect followed the log boom (left). The directions in the lower graph are in an earth-referenced coordinate system (middle). The vertical line indicates where the transect turned toward the right bank.

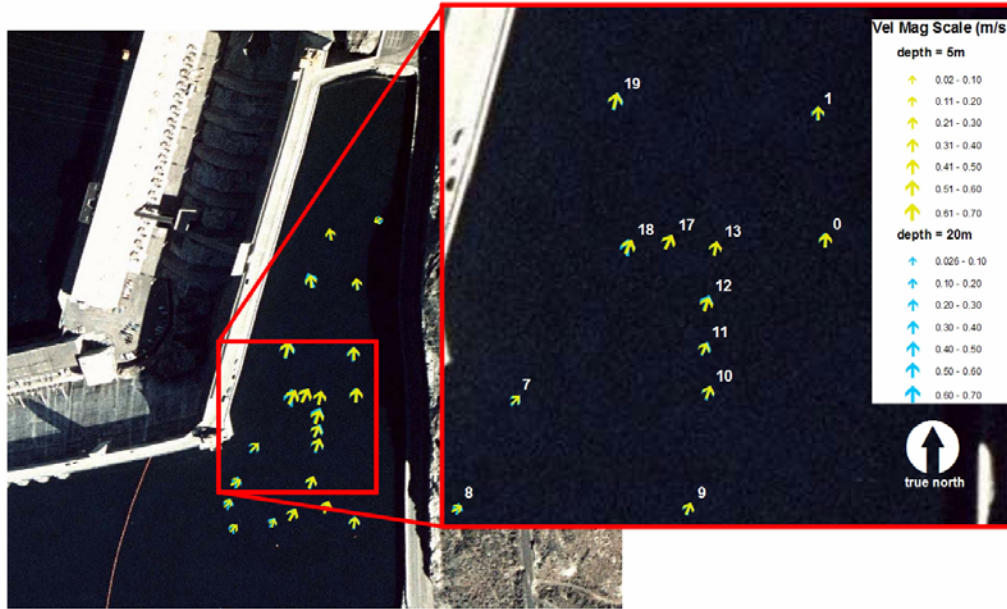
Figure D.15. Mobile Point Water Velocity Measurement Locations in the Forebay to the Third Powerplant at Grand Coulee Dam on August 6 and 7, 2003. The inset displays a zoomed-in view of velocity vectors near the barge. Points have been labeled in the order in which they were collected. Velocities at 5 and 20 m are plotted; however, velocities were generally the same at the two depths.

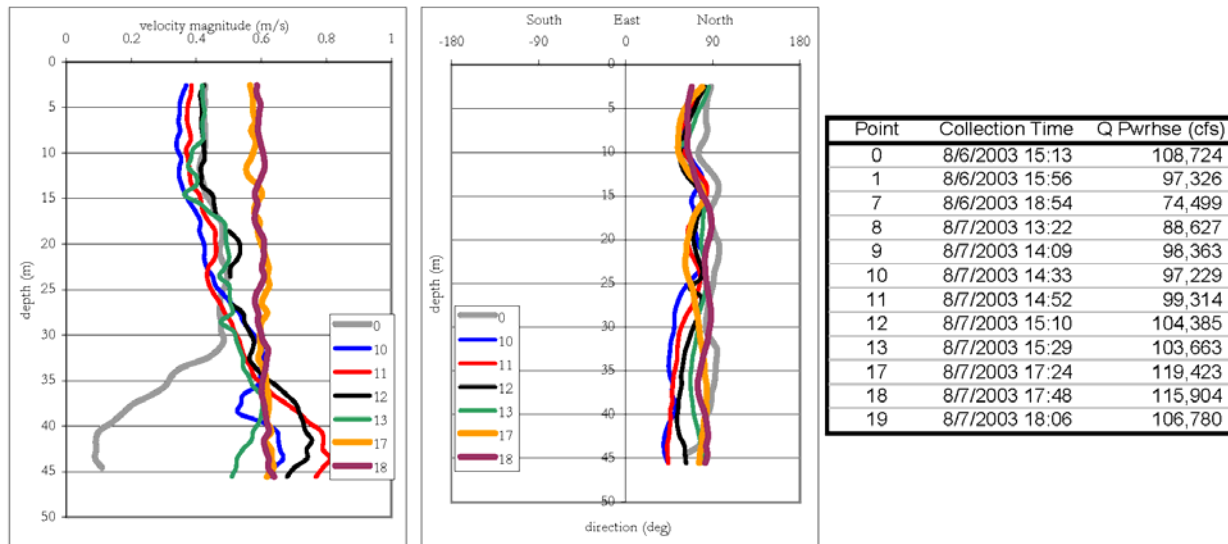
Figure D.16. Water Velocity Magnitudes and Direction With Depth for Some of the Point ADCP Measurements. Discharge and collection times are tabulated for all labeled points in Figure D.15.

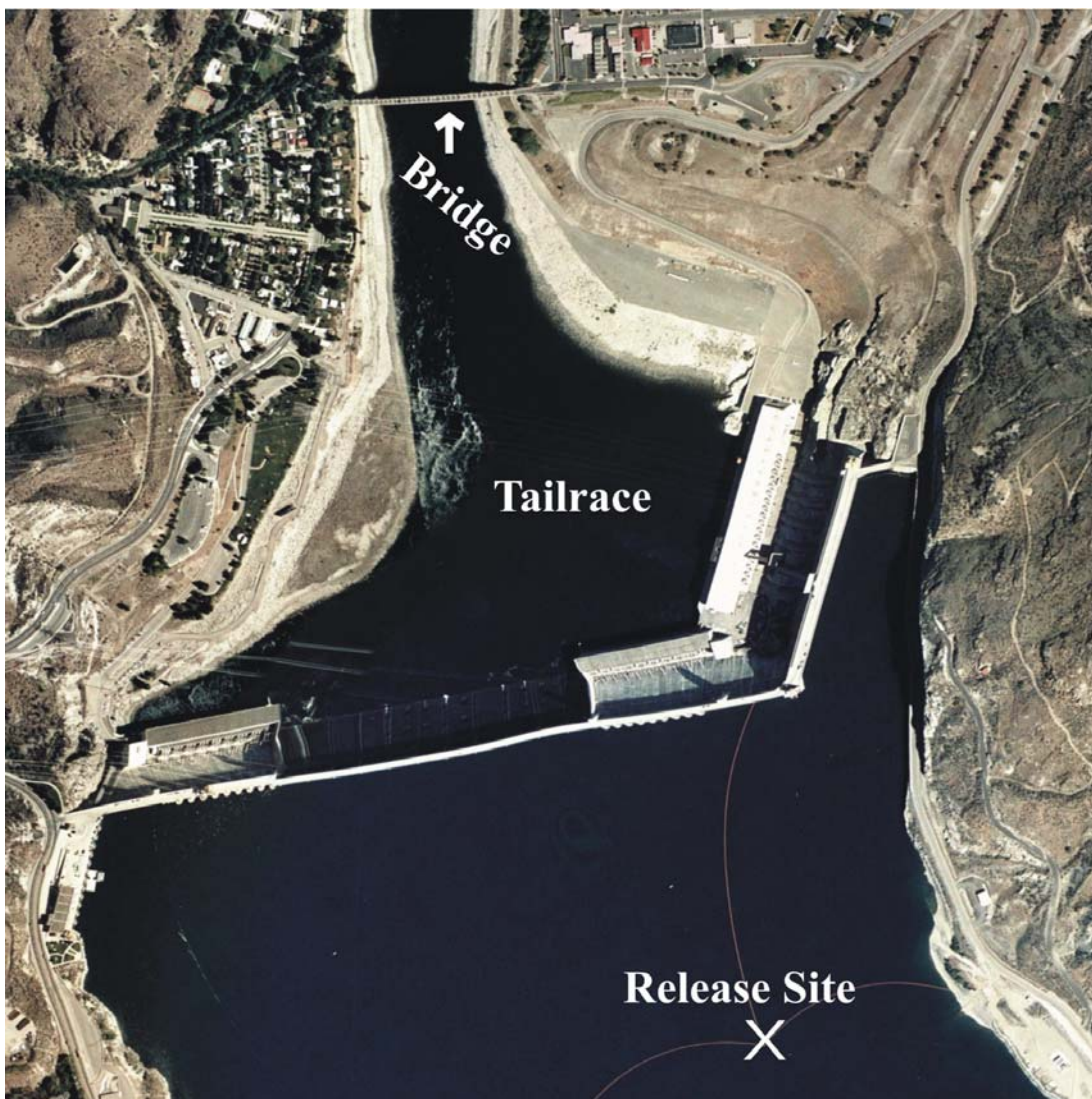
Figure E.1. Release Site for Acoustic Tagged Juvenile Kokanee, Grand Coulee Dam, June 2003

A total of 198 fish were released upstream of Grand Coulee dam (Figure E.1) in six groups (Table E.1). Half of the groups were released approximately 1 hour after sunset, and the other half were released 1 hour after sunrise.

The release site of juvenile kokanee for the 2003 study may have been a major factor contributing to where the fish first entered the third powerplant forebay. While first entrances occurred across the entire span of the forebay, their distribution was not uniform. More than a third (36%) of the implanted fish entered through the southwest 20% section of the forebay. In 2002, Perry et al. found that first entrances by the juvenile kokanee (Perry et al. 2003b) were more prevalent along the right bank (i.e., eastern shore) of the forebay (Perry et al. 2003b). They found that 40% of their tagged kokanee entered the third powerplant forebay within 35 m of the right bank. This was likely because most of the fish tagged during that study were released also along the eastern shore approximately 400 m upstream. The release location for this study was about the same distance from the dam but was several hundred meters out in the reservoir (Figure E.1).

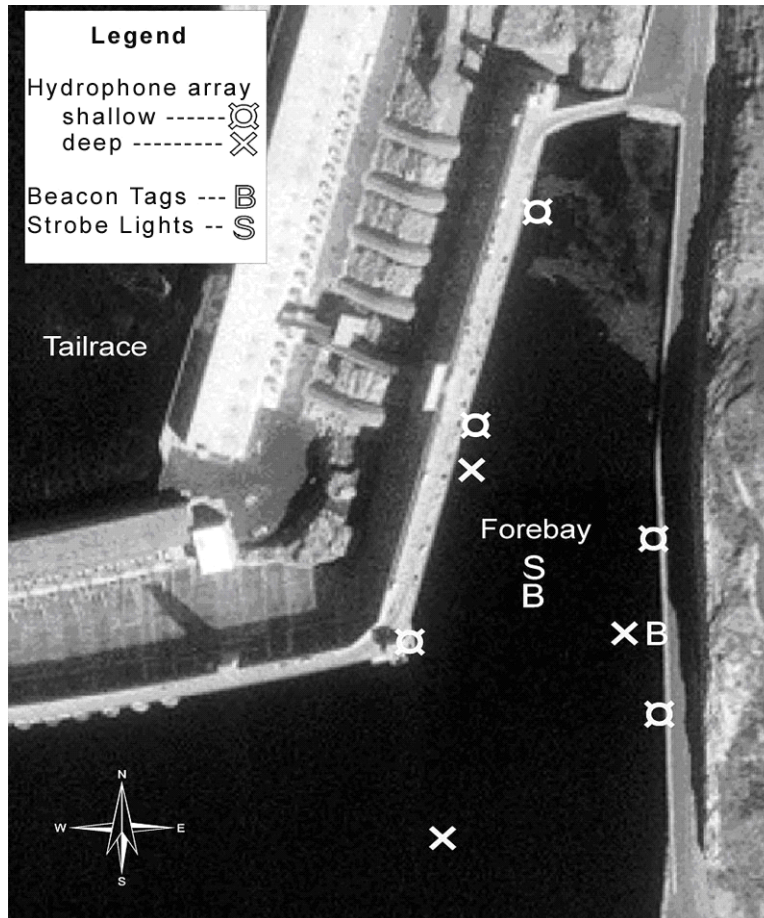
Figure E.2. Locations of the Hydrophone Array, Beacon Tags, and the Strobe Light Array near the Third Powerplant Forebay of Grand Coulee Dam, June 2003
