Chief Joseph Kokanee Enhancement Project

Strobe Light Deterrent Efficacy Test and Fish Behavior Determination at the Grand Coulee Dam Third Powerplant Forebay

Annual Report 2003 - 2004

DOE/BP-00000652-25

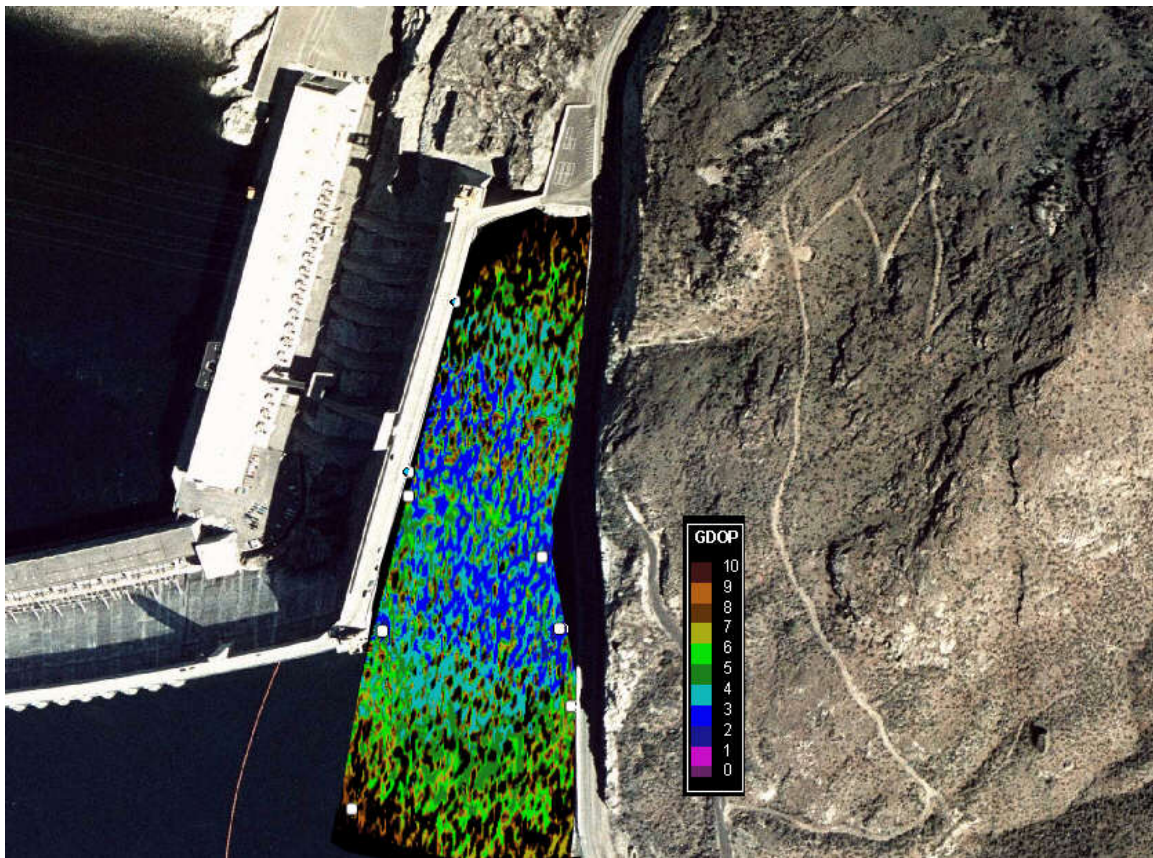
Figure E.3. Geometric Dilution of Precision (GDOP in meters) for the Area Within and Upstream of the Third Powerplant Forebay at Grand Coulee Dam, 2003. The GDOP contour shown is the absolute error in meters from FishTrack3D at a depth of 8 m.

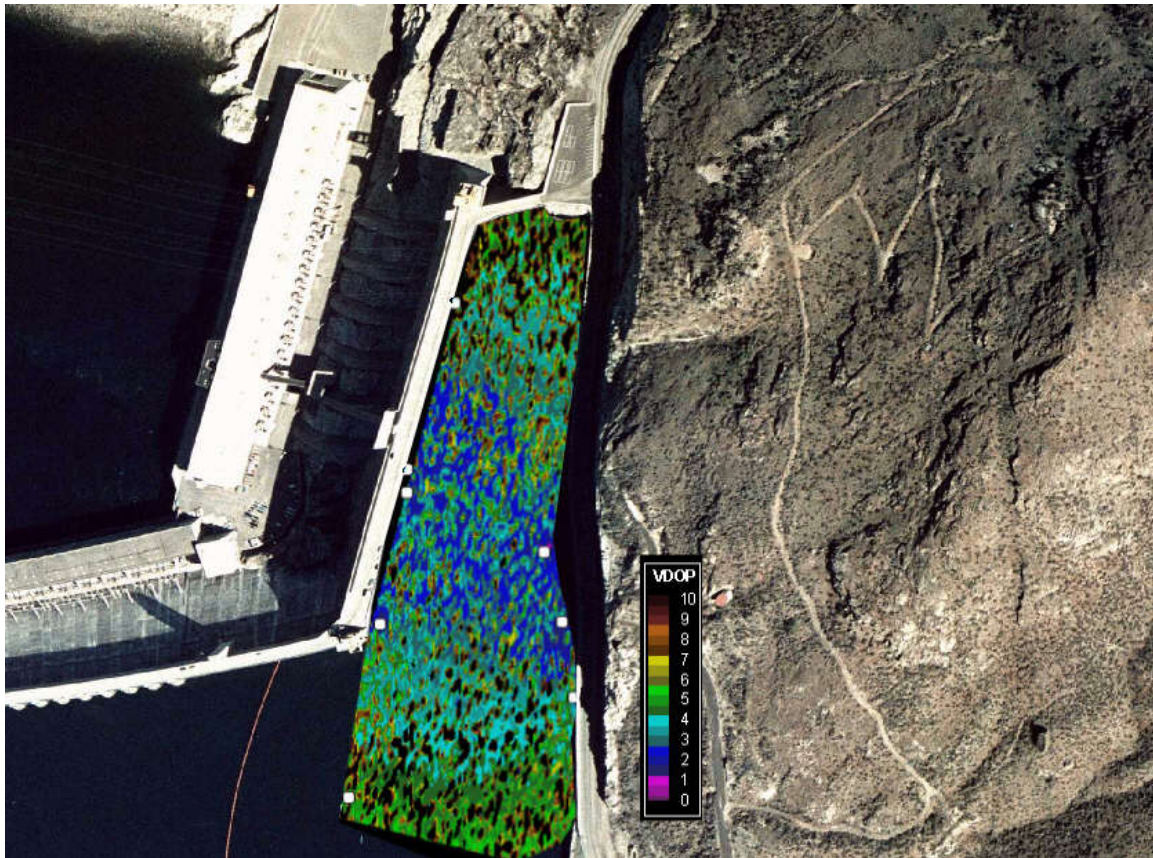
Figure E.4. Vertical Dilution of Precision (VDOP in meters) for the Area Within and Upstream of the Third Powerplant Forebay at Grand Coulee Dam, 2003. The VDOP contour shown is the absolute error in meters from FishTrack3D at a depth of 8 m.

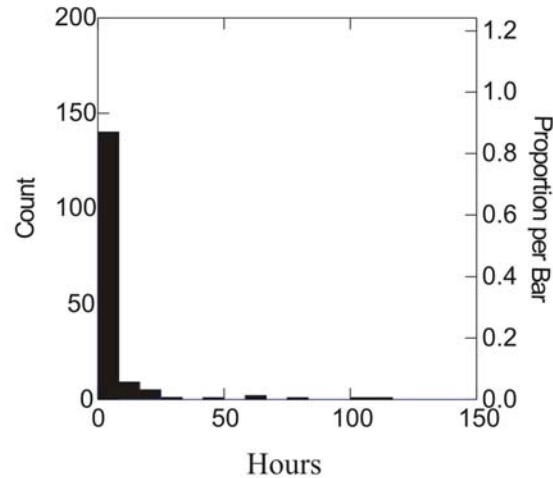
Figure E.6. Number of Hours for Acoustic Tagged Juvenile Kokanee (n = 162) to Travel 0.8 km from the Release Site into the Three-Dimensional Acoustic Array in the Forebay of the Third Powerplant of Grand Coulee Dam, June 2003

distribution of times for fish to enter the array was skewed, with most fish arriving in less than an hour, while some took more than 100 hr (Figure E.6). First entry of tagged juvenile kokanee into the array was distributed across the entire forebay entrance (Figure E.7). However, more than one-third (36%) of the tagged fish approached the forebay along the southwest corner.

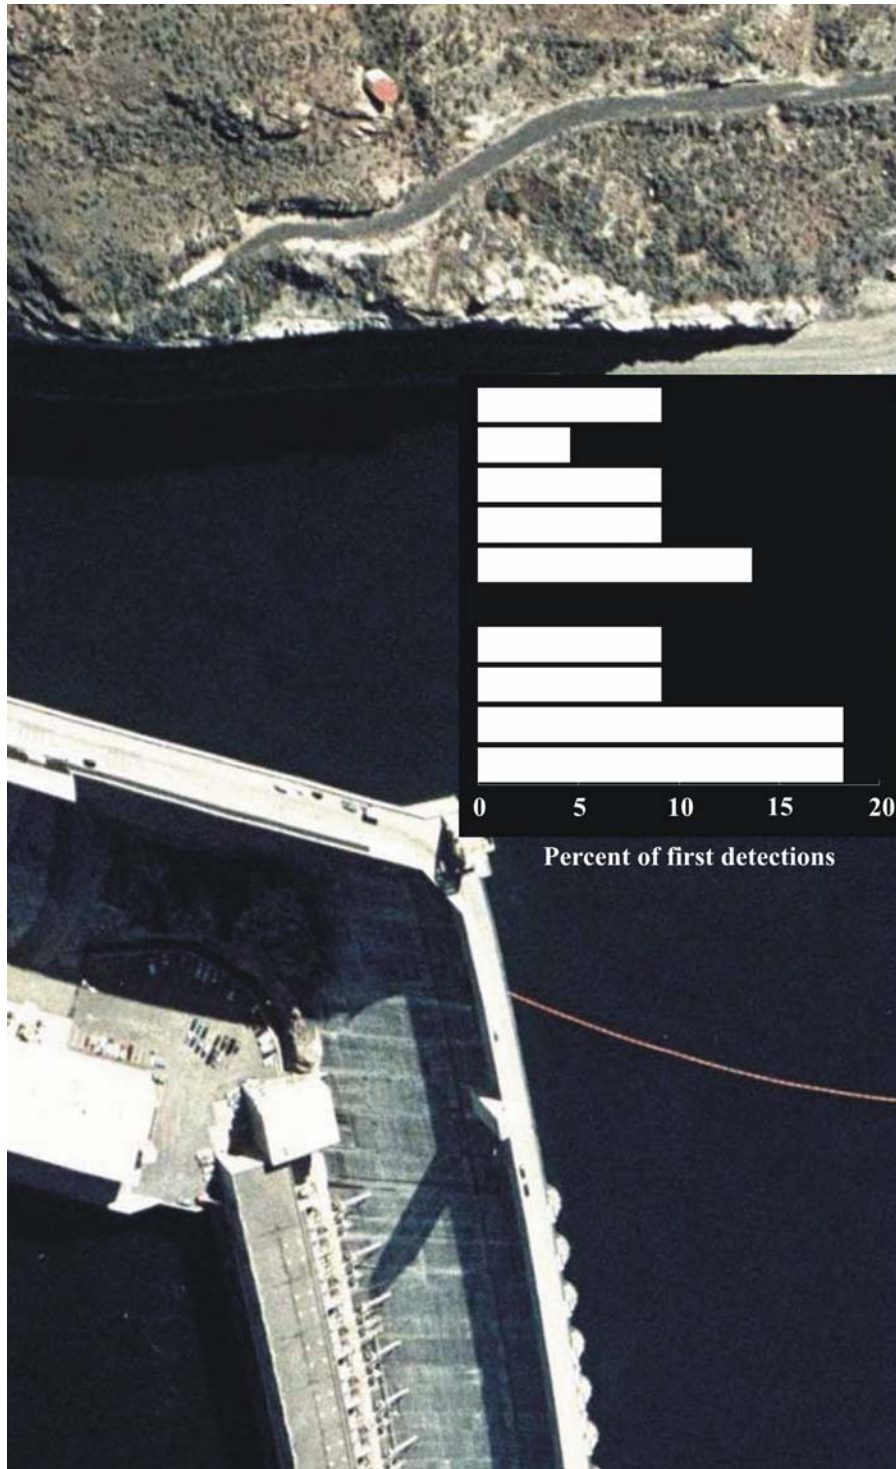
Figure E.7. Distribution of First Detections of Acoustic Tagged Juvenile Kokanee (n = 22) Across the Entrance to the Third Powerplant Forebay at Grand Coulee Dam, June 2003. The dam can be seen in the lower left half of the picture, while the third powerplant forebay is in the upper left half of the picture.

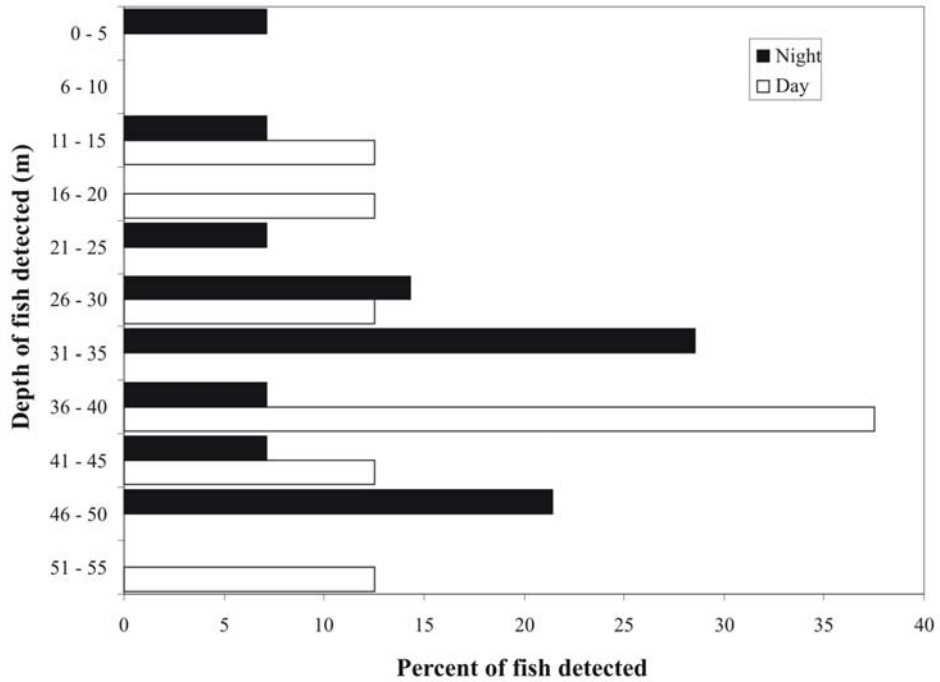
Figure E.8. Vertical Distribution of Acoustic Tagged Juvenile Kokanee Detected During the Day and Night (n = 22) Across the Entrance to the Third Powerplant Forebay, Grand Coulee Dam, June 2003

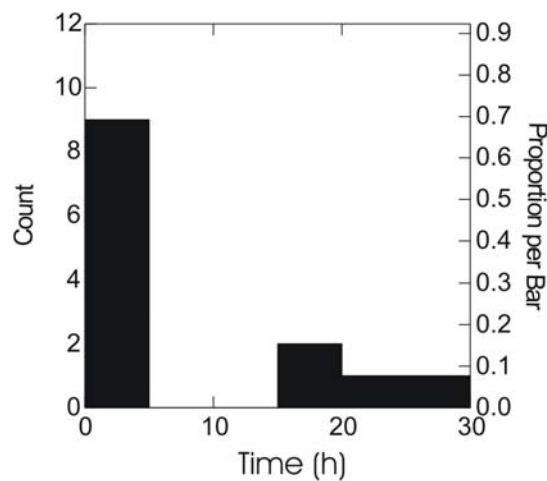
Figure E.9. Number of Hours for Acoustic Tagged Juvenile Kokanee to Reach the Bridge Below Grand Coulee Dam After Being Entrained Through the Third Powerplant, June 2003 (n = 13). The bridge is approximately 0.9 km downstream.

Most of the fish entrained through the third powerplant took a relatively short time to reach the bridge (median 0.22 hr, mean 7.3 hr, standard deviation 11.22 hr, n = 11). However, two of the entrained fish took more than 24 hr to reach the bridge (Figure E.9).

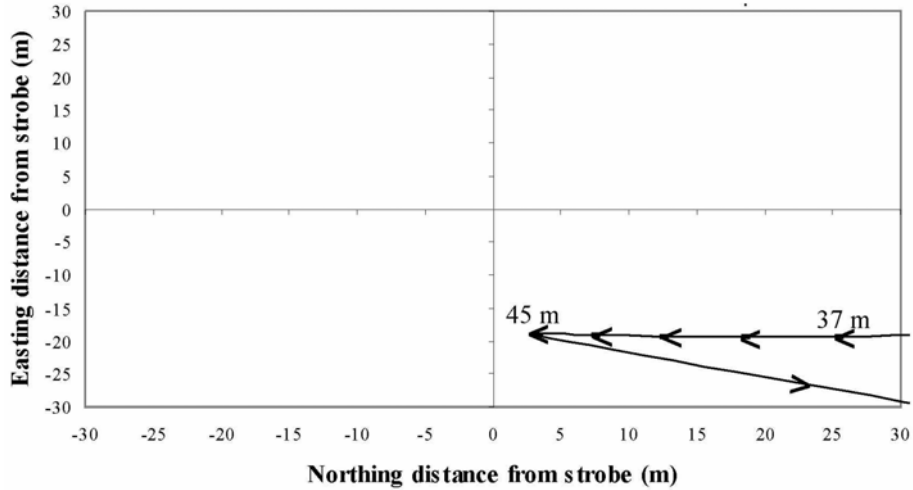
Figure E.10. Plan View of the Direction and Depth of a Tagged Juvenile Kokanee as It Approached the Strobe Lights in the Third Powerplant Forebay of Grand Coulee Dam, June 2003. Strobe lights were off. Arrows indicate the direction of fish movement. The strobe lights are at the origin in the center of the figure. Depths of the fish are indicated along the trajectory.

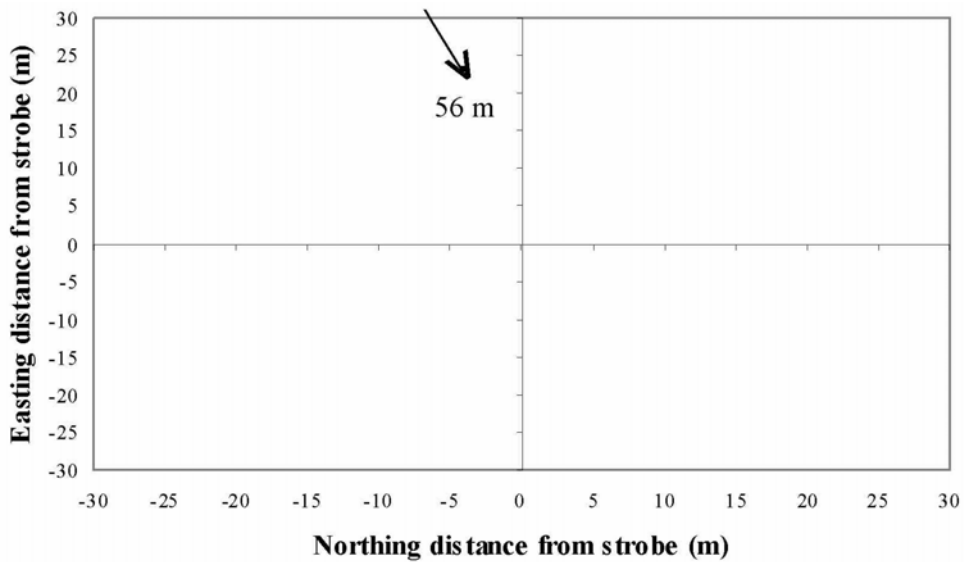
Figure E.11. Plan View of the Direction and Depth of a Tagged Juvenile Kokanee During the Day as It Approached the Strobe Lights in the Third Powerplant Forebay of Grand Coulee Dam, June 2003. Three strobe lights were on. Arrows indicate the direction of fish movement. The strobe lights are at the origin in the center of the figure. Depths of the fish are indicated along the trajectory.

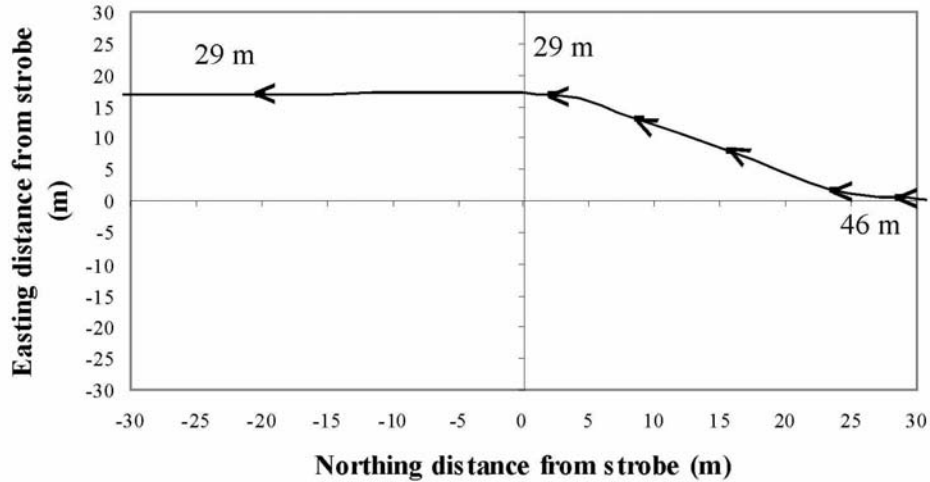
Figure E.12. Plan View of the Direction and Depth of a Tagged Juvenile Kokanee at Night as It Approached the Strobe Lights in the Third Powerplant Forebay of Grand Coulee Dam, June 2003. Three strobe lights were on. Arrows indicate the direction of fish movement. The strobe lights are at the origin in the center of the figure. Depths of the fish are indicated along the trajectory.

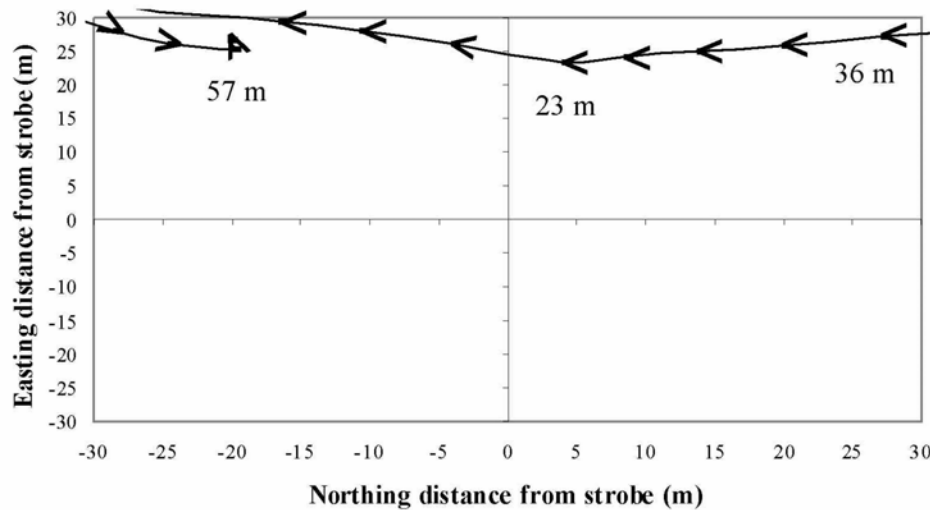
Figure E.13. Plan View of the Direction and Depth of a Tagged Juvenile Kokanee at Night as It Approached the Strobe Lights in the Third Powerplant Forebay of Grand Coulee Dam, June 2003. Three strobe lights were on. Arrows indicate the direction of fish movement. The strobe lights are at the origin in the center of the figure. Depths of the fish are indicated along the trajectory.

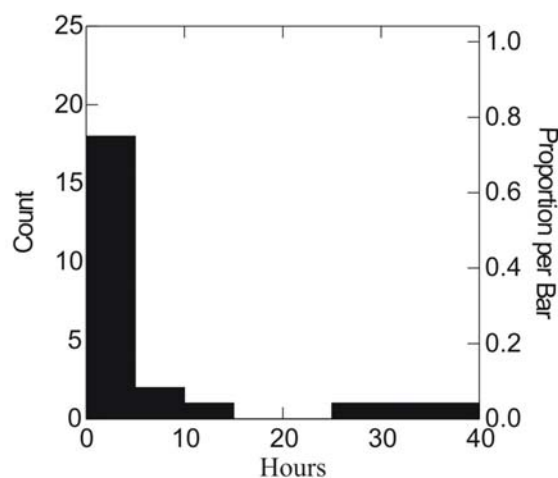
Figure E.14. Residence Time for Acoustic Tagged Juvenile Kokanee in the Third Powerplant Forebay of Grand Coulee Dam, June 2003 (n = 31)

The tagged fish spent a median of 0.4 hr (mean 5.7 hr) inside the third powerplant forebay. Most fish spent only a few hours in the third powerplant forebay. However, some fish spent more than 30 hours in the forebay (Figure E.14).

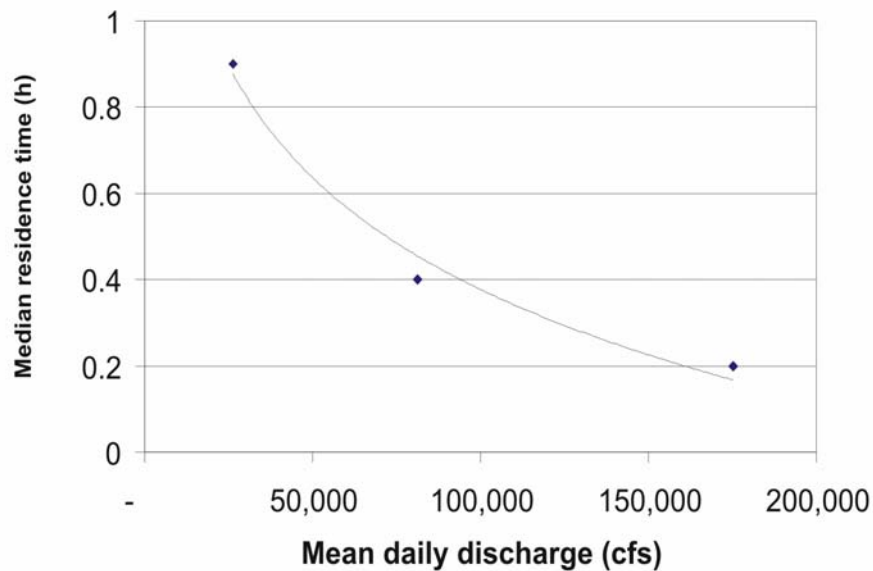
Figure E.15. Relationship Between Mean Daily Discharge Through the Third Powerplant Averaged over the Entire Study Period and the Median Residence Time for Acoustic Tagged Kokanee in the Third Powerplant Forebay, Grand Coulee Dam

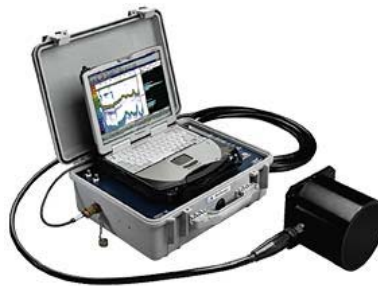
Mobile hydroacoustic surveys were conducted from a boat using a BioSonics, Inc.^(a) DT-X digital scientific echosounding system. The system comprised three components as pictured in Figure F.1: 1) a digital splitbeam transducer; 2) a ruggedized surface unit with programmable Linux-based Emb processor inside; and, 3) a ruggedized laptop computer to control the system operation and log data.

Figure F.1. DT-X Splitbeam Hydroacoustic System Used for Mobile Surveys at Grand Coulee Dam Third Powerplant in 2003

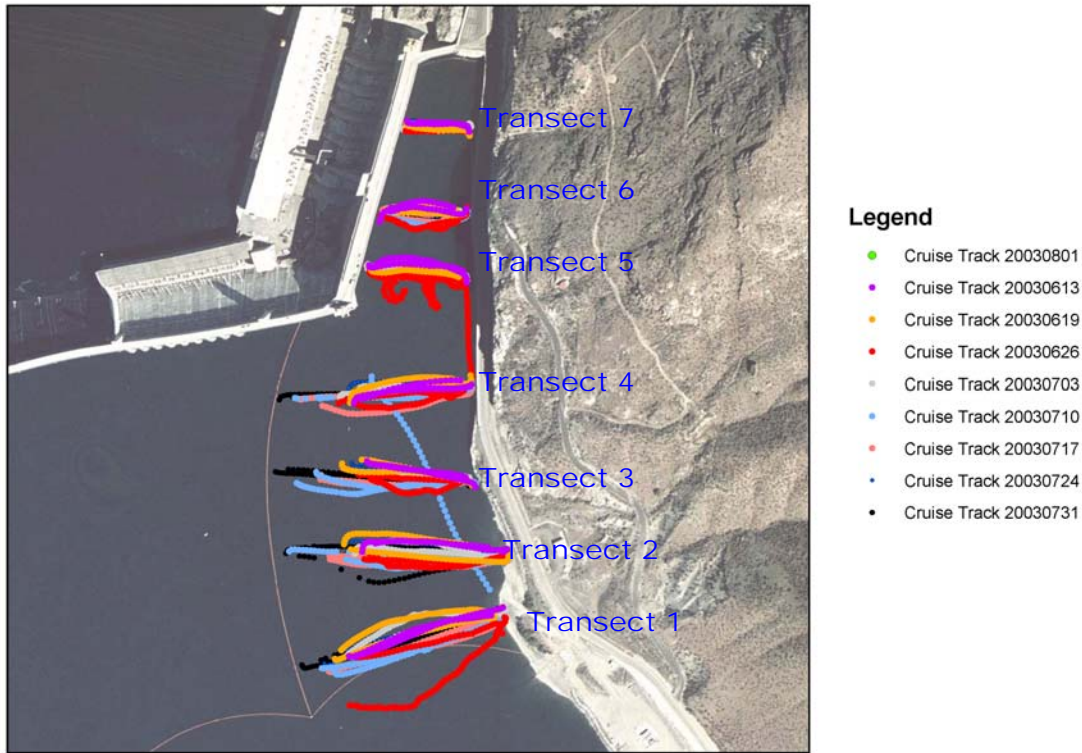
Figure F.2. Mobile Transects Conducted from June 13, 2003, to August 1, 2003, at Grand Coulee Dam Third Powerplant (shown with replication)

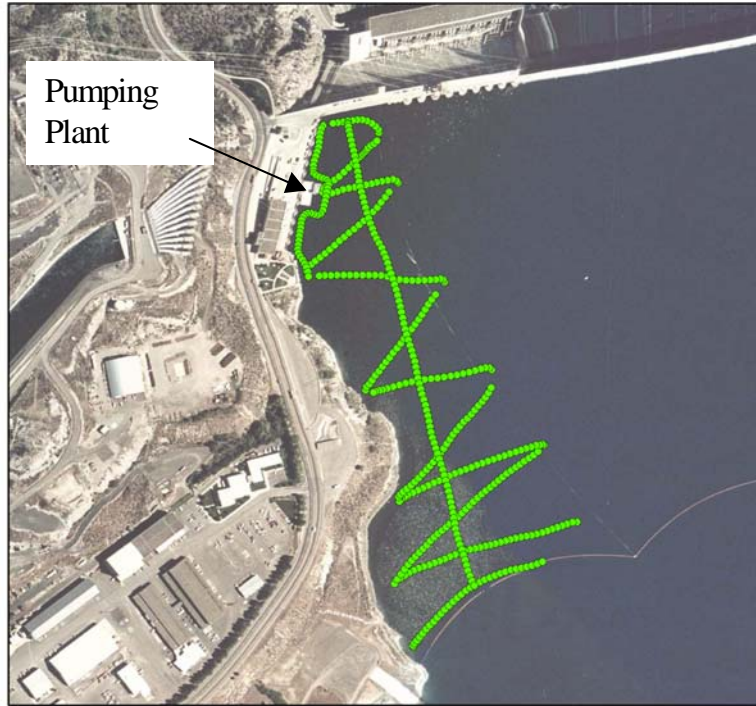
Figure F.3. Exploratory Mobile Survey Conducted Near the Pumping Plant (Grand Coulee Dam, August 1, 2003)

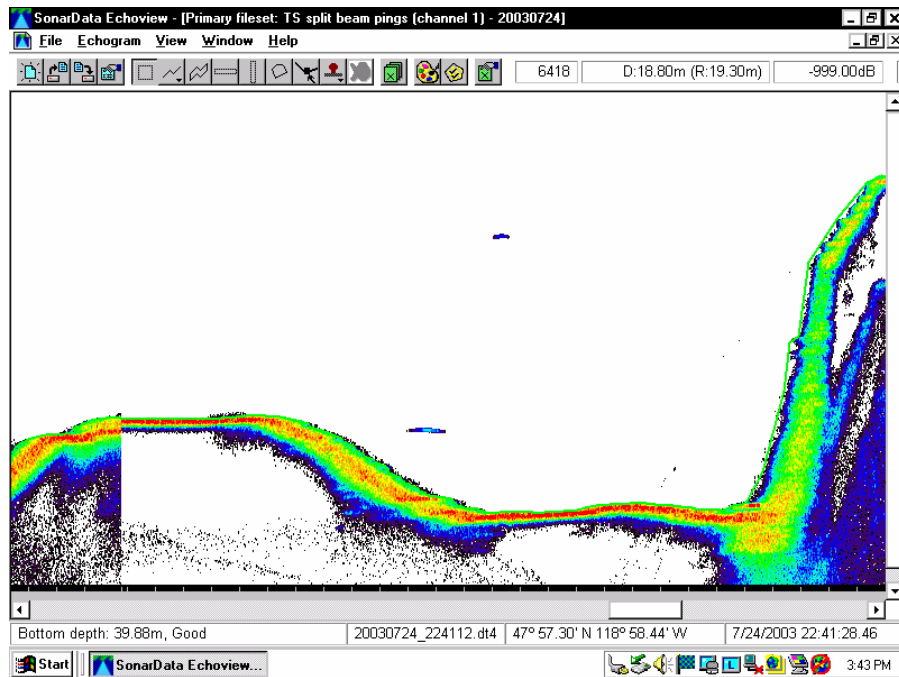
Figure F.4. Echoview Screen Showing Bottom Track and Two Fish in the Water Column (Grand Coulee Dam, July 24, 2003)

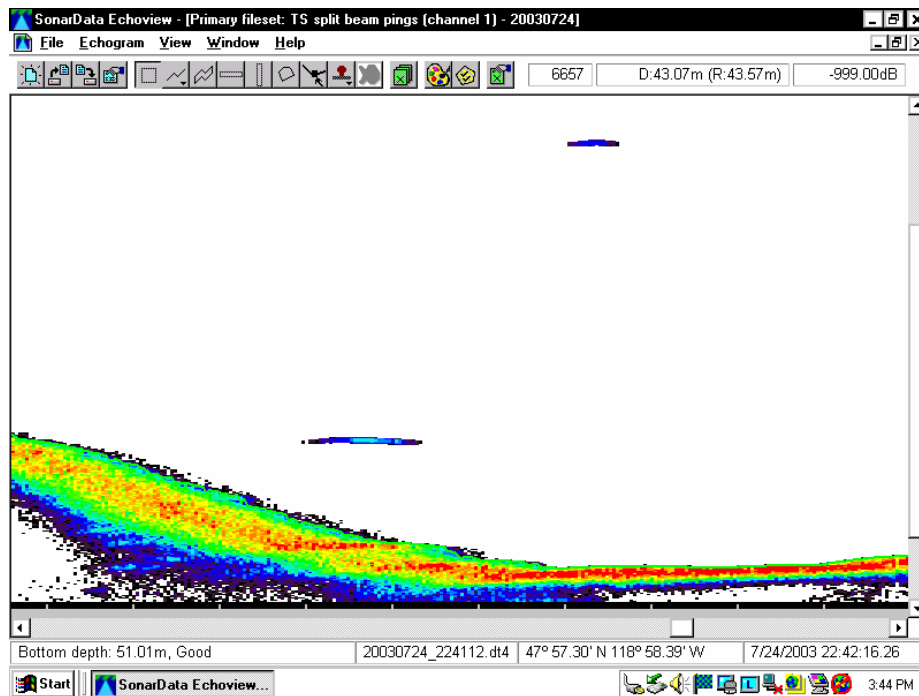
Figure F.5. Echoview Screen Showing Bottom Track and Two Fish in the Water Column Zoomed in To Better Show the Target Continuity (Grand Coulee Dam, July 24, 2003)

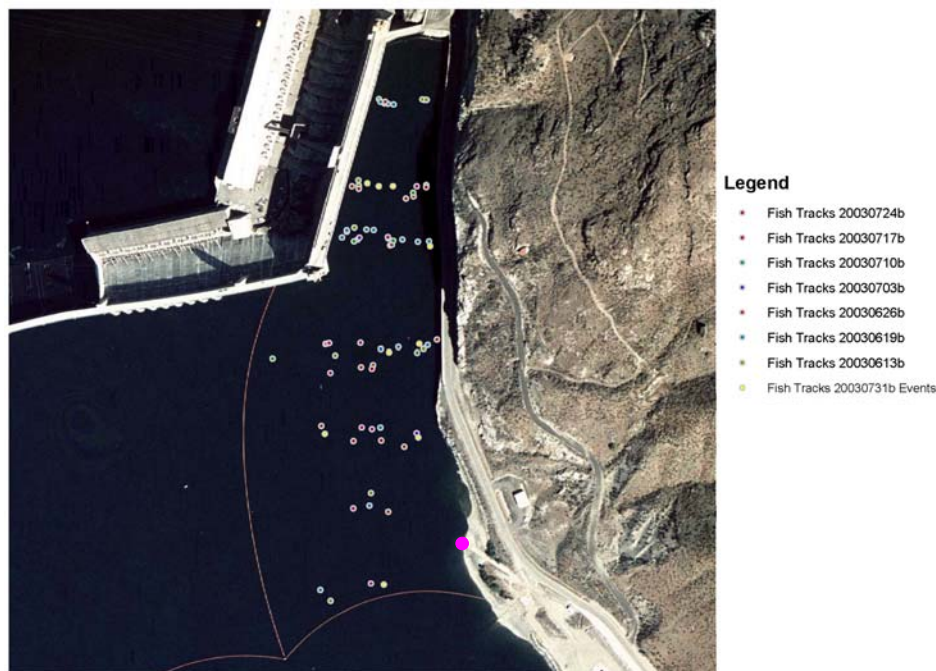
Figure F.6. Location of Fish Detected During Mobile Surveys of the Third Powerplant (right bank of Lake Roosevelt) Forebay at Grand Coulee Dam from June 13 through July 31, 2003. Pink dot indicates approximate location of boat launch.

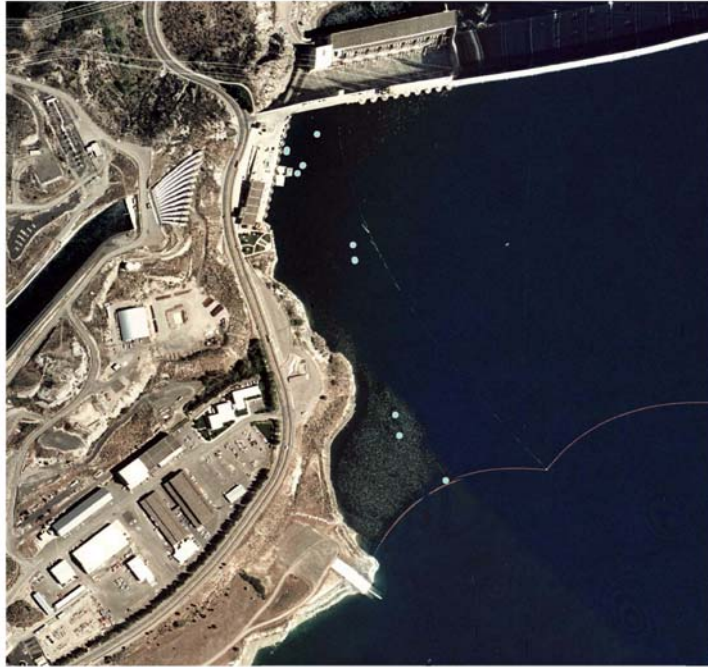
Figure F.7. Location of Fish Detected (blue dots) at the Pumping Plant (left bank) at Grand Coulee Dam (August 1, 2003)

was needed. The survey revealed the presence of several pelagic fish upstream of the pumping plant and another group associated with structures near the pumping plant (Figure F.7).

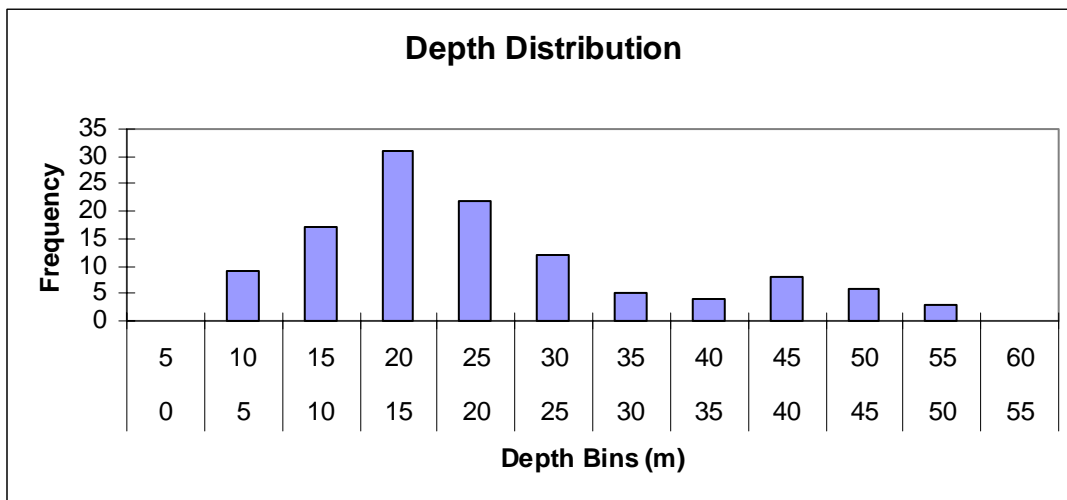
Figure F.8. Fish Depth Distribution at Grand Coulee Dam Third Powerplant Forebay in 2003 (n = 93). Fish were detected at night.

Vertical distribution of fish detected in the third powerplant forebay appeared to be bimodal in 2003 (Figure F.8). The majority of the fish were located between 10 and 30 m, with the peak between 15 and 20 m and

20 m. This was about 5 m below the strobe light frame in 2003, which was consistent with data collected in the illuminated region immediately upstream of the strobe lights at night. A second, much smaller peak in the distribution occurred between 40 and 45 m depth, with the deeper fish distribution ranging from 35 to 55 m.

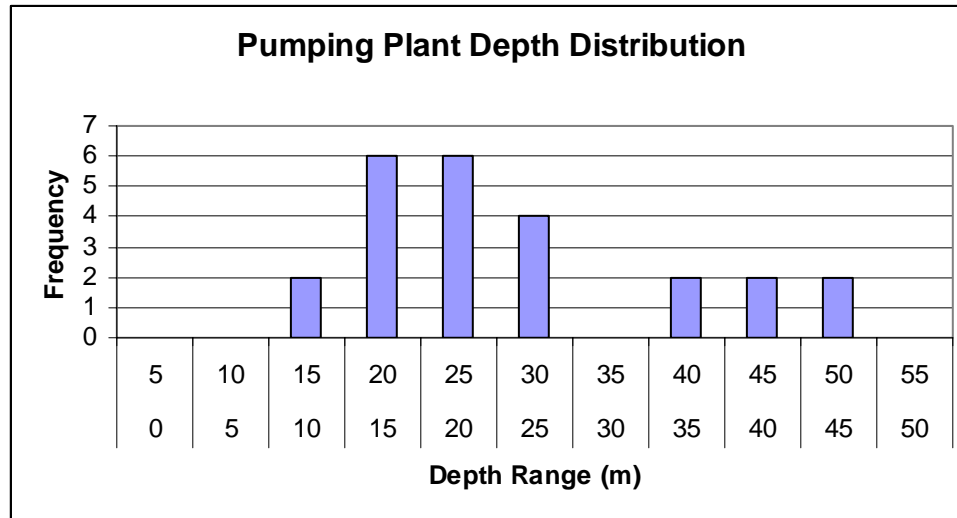
Figure F.9. Fish Depth Distribution at Grand Coulee Dam Pumping Plant Forebay in 2003 (n = 24). Survey conducted during daytime.

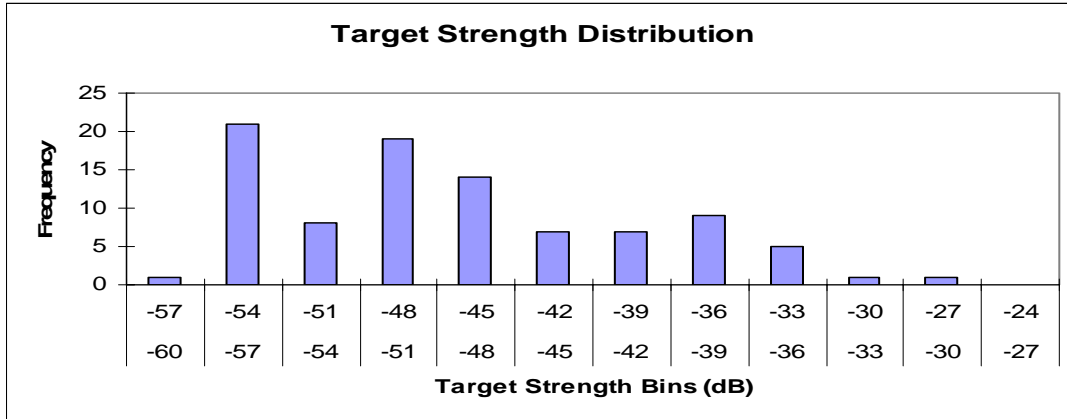
Figure F.10. Acoustic Size Distribution (Target Strength) of Fish in the Third Powerplant Forebay of Grand Coulee Dam in 2003 (n = 93)

Target strength measurements using the splitbeam approach varied widely throughout the third powerplant forebay during the season (Figure F.10). Smaller targets (<- 54 dB) may have been debris dropout, which usually was associated with a growing raft of debris at the north end of the third powerplant forebay. These smaller targets are more difficult to identify as fish because their effective sample volume is much smaller than that of larger fish targets. Thus, the number of ensonifications is less, usually at or near the minimum established to accept a target. With the small targets removed, the distribution takes on a bimodal appearance with peaks at about -50 dB and -38 dB. This suggests the presence of two distinct size classes of fish in the area of interest.

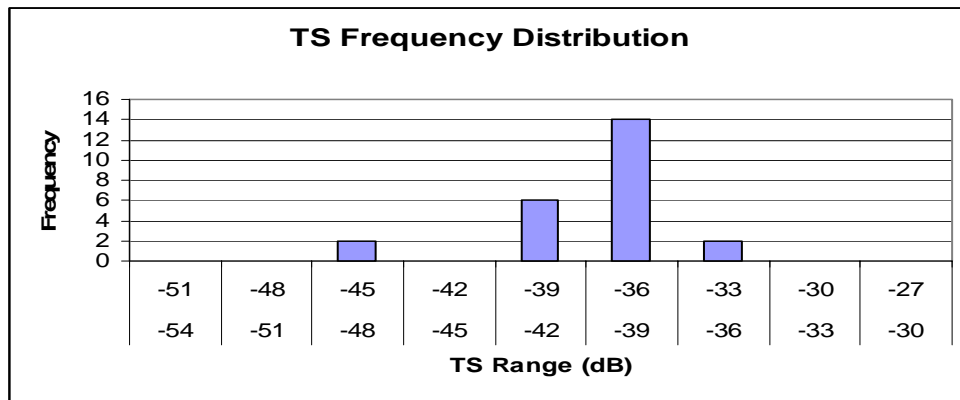
Figure F.11. Acoustic Size Distribution (Target Strength) of Fish at the Pumping Plant Forebay of Grand Coulee Dam in 2003 (n = 24)

We also examined the target strength distribution at the pumping plant (Figure F.11). The distribution of target sizes was quite different with the predominant size class being larger at the pumping plant than at the third powerplant forebay. This may be attributed to a couple of factors. First, the survey at the pumping plant was conducted during the day, while all surveys at the third powerplant were conducted at night. Smaller fish may have been seeking refuge during daylight hours to avoid predation. Second,

smaller fish may be more susceptible to entrainment at the pumping plant. The pumping plant forebay is a much smaller area with a large number of intakes. Small fish inhabiting this region would be expected to have a higher incidence of entrainment because of the constricted region and the large number of pumping units, particularly at night. However, this reasoning is purely speculative at this point. Additional study should be conducted to verify the true reason for the different size class structure in the two areas.

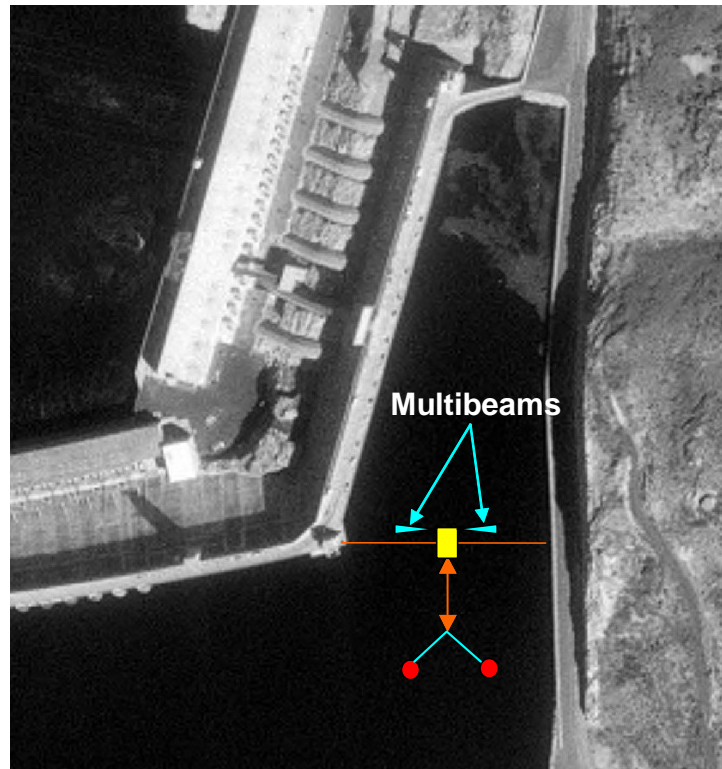
Figure G.1. Location of Two Multibeam Sonar Systems in the Forebay of the Third Powerplant, Grand Coulee Dam, 2003

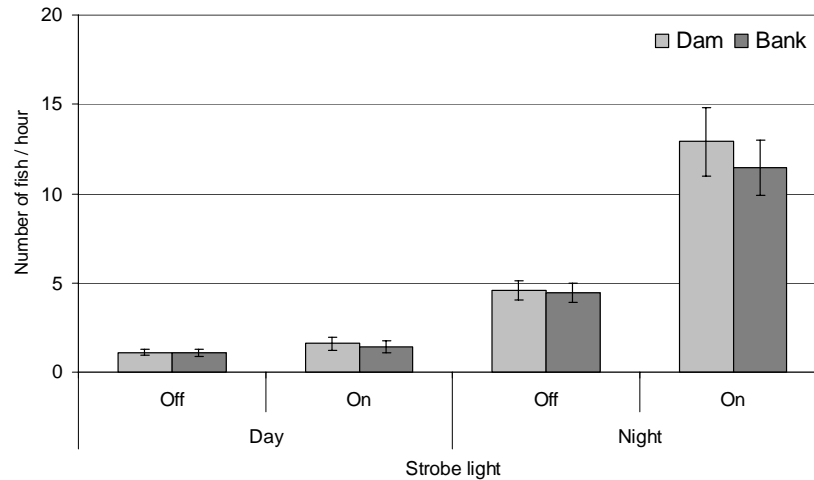
Figure G.2. Average Number of Fish Detected per Hour by Two Multibeam Sonar Heads in the Forebay of the Third Powerplant at Grand Coulee Dam Between June 4 and August 1, 2003. One sonar head ensonified the region toward the dam, while the other was oriented toward the right bank. Bars represent standard errors.

More than 20,500 fish targets were detected by the multibeam sonar between June 4 and August 1, 2003. The average numbers of fish detected per hour during the daytime and night when the lights were on and off are presented in Figure G.2. Data for the 1-hr on/off treatment were included in the totals for lights on and for lights off. The difference in counts between day and night is the result of unequal processing—only 5% of the day files were processed compared to more than 50% of the night files. There is a distinct difference between lights on and off at night, with more than twice as many fish detected when the lights were on compared to when the lights were off. There was no apparent difference during the day between lights on and off; however, the sample size was very small. Overall there was no *statistical* difference in the number of fish detected on either side of the forebay (184/day on the dam side versus 166/day on the right bank side) (t-test, $p = 0.46$).

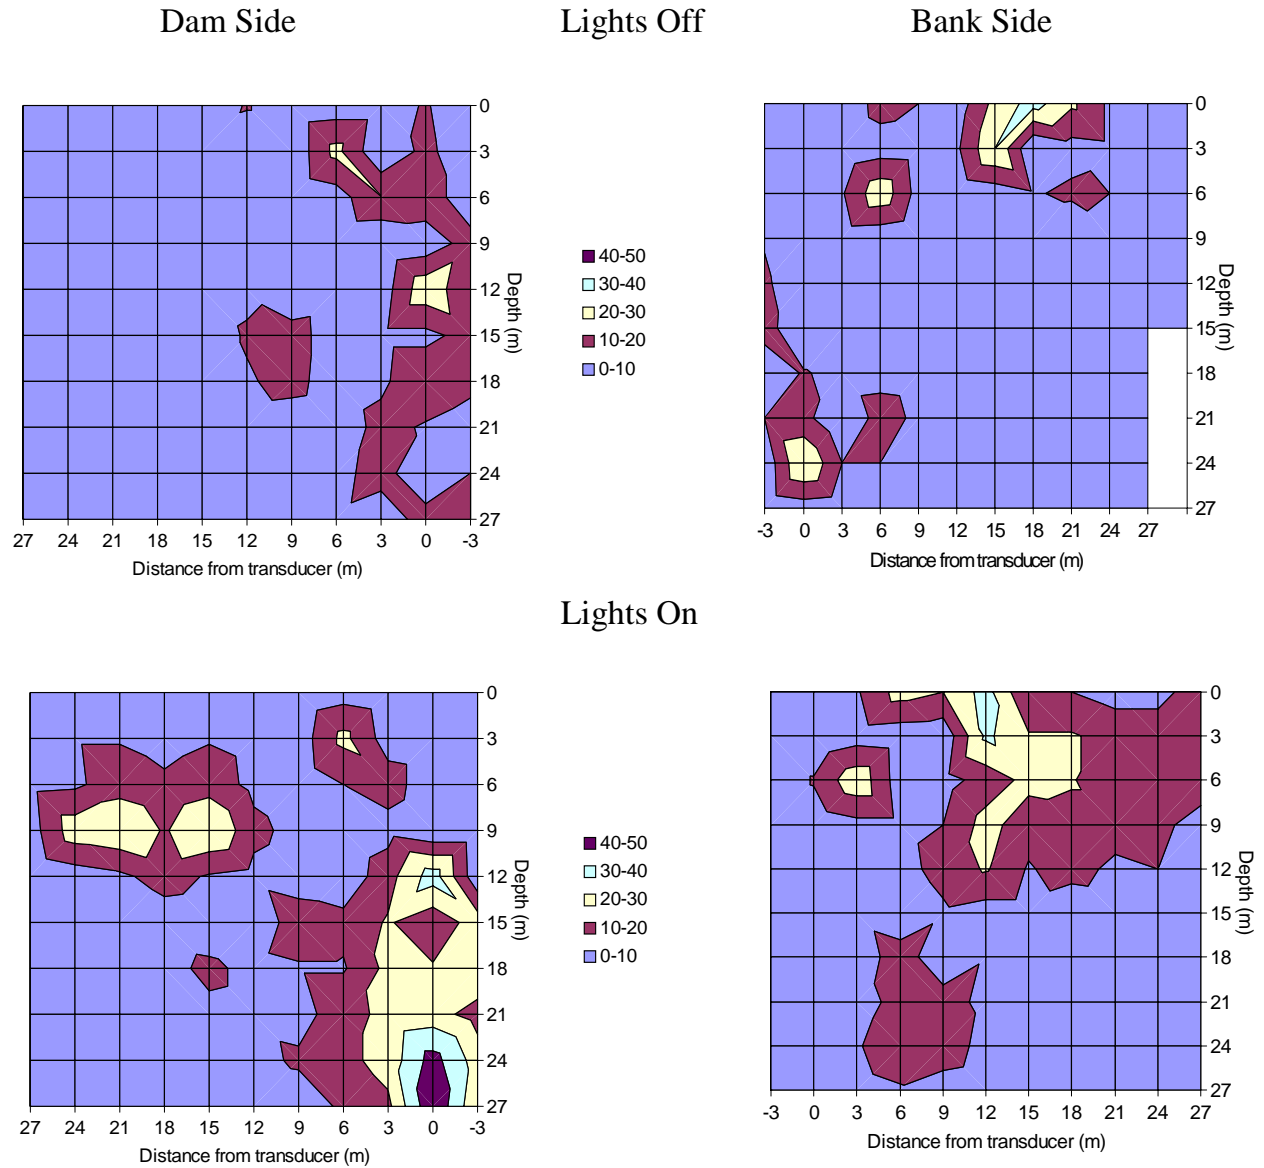
Figure G.3. Distribution of Fish Detected by Two Multibeam Sonar Heads During the Day Between June 4 and August 1, 2003. One multibeam sonar head was pointed toward the dam (Dam Side) and the other toward the right bank (Bank Side).

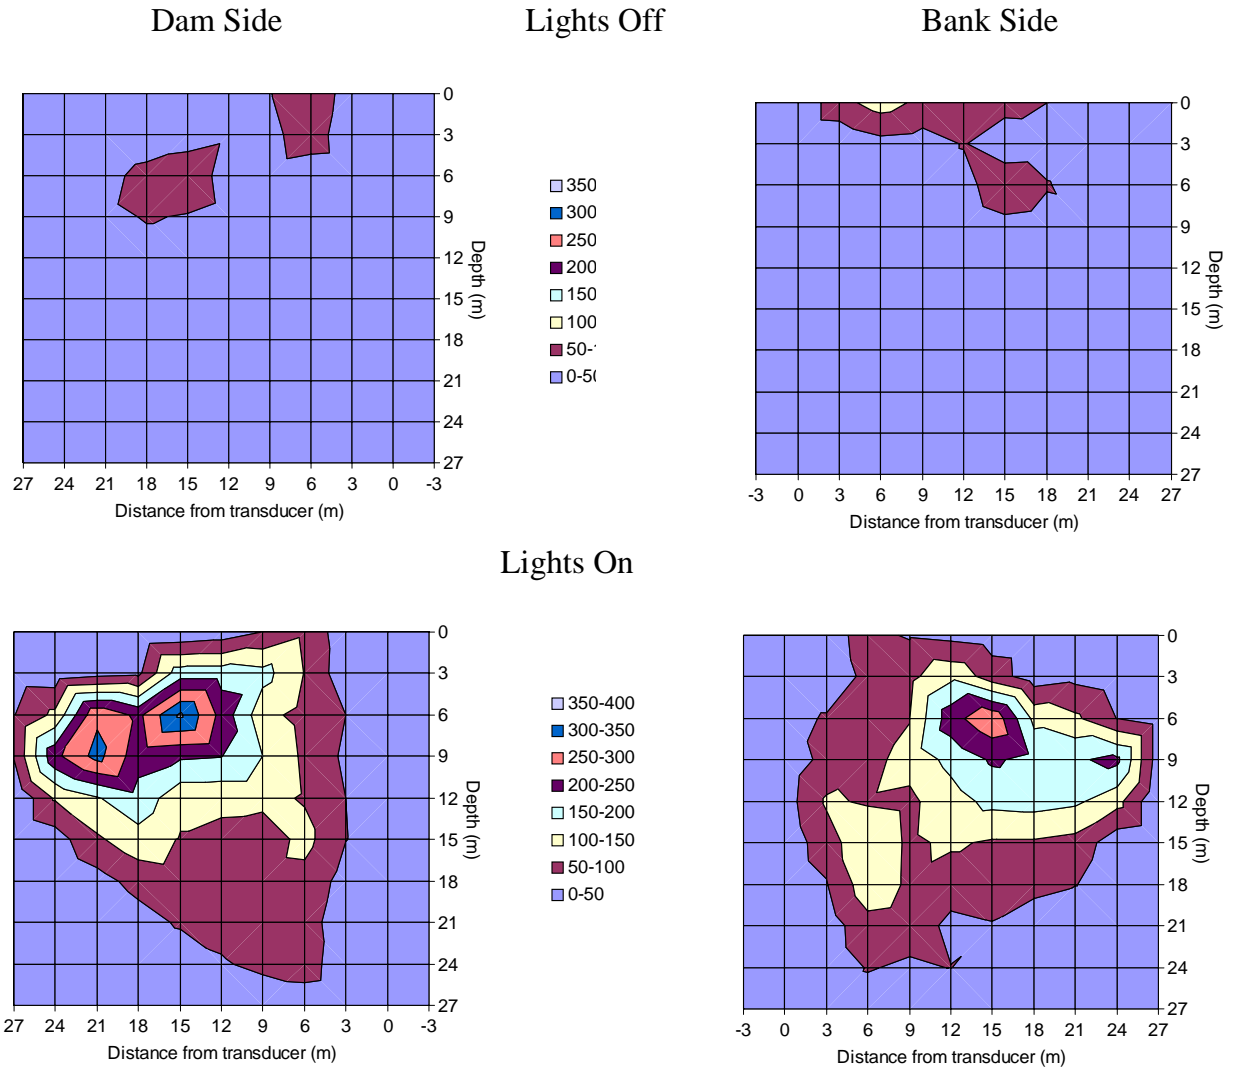
Figure G.4. Distribution of Fish Detected by Two Multibeam Sonar Heads at Night Between June 4 and August 1, 2003. One multibeam sonar head was pointed toward the dam (Dam Side) and the other toward the right bank (Bank Side).

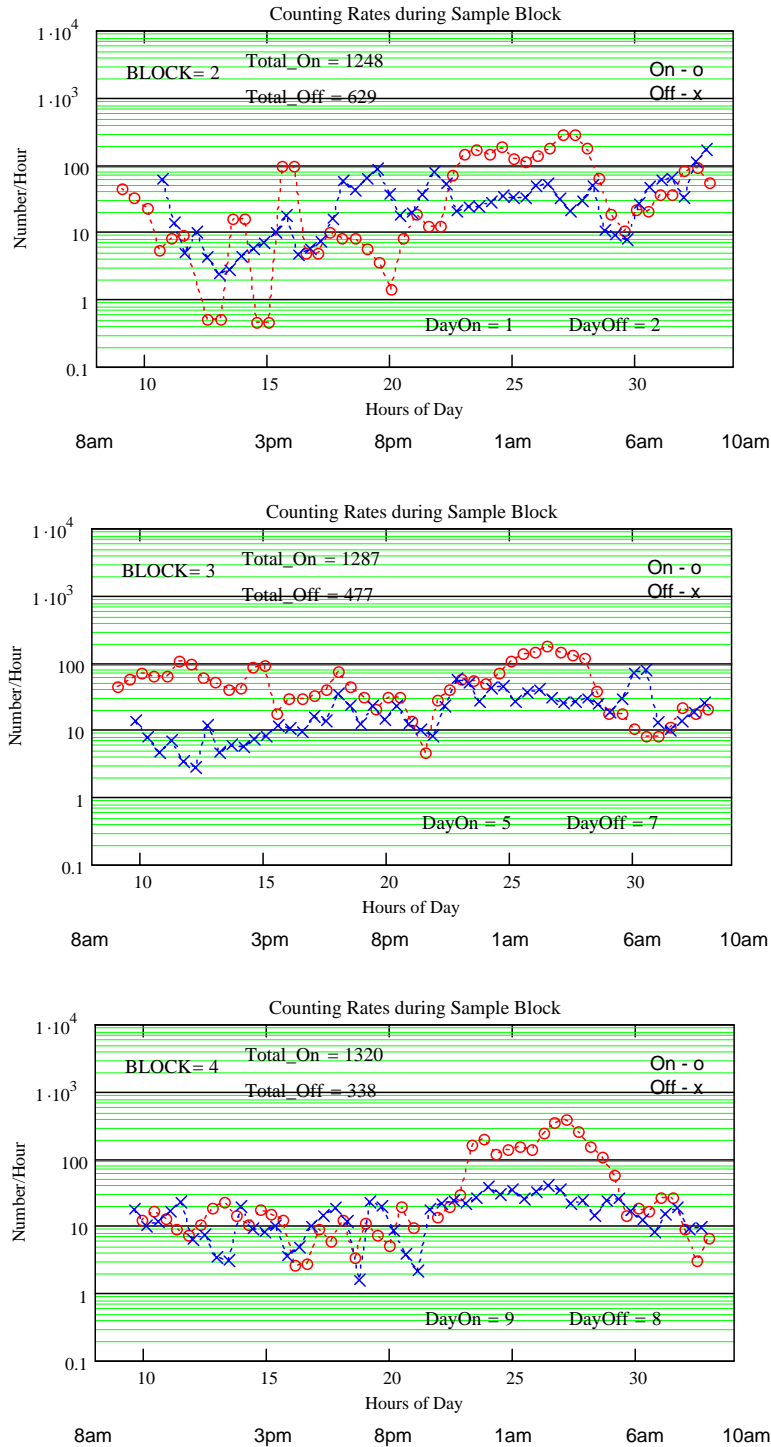
Figure H.1. Arrival Rates for Fish Detected During 24-hr Light Treatments for Blocks 2 (June 17–19, 2003) through 4 (June 24–26, 2003). Totals refer to number of fish detected. DayOn and DayOff refer to the study day numbered from June 17. Red indicates arrivals when strobe lights are on; blue represents arrivals when strobe lights are off.

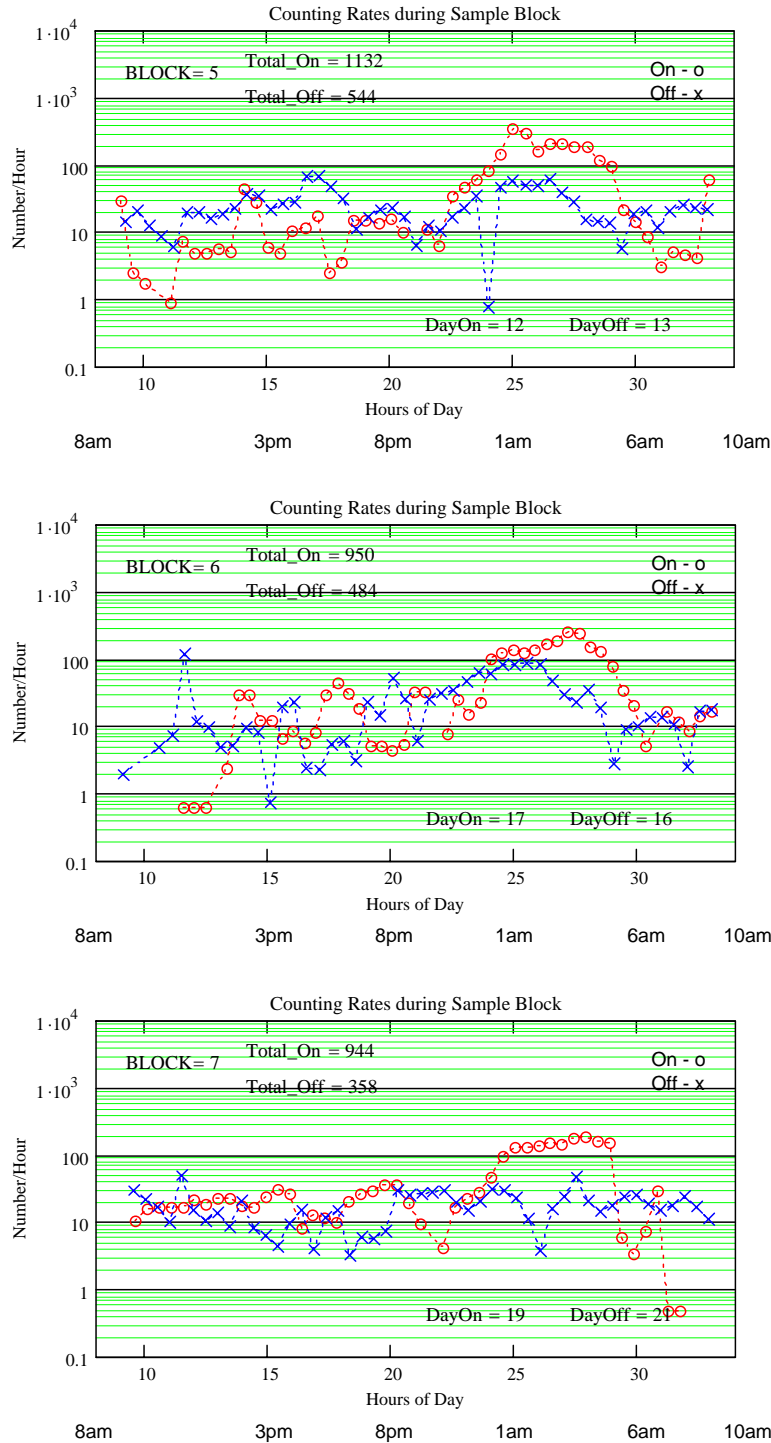
Figure H.2. Arrival Rates for Fish Detected During 24-hr Light Treatments for Blocks 5 (June 28–30, 2003) through 7 (July 5–7, 2003). Totals refer to number of fish detected. DayOn and DayOff refer to the study day numbered from June 17. Red indicates arrivals when strobe lights are on; blue represents arrivals when strobe lights are off.
