Chief Joseph Kokanee Enhancement Project

Strobe Light Deterrent Efficacy Test and Fish Behavior Determination at the Grand Coulee Dam Third Powerplant Forebay

Annual Report 2003 - 2004

DOE/BP-00000652-25

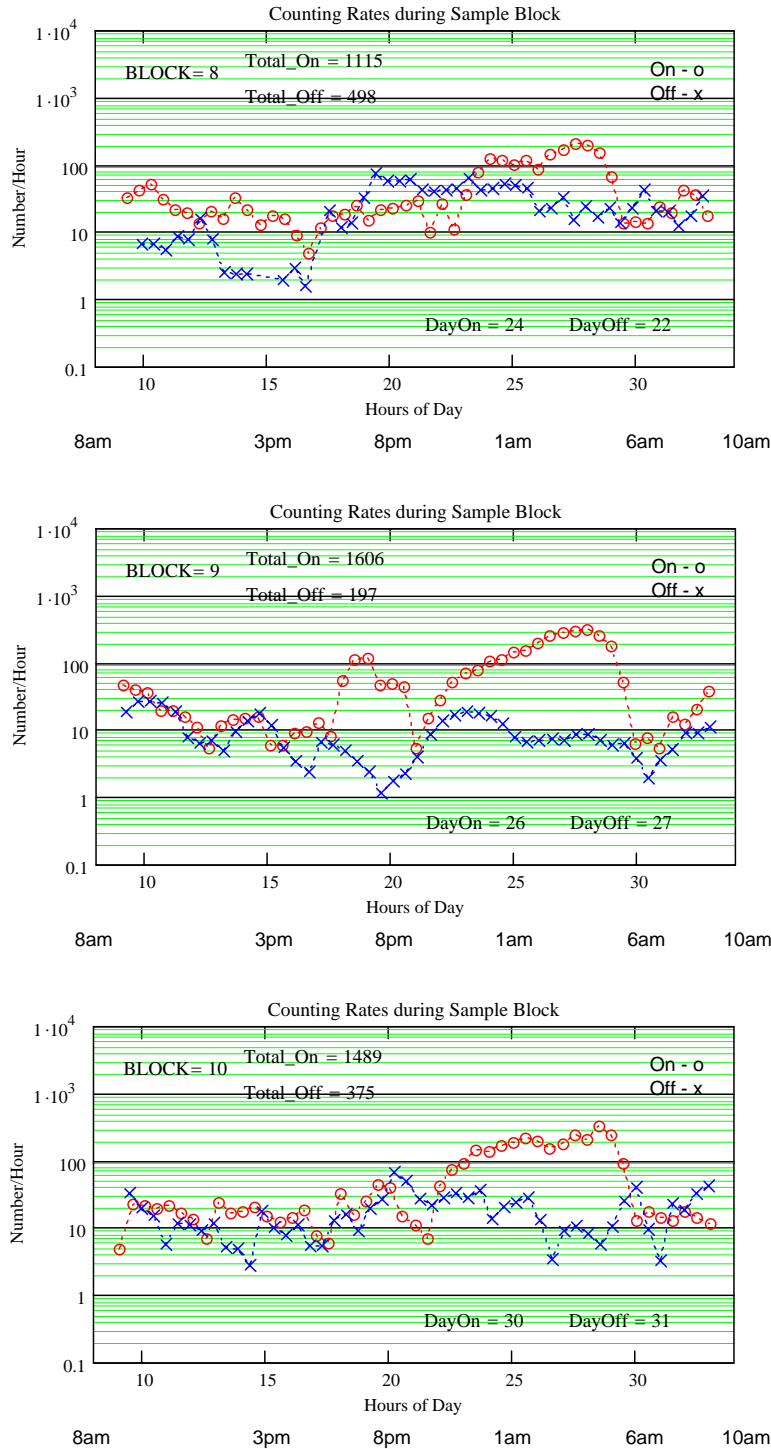
Figure H.3. Arrival Rates for Fish Detected During 24-hr Light Treatments for Blocks 8 (July 8–10, 2003) through 10 (July 15–17, 2003). Totals refer to number of fish detected. DayOn and DayOff refer to the study day numbered from June 17. Red indicates arrivals when strobe lights are on; blue represents arrivals when strobe lights are off.

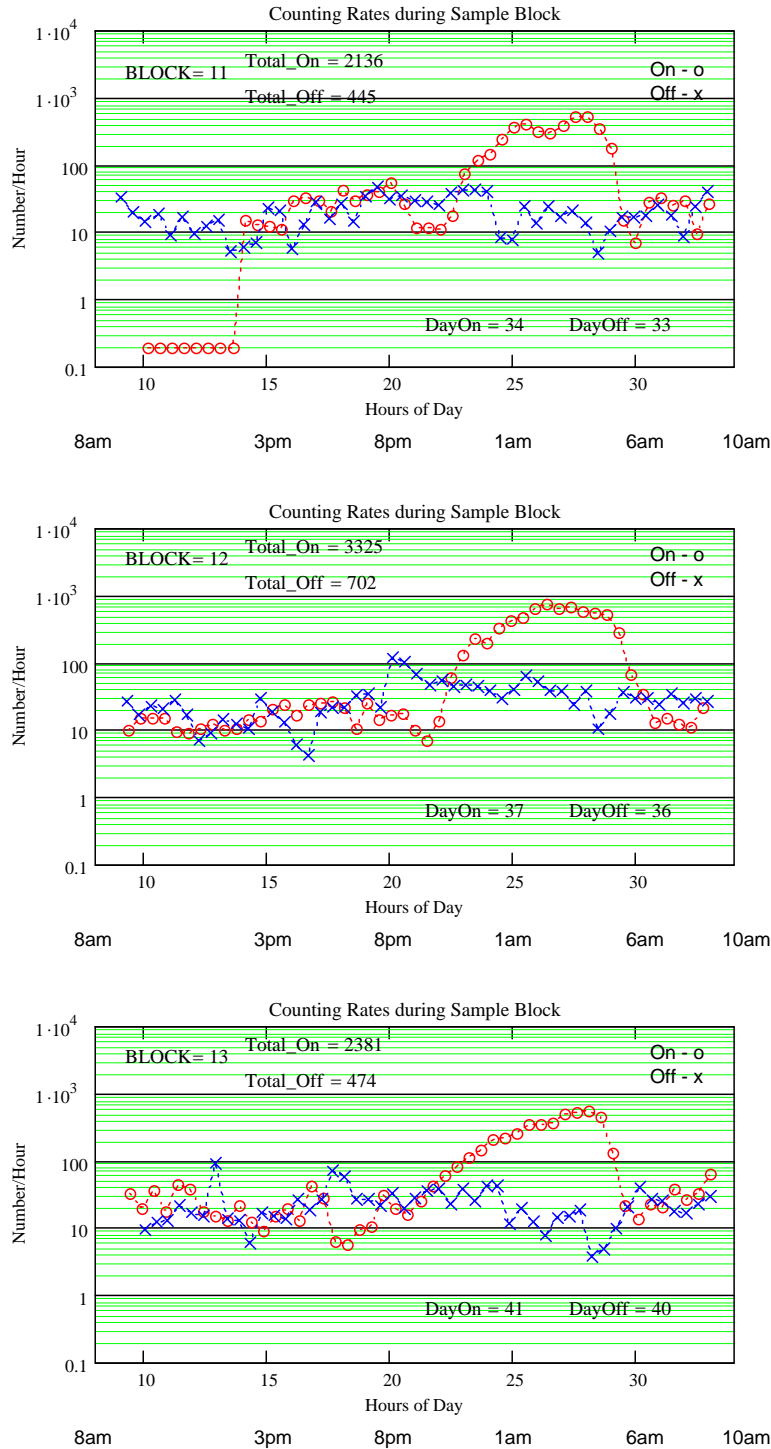
Figure H.4. Arrival Rates for Fish Detected During 24-hr Light Treatments for Blocks 11 (July 19–21, 2003) through 13 (July 26–28, 2003). Totals refer to number of fish detected. DayOn and DayOff refer to the study day numbered from June 17. Red indicates arrivals when strobe lights are on; blue represents arrivals when strobe lights are off.

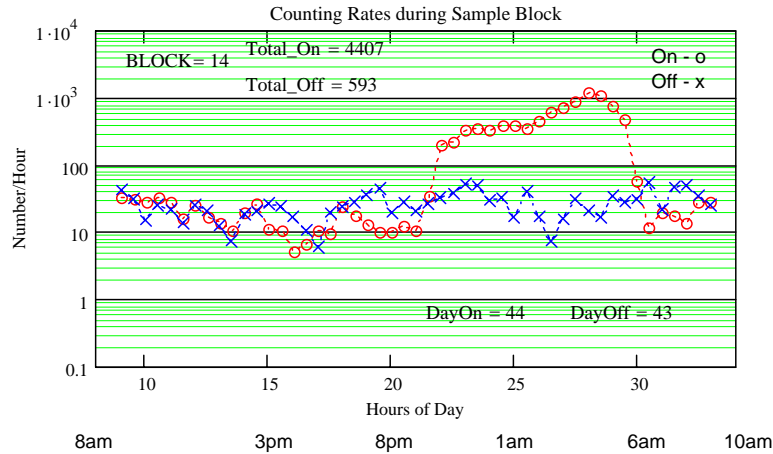
Figure H.5. Arrival Rates for Fish Detected During 24-hr Light Treatments for Block 14 (July 29–31, 2003). Totals refer to number of fish detected. DayOn and DayOff refer to the study day numbered from June 17. Red indicates arrivals when strobe lights are on; blue represents arrivals when strobe lights are off.

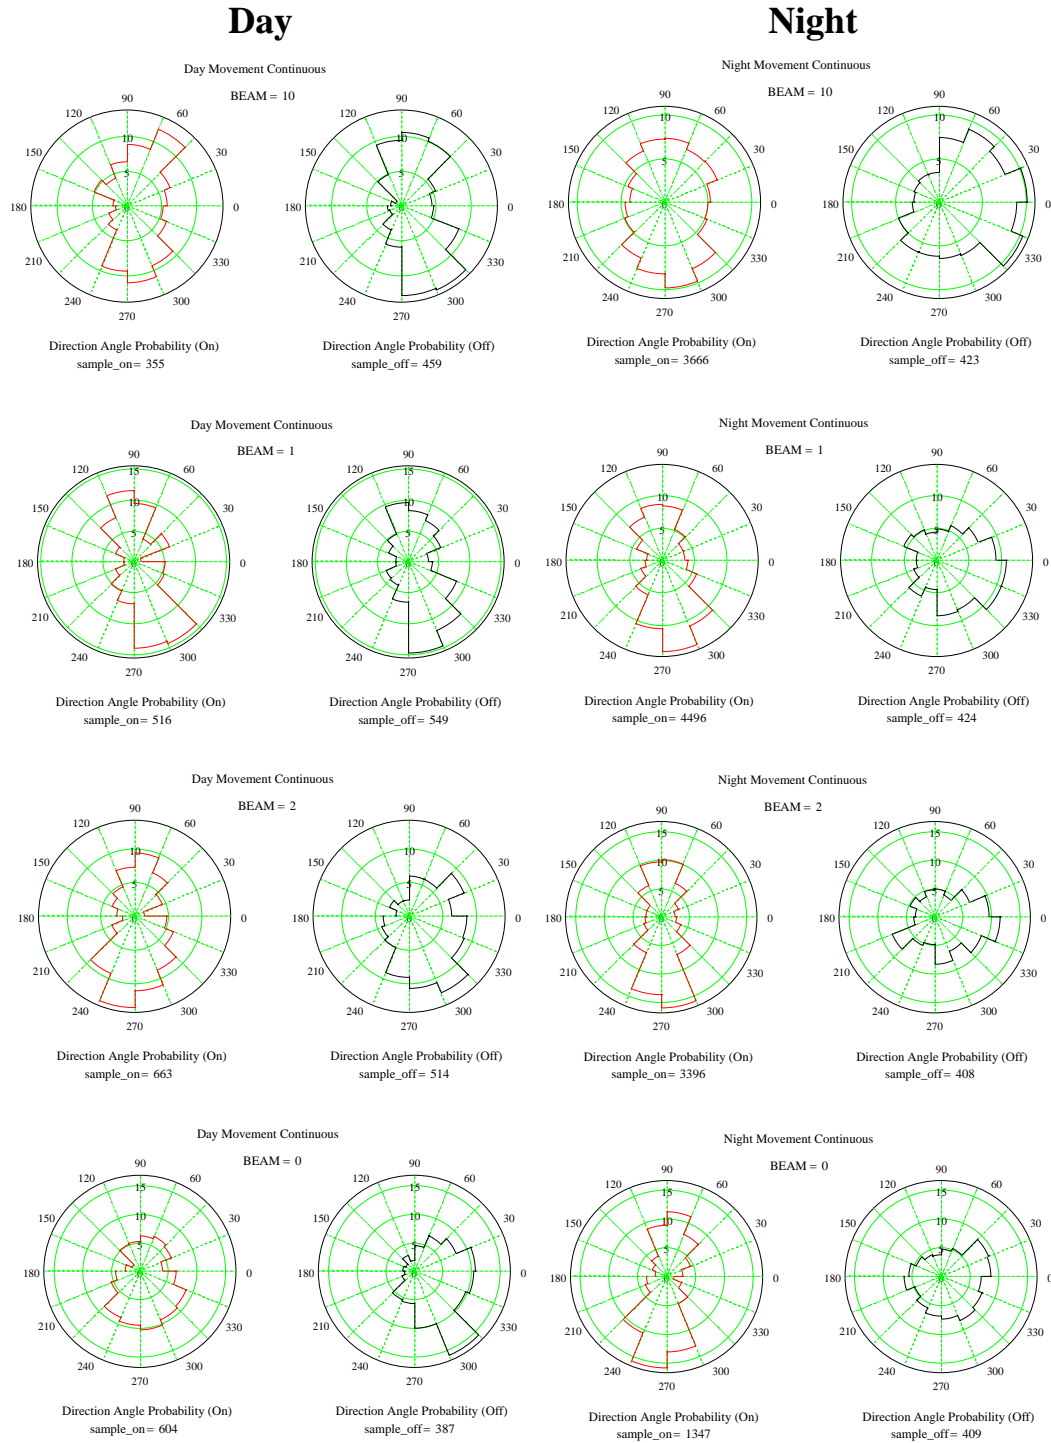
Figure H.6. Swimming Direction for Fish Detected by Splitbeam Transducers 10 (6 m from lights), 1 (10 m from lights), 2 (14 m from lights), and 0 (22 m from lights) During the Day and at Night When the Strobe Lights Were On (Red) and Off (Black) for 24 Hours. Note the scales are not consistent.

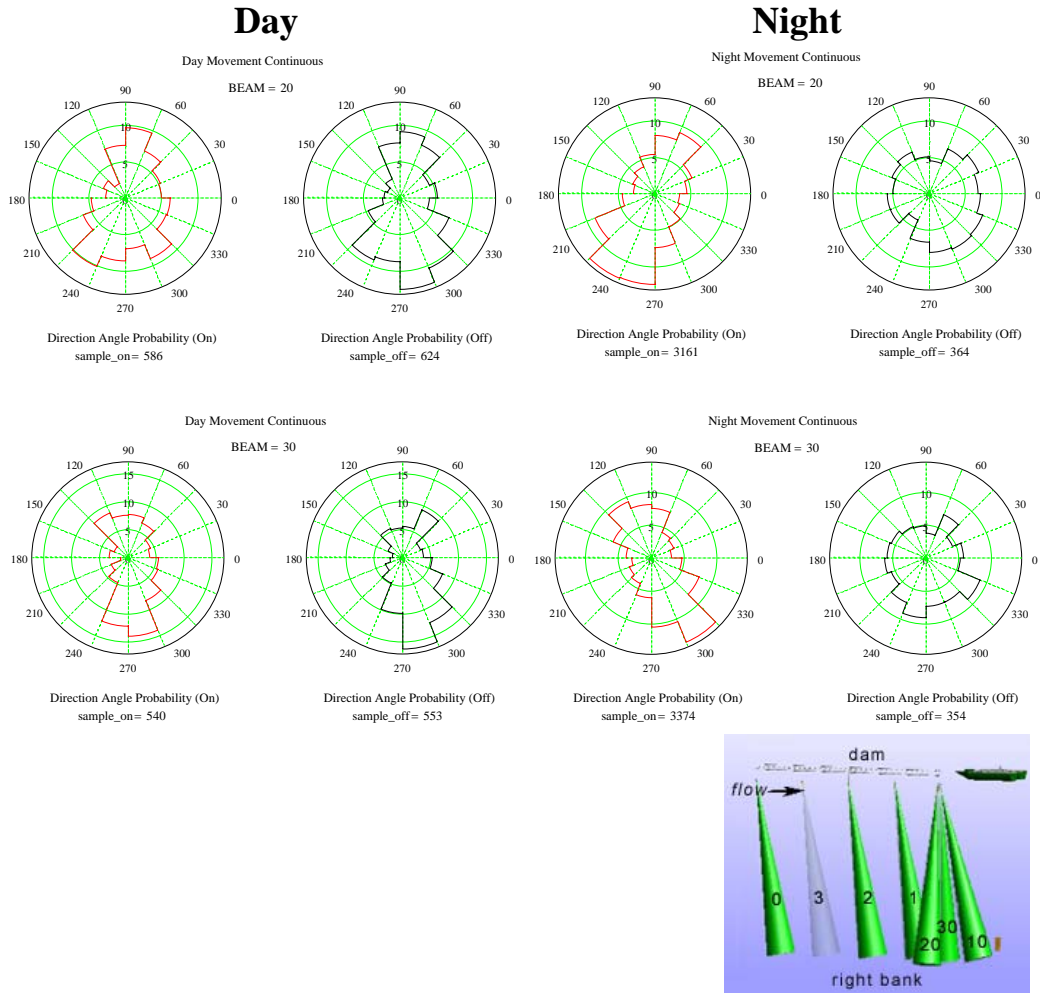
Figure H.7. Swimming Direction for Fish Detected by Splitbeam Transducers 20 (6 m from lights oriented toward the dam) and 30 (6 m from lights oriented toward the right bank) During the Day and at Night When the Strobe Lights Were On (Red) and Off (Black) for 24 Hours. Note the scales are not consistent.

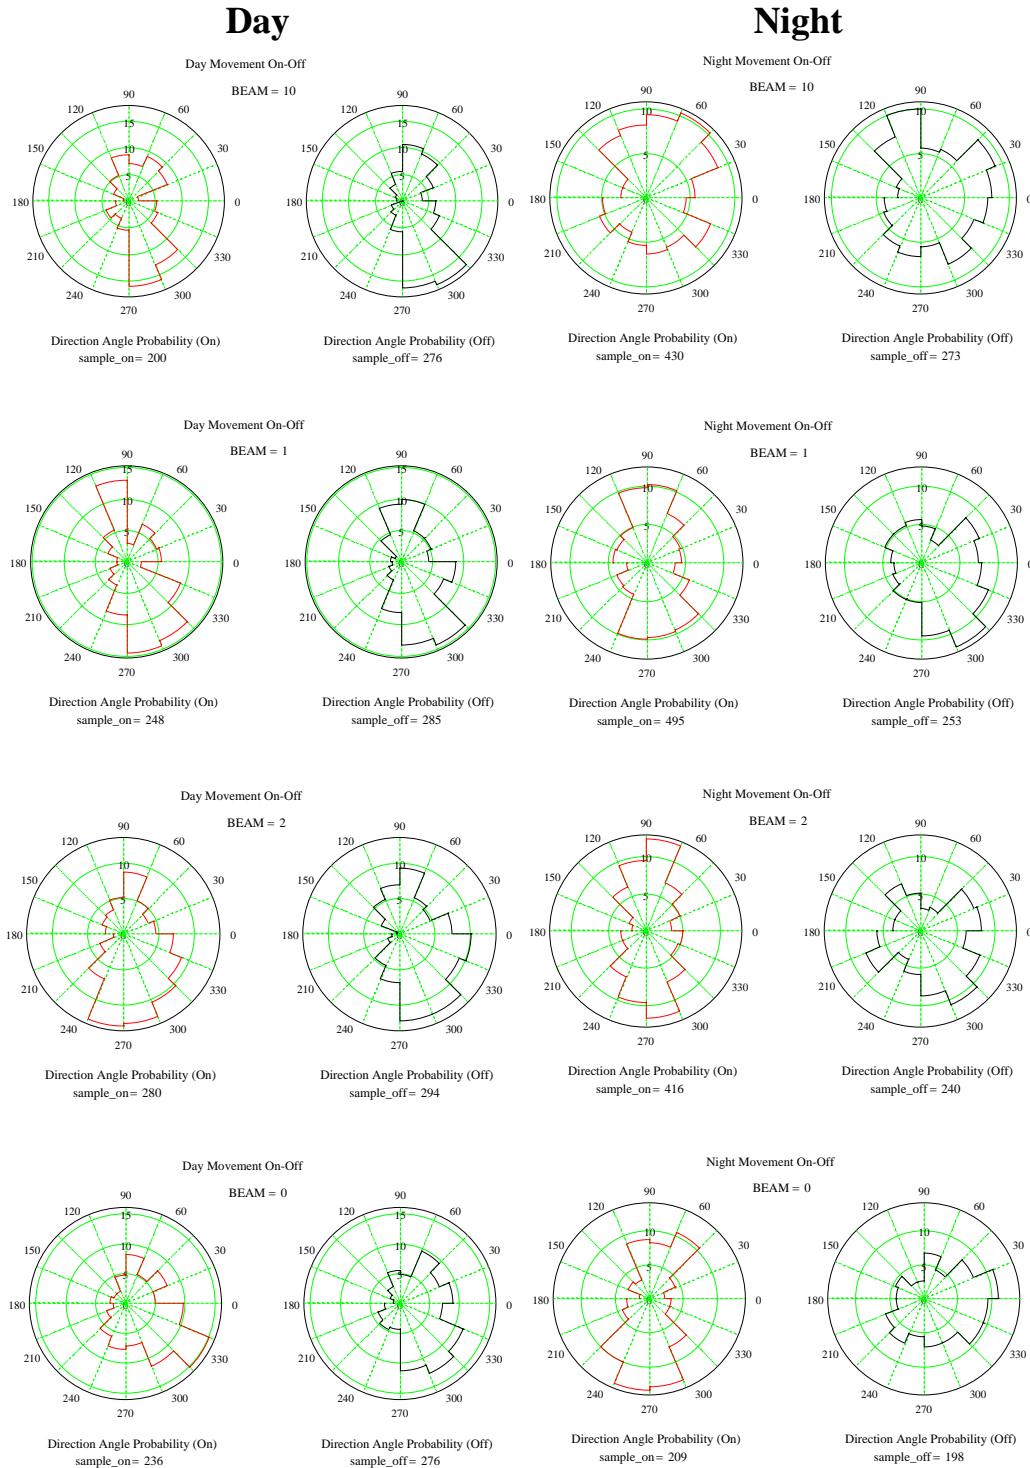
Figure H.8. Swimming Direction for Fish Detected by Splitbeam Transducers 10 (6 m from lights), 1 (10 m from lights), 2 (14 m from lights), and 0 (22 m from lights) During the Day and at Night When the Strobe Lights Were On (red) and Off (black) for 1 Hour. Note the scales are not consistent.

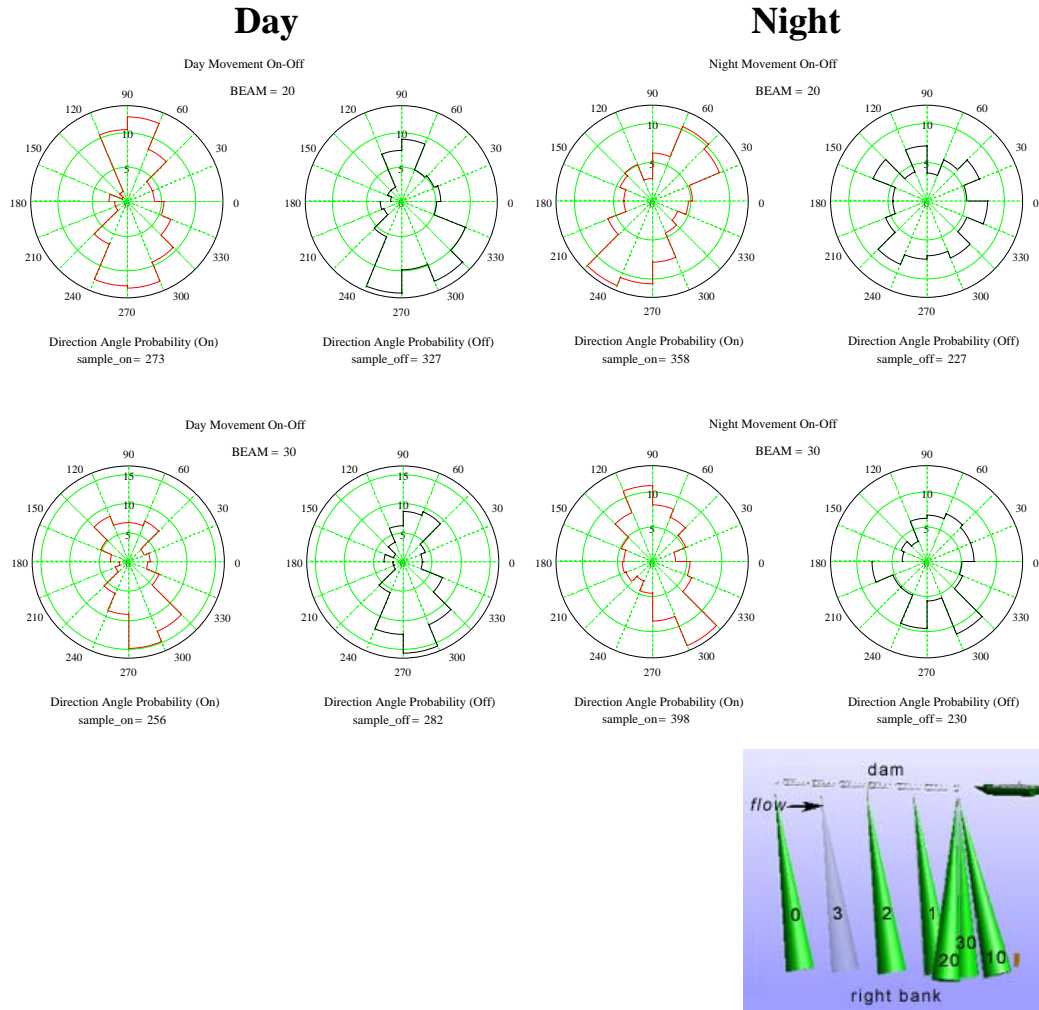
Figure H.9. Swimming Direction for Fish Detected by Splitbeam Transducers 20 (6 m from lights oriented toward the dam) and 30 (6 m from lights oriented toward the right bank) During the Day and at Night When the Strobe Lights Were On (red) and Off (black) for 1 Hour. Note the scales are not consistent.

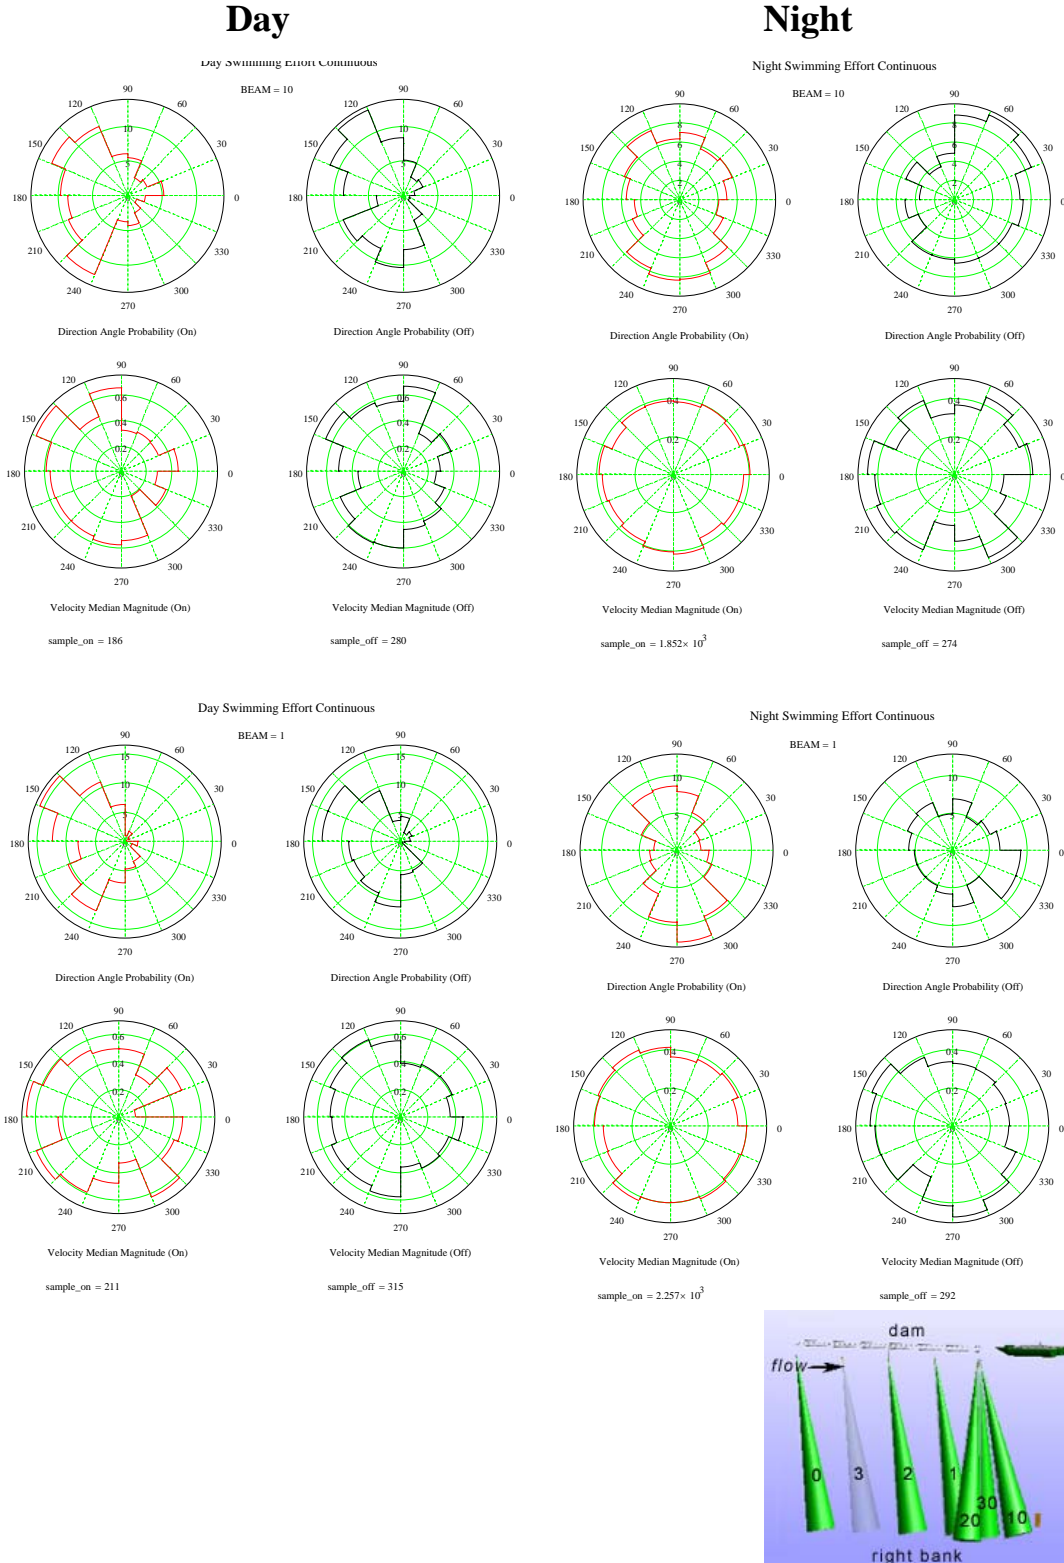
Figure H.10. Swimming Effort (direction and speed) for Fish Detected by Splitbeam Transducers 10 (6 m from lights) and 1 (10 m from lights) During the Day and at Night When the Strobe Lights Were On (red) and Off (black) for 24 Hours. Effort direction is the upper histogram, velocity (m/s) is the lower histogram. Note the scales are not consistent.

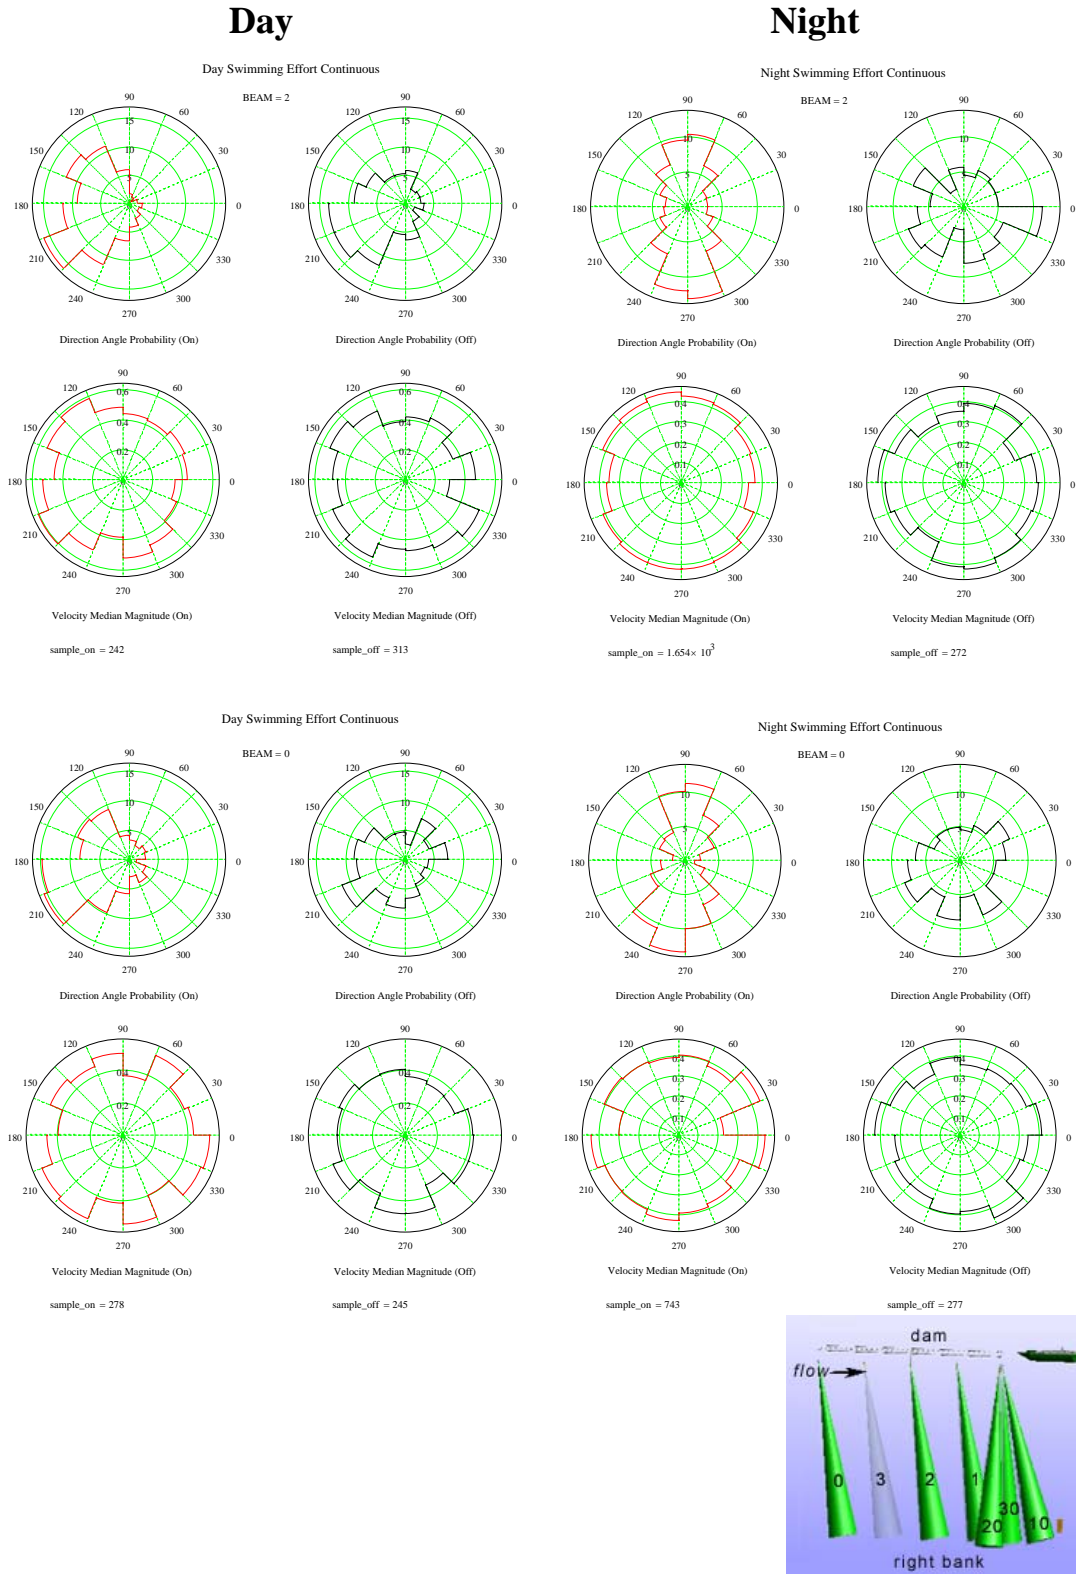
Figure H.11. Swimming Effort (direction and speed) for Fish Detected by Splitbeam Transducers 2 (14 m from lights) and 0 (22 m from lights) During the Day and at Night When the Strobe Lights Were On (red) and Off (black) for 24 Hours. Effort direction is the upper histogram, velocity (m/s) is the lower histogram. Note the scales are not consistent.

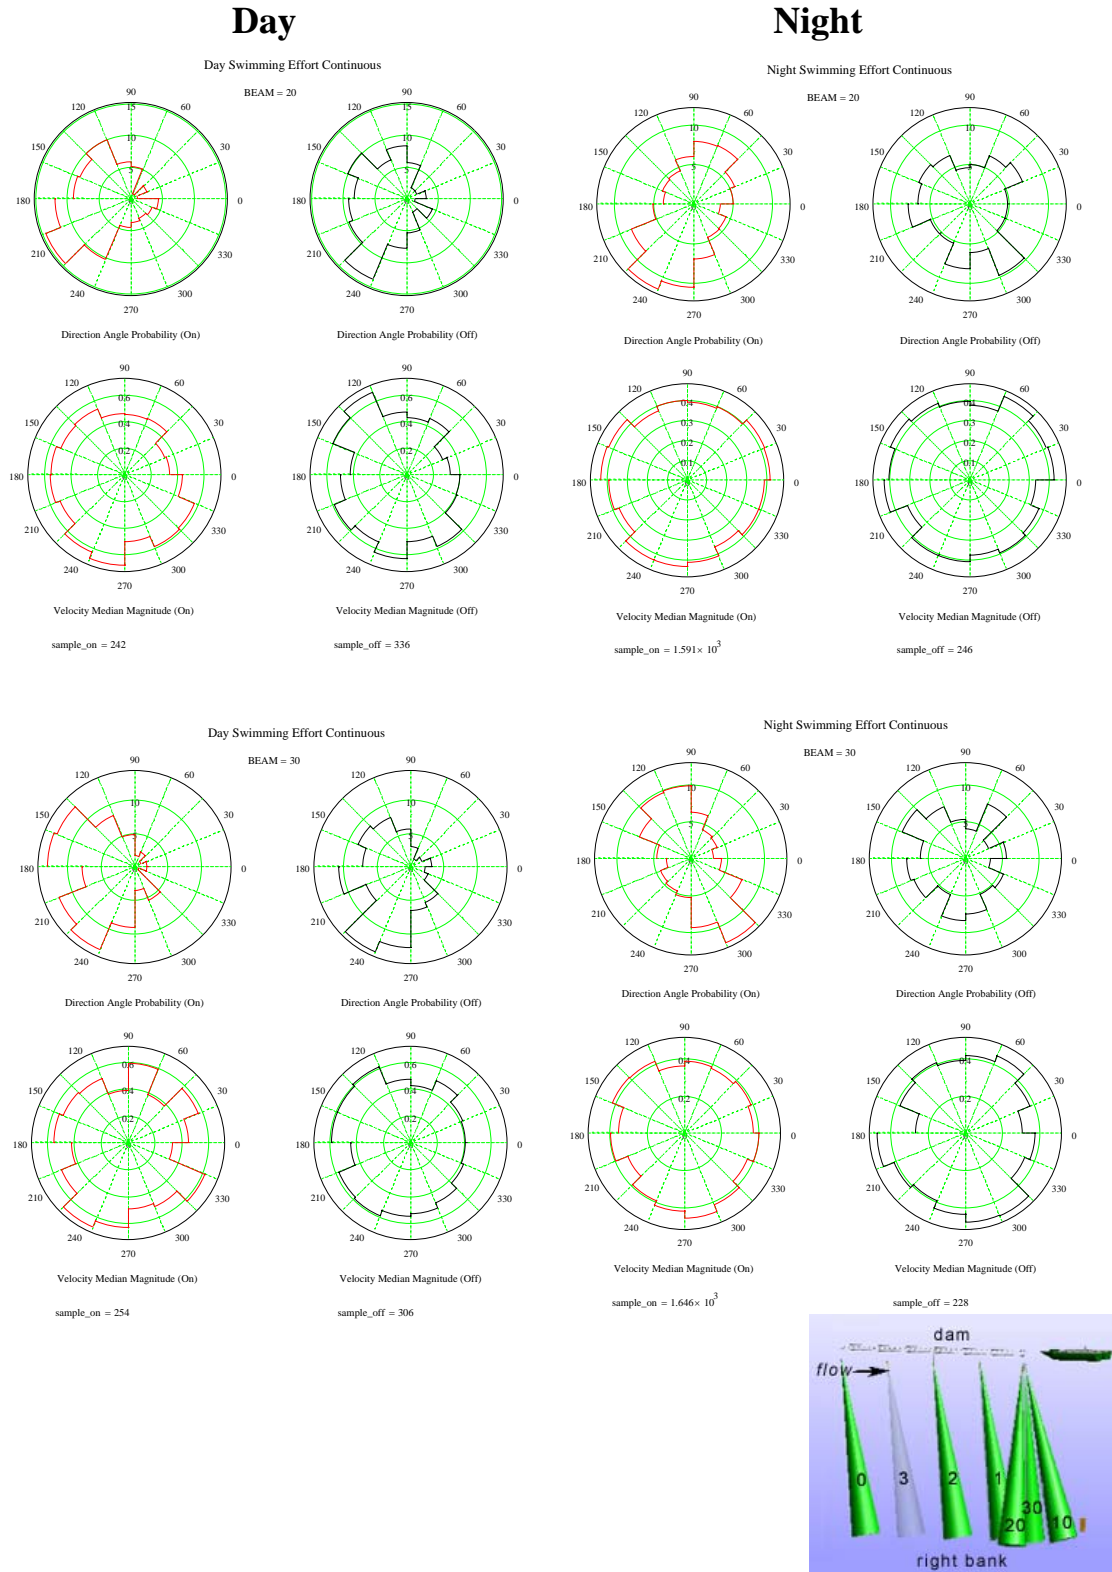
Figure H.12. Swimming Effort (direction and speed) for Fish Detected by Splitbeam Transducers 20 (6 m from lights, dam side) and 30 (6 m from lights, right bank side) During the Day and at Night When the Strobe Lights Were On (red) and Off (black) for 24 Hours. Effort direction is the upper histogram, velocity (m/s) is the lower histogram.

Fish swimming effort during the daytime was generally upstream in opposition to the flow. This response was apparent under both lights-on and lights-off treatments. At night under low flow conditions, swimming effort was dependent on the light treatment. When lights were on, swimming effort was across the forebay, toward either the dam or the right bank. This response was evident for fish detected by all six splitbeam transducers. For fish detected by the splitbeam closest to the lights (i.e., transducer 10 at 6 m), there is somewhat more variability than at either the next transducer upstream (i.e., transducer 1 at 10 m) or for the other two transducers at 6 m (i.e., transducers 20 and 30). When the lights were off at night, there was no dominant direction of swimming effort.

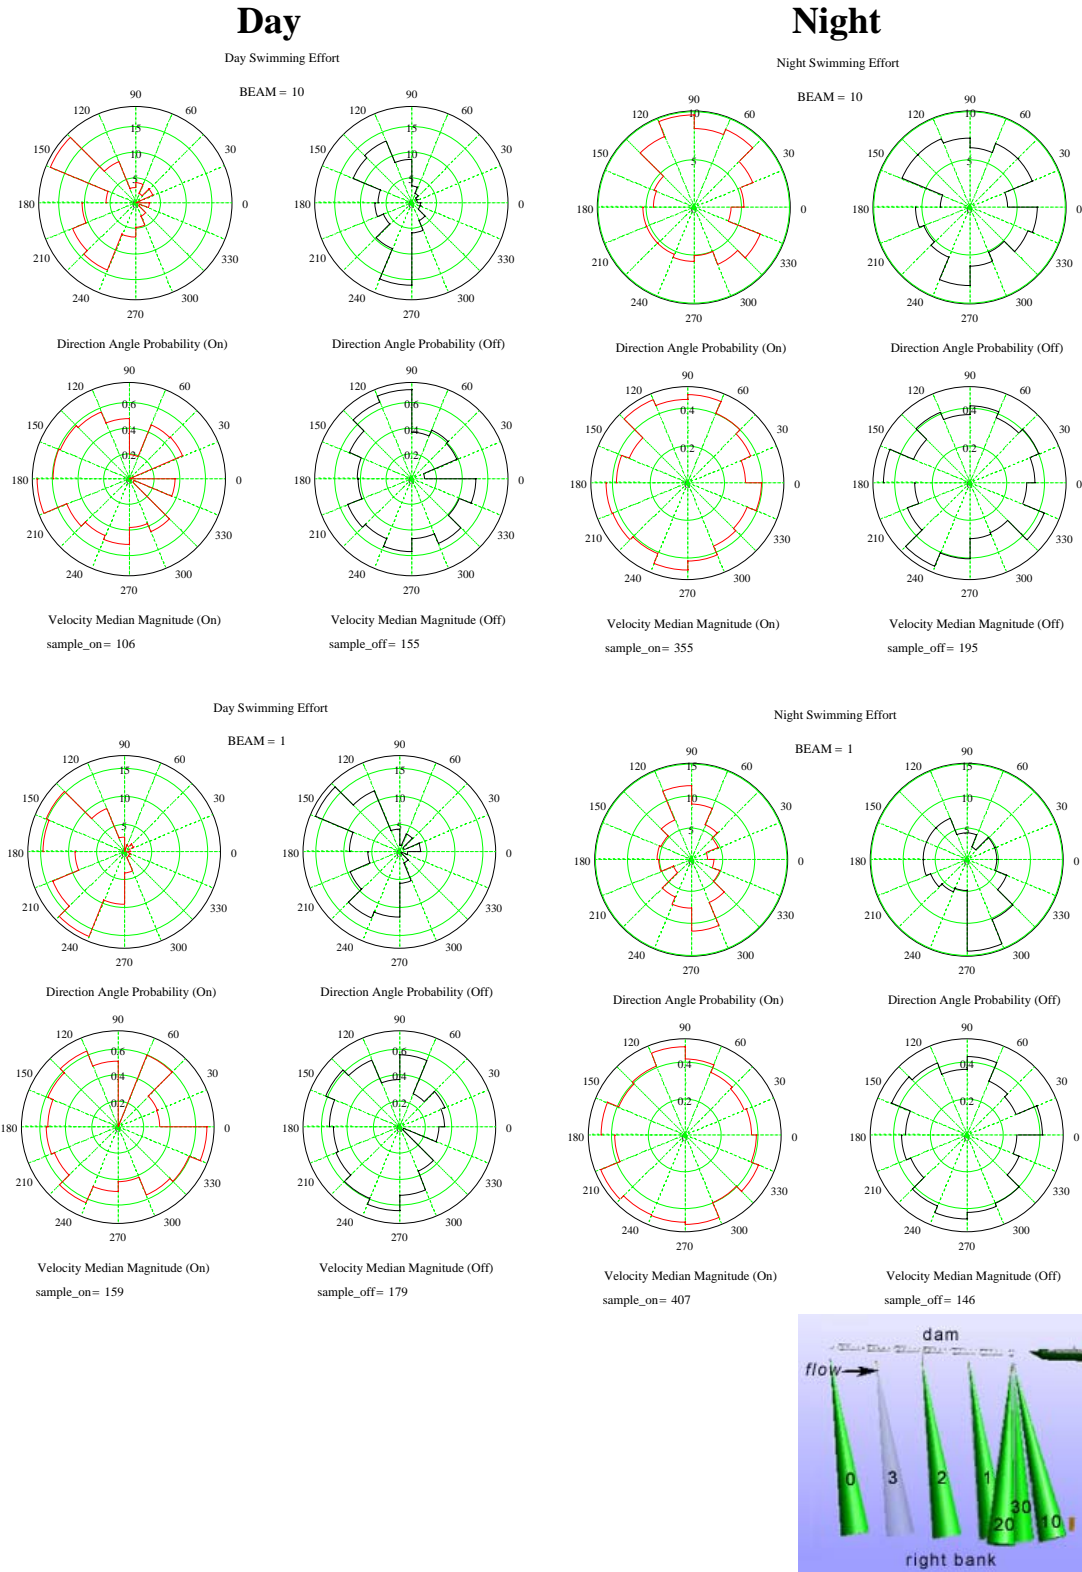
Figure H.13. Swimming Effort (direction and speed) for Fish Detected by Splitbeam Transducers 10 (6 m from lights) and 1 (10 m from lights) During the Day and at Night When the Strobe Lights Were On (red) and Off (black) for 1 Hour. Effort direction is the upper histogram, velocity (m/s) is the lower histogram. Note the scales are not consistent.

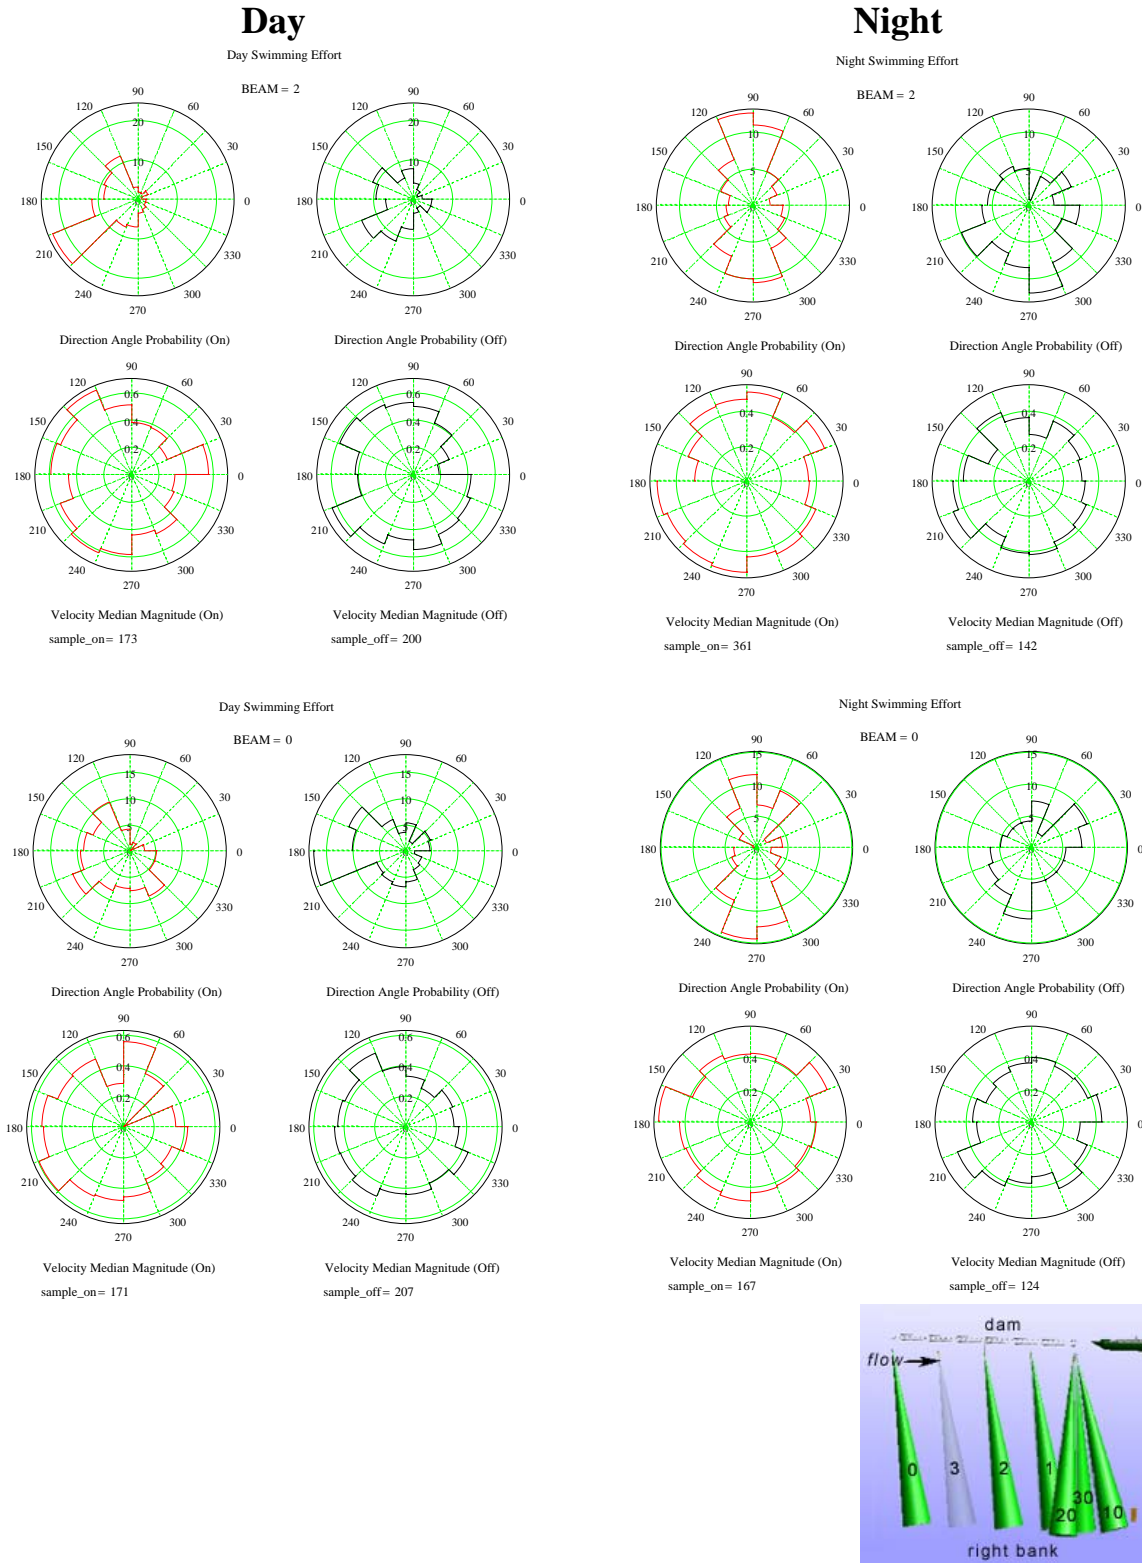
Figure H.14. Swimming Effort (direction and speed) for Fish Detected by Splitbeam Transducers 2 (14 m from lights) and 0 (22 m from lights) During the Day and at Night When the Strobe Lights Were On (red) and Off (black) for 1 Hour. Effort direction is the upper histogram, velocity (m/s) is the lower histogram. Note the scales are not consistent.

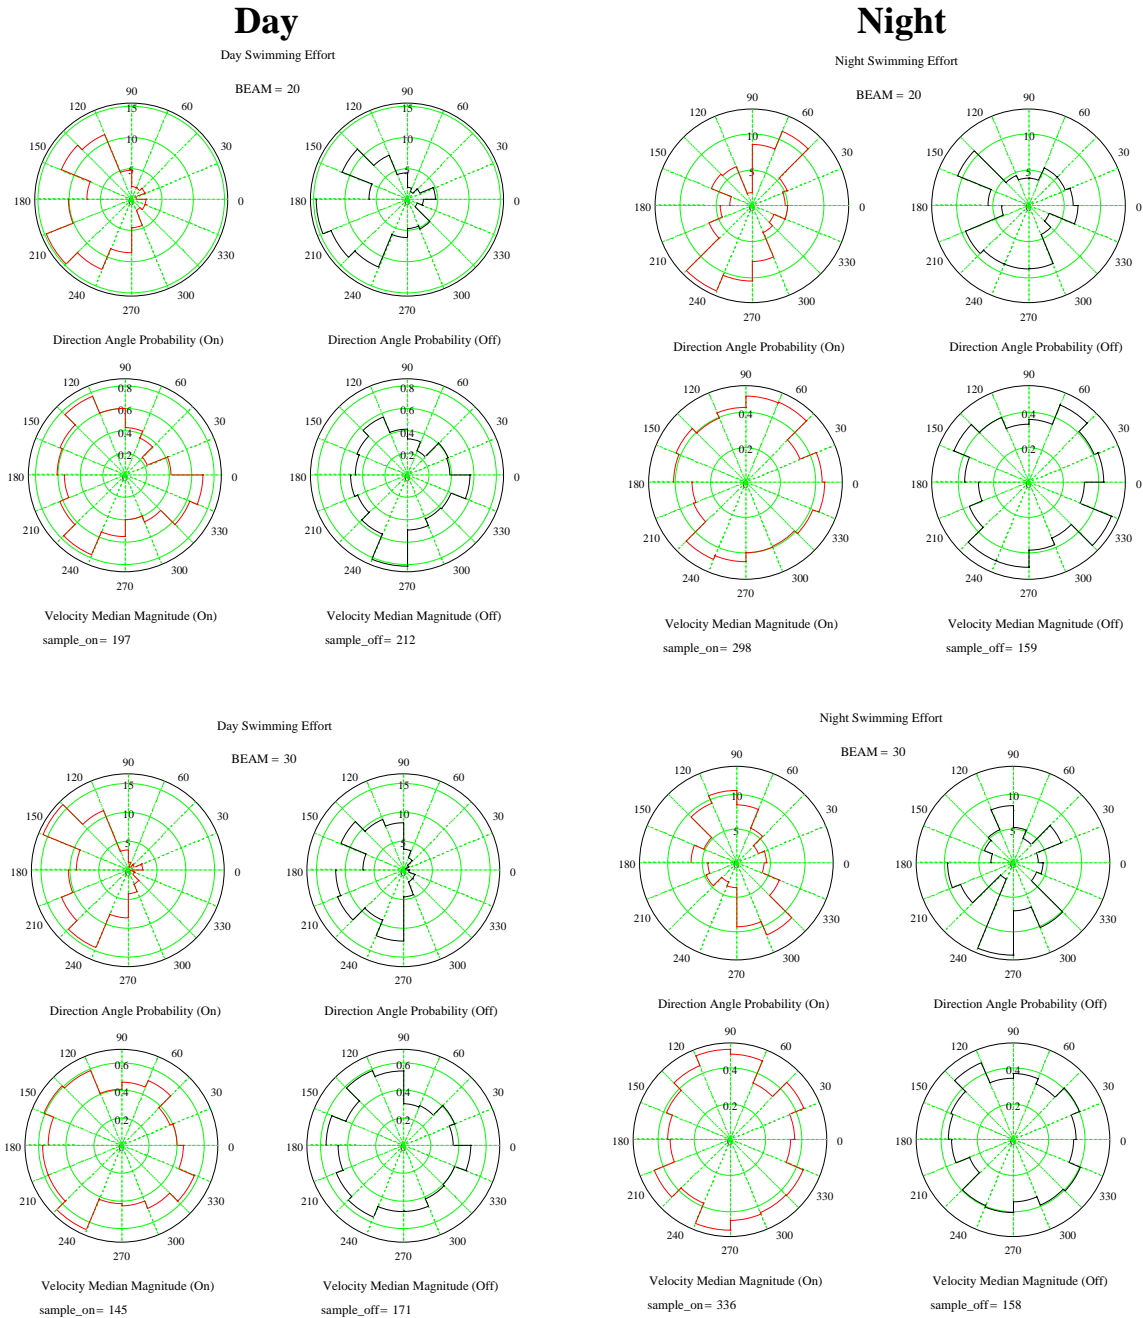
Figure H.15. Swimming Effort (direction and speed) for Fish Detected by Splitbeam Transducers 20 (6 m from lights, dam side) and 30 (6 m from lights, right bank side) During the Day and at Night When the Strobe Lights Were On (red) and Off (black) for 1 Hour. Effort direction is the upper histogram, velocity (m/s) is the lower histogram. Note the scales are not consistent.

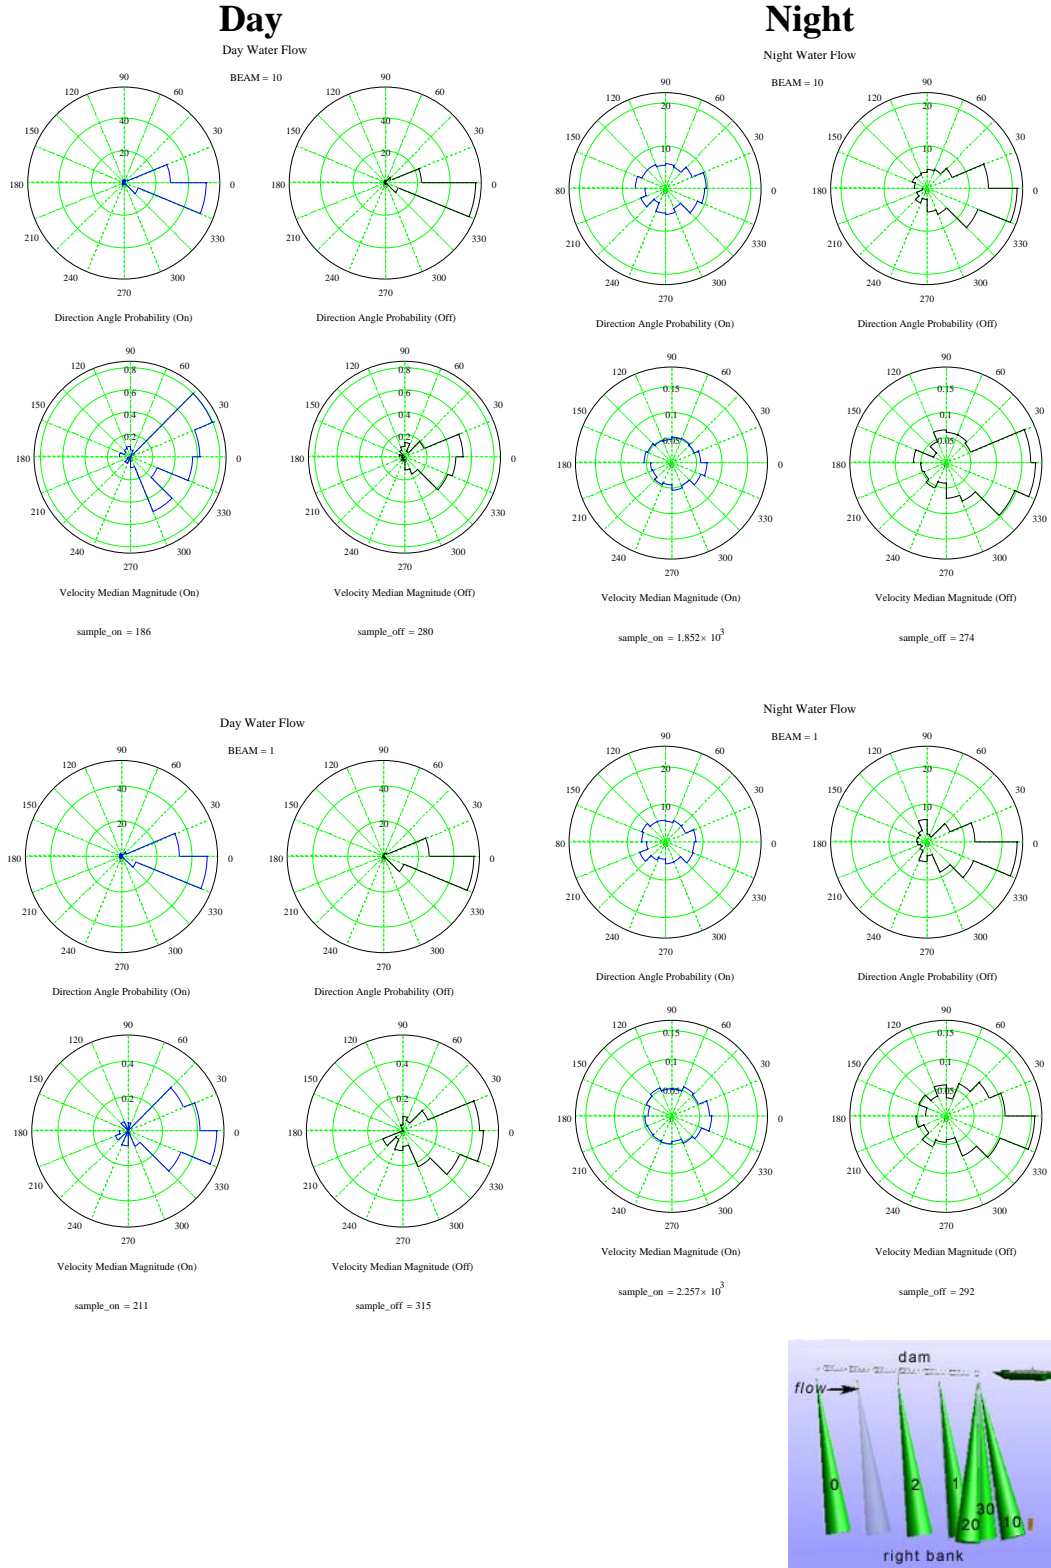
Figure H.16. Water Flow at Splitbeam Transducers 10 (6 m from lights) and 1 (10 m from lights) During the Day and at Night When the Strobe Lights Were On (blue) and Off (black) for 24 Hours. Direction is the upper histogram, velocity (m/s) is the lower histogram. Note the scales are not consistent.

During the daytime, the dominant direction of water flow in the forebay of the third powerplant was downstream and slightly toward the right bank. The velocity magnitude was the highest (maximum 0.8 m/s) at the splitbeam transducer closest to the light frame (i.e., 6 m) (Figure H.16) and lowest (maximum < 0.4 m/s) at the transducer farthest from the lights (i.e., 22 m) (Figure H.17).

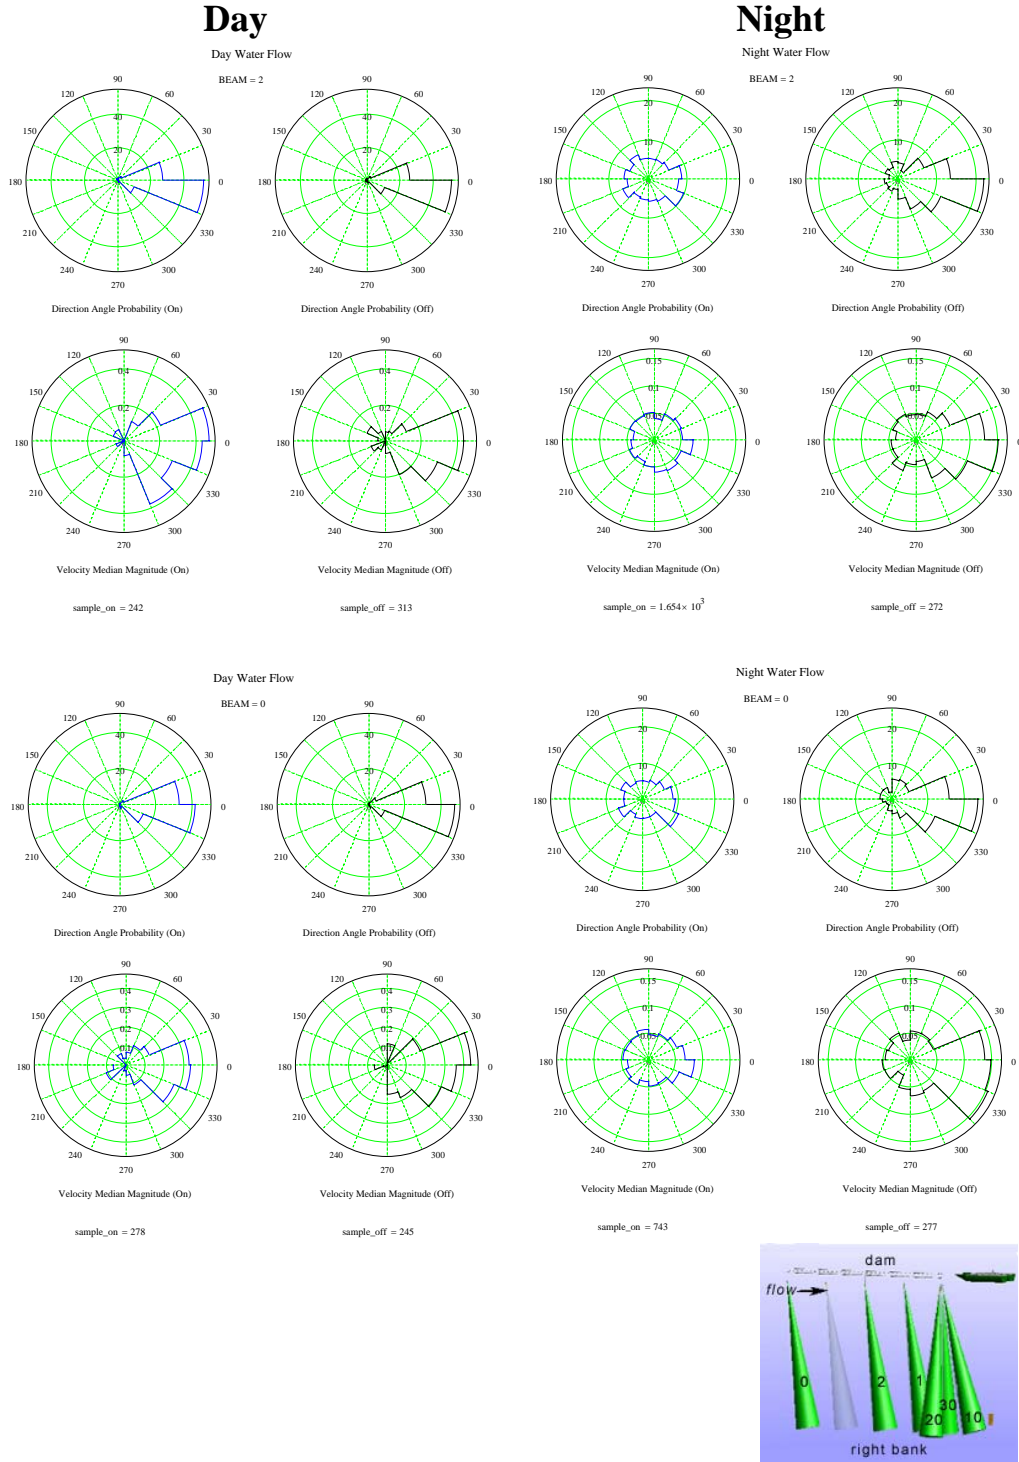
Figure H.17. Water Flow at Splitbeam Transducers 2 (14 m from lights) and 0 (22 m from lights) During the Day and at Night When the Strobe Lights Were On (blue) and Off (black) for 24 Hours. Direction is the upper histogram, velocity (m/s) is the lower histogram. Note the scales are not consistent.
