Chief Joseph Kokanee Enhancement Project

Strobe Light Deterrent Efficacy Test and Fish Behavior Determination at the Grand Coulee Dam Third Powerplant Forebay

Annual Report 2003 - 2004

DOE/BP-00000652-25

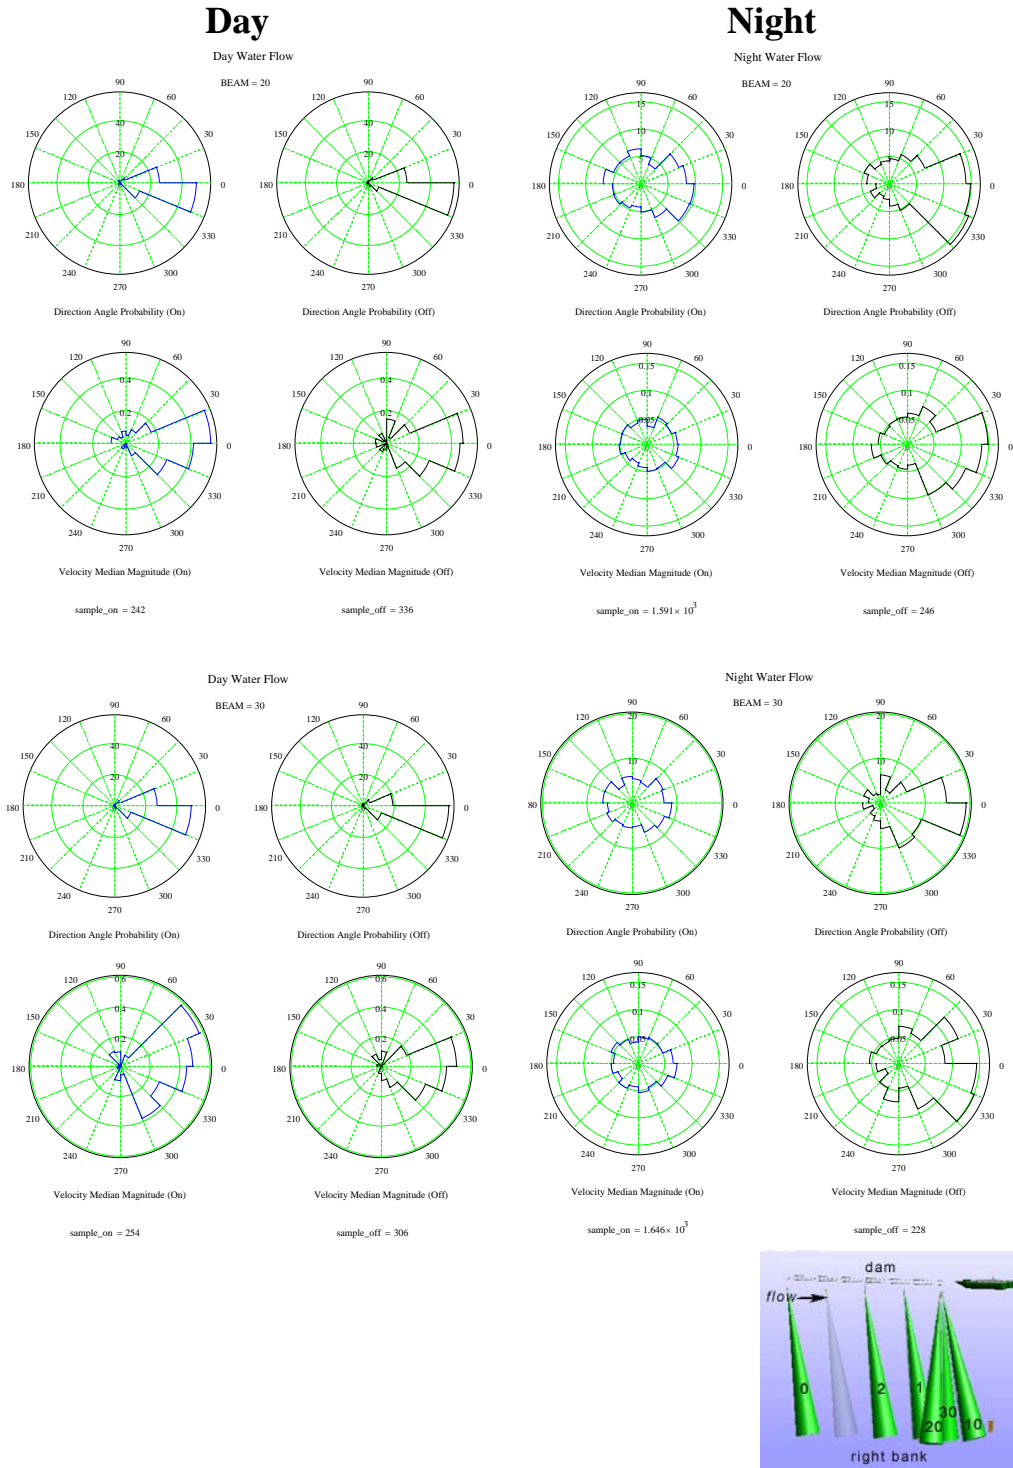
Figure H.18. Water Flow at Splitbeam Transducers 20 (6 m from lights, dam side) and 30 (6 m from lights, right bank side) During the Day and at Night When the Strobe Lights Were On (blue) and Off (black) for 24 Hours. Direction is the upper histogram, velocity (m/s) is the lower histogram. Note the scales are not consistent.

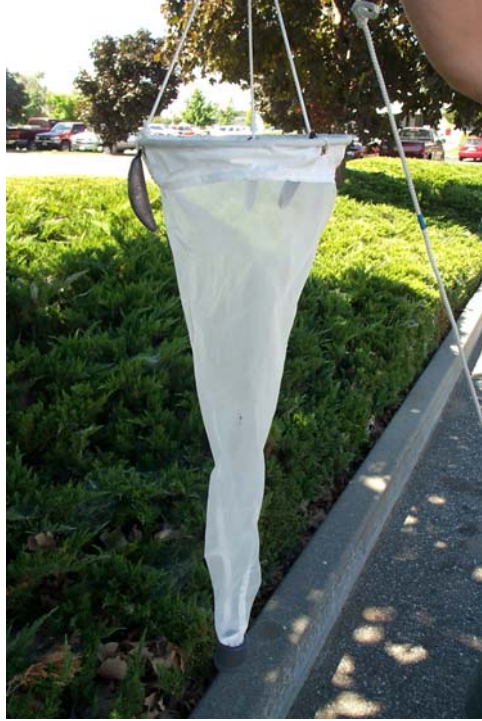
Figure I.1. Vertical Tow Plankton Net

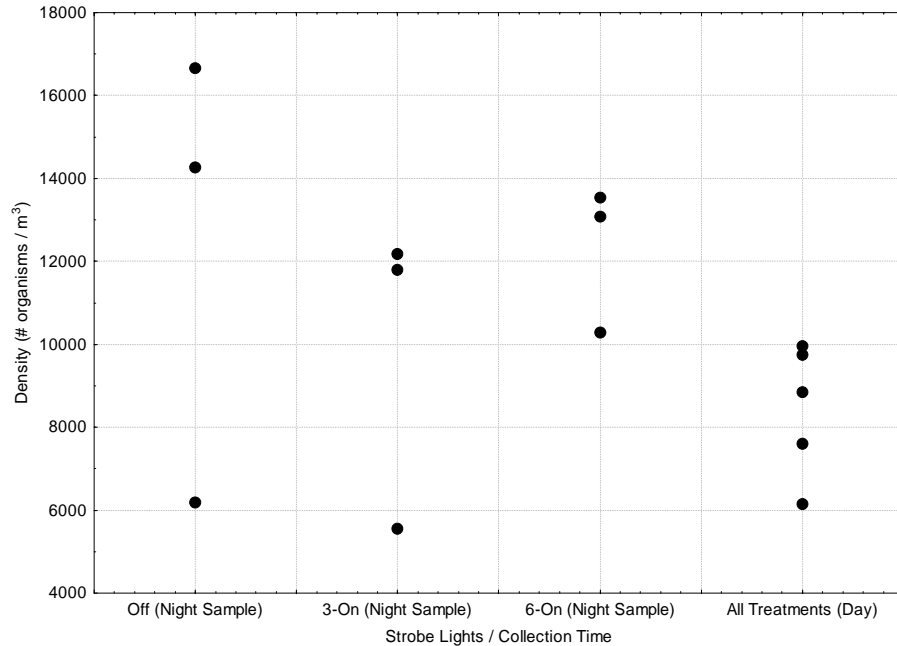
Figure I.2. Density of Zooplankton Sampled at Night from the Barge under Three Strobe Light Conditions (Lights Off, 3 Lights On, and 6 Lights On) and During the Day Upstream of the Barge Under All Strobe Light Conditions at Grand Coulee Dam, 2003

The data showed a generally greater density of zooplankton under the barge near the light frame under all light conditions sampled at night compared to the forebay location upstream of the barge that was sampled during the daytime (Figure I.2). There may also be a very slight difference between three

light conditions; however, the number of samples was too small to confirm this. The density of the forebay samples is similar to and slightly higher than densities found by Cichosz et al. (1999), but more sampling should be done next year to confirm this.
