SEM Characterization of an Irradiated Dispersion Fuel Plate with U-10Mo Particles and 6061 Al Matrix

RERTR 2009

**RERTR 2009 _ 31st INTERNATIONAL MEETING ON
REDUCED ENRICHMENT FOR RESEARCH AND TEST REACTORS**

**SEM CHARACTERIZATION OF AN IRRADIATED DISPERSION
FUEL PLATE WITH U-10MO PARTICLES AND 6061 AL MATRIX**

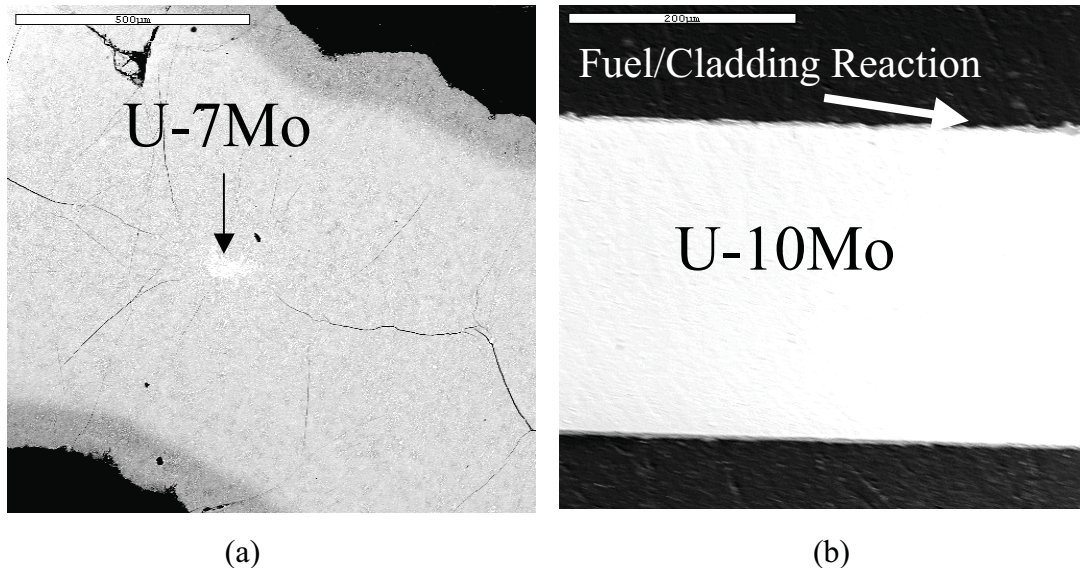
Fig 9. SEM micrographs of (a) U-7Mo and (b) U-10Mo foils after HIPing at 580°C for 3 hrs. The black areas are 6061 Al cladding and the medium-contrast areas are interaction product [5]. Micron bar is 500 µm in (a), and 200 µm in (b).

Besides just improving the understanding of fuel/matrix interaction layer behavior during irradiation of dispersion fuels, another benefit of the characterization of fuel plate VIR010 is the fact that the developed interaction layers for this plate should be similar to ones that can develop in an irradiated monolithic fuel plate with a U-10Mo foil and 6061 Al cladding, particularly for plates that begin irradiation with little foil/cladding interaction layer formation. For HIPed U-10Mo fuel plates, the exposure to up to 580°C temperatures will result in the presence of up to 2 to 3 microns of interaction layer thickness at the U-10Mo/6061 Al interface after fabrication [11]. Like for dispersion fuel plates, there are different reaction rates with 6061 Al in monolithic fuel plates, depending on the Mo content in the fuel. U-10Mo reacts much more sluggishly than does U-7Mo. In fuel plates HIPed at 580°C, the U-7Mo foil is almost completely consumed by interaction product (see Fig. 9), and the U-10Mo foil reacts little with the 6061 Al cladding to form an interaction product. However the interaction that does occur for U-10Mo versus 6061 Al at 580°C is greater than what is seen for dispersion fuels rolled at 500°C.
