# River Corridor Closure Contract

## 100 Area D4 Project Building Completion Report – July 2007 to December 2008

April 2009

**Washington Closure Hanford**

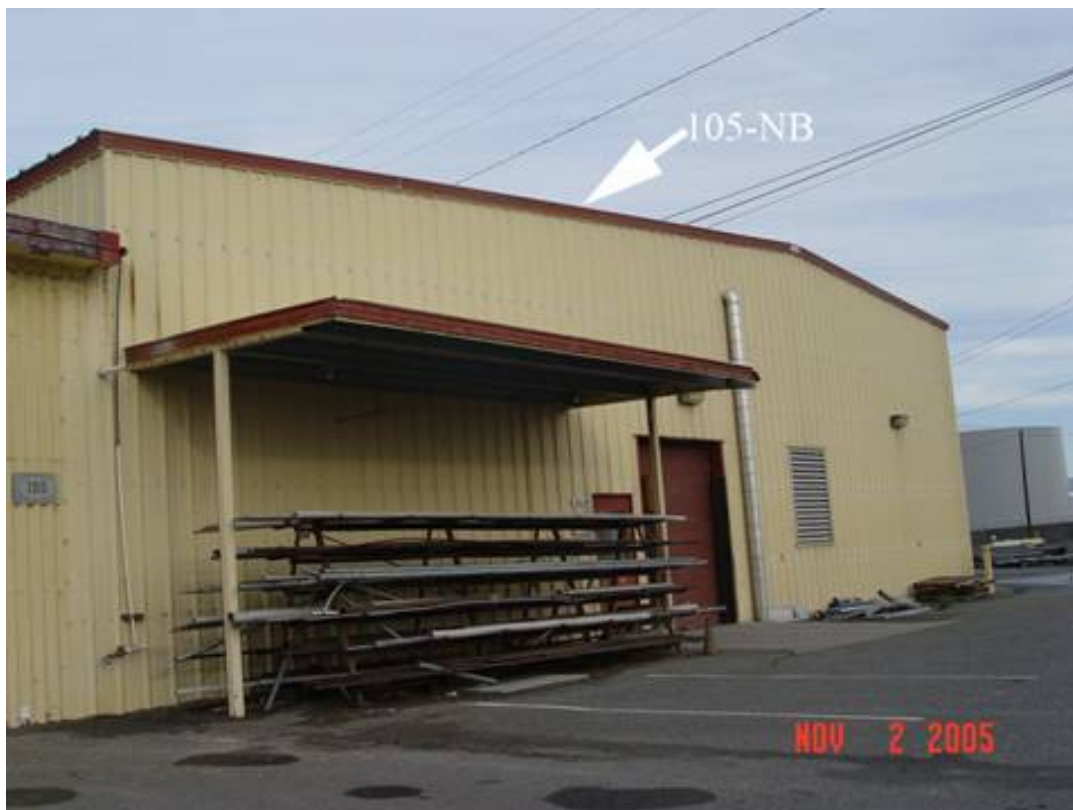
**Figure 1. 105-NB Maintenance Building Addition.**

The 105-NB Mechanical Shop Addition was a 105-ft by 80-ft (32-m by 24.4-m) one-story steel frame building with painted steel siding attached to the north side of the 105-N Reactor Administration Offices (Figure 1). The building was on a reinforced concrete slab foundation and had a steel gable roof. The building was used to house an expanded maintenance shop.

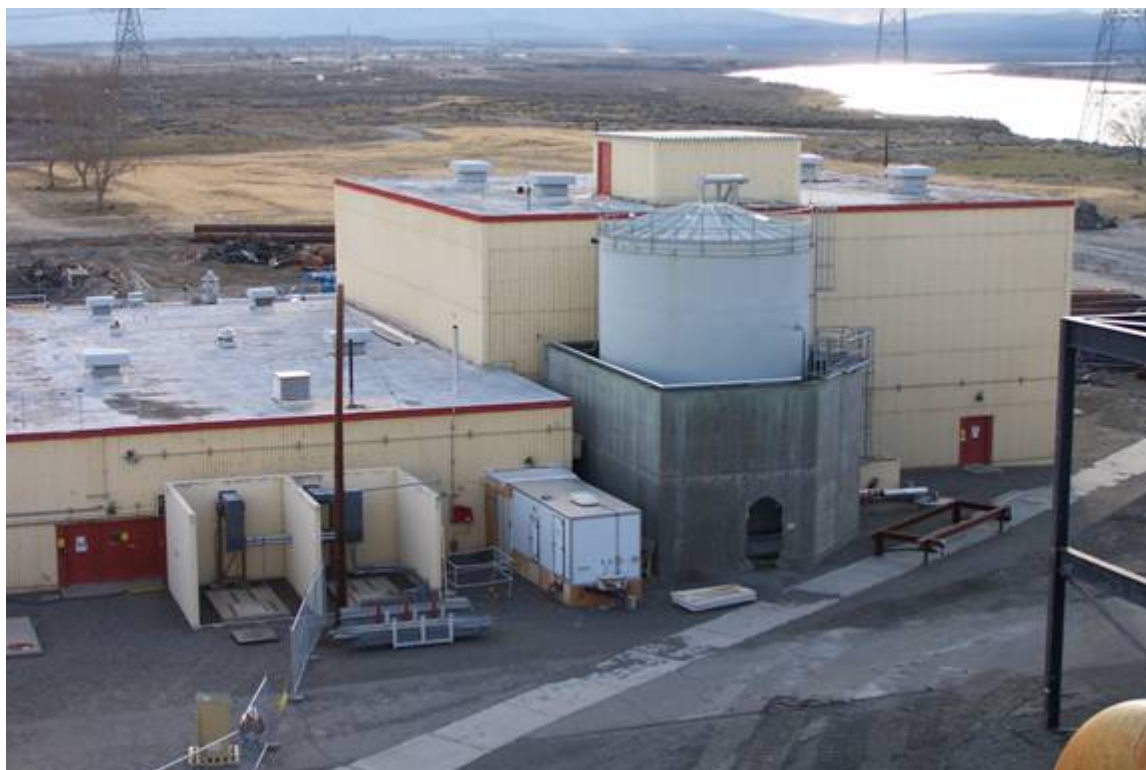
**Figure 2. 163-N Demineralizer Plant.**

The 163-N Demineralizer plant encompassed 11,675 ft<sup>2</sup> (1,084.6 m<sup>2</sup>) gross area (Figure 2). The processing and laboratory space took up 10,475 ft<sup>2</sup> (973.2 m<sup>2</sup>). It was a one-story, high-bay, steel-frame building with corrugated metal siding. The building was on a reinforced concrete slab foundation and was used to demineralize, de-gas, and pump filtered and treated water into a 3.8 million liter (1 million gallon) storage tank. The facility is physically adjacent to the 183-N facility.

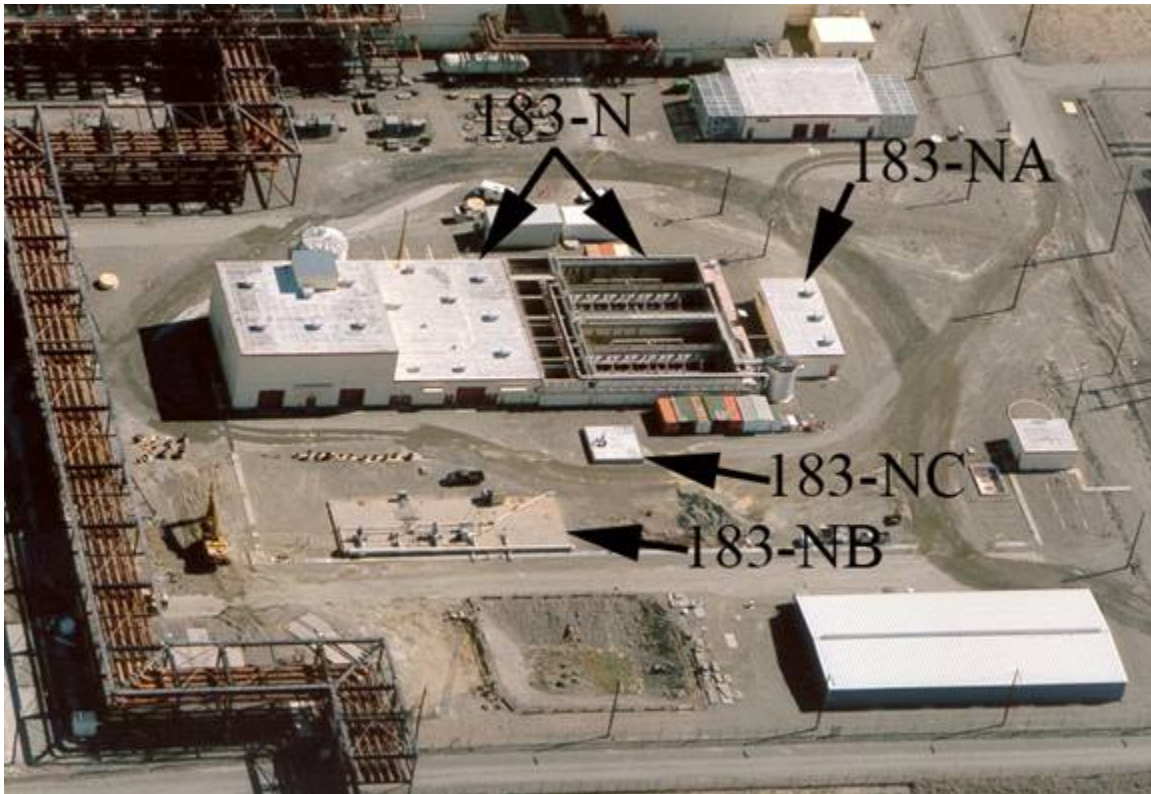
**Figure 3. 183-N Water Filter Plant.**

The 183-N Water Treatment Plant is a 20,700-ft<sup>2</sup> (1,923.1-m<sup>2</sup>) one-story, concrete masonry and steel-sided building on a reinforced-concrete foundation (Figure 3). This square footage estimate covers the 183-N Building up to its union with the 163-N Building. The 183-N Building consists of the service bay, the chemical treatment and pipe gallery bay, the coagulation basin and filters, and the coagulator drive bay. The coagulation basin is also referred to as the settling basin.

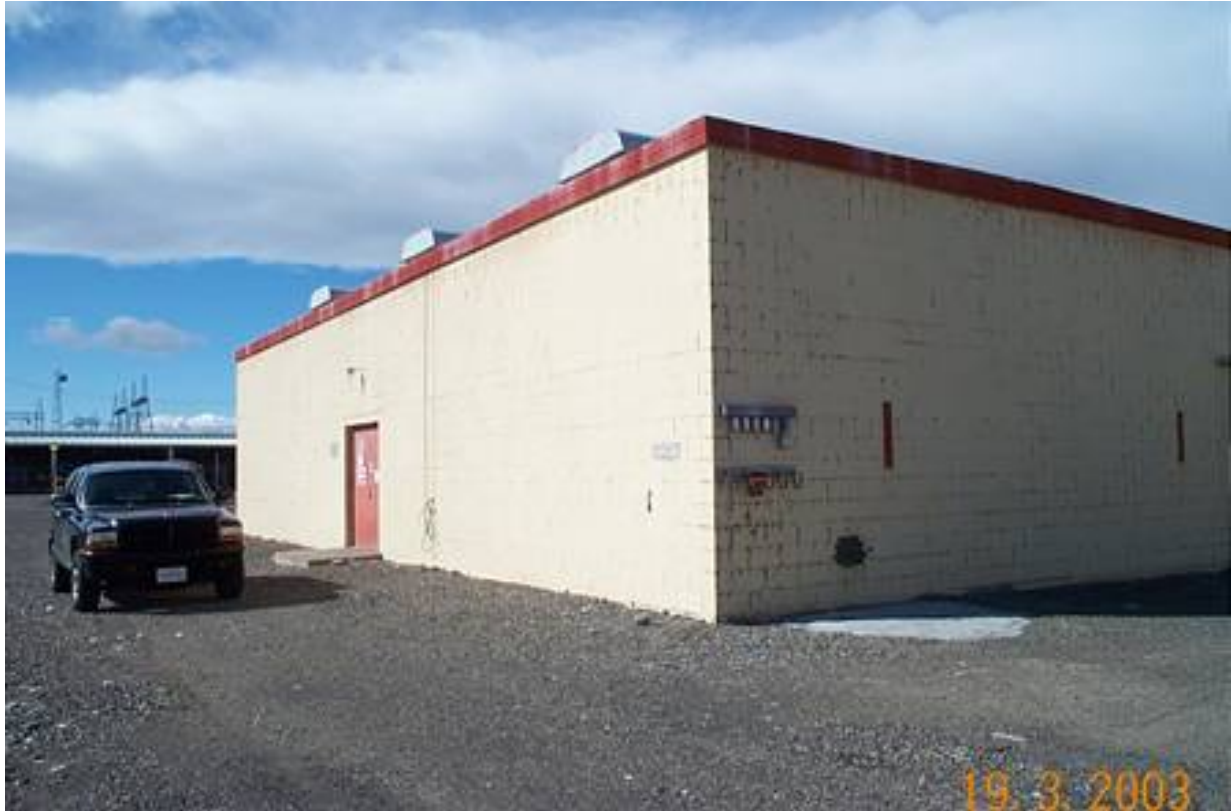
**Figure 4. 183-NA Water Filter Plant Pump House.**

The 183-NA Pump House was a rectangular one-story concrete masonry structure with reinforced concrete panel flat roof and a poured concrete foundation (Figure 4). 183-NA was approximately 20 ft (6 m) to the east of the 183-N Coagulators and measured 66 ft by 33 ft (20 m by 10 m). The building was used to house the pumps for water filter operations.

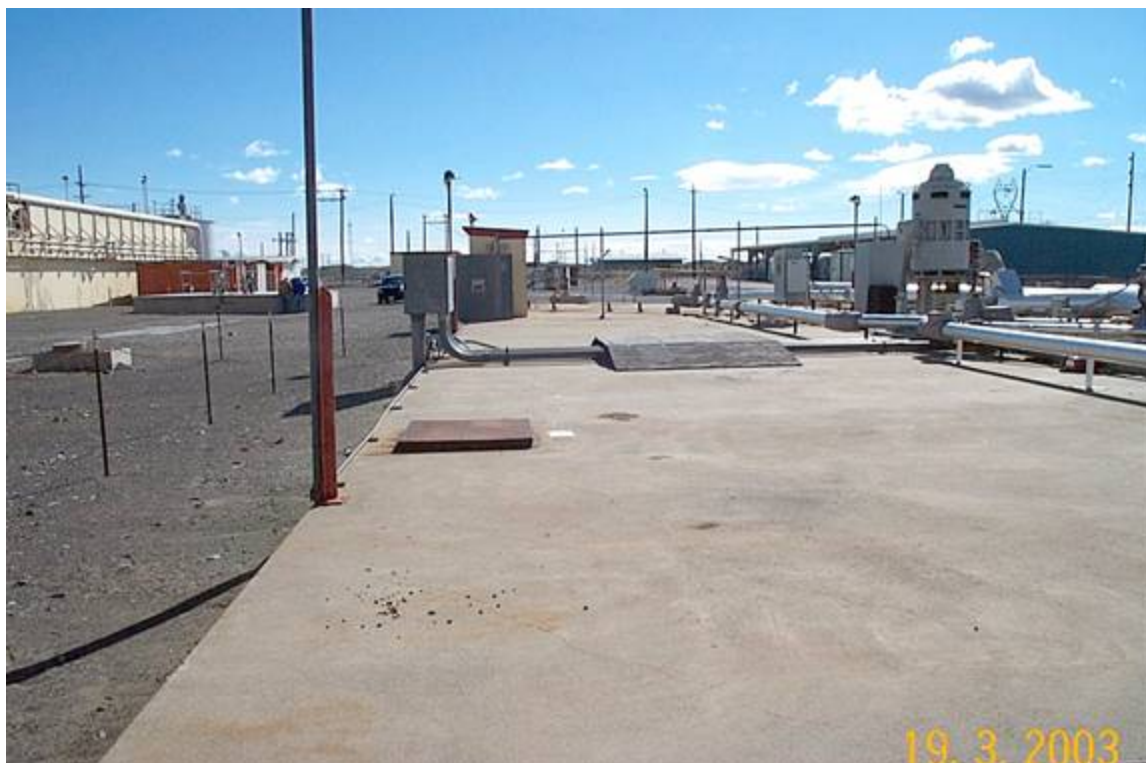
**Figure 5. 183-NB Water Filter Plant Pump House.**

The 183-NB Clearwell was a buried, rectangular, reinforced concrete structure approximately 120 ft by 40 ft by 12 ft (36.5 m by 12.1 m by 3.6 m deep), with the top surface protruding approximately 0.3 m (1 ft) above grade (Figure 5). Several pumps and associated control equipment were mounted on top of the concrete surface. The facility was used to store filtered water.

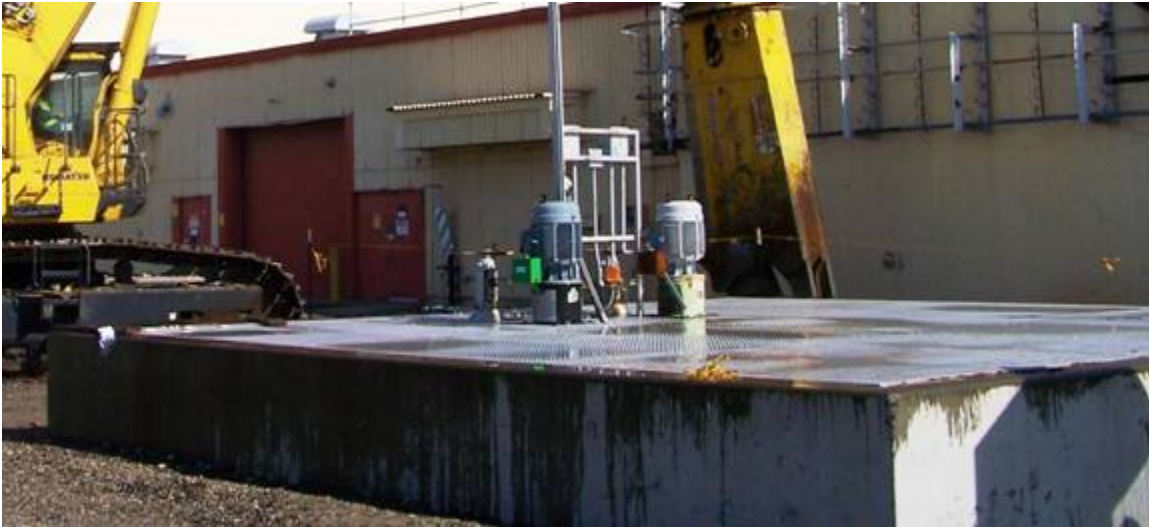
**Figure 6. 183-NC Filter Backwash Sump.**

The 183-NC Filter Backwash Sump was an 8.5-m by 8.5-m (28-ft by 28-ft) box-shaped, reinforced concrete sump with the top surface protruding about 0.9 m (3 ft) above grade (Figure 6). The top surface is diamond plate steel.

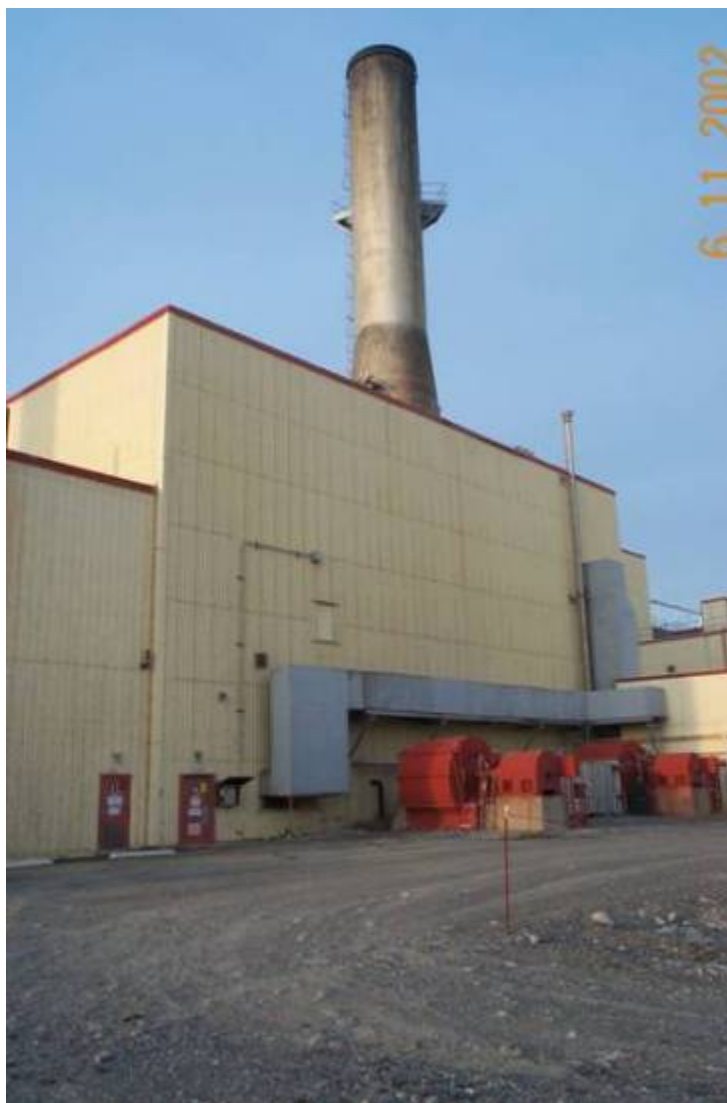
**Figure 7. 184-N Plant Service Power House.**

The 184-N Plant Service Power House was a rectangular, four-story building with channeled steel siding over a structural steel frame (Figure 7). The stairwells, offices, control room, and the mezzanine walls were concrete masonry units. Floors were reinforced concrete and metal grating. The roof was pre-cast concrete planks supported by a structural steel beam-girder system and covered with 4-ply built-up roof with 2 in. insulation. The powerhouse dimensions were 96 ft by 112 ft (10,752 ft<sup>2</sup>) by 70 ft high. The main building equipment was a 575,000 Btu/hr Foster Wheeler boiler and 15,000 kW turbine generator.

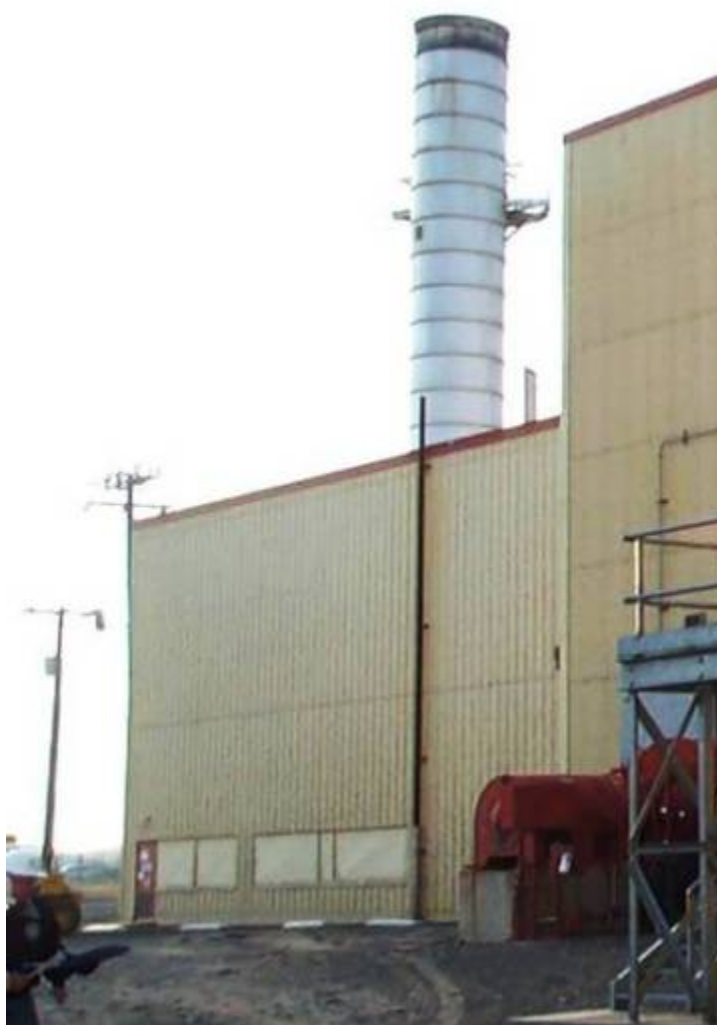
**Figure 8. 184-NA Auxiliary Power Annex Building.**

The 184-NA Auxiliary Power Annex Building was a rectangular, one-story metal-frame building with channeled steel siding and reinforced concrete floor (Figure 8). The roof was comprised of pre-cast concrete panels supported by a structural steel beam-girder system. The west wall was a common wall with 184-N. The annex building dimensions were 60 ft by 75 ft (4,500 ft<sup>2</sup>) by 40 ft high. The main building equipment was two Combustion Engineering package boilers, blowers for combustion air, and compressed air system.

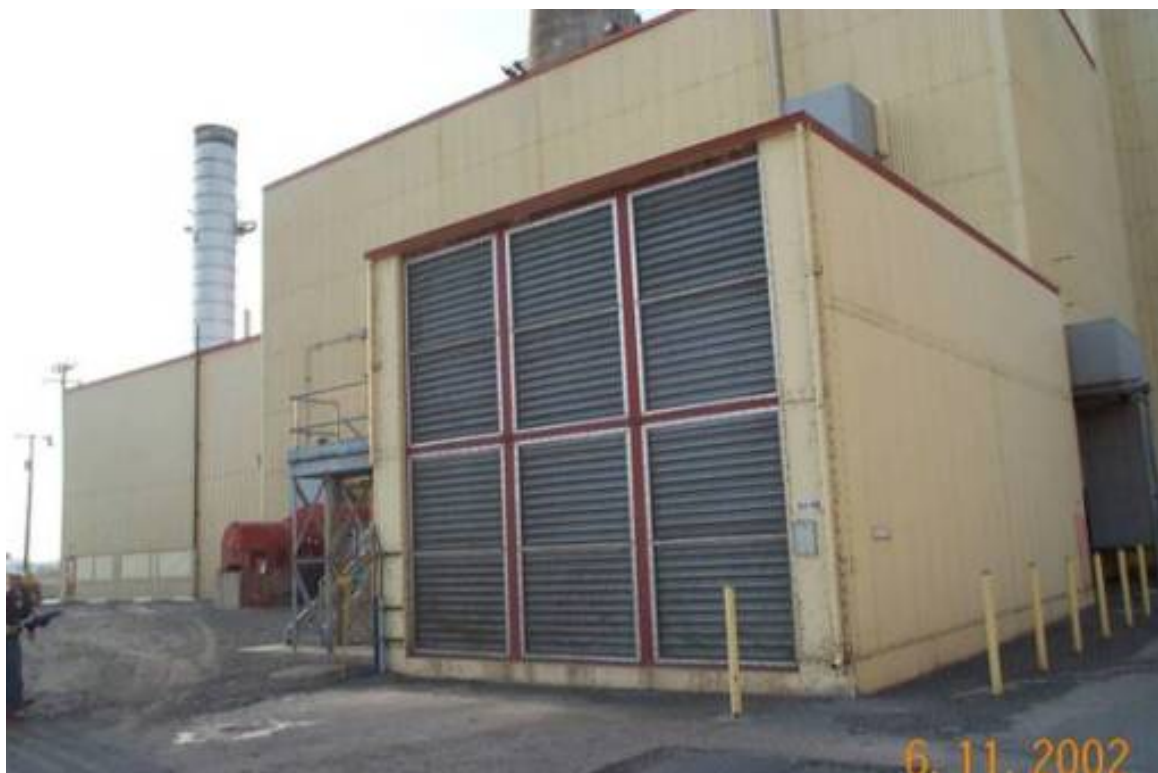
**Figure 9. 184-NB Air Handling Main Building.**

The 184-NB Air Handler Main Building was a pre-engineered rectangular, steel-sided building with a reinforced concrete floor located approximately 14 ft (4 m) north of 184-N (Figure 9). Aerial photographs indicate the roof membrane is the same as 184-N and 184-NA. The north wall was all louvers. The Air Handler Main Building dimensions were approximately 24 ft by 39 ft (936 ft<sup>2</sup>). Building equipment included an HVAC system for 184-N.

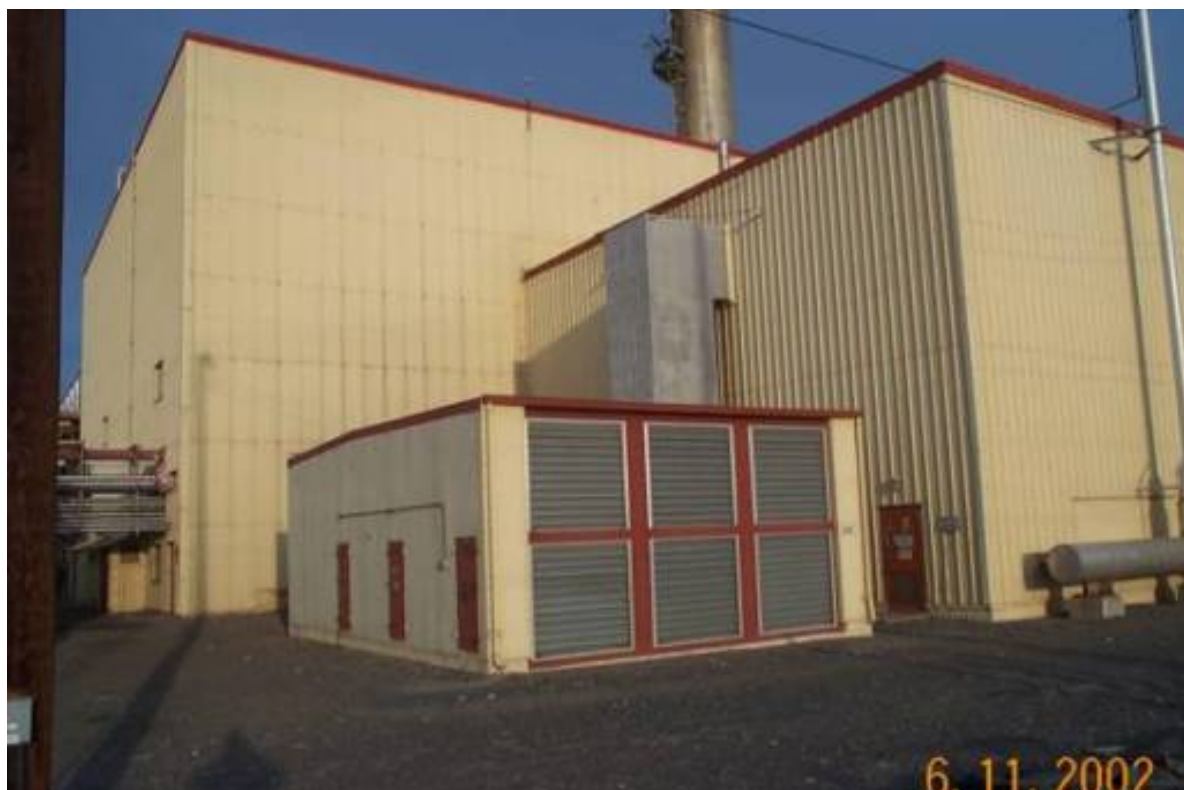
**Figure 10. 184-NC Air Handling Annex Building.**

The 184-NC Air Handler Annex Building was a pre-engineered rectangular steel sided building with a reinforced concrete floor located south of 184-NA (Figure 10). Aerial photographs indicate the roof membrane is the same as 184-N and 184-NA. The east wall was all louvers. The Air Handler Main Building dimensions were approximately 33 ft by 24 ft (784 ft<sup>2</sup>). Building equipment included an HVAC system for 184-NA.

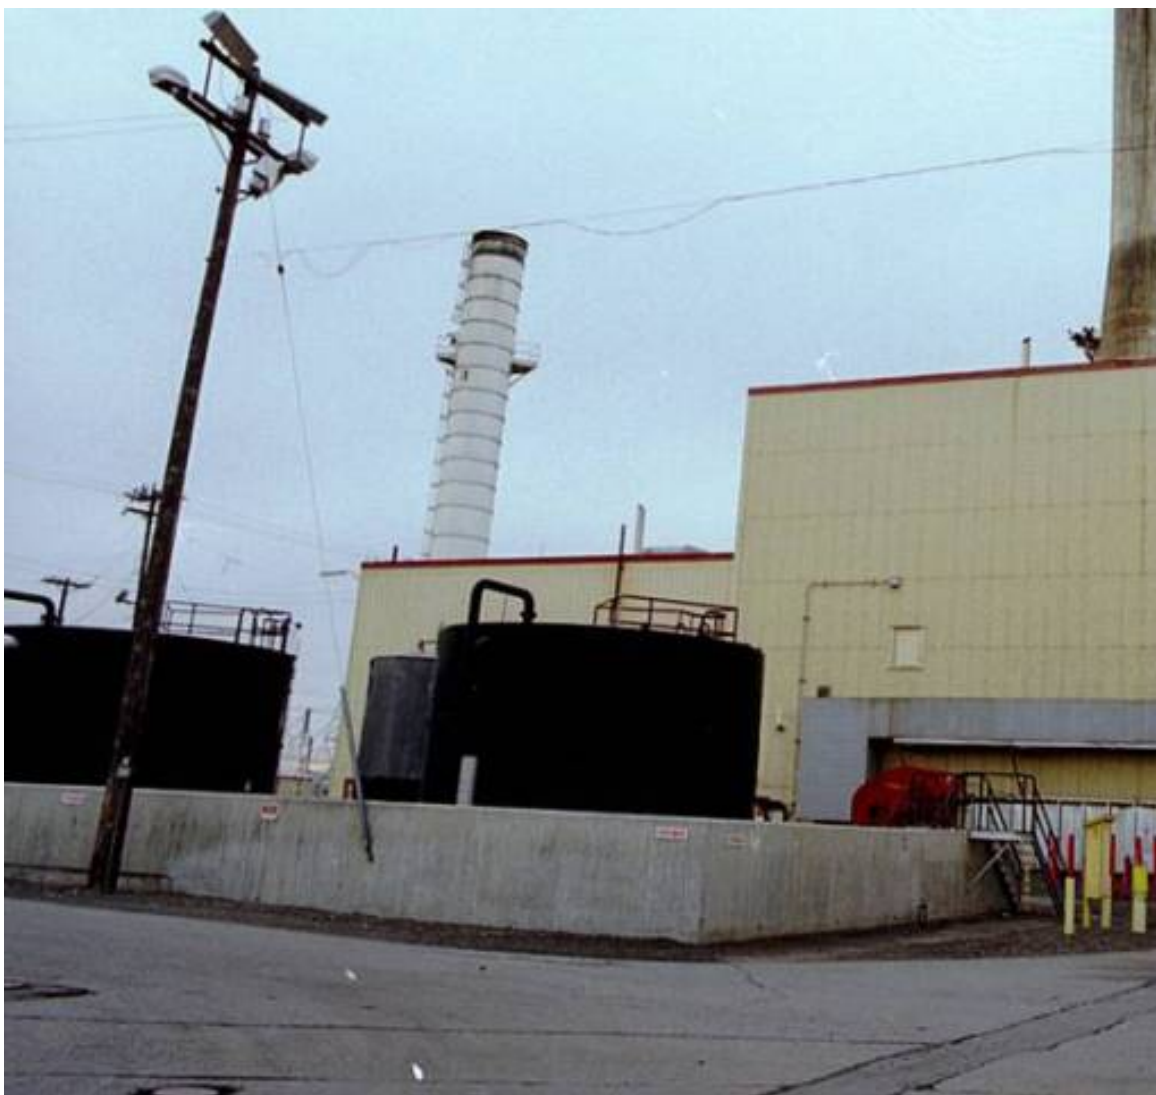
**Figure 11. 184-ND Fuel/Diesel Oil Day Tanks.**

The 184-ND Fuel/Diesel Oil Day Tanks consisted of two 50,000-gal oil storage tanks and one 15,000-gal catch tank (Figure 11). They were located inside a reinforced concrete containment basin. There was no roof to this facility. The day tank dimensions were approximately 81 ft by 41 ft (3,400 ft<sup>2</sup>). These tanks were used for day use of fuel/diesel for boilers in 184-N and 184-NA.

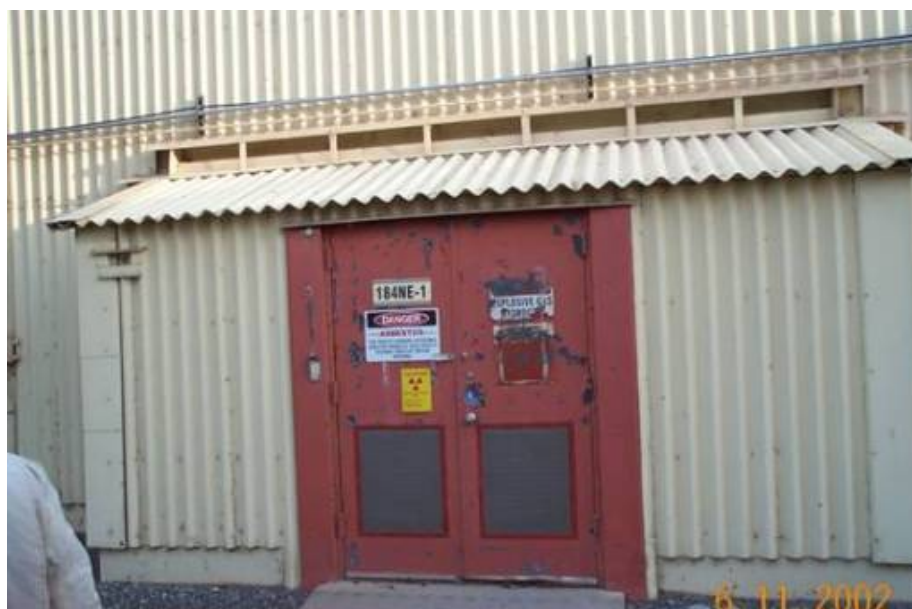
**Figure 12. 184-NE-1 Compressed Gas Shed.**

The 184-NE Compressed Gas Sheds were two corrugated metal gas bottle storage sheds attached to the south wall of 184-N (Figures 12 and 13). The sheds north wall was common with 184-N. The floors were reinforced concrete or steel plates. The roofs were corrugated steel panels. The 184-NE-1 West Shed was approximately 4 ft by 17 ft (62 ft<sup>2</sup>) and the 184-NE-2 East Shed was approximately 4 ft by 11 ft (40 ft<sup>2</sup>). Gas cylinders were stored in the sheds and gas fed into 184-N.

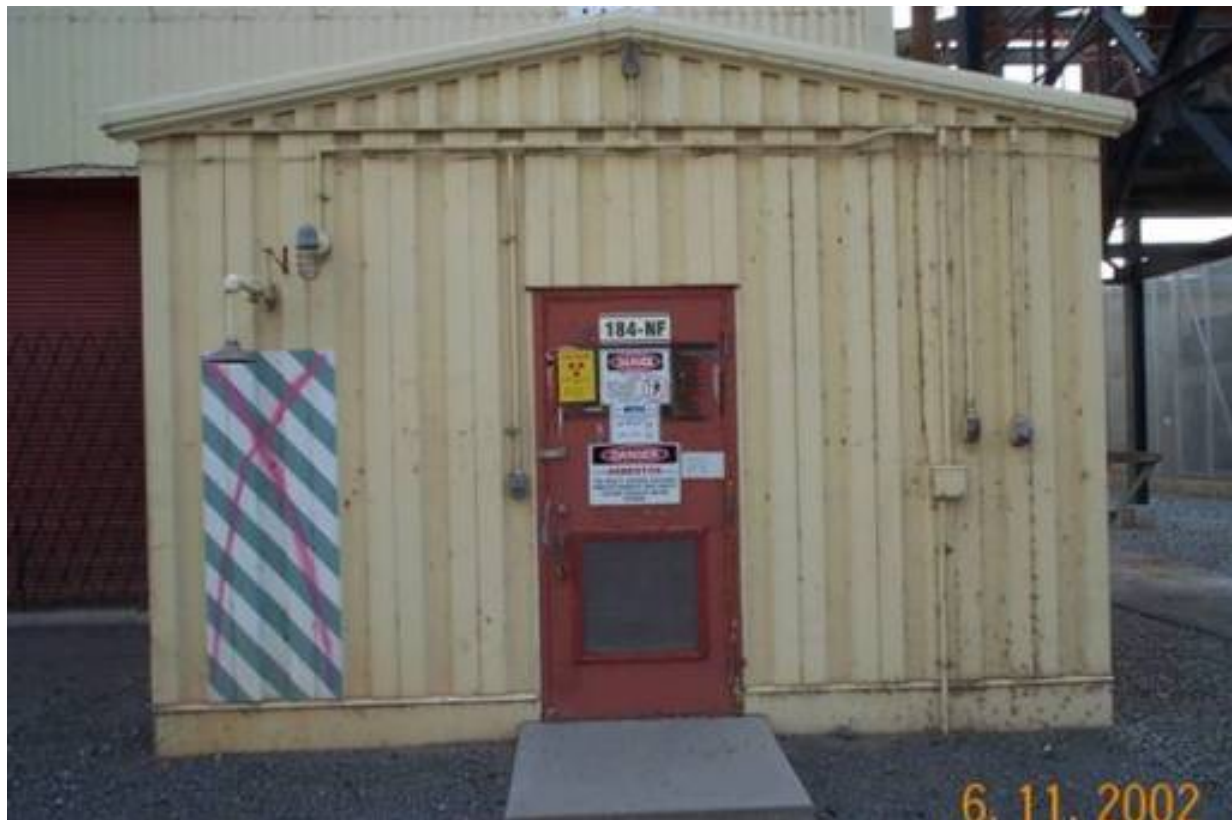
Figure 14. 184-NF Chemical Injection Pump Shed.

The 184-NF Chemical Injection Pump Shed was a channeled metal light-weight steel-framed structure attached to the southwest corner of 184-N (Figure 14). The east wall was common to 184-N. The floor was reinforced concrete. The roof was a metal shallow gable roof. The building housed the chemical makeup system for 109-N.

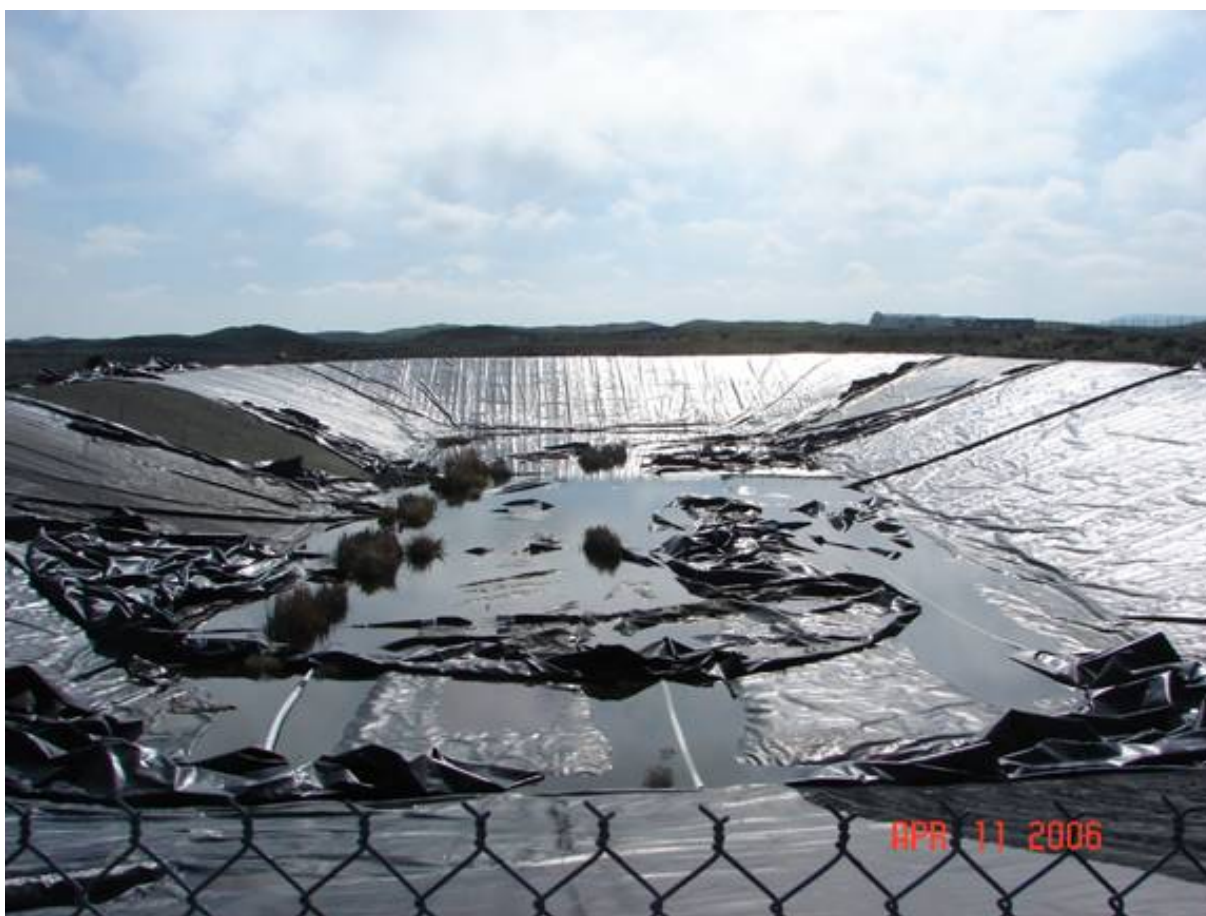
**Figure 15. 1312-N Liquid Effluent Retention Basin.**

The 1312-N Facility was an excavated basin 513 ft by 264 ft by approximately 26 ft deep (156 m by 80 m by 8 m), lined with 60-mil high-density polyethylene (Figure 15). The 1312-N Liquid Effluent Retention Basin (also referred to as the Liquid Effluent Retention Facility) was constructed as a part of the post-Chernobyl safety upgrades to N Reactor (N Reactor Accelerated Safety Enhancement Program). It was designed to retain reactor coolant and other contaminated water in the event of a loss of emergency coolant accident scenario.

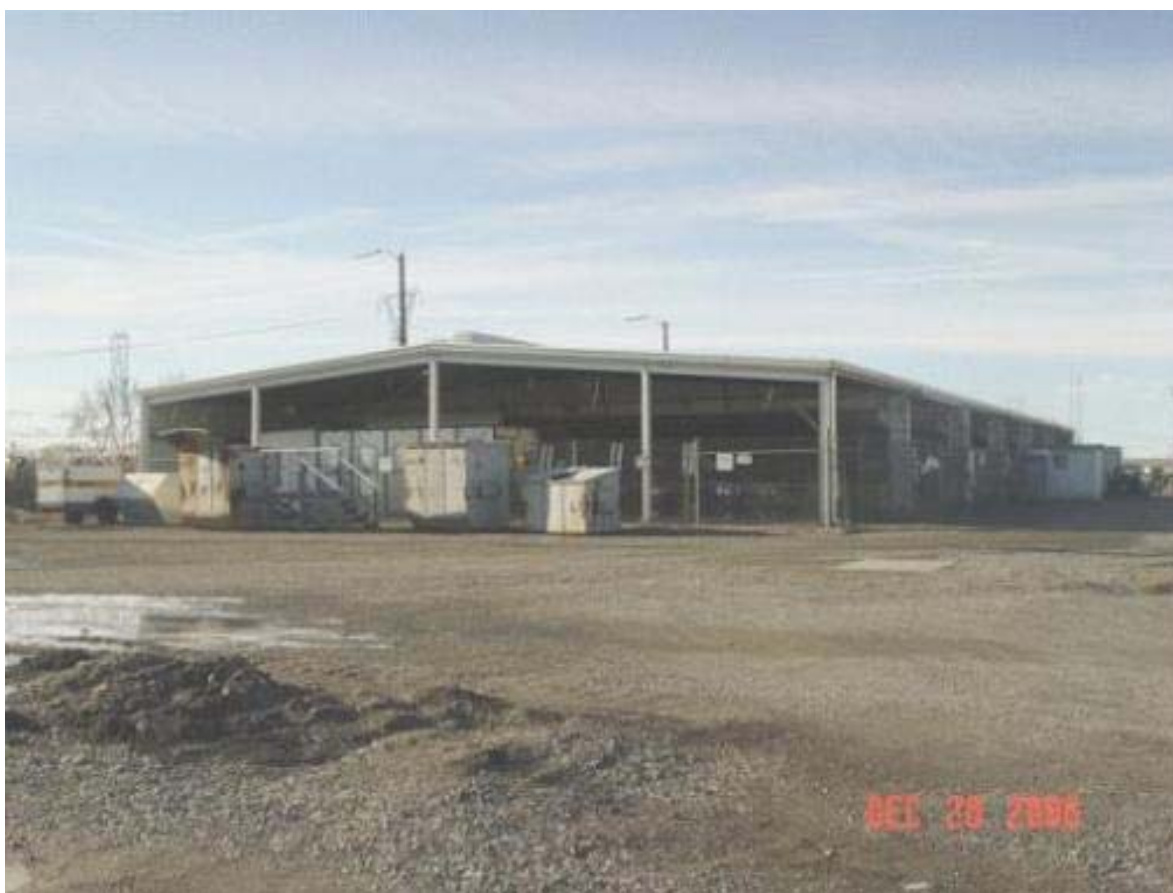
**Figure 16. 1330-N Waste Storage Facility.**

The 1330-N Waste Storage Facility was a curbed and fenced concrete pad (Figure 16). The pad was covered by an open metal shed, installed over the pad in the late 1980s that was divided into three storage areas each with its own locked gate. The entire unit was approximately 150 ft by 60 ft (46 m by 18 m). The south and west sides of the unit had sheet metal siding. The east and north sides were open. An asphalt parking/driving area was on the north side; gravel surrounds the rest of the facility.

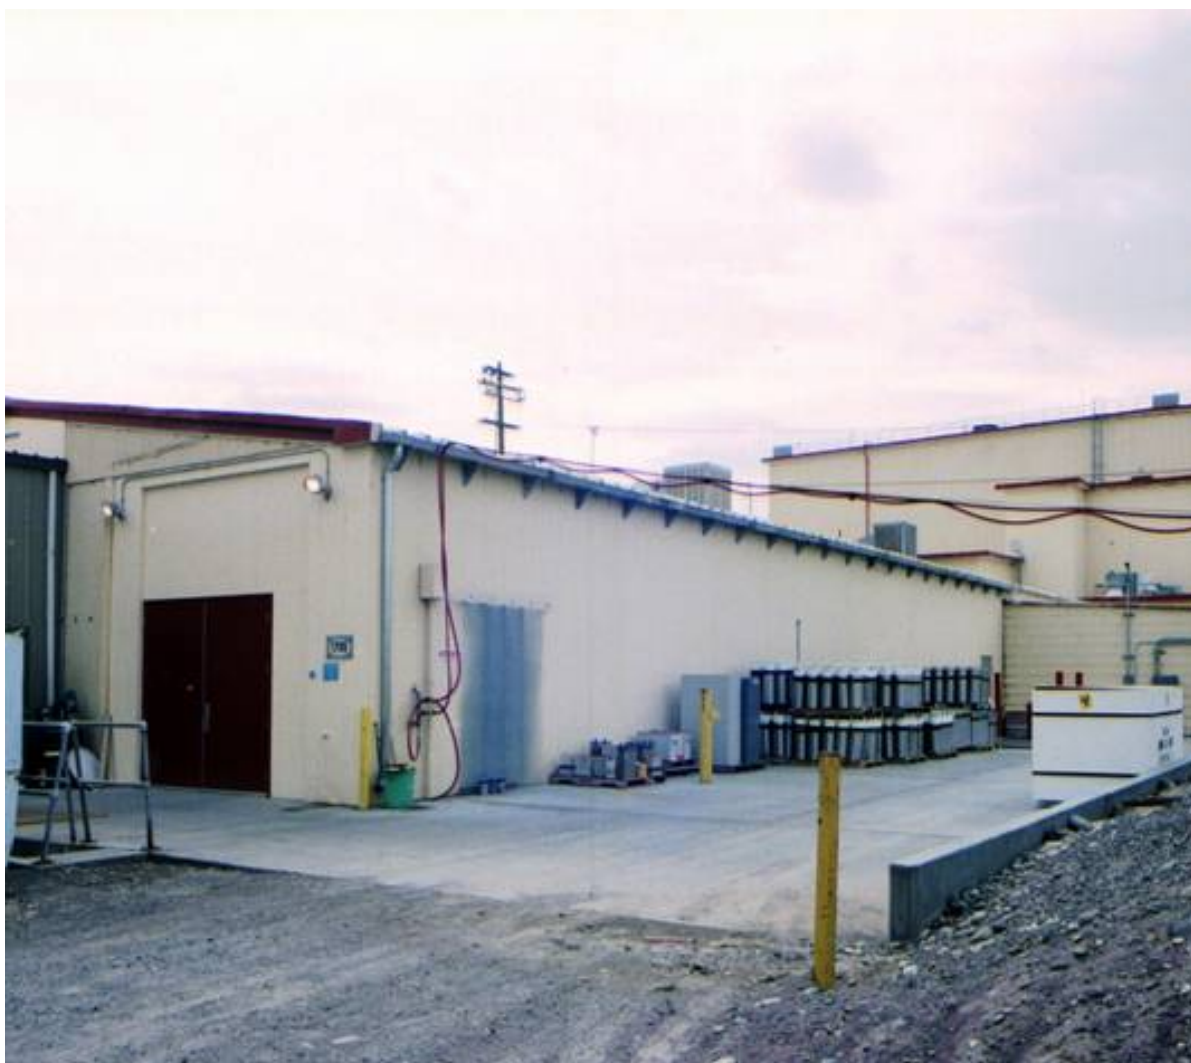
**Figure 17. 1705-N Instrument and Electrical Facility.**

The 1705-N Instrument and Electrical Facility was a rectangular, one-story steel-frame building with a poured concrete foundation (Figure 17). The walls and gable roof were corrugated metal. The east wall is shared with 1705-NA and the north wall is shared with 1706-N. The 1705-N Facility was part of the original N Reactor complex to provide space for a variety of operations and support services including a module shop, communication shop, instrument shop, electrical shop, small appliance storage, document storage, conference room, and restrooms. The 1705-N Instrumentation and Electrical Facility was a 50-ft by 152-ft (15-ft by 46-m) pre-engineered, one-story metal building attached to the north wall of 105-N Reactor Building. The building covered 9,240 ft<sup>2</sup> (858 m<sup>2</sup>).

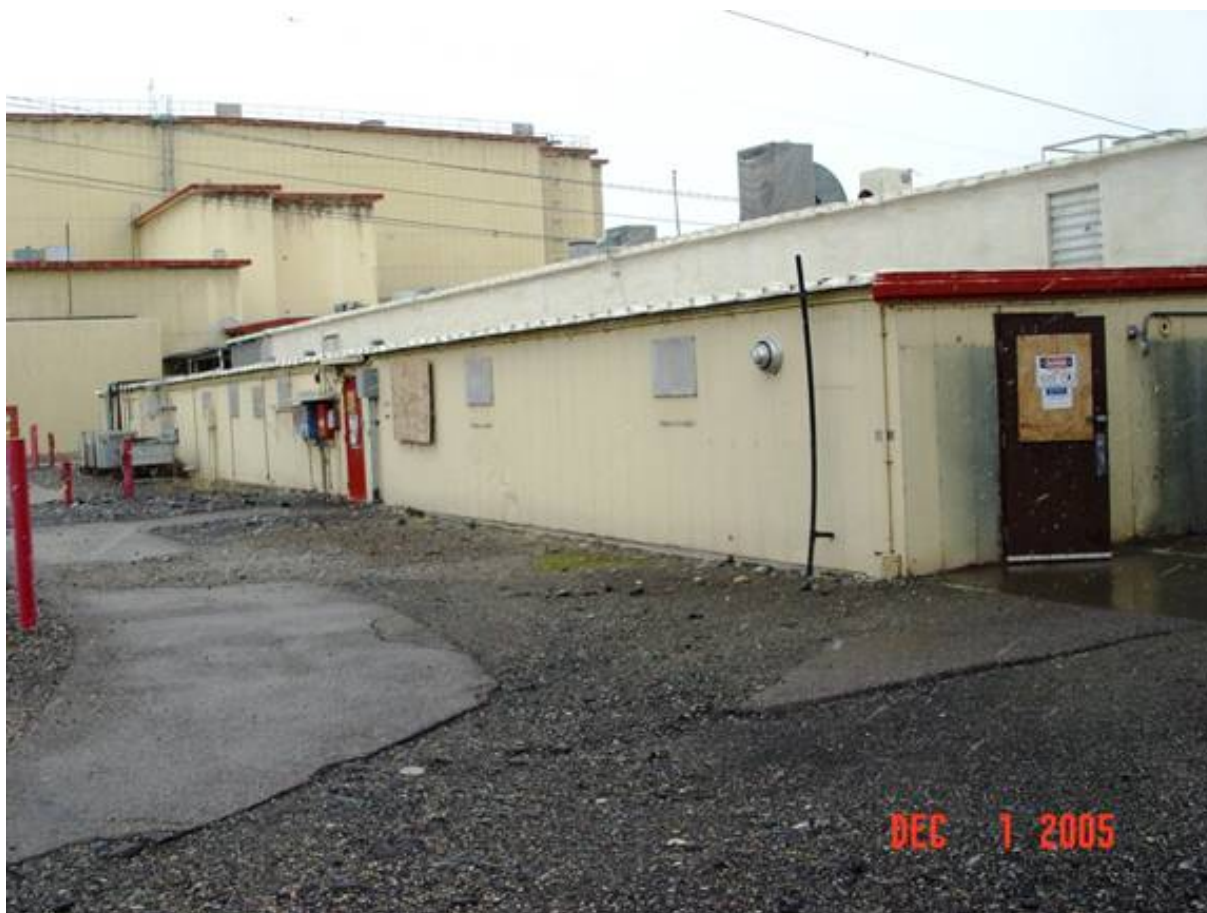
**Figure 18. 1705-NA Maintenance Shop Annex.**

The 1705-NA Maintenance Shop Annex was a rectangular, one-story steel-frame building with a poured concrete foundation and corrugated metal exterior wall and flat roof surfaces (Figure 18). The west wall of 1705-NA is shared with 1705-N. It was originally used for maintenance work on motors and later as office space. The 1705-NA Maintenance Shop Annex was a 20-ft by 130-ft (6-m by 40-m) steel-framed building with metal siding and covered a 2,583-ft<sup>2</sup> (240-m<sup>2</sup>) area.

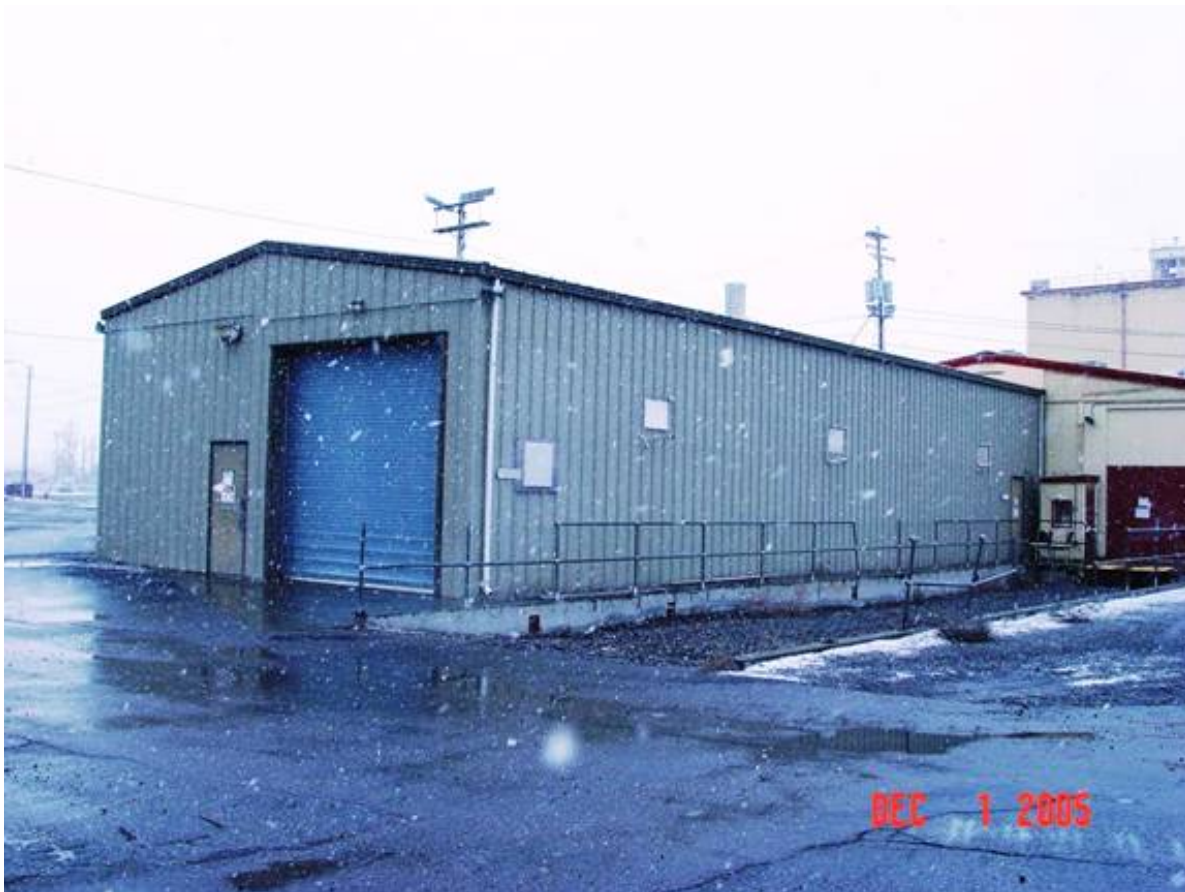
**Figure 19. 1706-N Storage Building/Maintenance Shop.**

The 1706-N Storage Building/Maintenance Shop was a rectangular, one-story steel-frame building with a poured concrete foundation (Figure 19). The 1706-N Storage Building/Maintenance Shop was a 30-ft by 75-ft (9-m by 23-m) pre-engineered, steel-framed building with metal siding that covered 2,228 ft<sup>2</sup> (207 m<sup>2</sup>). The walls and gable roof were corrugated metal. Attached to the east side of 1706-N was an open air shed with a steel roof supported by galvanized pipes. Chain link fencing attached to the pipes prevented unauthorized access to the shed. The south wall of 1706-N was shared with 1705-N. A loading ramp with embedded snow melting units was located along the west side of the building. The 1706-N Building was constructed in 1984 to serve as a storage facility for the 100-N Area. Within a few years it was being used as an electrical motor repair shop.

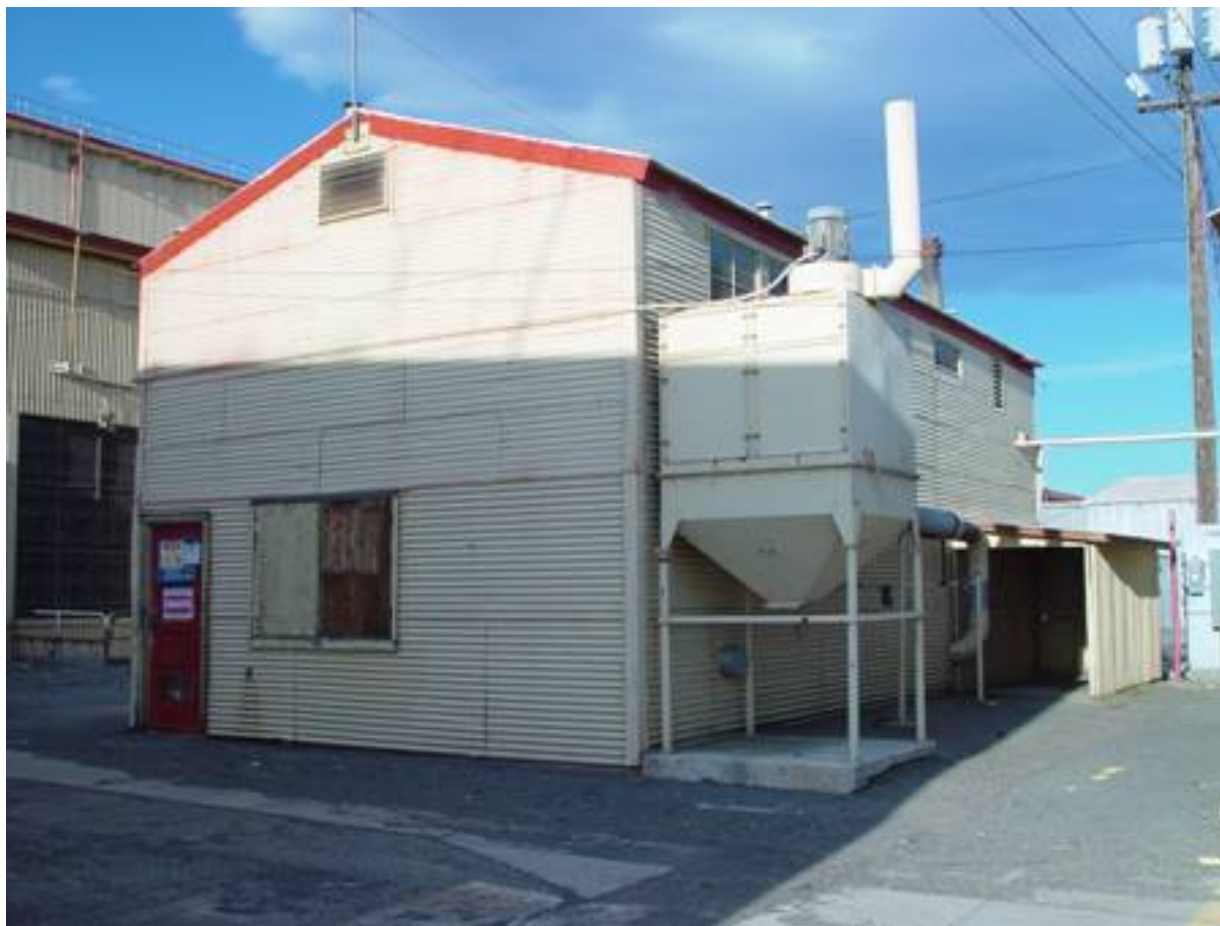
**Figure 20. 1712-N Insulation Shop.**

The 1712-N Insulation Shop was constructed around 1962 as part of the original N Reactor complex (Figure 20). It was a rectangular, two-story steel frame building with a reinforced poured concrete foundation, corrugated metal exterior wall surface, and a corrugated metal gable roof. The second story was enclosed on one-half and opened from the first floor to the roof on the second story in the second half. Interior walls were 2-in. by 4-in. studs with cement asbestos or gypsum wallboard. A small wood and corrugated sheet metal lean-to type storage shed was attached to the northwest corner of 1712-N. An asbestos dust collector was located on a concrete pad at the northeast corner of 1712-N. The 1712-N Insulation Shop was the primary work location for the 100-N Area insulators. The facility held equipment for shaping and cutting insulation for 100-N piping systems and equipment.

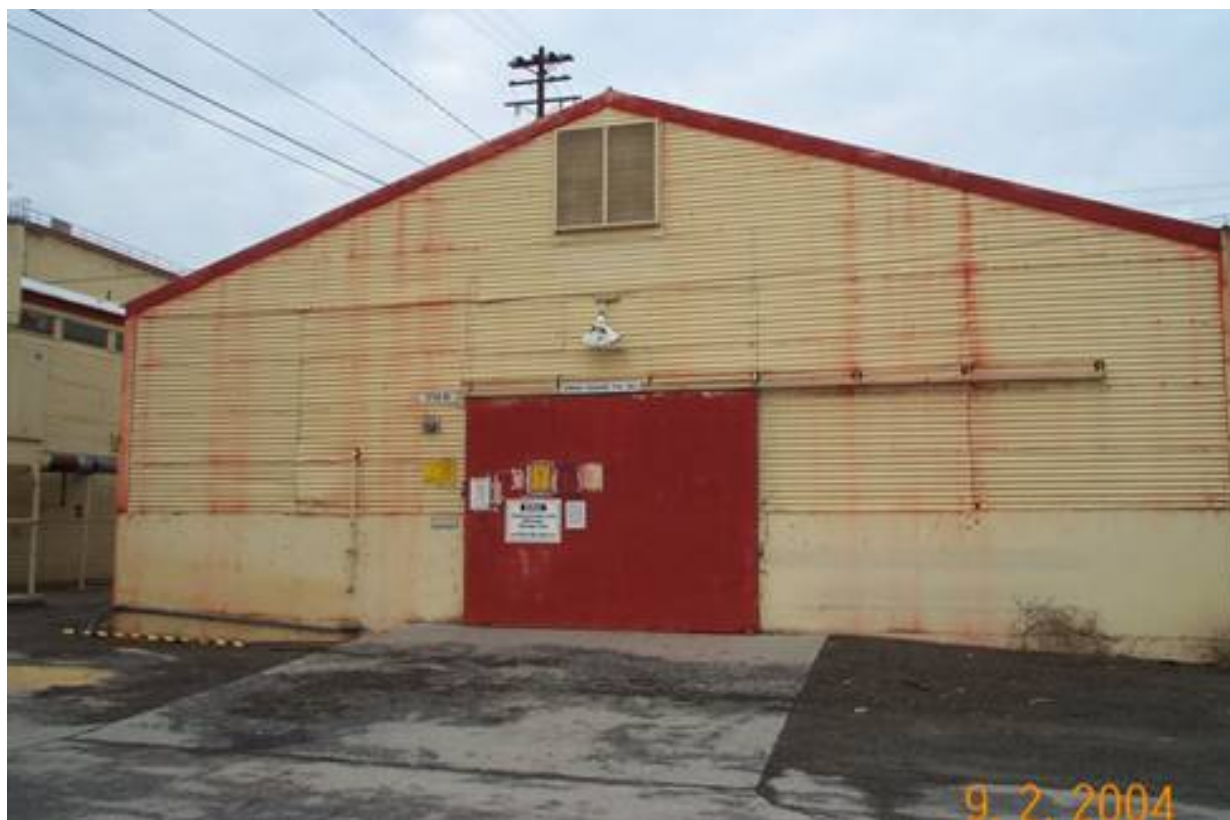
**Figure 21. 1714-N Warehouse and Receiving.**

The 1714-N Building was constructed in 1966 (Figure 21). 1714-N was a rectangular, one-story metal frame building with reinforced concrete grade beams, a poured concrete foundation, corrugated metal exterior wall surface, and metal gable roof. It measured 40 ft by 80 ft (12.2 m by 24.4 m). The 1714-N Warehouse was initially used for warehousing small tools and parts used at 100-N. Later it was used to store radioactive materials.
