# River Corridor Closure Contract

## 100 Area D4 Project Building Completion Report – July 2007 to December 2008

April 2009

**Washington Closure Hanford**

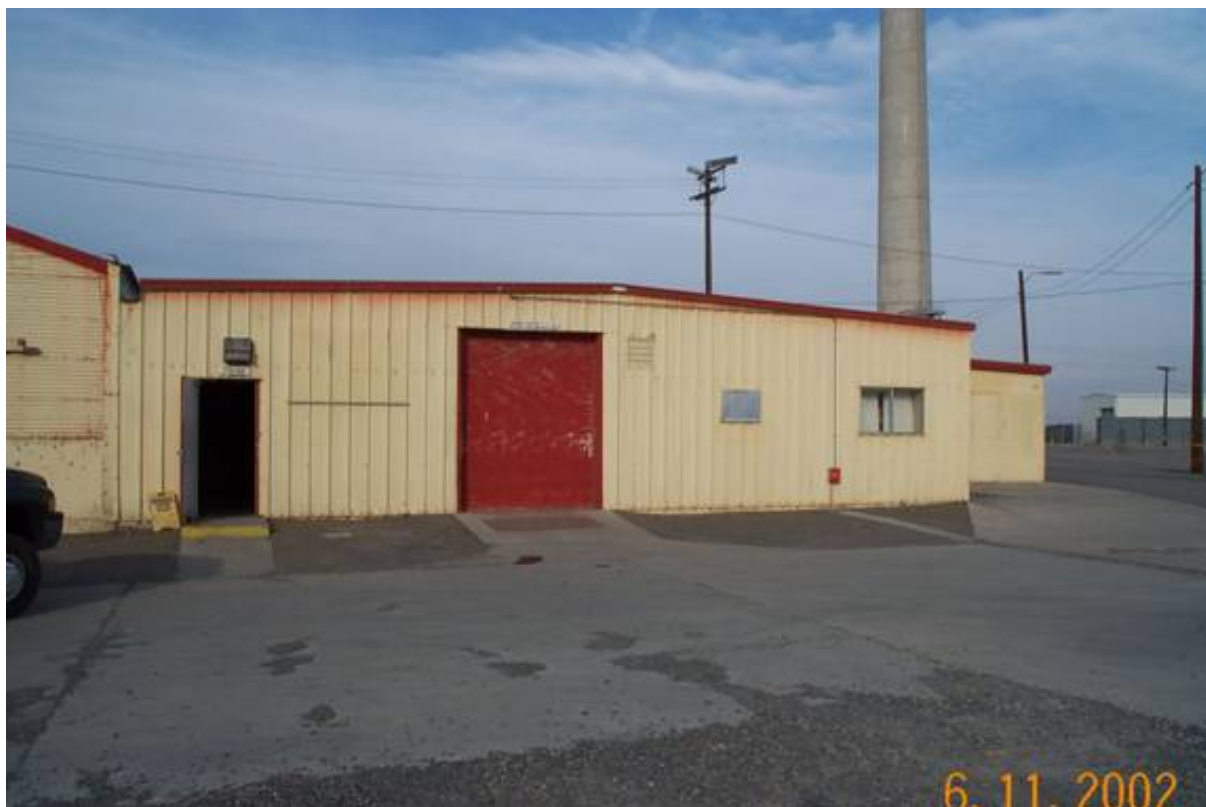
**Figure 22. 1714-NA Warehouse.**

The 1714-NA Receiving and Inspection Warehouse was constructed in 1982 to support 100-N Area receiving and inspection activities (Figure 22). It was a rectangular, one-story metal frame building with a reinforced poured concrete foundation, corrugated metal exterior wall surface, and metal gable roof. The 1714-NA Building is 51 ft by 80 ft (15.5 m by 24.4 m), 4,080 ft<sup>2</sup> (379 m<sup>2</sup>).

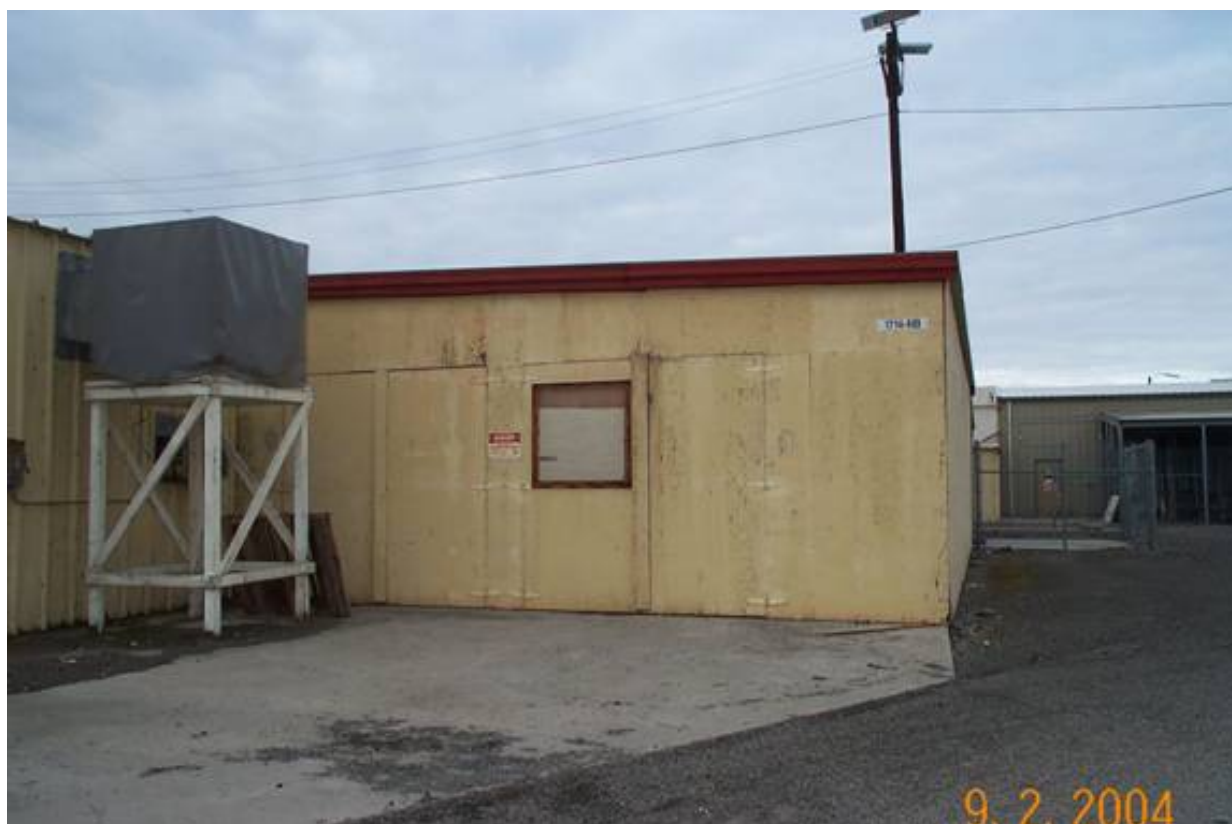
**Figure 23. 1714-NB Warehouse.**

The 1714-NB was a rectangular, one-story wood frame building with a poured concrete foundation, plywood siding, and a gable corrugated metal roof (Figure 23). The building was 24 ft by 40 ft (7.3 m by 12.2 m). 1714-NB was attached to and directly north of the 1714-NA Building. The 1714-NB was constructed to provide space for small tools, parts, and equipment for daily use. It was later used for storage of radioactive materials.

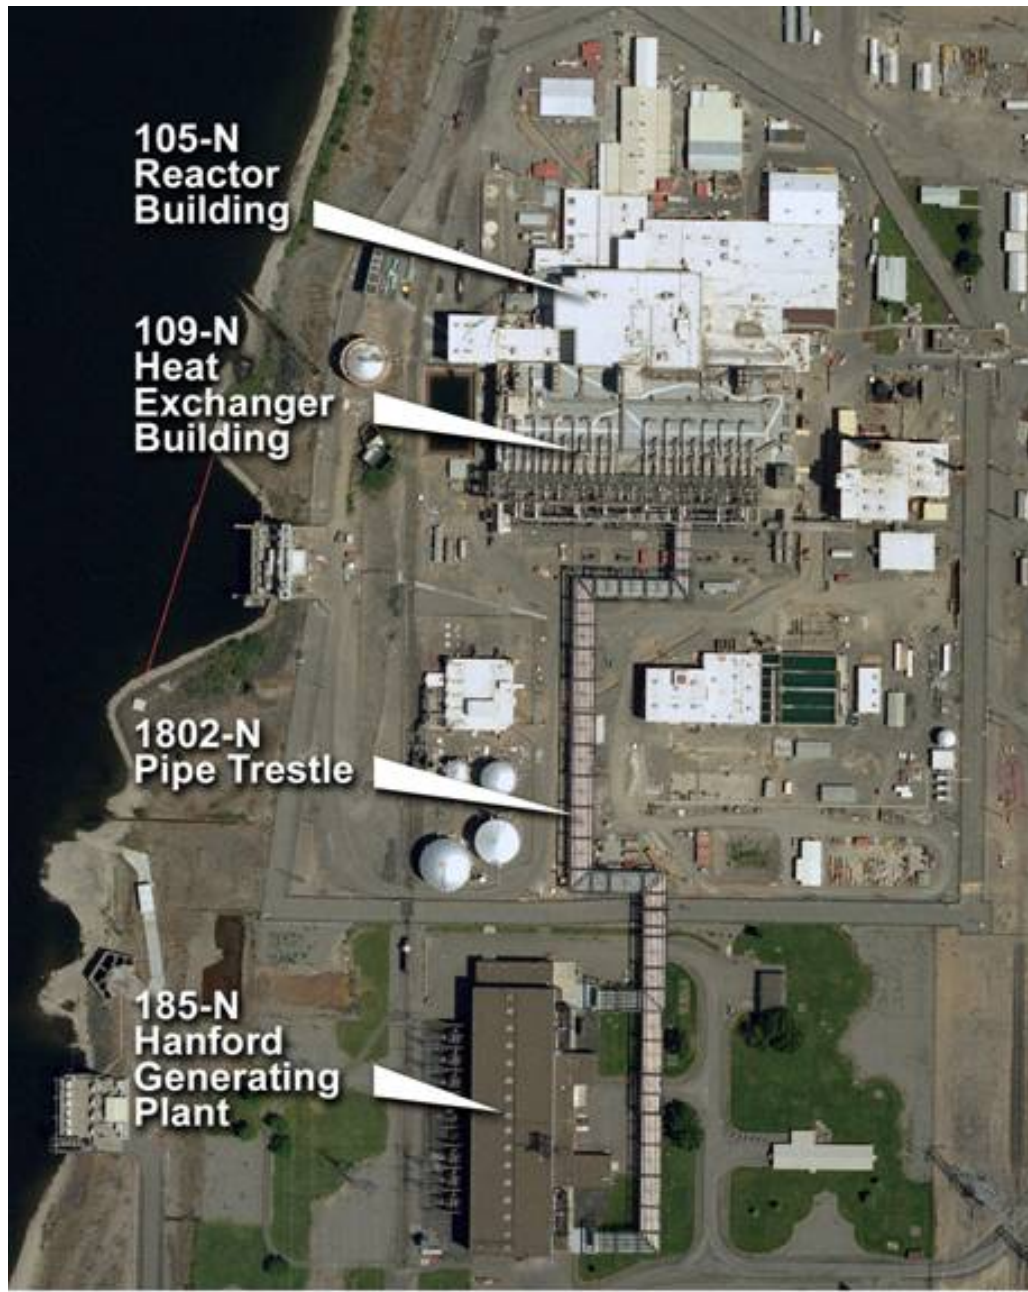
Figure 24. 1802-N Pipe Trestle.

The 1802-N Pipe Trestle includes the piping and support structure that supplied steam from the 109-N Building to the Hanford Generating Plant (HGP) and steam condensate return lines from the HGP back to 109-N (Figure 24).

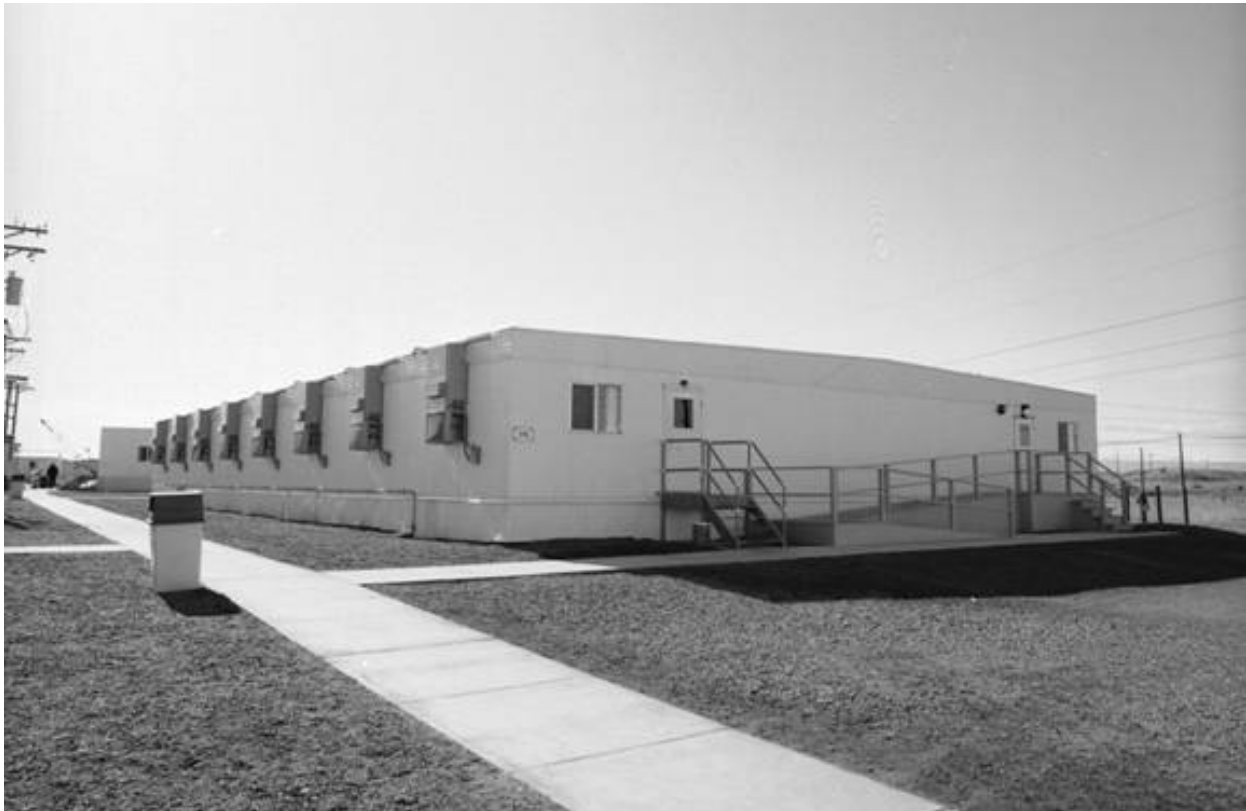
**Figure 25. MO-050 Mobile Office.**

MO-050 (1115-N) was one of several mobile offices that were installed in the 100-N Area in the 1980s (Figure 25). It consisted of eight sheet metal and plywood trailers on I-beam trailer frames. The MO-050 facility was used to house support personnel offices in the 100-N Area. In addition to office space, MO-050 also contained a lunchroom/kitchen, 32 offices, restrooms, and 2 classrooms.

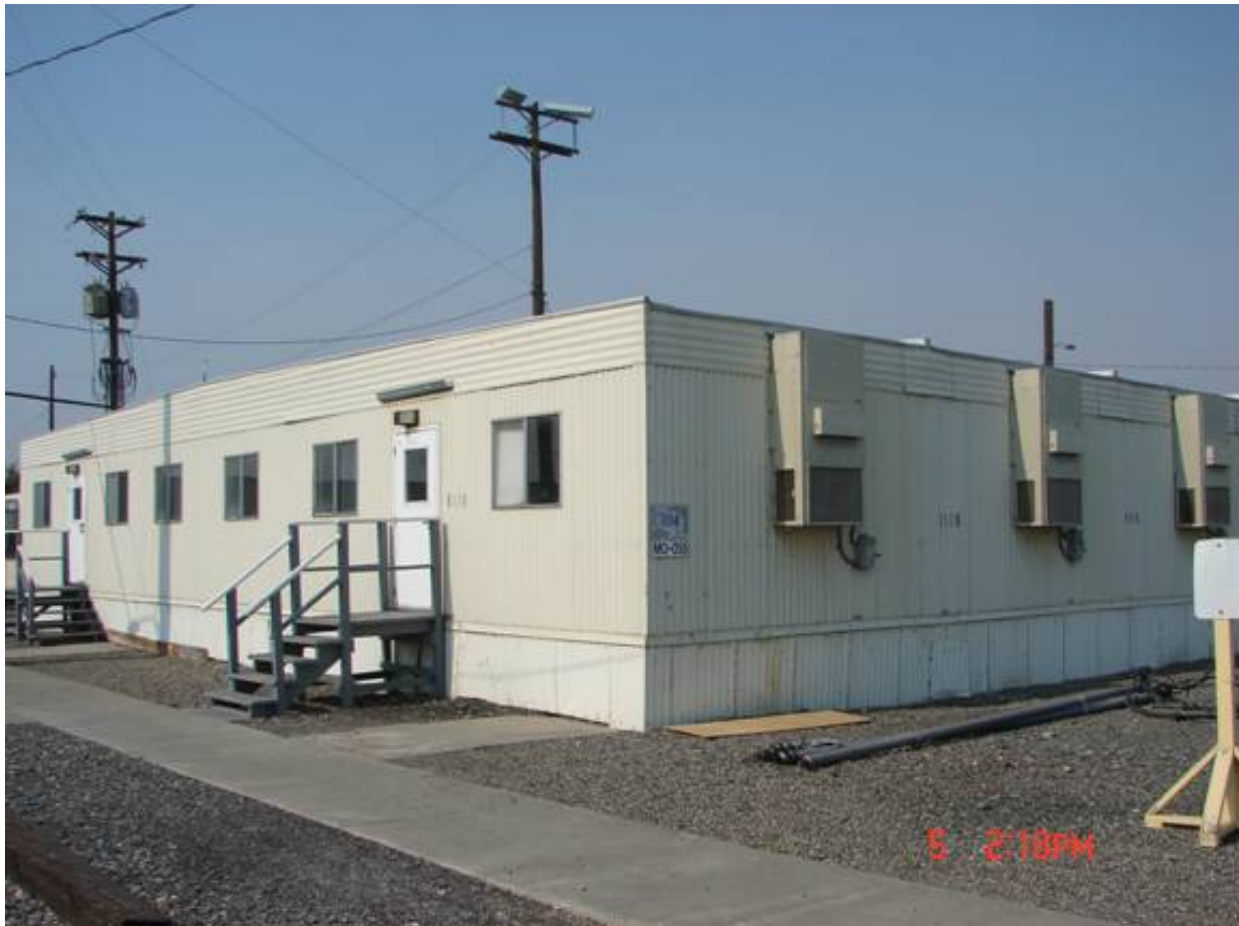
**Figure 26. MO-055 Mobile Office.**

MO-055 (1114-N) was one of several mobile offices that was installed in the 100-N Area in the 1980s (Figure 26). It consisted of four sheet metal and plywood trailers on I-beam trailer frames. The MO-055 facility was used to provide office space for site support personnel in the 100-N Area. The building was attached to the MO-911 (1114-NA) mobile office. Together with MO-911, the two facilities contained 20 offices, restrooms, and a kitchen.

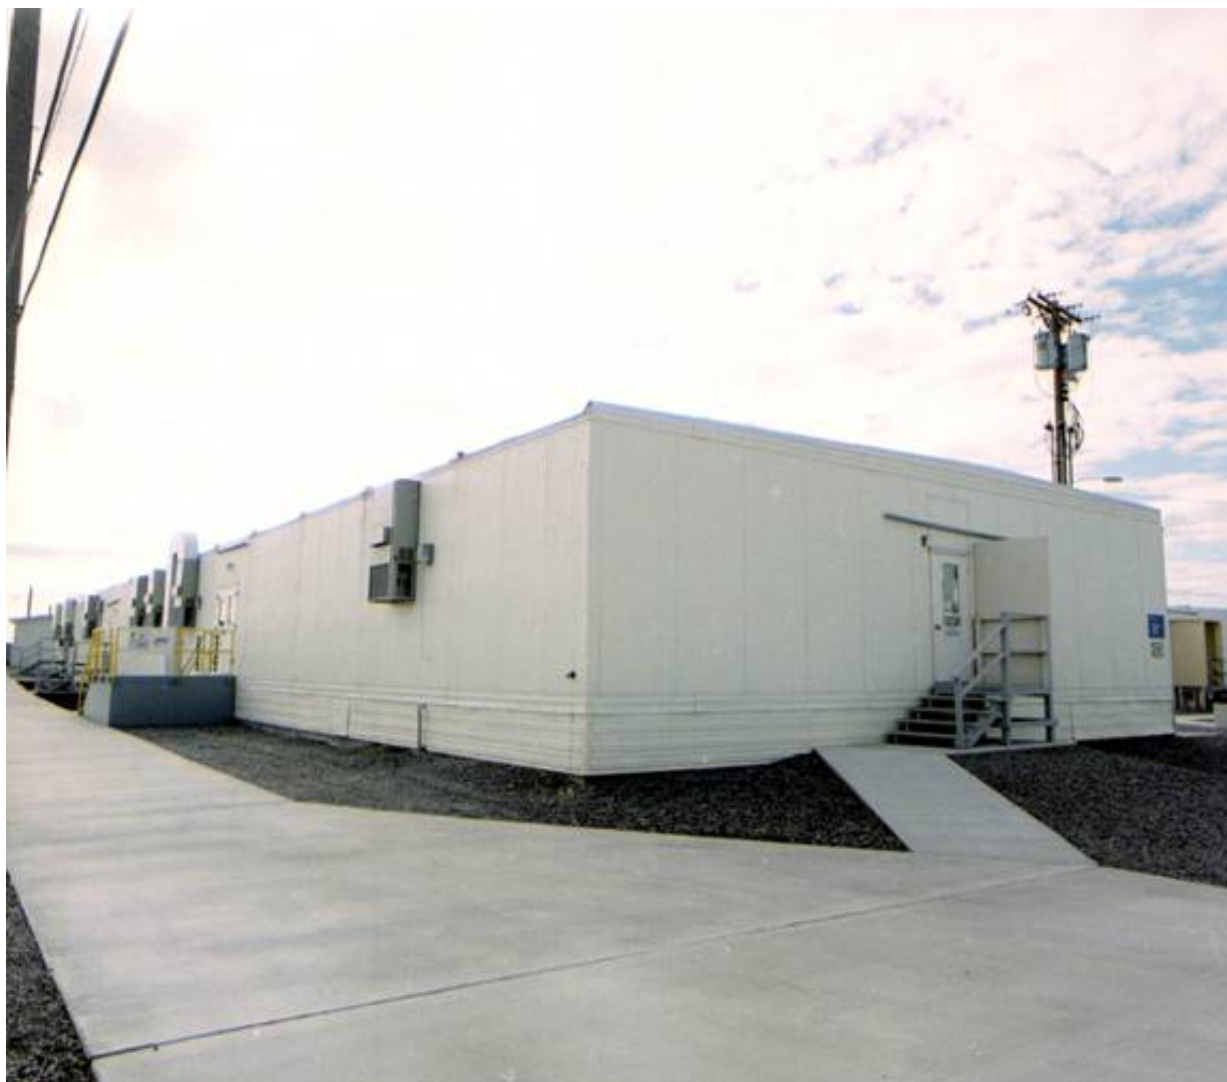
**Figure 27. MO-358 Mobile Office (Training Simulator).**

MO-358 (1116-N) was one of several mobile offices that was installed in the 100-N Area in the 1980s (Figure 27). It consisted of 10 sheet metal and plywood trailers on I-beam trailer frames. The 1116-NB Air Compressor Building was a small wooden shed located off the northwest corner of the 1116-N Building. As the name suggests, the structure housed an air compressor needed to operate the 1116-N Training. The 1116-N Building was used as a training simulator for the 100-N Area and housed a replica of the 100-N Reactor control room. In addition, it contained seven offices, a kitchen, and restrooms.

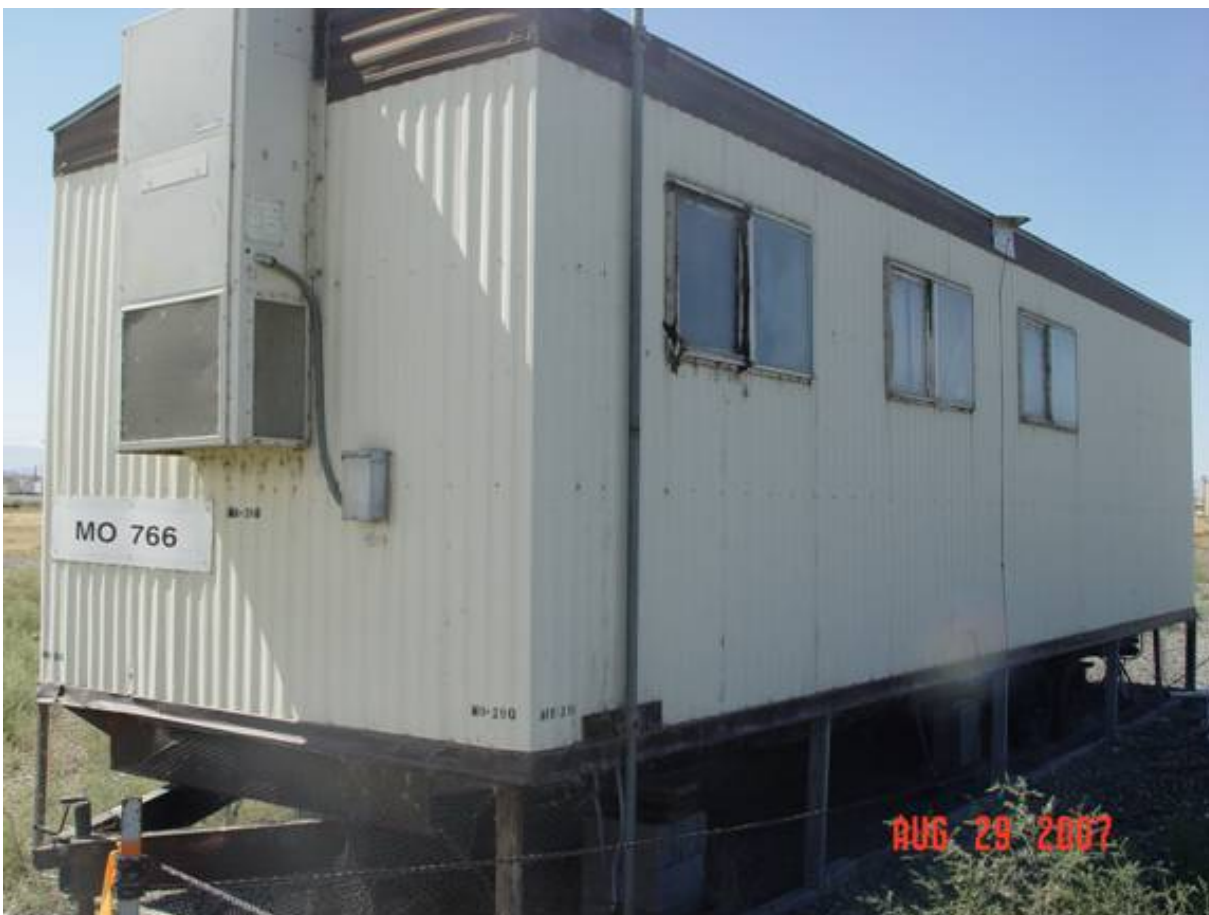
**Figure 28. MO-390 Mobile Office (Field Trailer).**

The MO-390 trailer appears to have originally been located in the 200 West Area near the 271-U Building during the mid-1990s (Figure 28). It was relocated around 1997 to the 100-B/C Area for the 105-C Interim Safe Storage project. In 2000, the MO-390 trailer was brought to the 100-N Area where it remained until it was demolished in 2007. It was a single-wide trailer that measured 10 ft by 32 ft (3.1 m by 9.8 m). In the 100-N Area, the MO-390 trailer functioned as a Radiological Control Technician trailer in support of the 100-NR-1 TSD site project. Apparently, MO-390 was labeled as MO-766 in 2004 and used as a counting room and storage trailer in support of 100-N crib remediation. In 2007, just before the MO-390 building was demolished, it was observed to have signs on it that read "MO-766." Using the serial codes of the trailers, it was determined that MO-766 was actually located near ERDF, with a sign that read "MO-740." The real MO-740 building has not been located. It seems likely that MO-390 functioned as MO-766 since 2004 when MO-766 was supposed to have been installed.

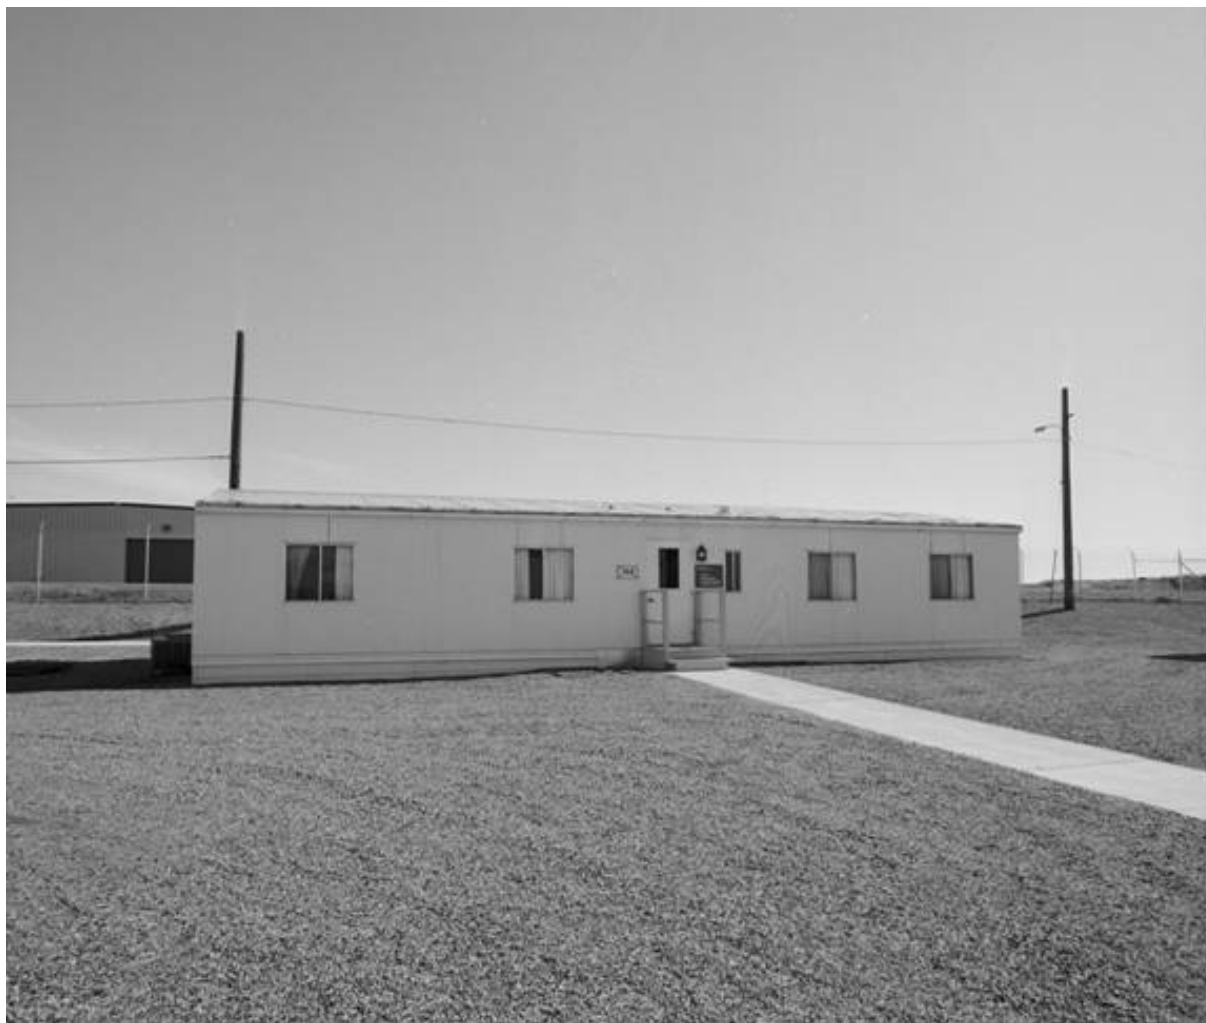
**Figure 29. MO-900 Mobile Office.**

MO-900 (1124-N) was one of several mobile offices that were installed in the 100-N Area in the 1980s (Figure 29). It consisted of two sheet metal and plywood trailers on I-beam trailer frames. As was the case with most of the mobile trailer buildings on the Hanford Site, the primary purpose of MO-900 was to provide office space. The building housed four offices, a kitchen, and restrooms. The facility was later used for records storage.

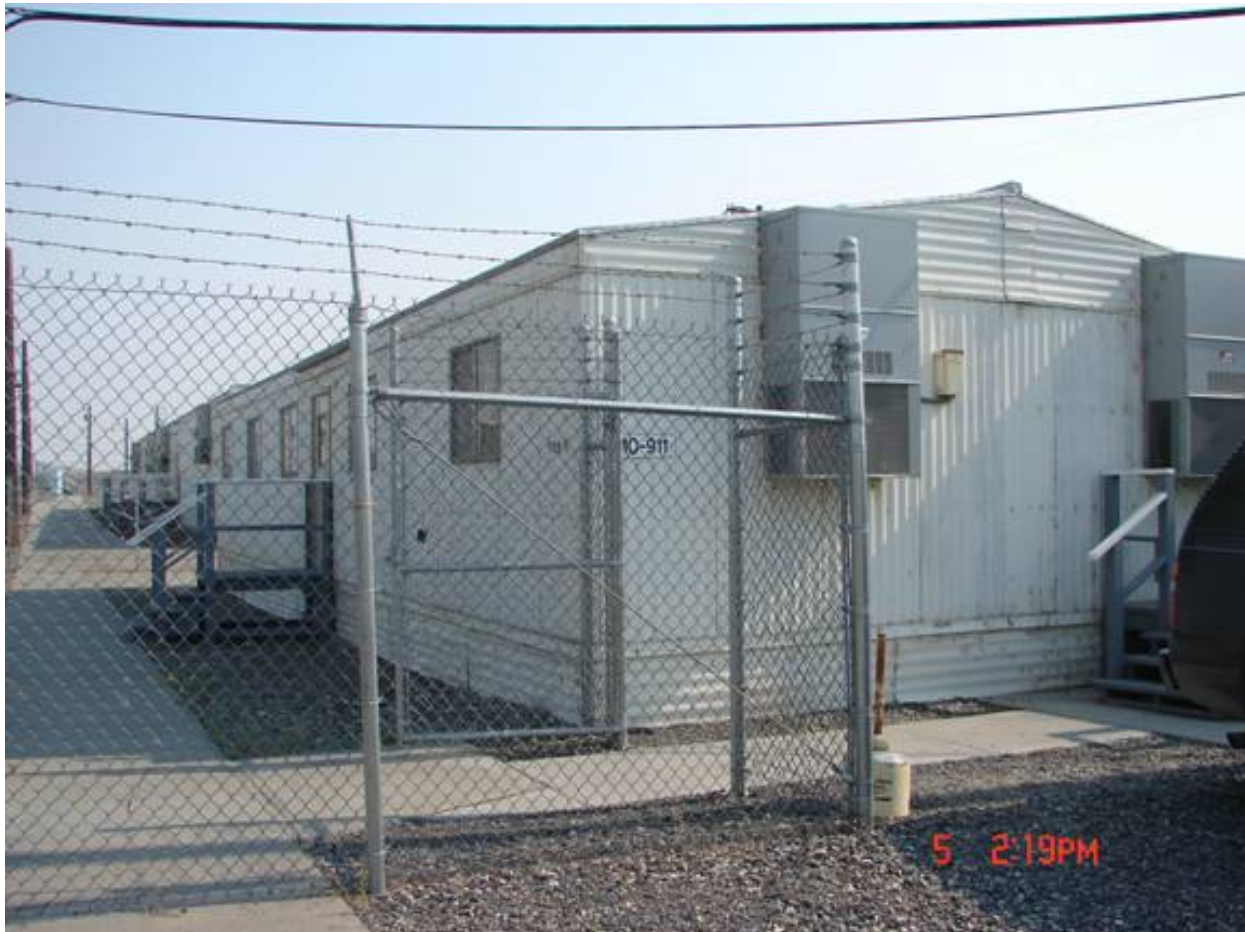
**Figure 30. MO-911 Mobile Office.**

MO-911 (1114-NA) was one of several mobile offices that were installed in the 100-N Area in the 1980s (Figure 30). It consisted of two sheet metal and plywood trailers on I-beam trailer frames. The building was connected to the MO-055 (1114-N) mobile office. The MO-911 facility was used to provide office space for field support personnel in the 100-N Area. Together with MO-055, the two facilities contained 20 offices, restrooms, and a kitchen.

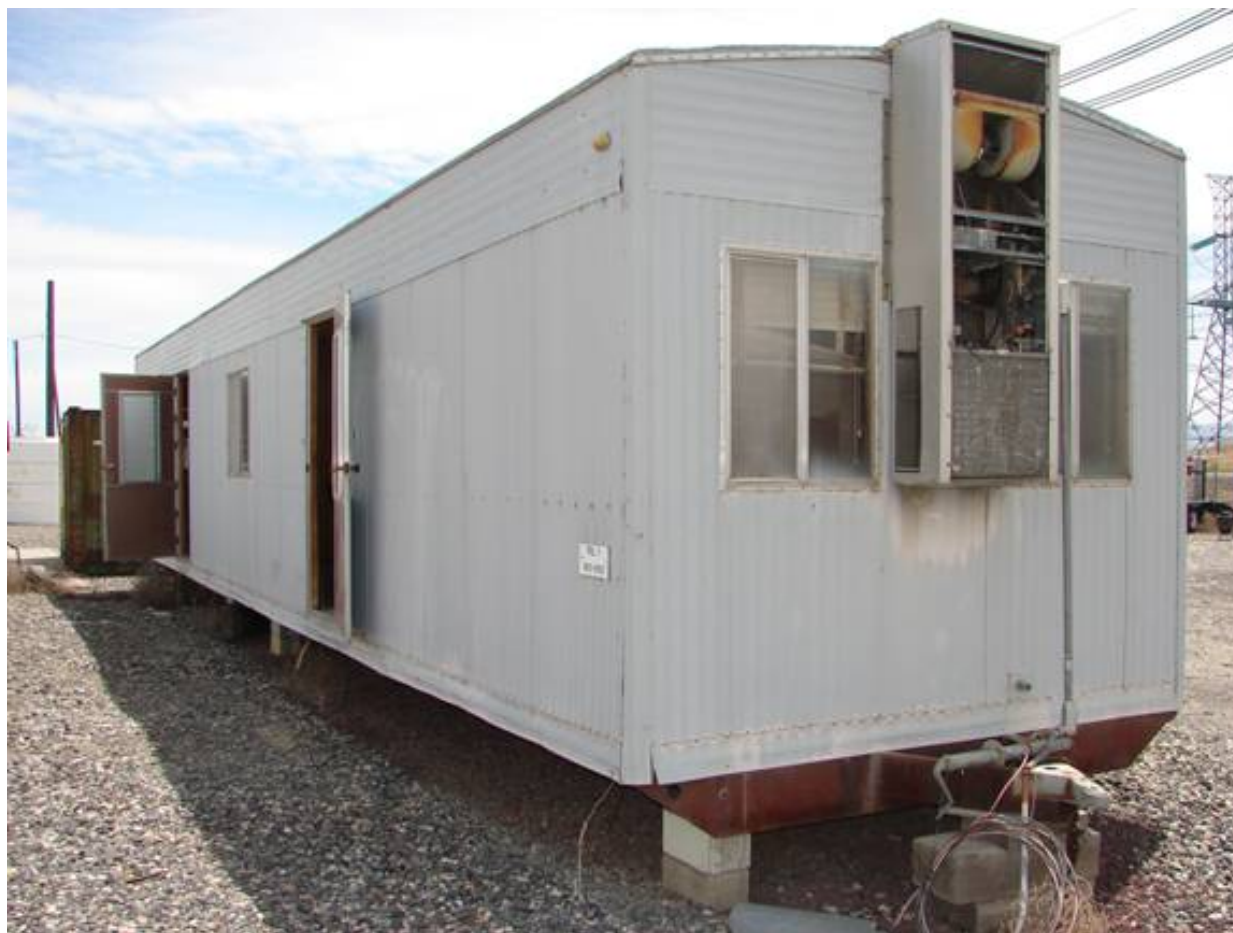
**Figure 31. MO-950 Mobile Office.**

MO-950 was a single-wide mobile office trailer facility in the 100-N Area (Figure 31). MO-950 was located in the southeastern portion of the 100-N Area and was associated with the laydown yard. The MO-950 facility provided office space at the 100-N laydown yard.
