Chief Joseph Kokanee Enhancement Project

Strobe Light Deterrent Efficacy Test and Fish Behavior Determination at the Grand Coulee Dam Third Powerplant Forebay

Annual Report 2001 - 2002

DOE/BP-00000652-23

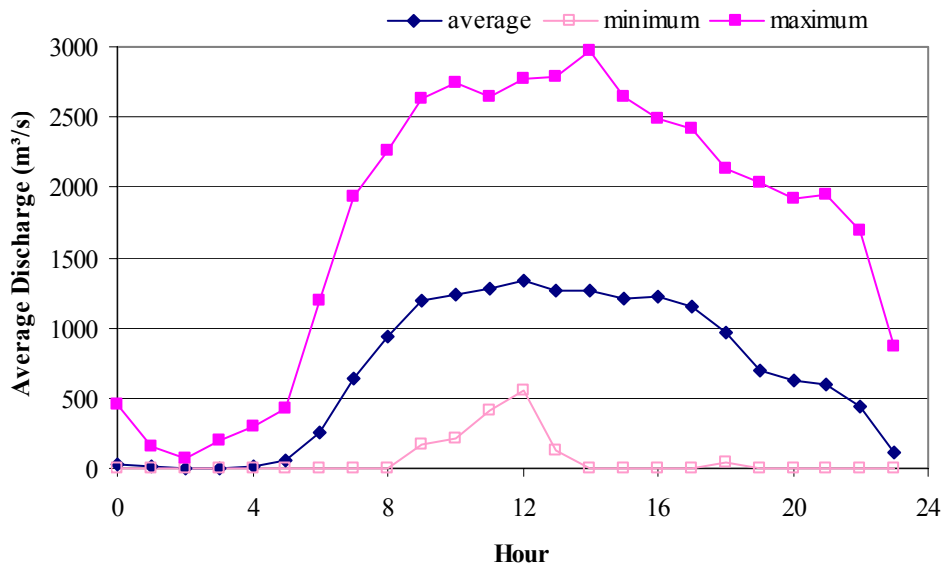
Figure 2.5. Discharge Over 24 Hours at the Third Powerplant at Grand Coulee Dam. Data were averaged over the period June 30 through August 3, 2001.

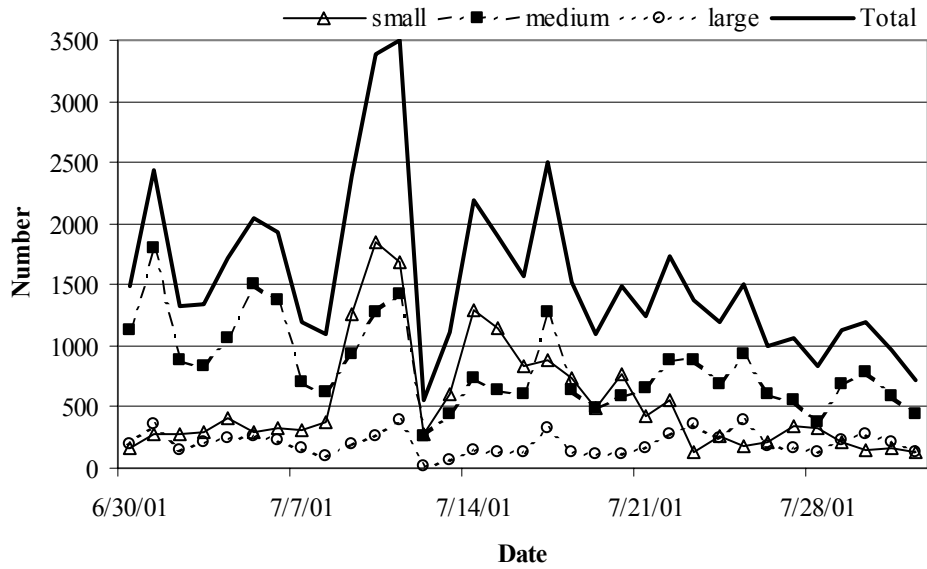
Figure 4.2. Number of Fish Targets Detected During Study Period at Grand Coulee Dam in 2001. Ranges for size categories, based on target strength, were as follows: small ≤ -42 dB; medium > -42 to ≤ -32 dB; large > -32 dB.

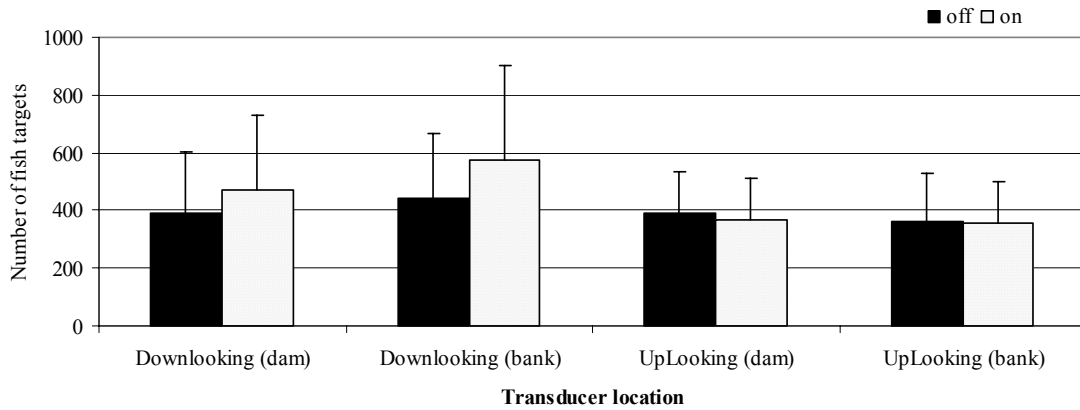
Figure 4.4. Number of Fish Tracks Detected by Each Splitbeam Transducer When Strobe Lights Were Off (24 hr) and On (24 hr). Bars are ± 1 standard deviation ($n = 10$).

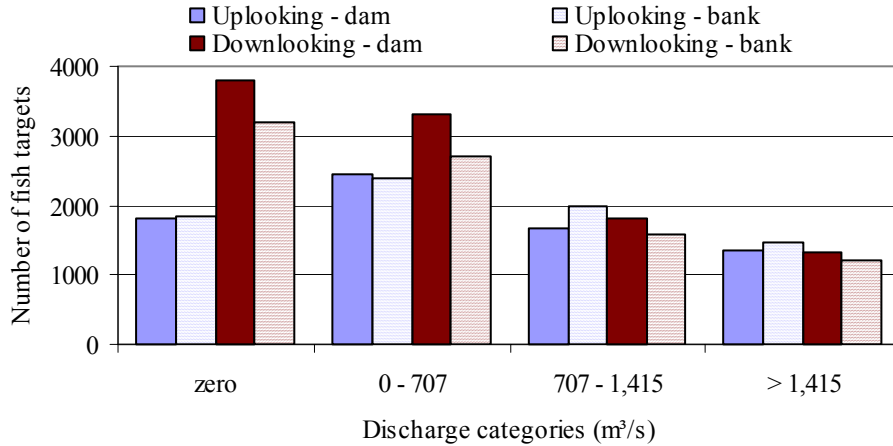
Figure 4.6. Number of Fish Targets Detected with Respect to Discharge from Third Powerplant and Transducer Location

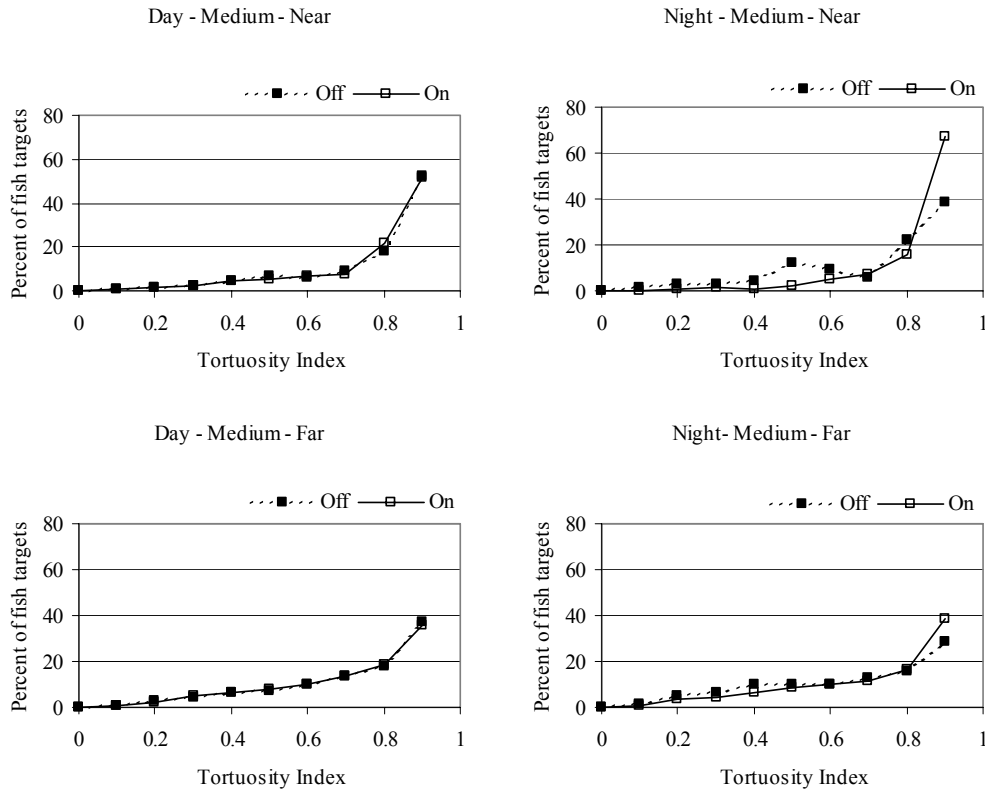
Figure 4.12. Tortuosity Index for Medium (-42 to -32 dB) Fish Targets at Two Distances from the Lights During Day and Night. Indices near 1 indicate a straight track, while indices near zero are turning or milling.

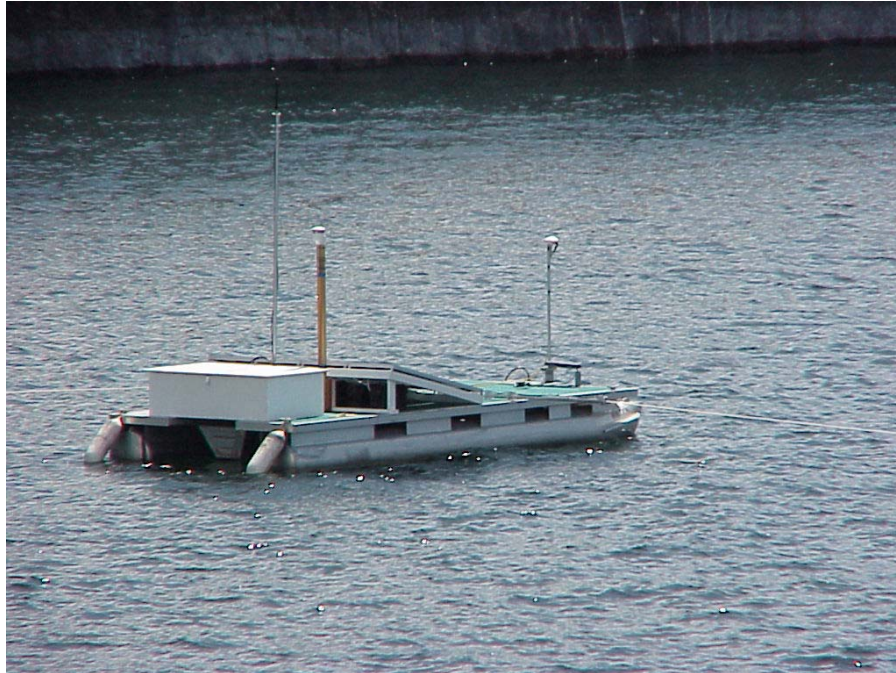
Figure B.1. Mobile Platform (i.e., traversing) at the Entrance to the Third Powerplant Forebay at Grand Coulee Dam, 2001

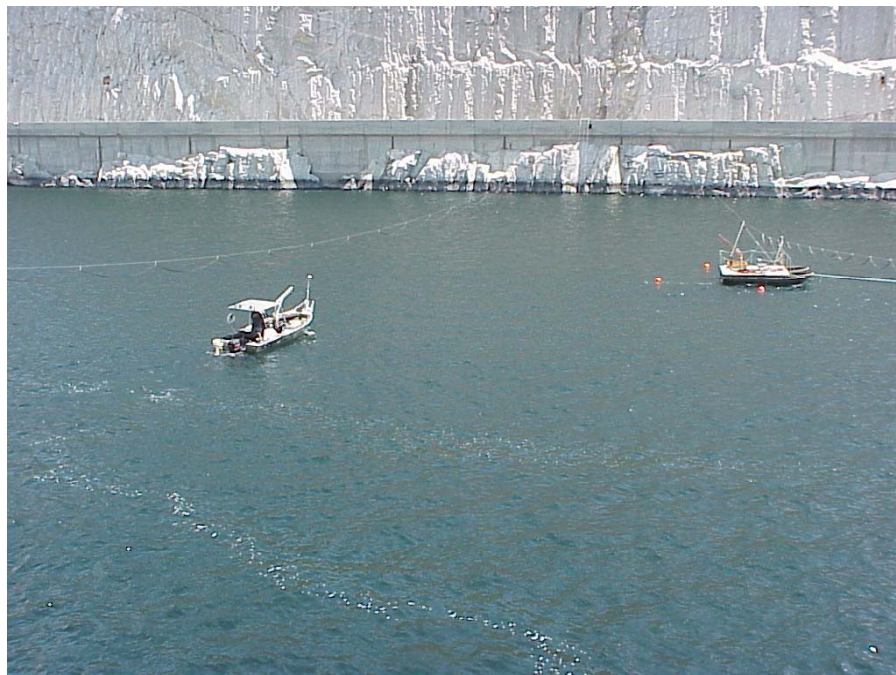
Figure B.2. Boat Conducting Mobile Transects in the Vicinity of the Fixed Barge to Supplement the Distributional Data. Fixed barge is on the right.

The locations of the mobile transects are depicted in Figure B.3 along with the overall depth distribution of targets detected during the mobile surveys. It should be noted that the data presented here are in terms of target detections and not fish or fish tracks since the primary purpose of the data was to determine the relative distribution of targets and not to quantify the population. We noted five distinct peaks in the data with depth: at the surface; at about 15 m; at 22-23 m; at about 40 m; and finally, at 46 m. The majority of targets were at the deeper depths (25 to 55 m). When these targets were classified into the three size categories used for the analysis of the fixed barge data (small, ≤ -42 dB; medium, > -42 to ≤ -32 dB; and large, > -32 dB), we found that the majority of the targets detected below 30 m were small targets with most well below the target threshold (Figures B.4 through B.9). During data processing and analysis, we noted large “clouds” of very small targets appearing periodically at the mobile platform transect. These targets were presumed to be zooplankton due to their small target sizes and large congregations.

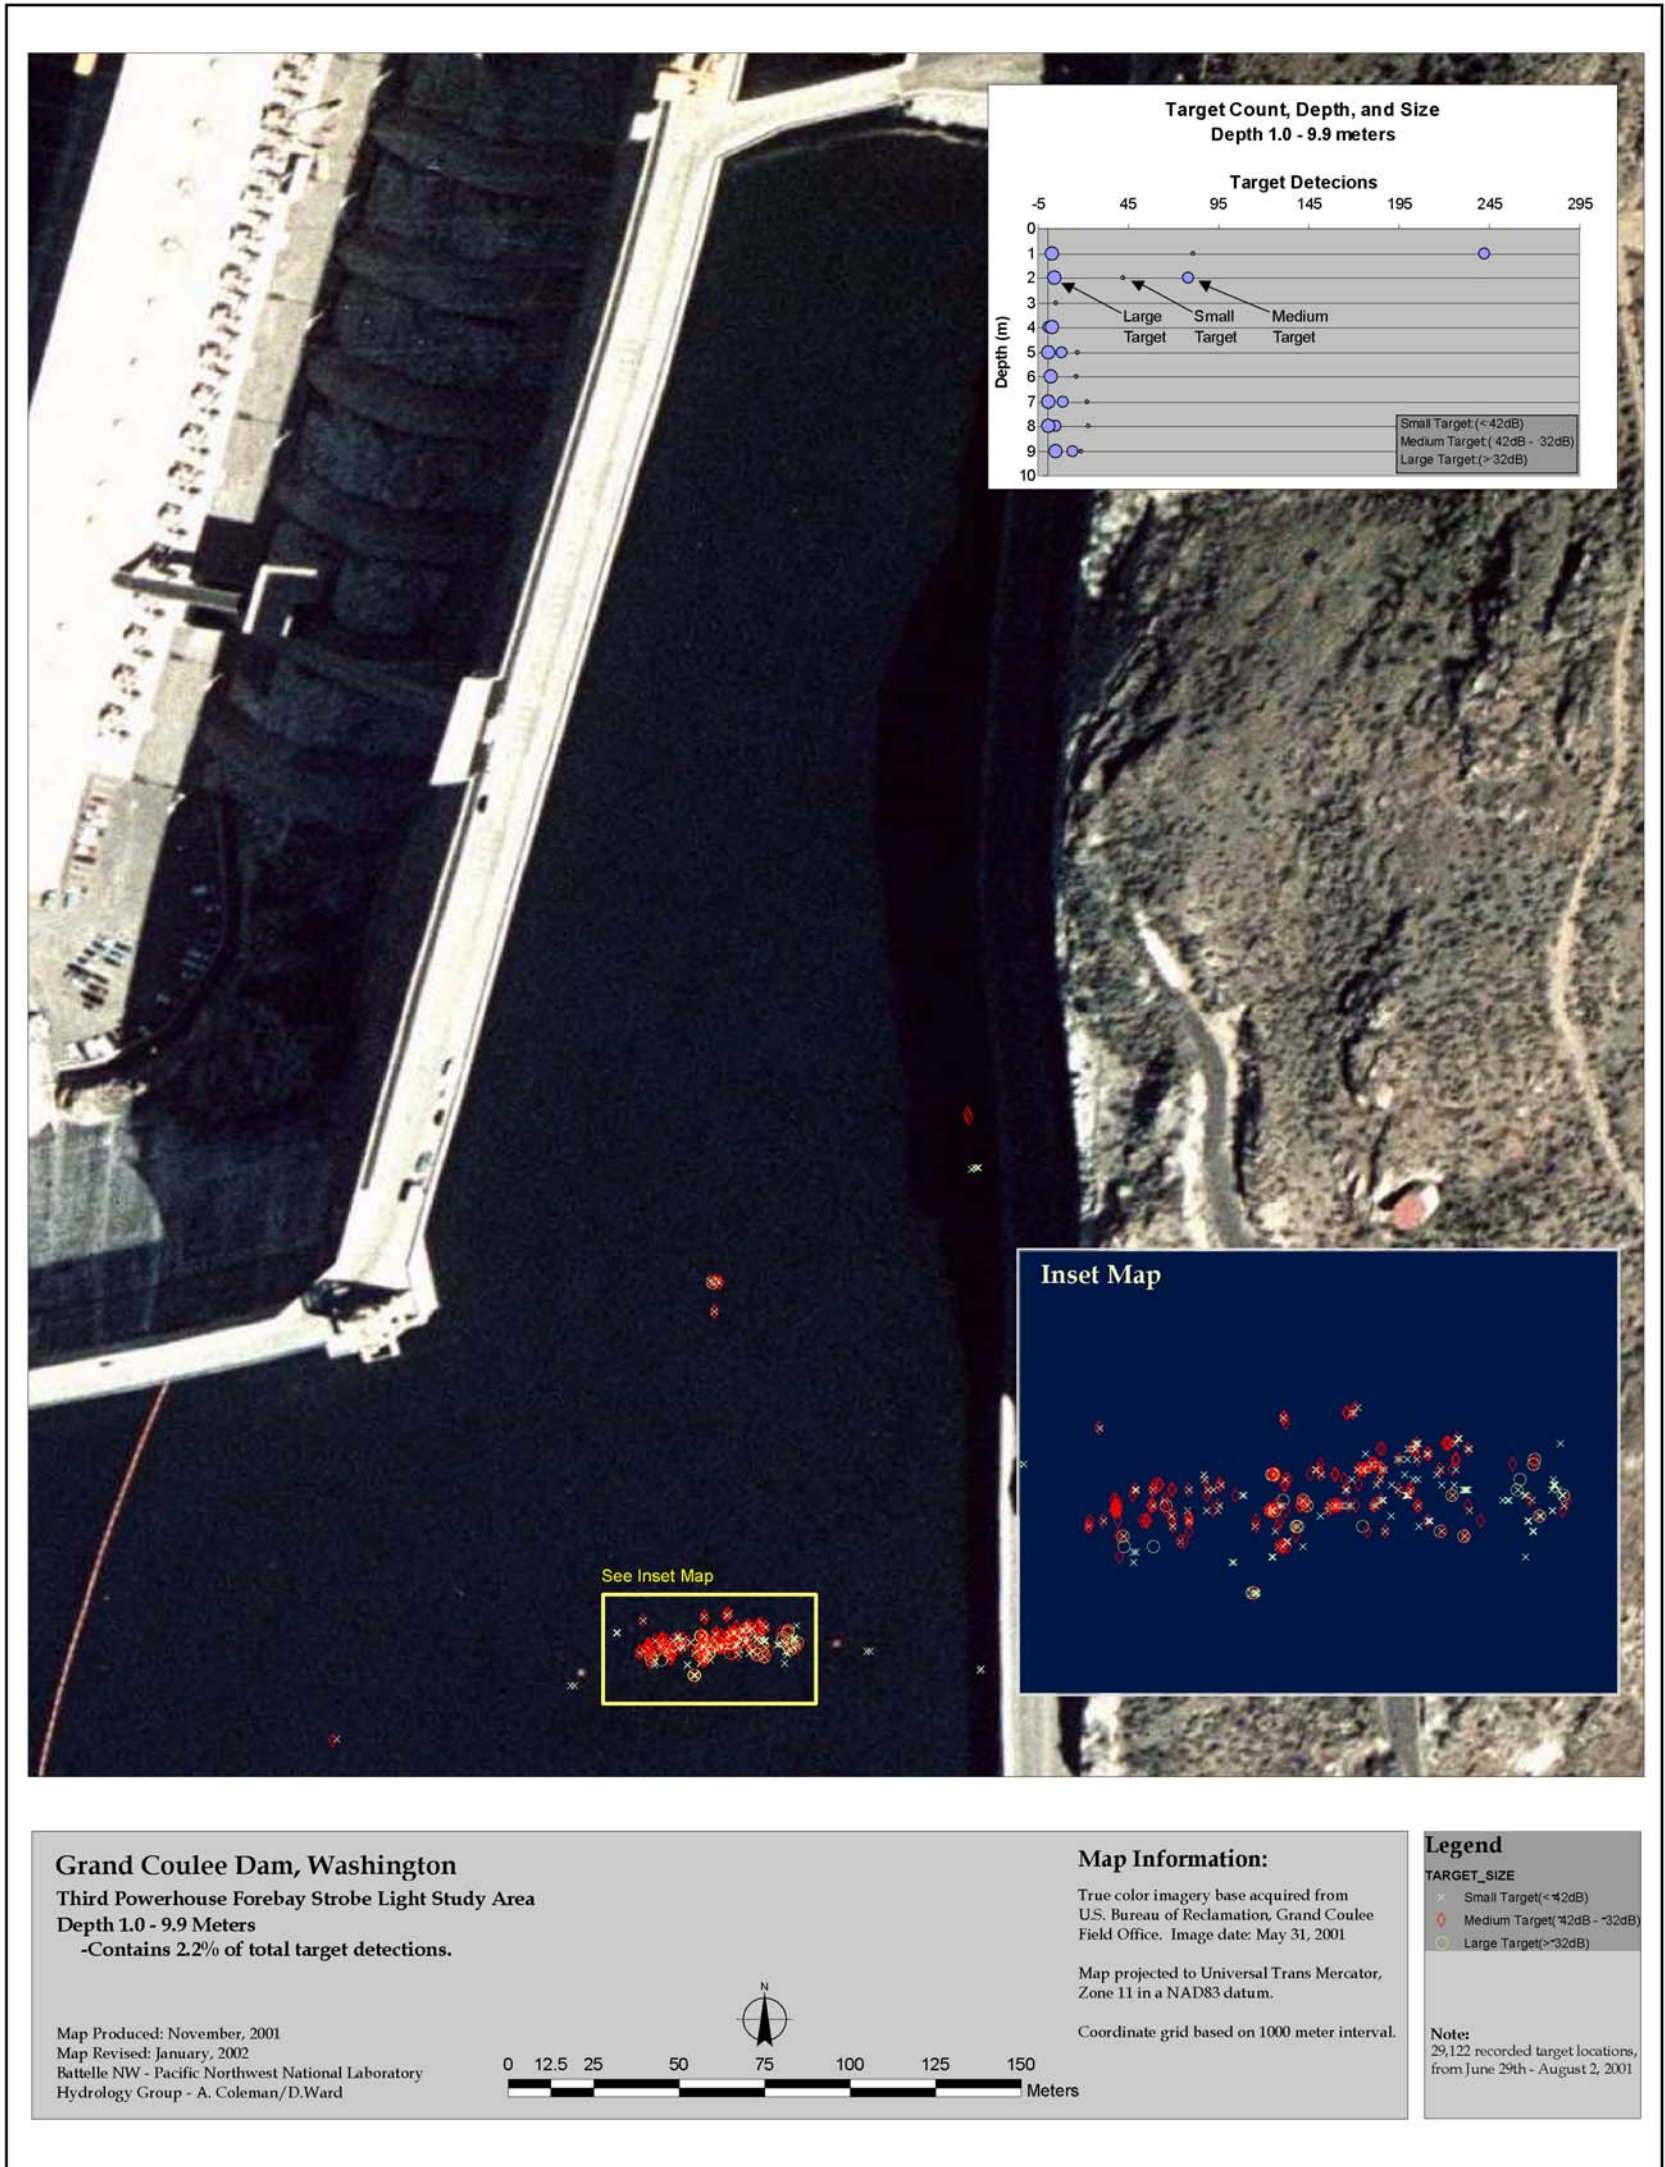
Figure B.4. Location of Targets Within 10 m of the Surface Detected by the Mobile Hydroacoustic Surveys in 2001. Three size-groups of targets are indicated based on target strength (dB).

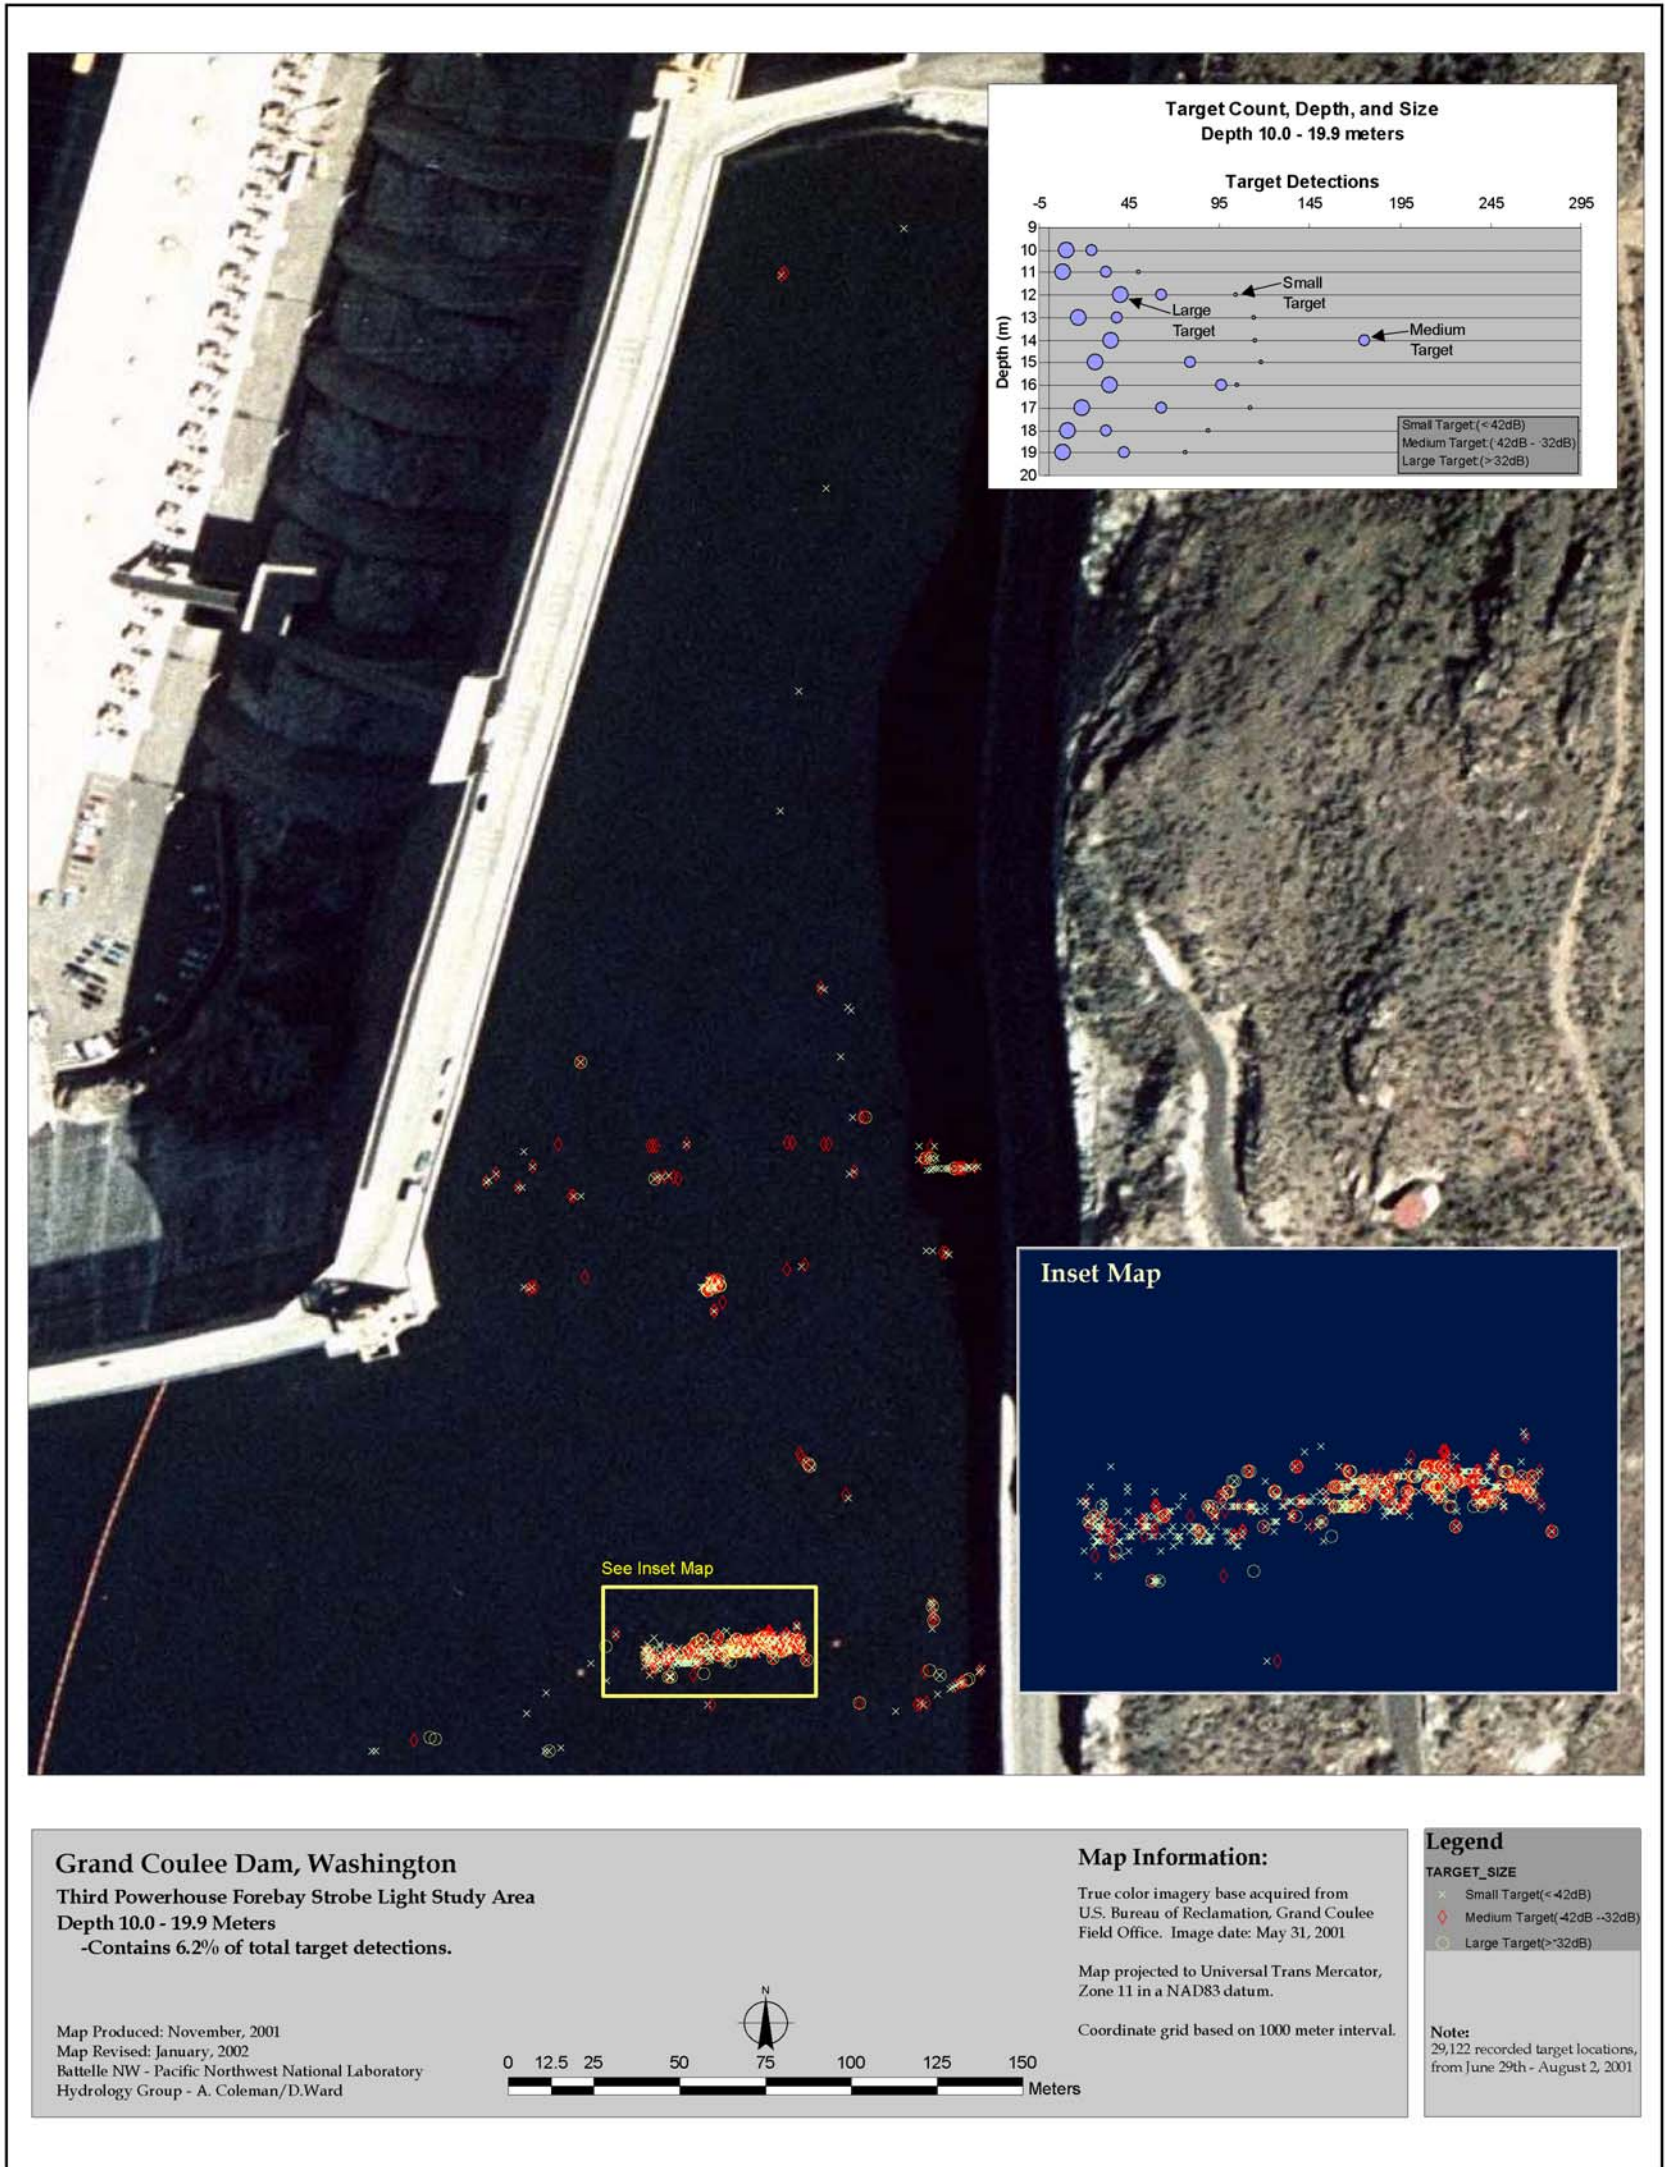
Figure B.5. Location of Targets Between 10-19.9 m from the Surface Detected by the Mobile Hydroacoustic Surveys in 2001. Three size-groups of targets are indicated based on target strength (dB).

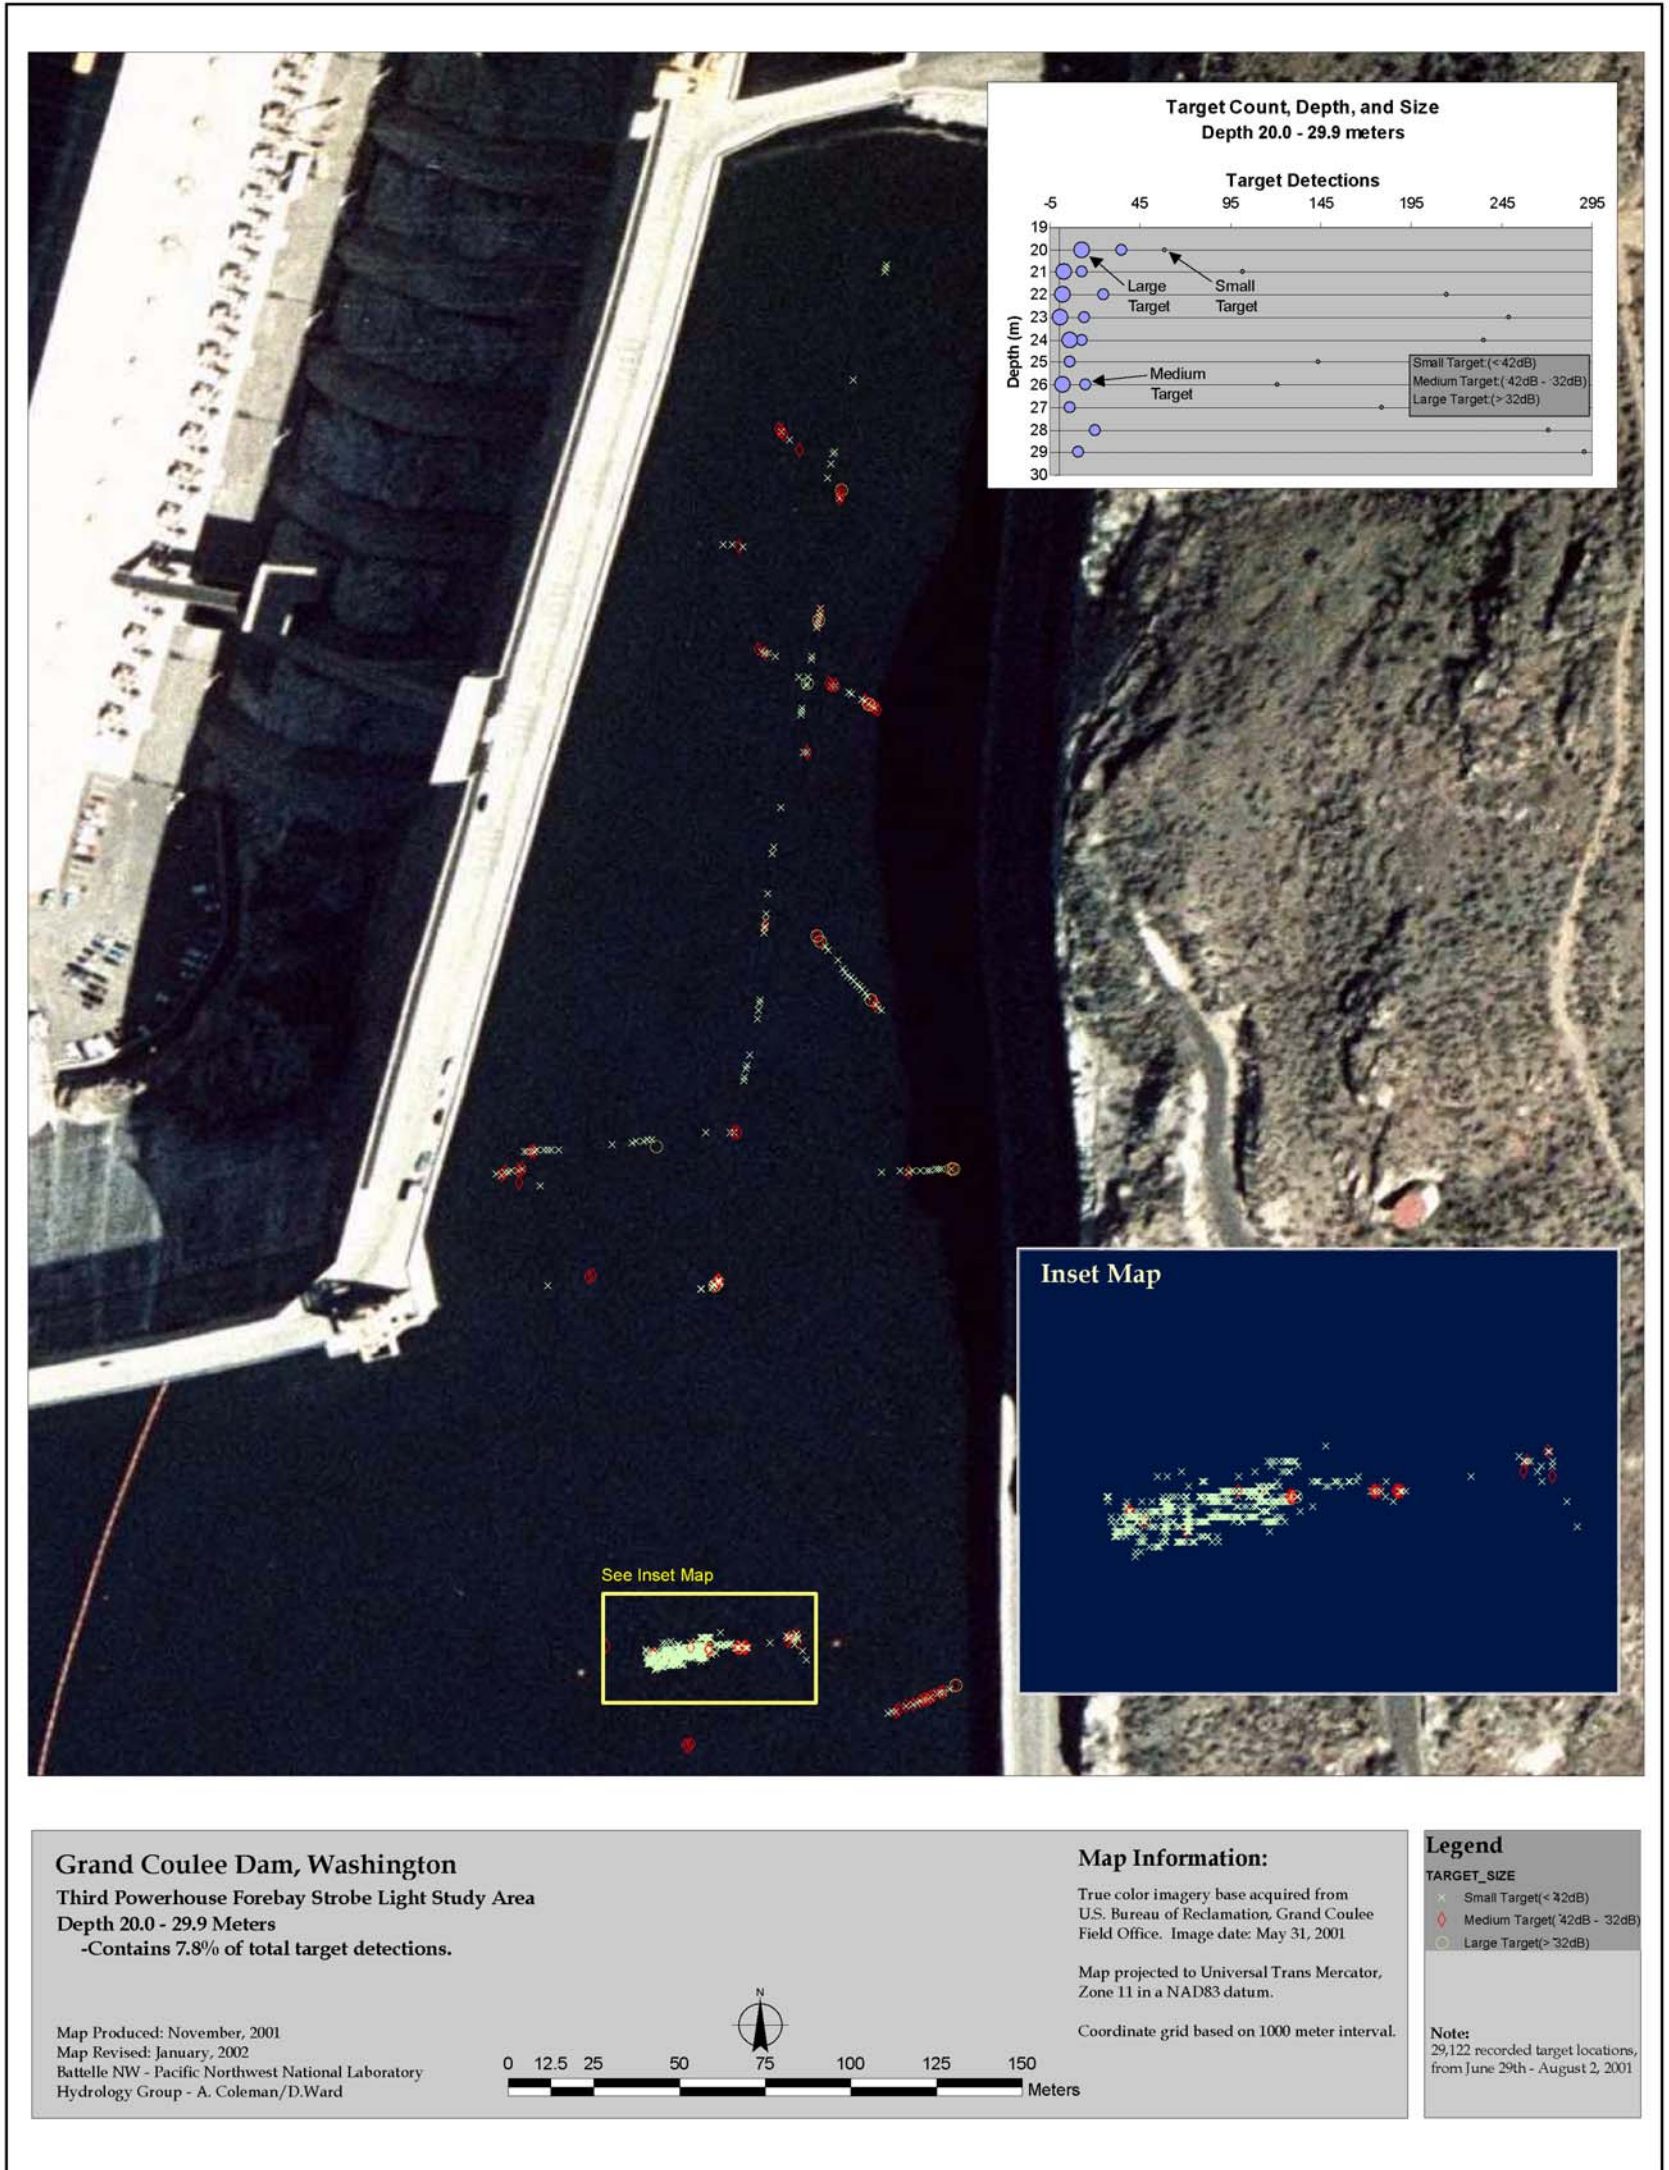
Figure B.6. Location of Targets Between 20-29.9 m from the Surface Detected by the Mobile Hydroacoustic Surveys in 2001. Three size-groups of targets are indicated based on target strength (dB).

Zig-zag boat transects conducted immediately in front of the third powerplant, within the cul de sac, indicated that the target distribution was slightly deeper (20 to 30 m) than that found at the entrance to the cul de sac (Figure B.6). Because these data were collected only periodically, this indication should not be construed as definitive. However, the distribution appeared to be different from that farther upstream and suggests the need to conduct more rigorous boat sampling in the future to determine the extent to which fish utilize that region.

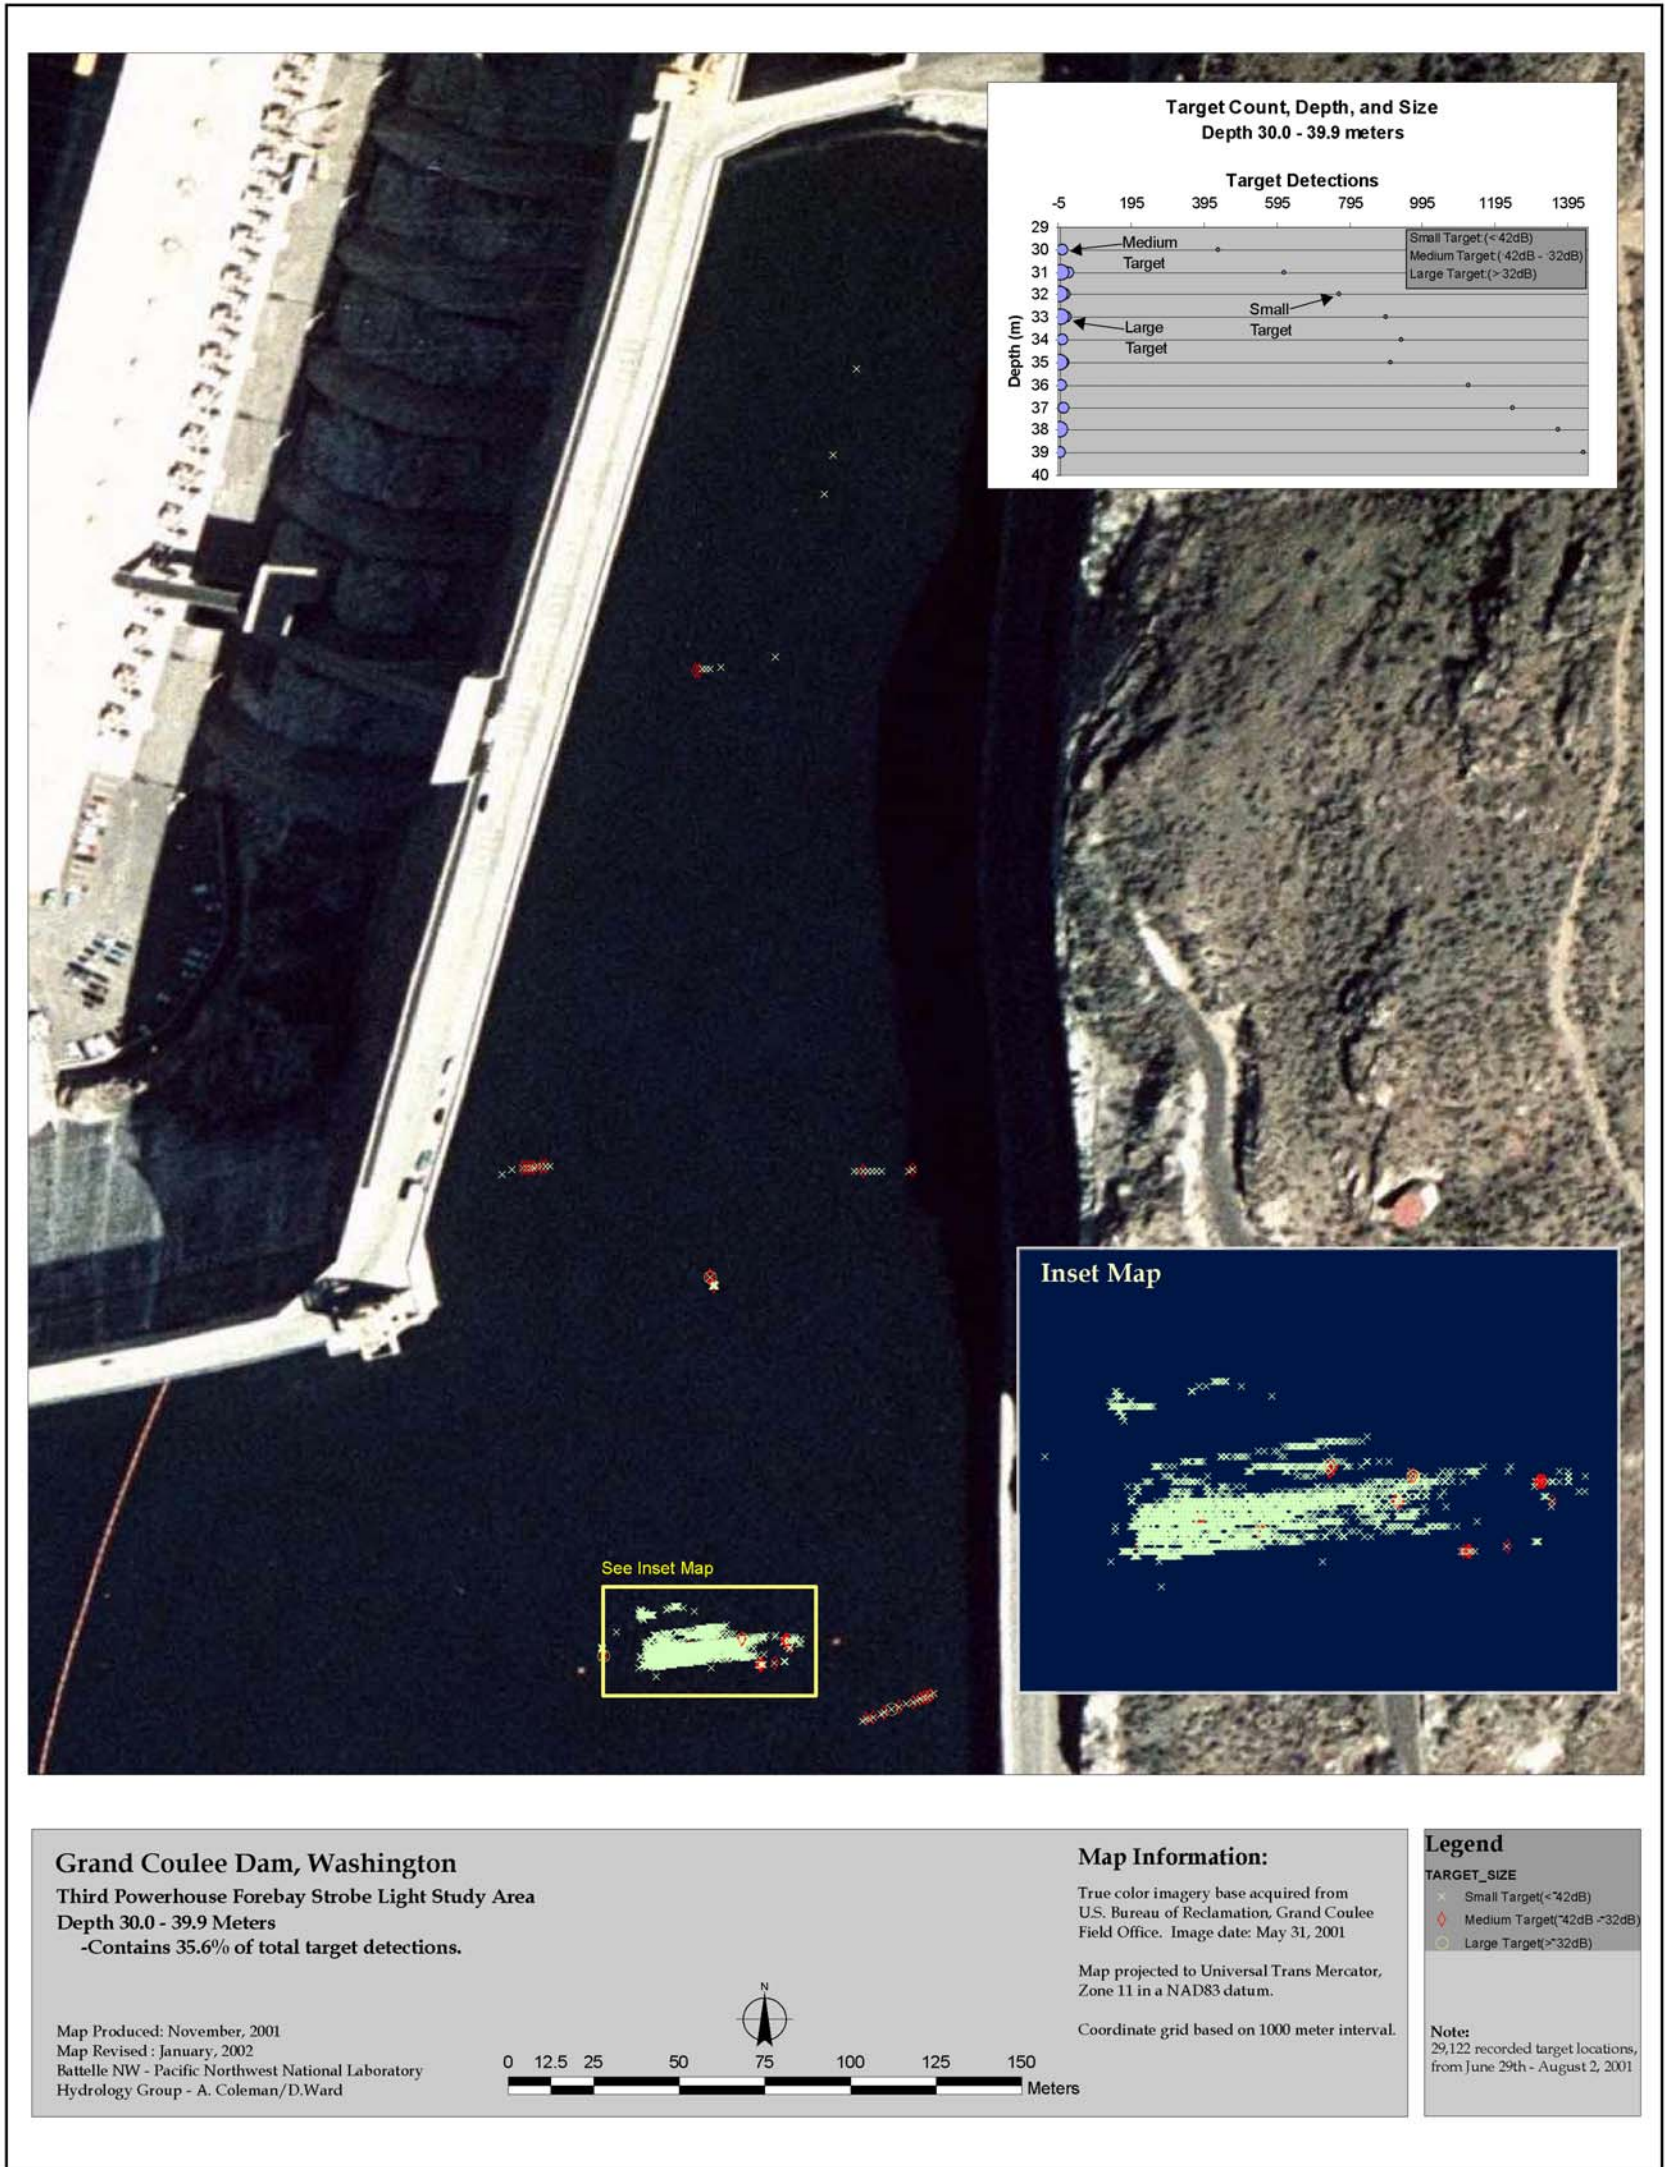
Figure B.7. Location of Targets Between 30-39.9 m from the Surface Detected by the Mobile Hydroacoustic Surveys in 2001. Three size-groups of targets are indicated based on target strength (dB).

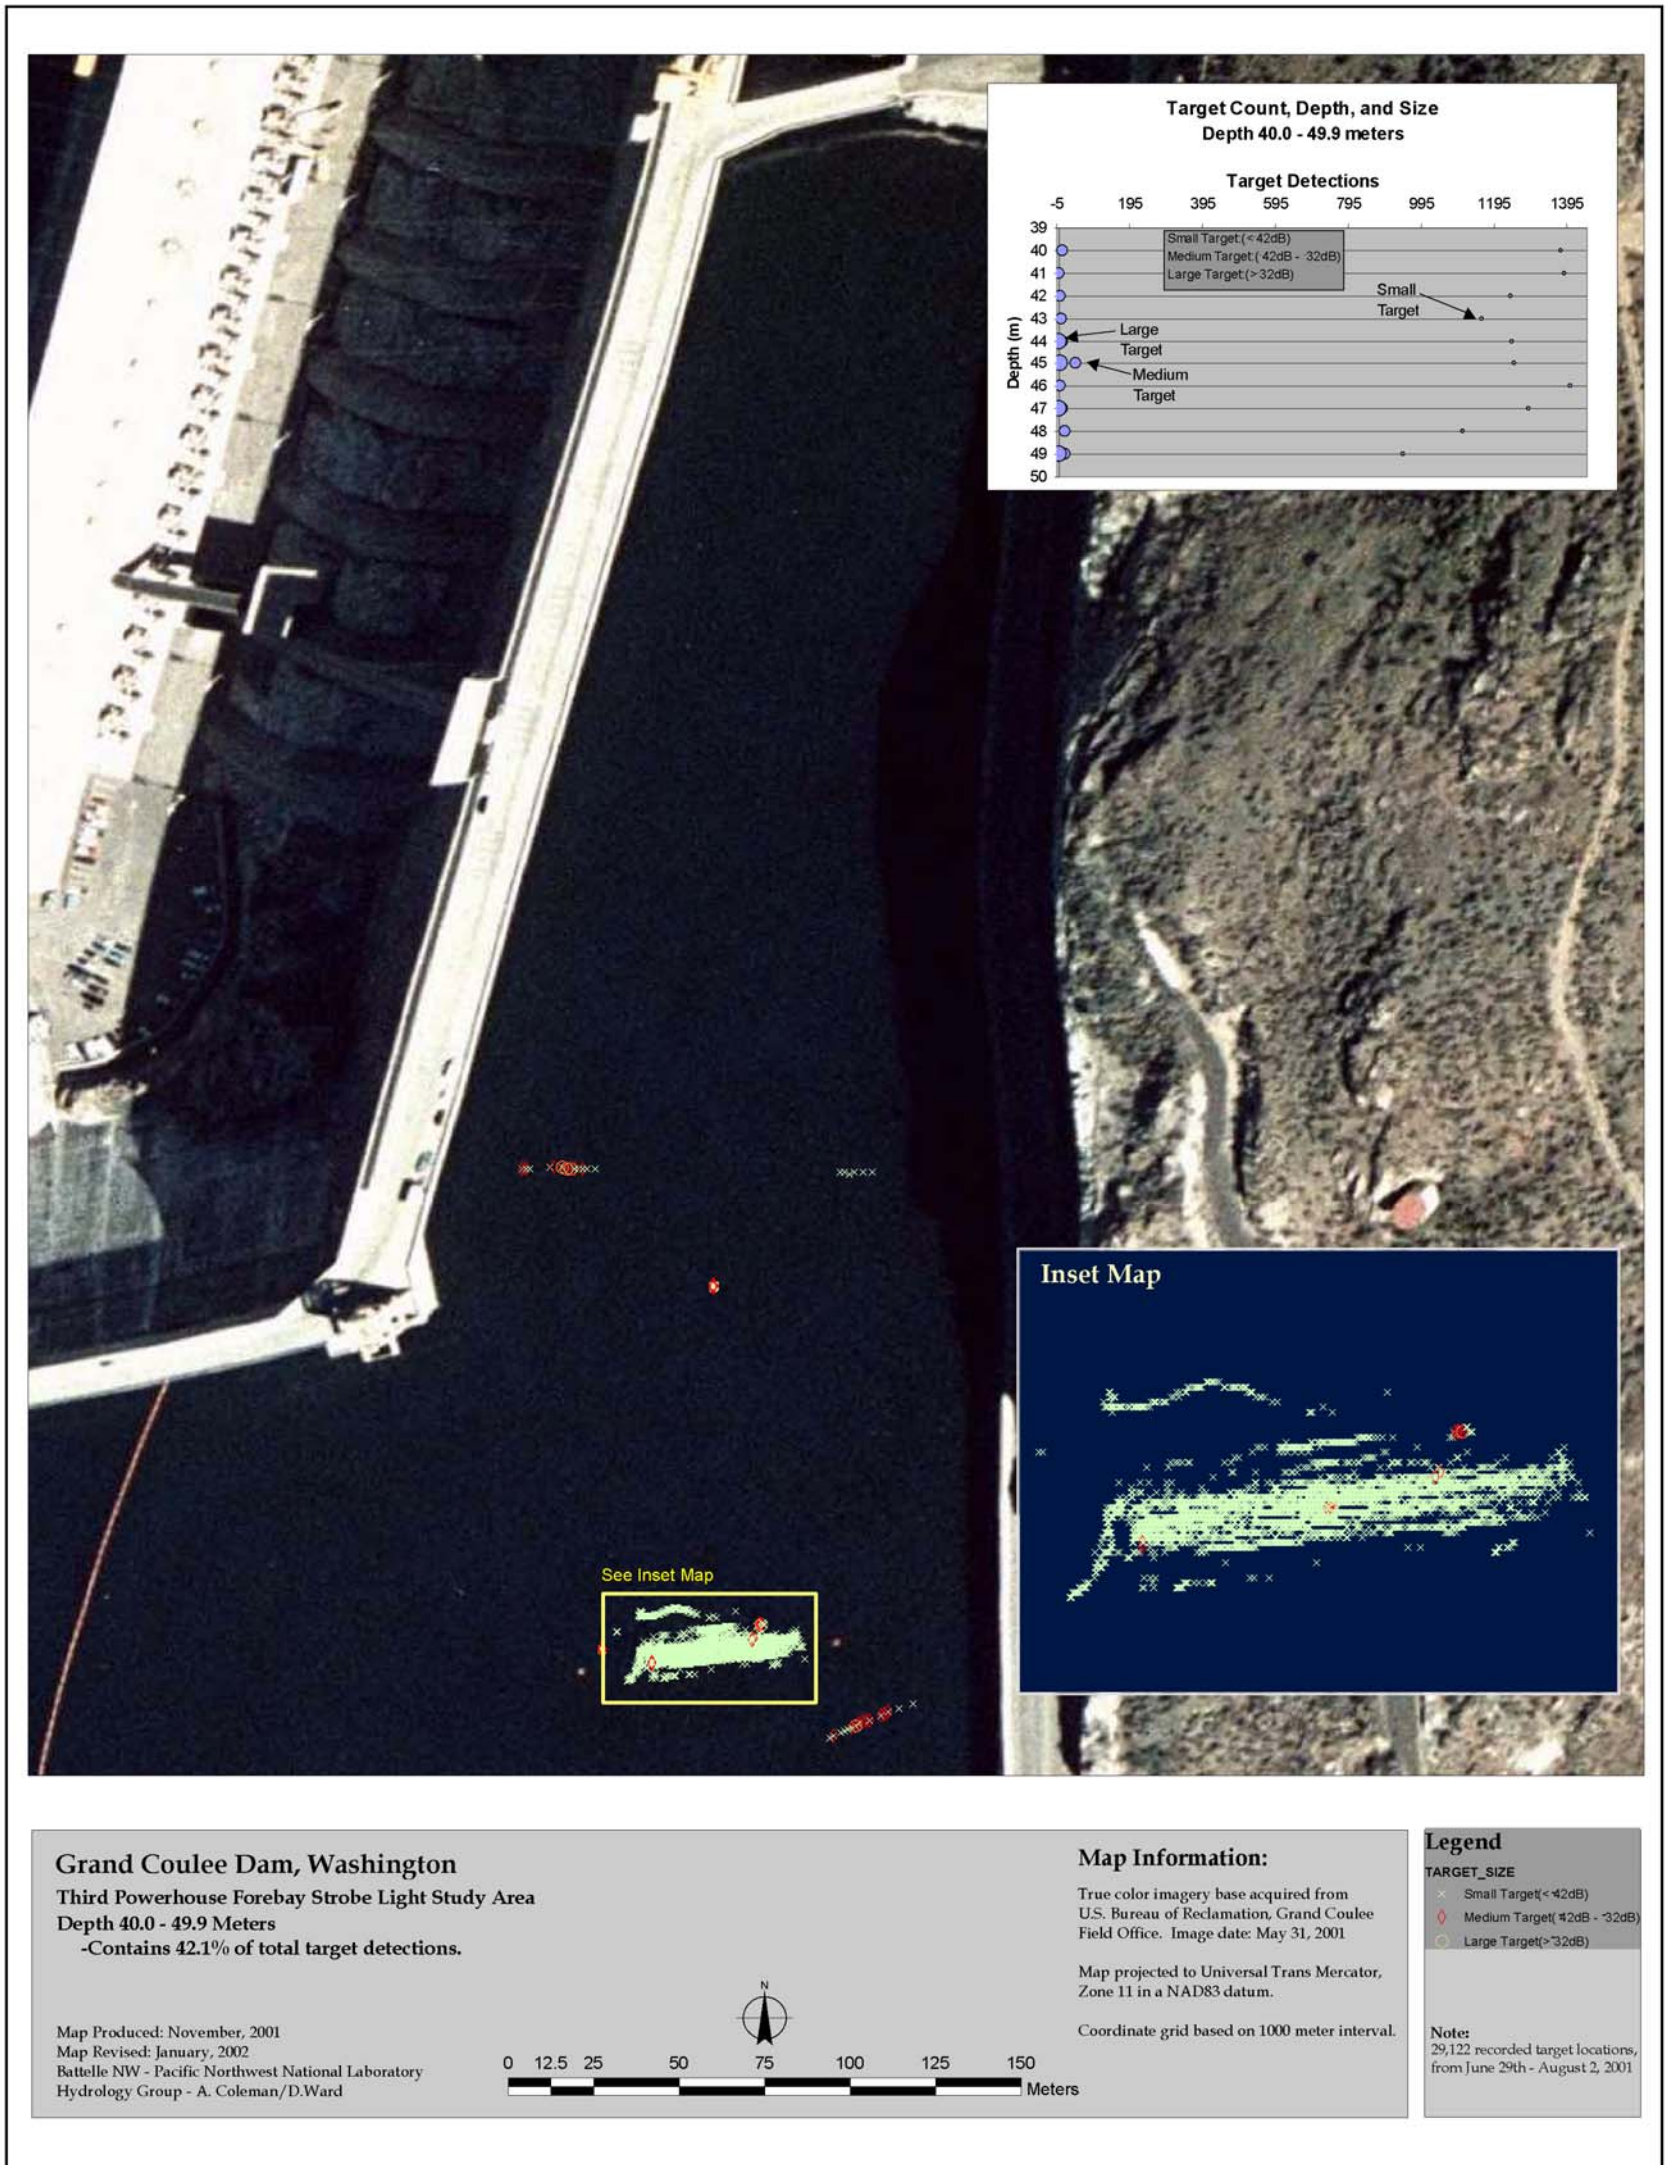
Figure B.8. Location of Targets Between 40-49.9 m from the Surface Detected by the Mobile Hydroacoustic Surveys in 2001. Three size-groups of targets are indicated based on target strength (dB).
