Chief Joseph Kokanee Enhancement Project

Strobe Light Deterrent Efficacy Test and Fish Behavior Determination at the Grand Coulee Dam Third Powerplant Forebay

Annual Report 2001 - 2002

DOE/BP-00000652-23

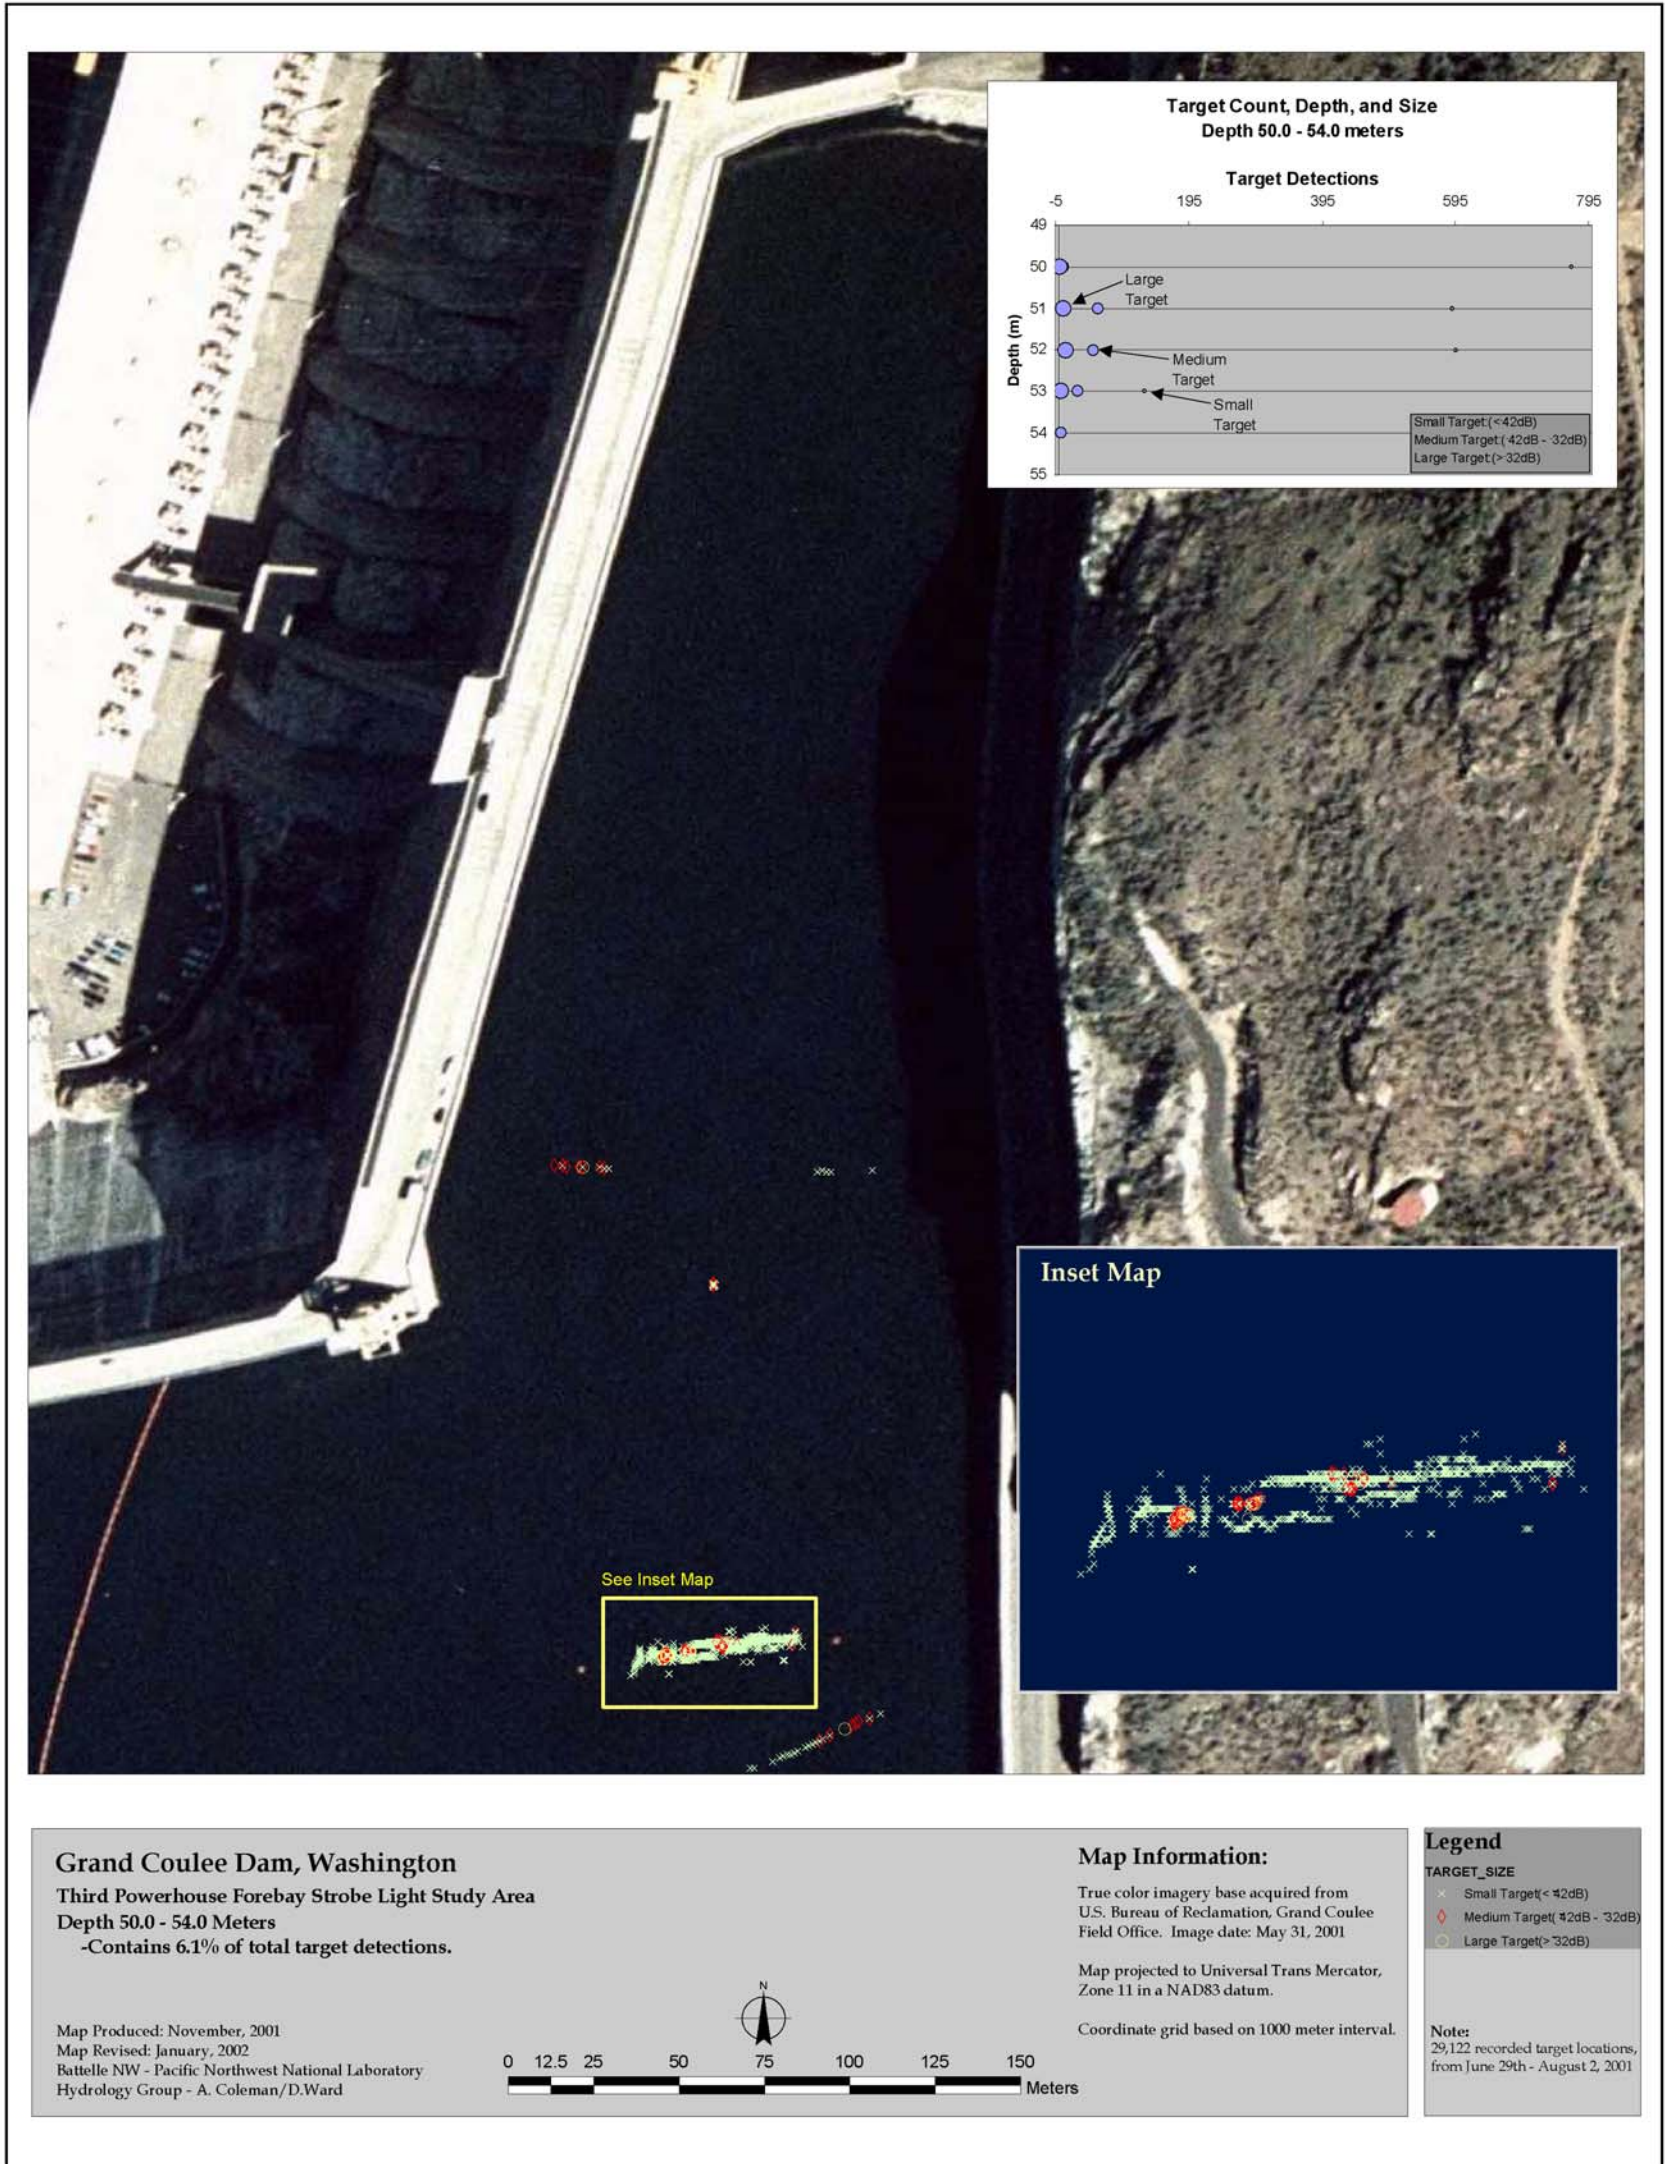
Figure B.9. Location of Targets Between 50-54 m from the Surface Detected by the Mobile Hydroacoustic Surveys in 2001. Three size-groups of targets are indicated based on target strength (dB).

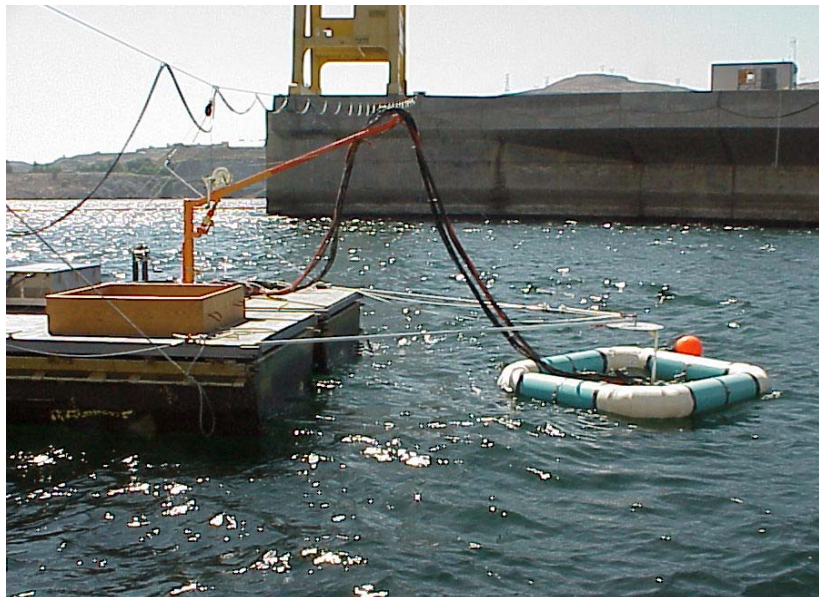
Figure E.1. Position of the Floating Calibration Frame During the Calibration Effort at Grand Coulee Dam in 2001
