Optical Brightener Study of Spruce Creek

Town of Kittery, ME

FB Environmental Associates, Inc.

February 2010

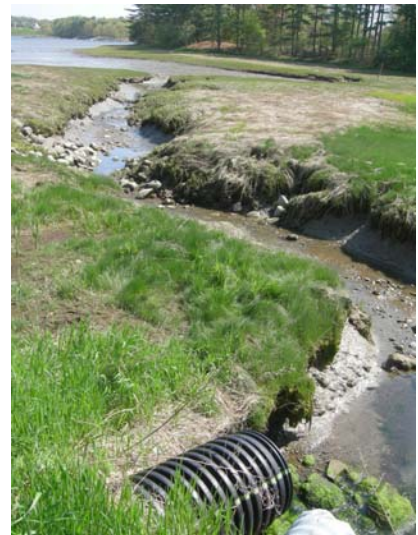
Stormwater outfall to Spruce Creek

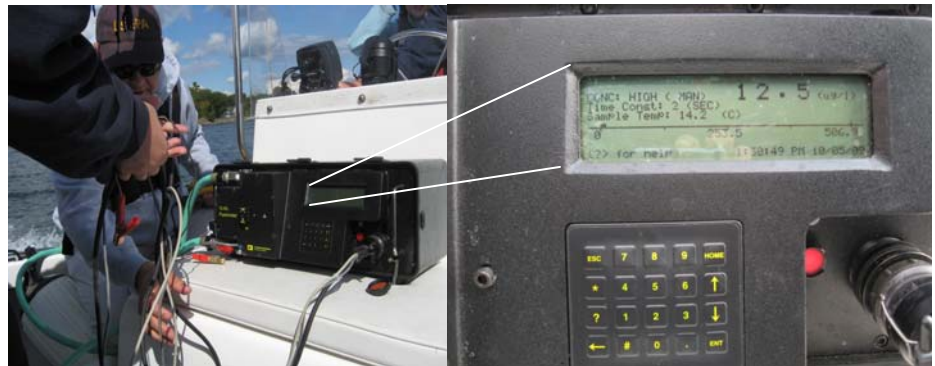
The Turner 10-AU field fluorometer and data screen while in use

Project Team members assessed the sites by boat using the Turner 10-AU field fluorometer to investigate the possible presence of optical brighteners. The instrument was outfitted with a flow-cell

and sample probe to continuously monitor for fluorescence. Before the field survey, the fluorometer was calibrated with a 500 µg/L fluorescent dye solution and blanked with seawater obtained from a sample site. Meter readings were expressed in µg/L. Project team members attempted to travel near all inflowing tributaries in the watershed with the fluorometer to begin measuring before proceeding slowly back downstream. Project staff geographically analyzed the bacterial concentrations using GIS maps prepared for the survey and combined the results of the October sampling with the spring end-of-pipe sampling Results are displayed in Figure 2.

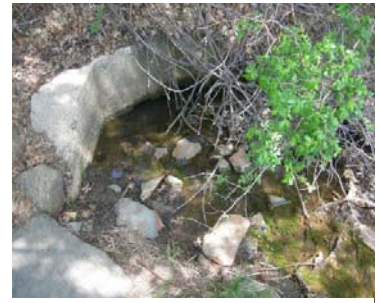
Significant hotspot stormwater outfall in Admiralty Village in Kittery

- Exceedances of the bacteria water quality standard (*E. coli* >236 cfs/100 ml or a Geomean of 64/100 ml) were found throughout the study area during preliminary end-of-pipe testing.
- Several hotspots were found – the most significant being the stormwater outfall at Admiralty Village in Kittery (picture to the right). This site had very high readings during both wet and dry weather.
- Bacteria counts tended to increase during wet weather conditions.
