Stewardship Plan for the 5 Corners Reserve, Lee, NH

Stewardship Plan for the Lee Five Corners Reserve

Lee, New Hampshire

Prepared by
Ellen Snyder
Certified Wildlife Biologist
Ibis Wildlife Consulting

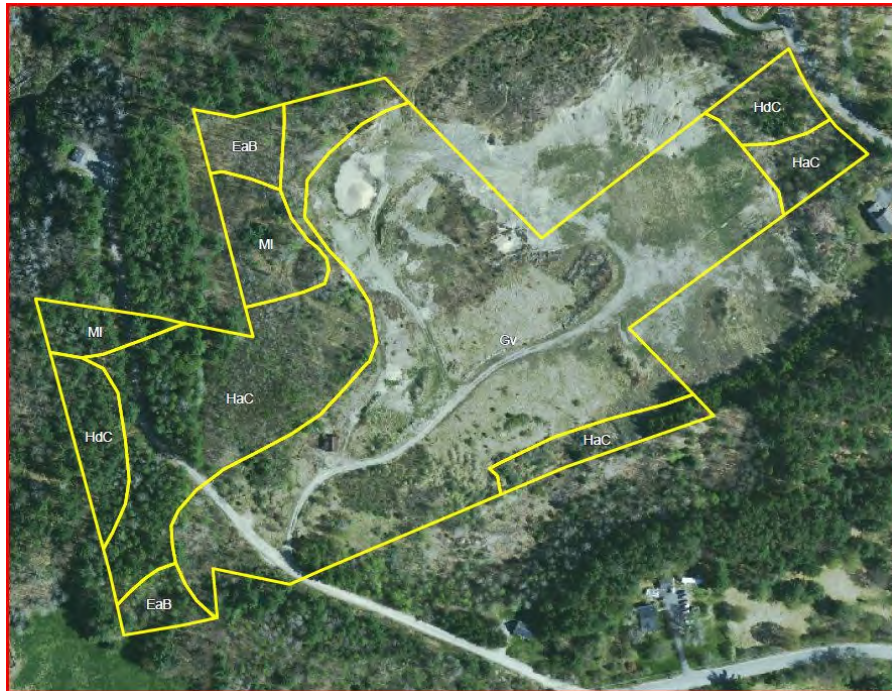
Figure 2 Soils re-drawn from NRCS Strafford County Soil Survey Data (2001) to reflect extent of removal of top soil during previous sand and gravel operations.

The NRCS (2001) Soil Survey mapped four soil types for the Lee Five Corners Reserve (Table 3). Most of the soil type is classified as "gravel and borrow pit" since the original soils were removed as part of the sand and gravel operation. Likely much of the disturbed area was originally well-drained Hinckley loamy sands and Hollis-Charlton very rocky fine sandy loams.
