# Archaeological Monitoring of the Urban Reach Section of the San Antonio River Improvement Project: Archaeological Monitoring of the Urban Reach Section of the San Antonio River Improvement Project

San Antonio, Bexar County, Texas

Texas Antiquities Permit No. 5377

Prepared by:
Center for Archaeological Research
The University of Texas at San Antonio
Archaeological Report, No. 407

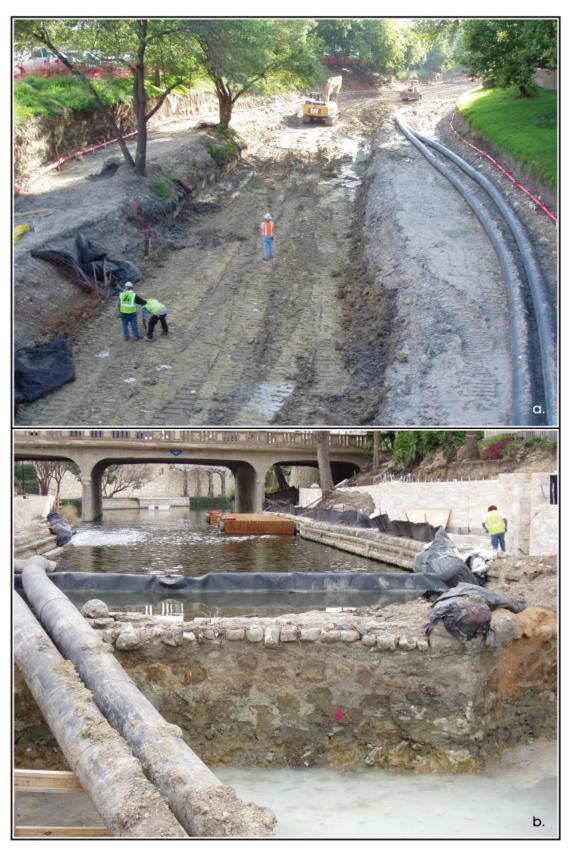
Figure 1-5. *Piping river-water around the construction zone: a) river-water bypasses construction in pipes seen on the right; b) returning the water to the river at the Lexington Avenue (Hugman) Dam.*

In order to perform the needed construction for this project, the prime contractor, Zachary Construction Corporation, piped river water from behind a temporary dam structure north of Grayson Street, around the construction zone (Figure 1-5a) and returned the water to the river at the Lexington Avenue Dam (also known as the Hugman dam, now site 41BX1818; Figure 1-5b), a structure built by the Works Progress Administration (WPA) between 1940 and 1941 as part of the original river beautification project that created the Riverwalk (see Chapter 2).

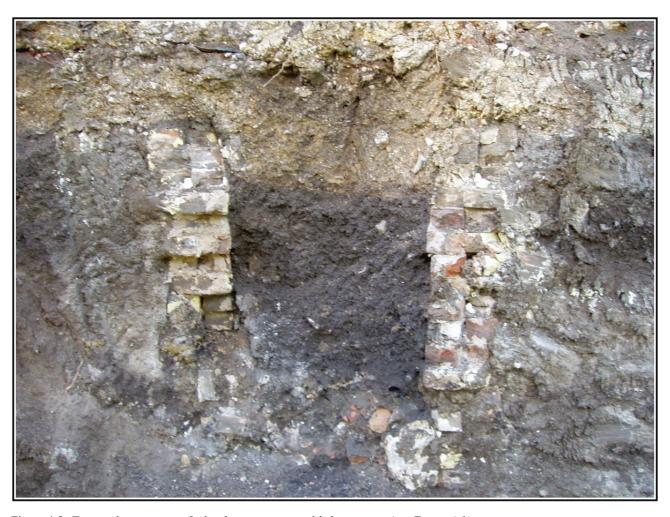
Figure 4-2. Feature 1, a remnant of a brick structure, most likely a cistern (see Figure 4-1).

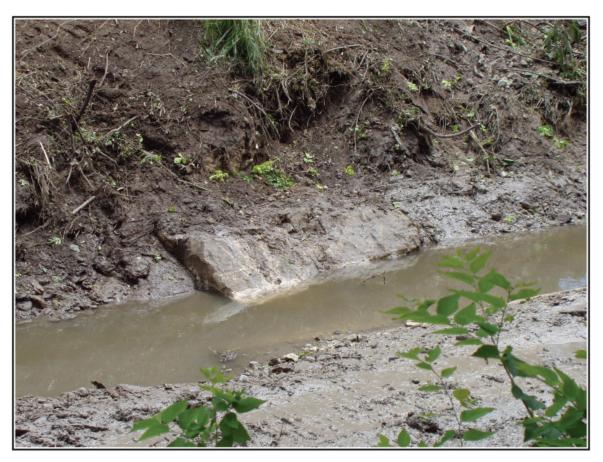
Figure 4-3. Alamo Mills Dam (41BX1817) when first encountered.

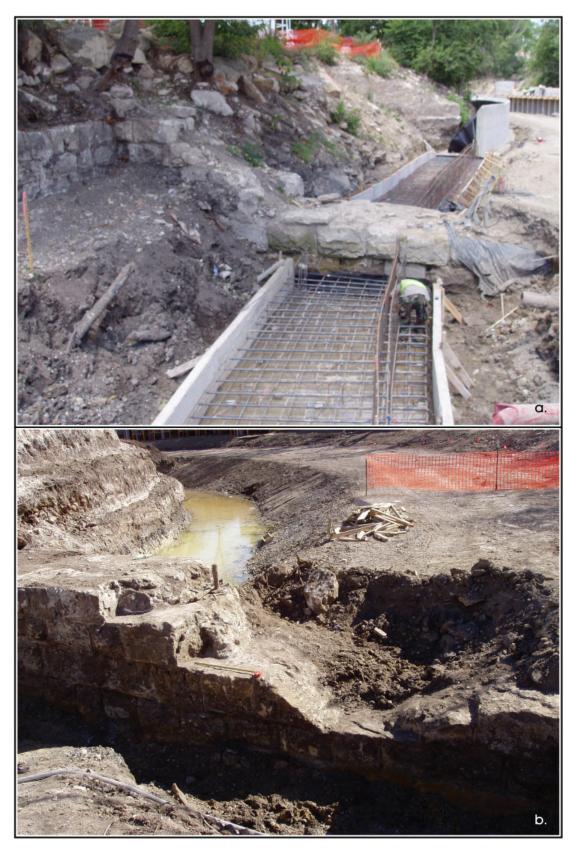
Figure 4-8. The Alamo Mills Dam after it was uncovered in 2008: a) protruding from the east bank; b) coming from the west bank.

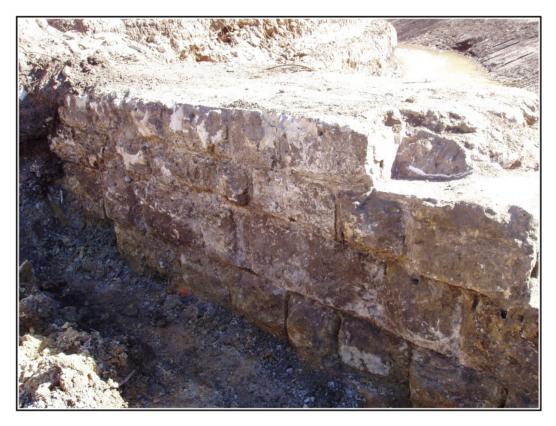
to the massive size of the dam (Figure 4-9). Adjacent to the dam, a retaining wall was uncovered under a concrete apron on the east bank of the San Antonio River. When the apron was removed, it was noted that the retaining wall was located where the mouth of the raceway was supposed to have been (Figure 4-10). The purpose of the retaining wall is unknown, but two possible ideas of its use include: 1) the retaining wall was to guide water into the race way at the 45°angle located below the dam; 2) the retaining wall was constructed at a later date when the raceway was no longer needed and filled in. The second idea appears to be more plausible when considering the nature of the river flow. It is not common to

Figure 4-9. Detail of limestone blocks used to complete the Alamo Mills Dam.

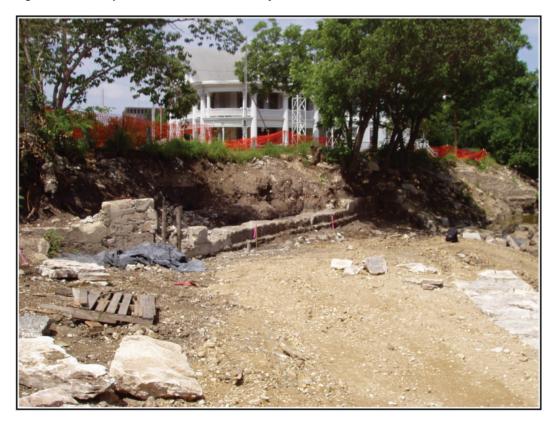
$Figure~4-10.~{\it View~of~Alamo~Mills~Dam~and~adjoining~retaining~wall}.$

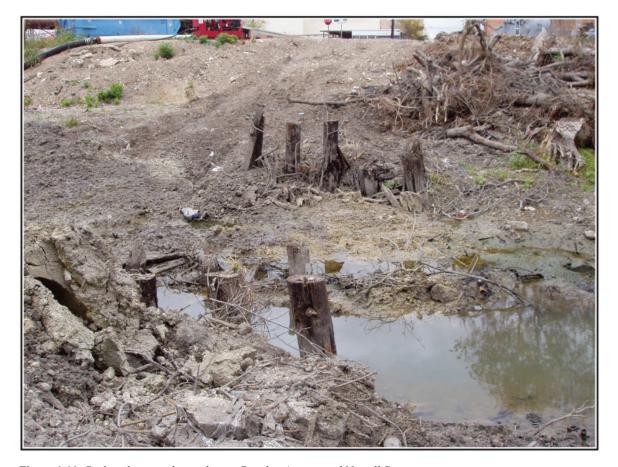
- Feature 3: Remnants of railroad trusses were observed between the Camden Street Bridge and the overpass of IH-35. The tracks would have led to the Pearl Brewery. The trusses were removed during the project.

Figure 4-11. Railroad trusses located near Camden Avenue and Newell Street.

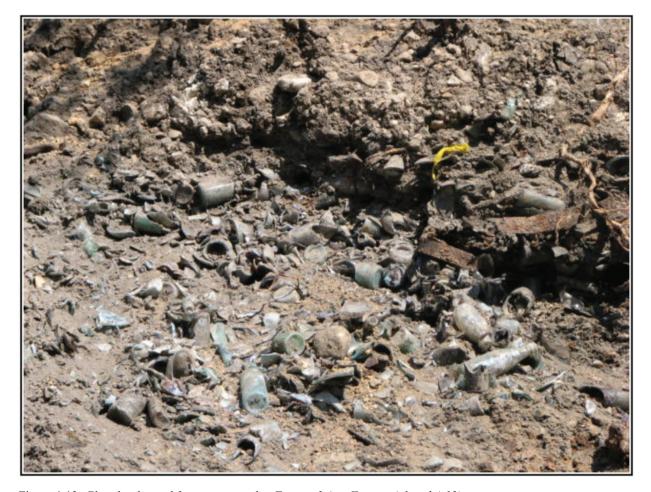
Figure 4-13. Glass bottles and fragments noted in Feature 3 (see Figures 4-1 and 4-12).

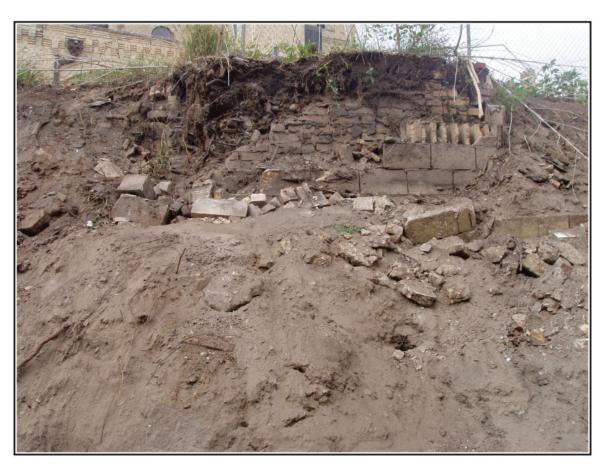
Figure 4-16. Feature 5, brick wall (see Figures 4-1 and 4-12).

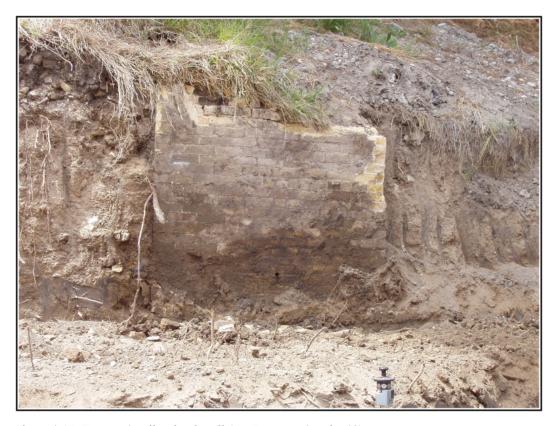
Feature 6 is a yellow brick "wall" that is located along the west bank of the San Antonio River just south of the IH-35 overpass (Figure 4-12 and Figure 4-17). The wall may be the outside of a cistern, though not round in form. The feature consisted of yellow bricks 21-x-10-x-6 cm in dimension laid to form a wall approximately 185 cm wide and 210 cm tall. Some fragments of bone and glass were found adjacent to the brick wall. The base of the feature exhibits stepped bricks, in which each course of brick is laid approximately 3 cm off center from the previous course (Figure 4-18). This occurs

Figure 4-17. Feature 6, yellow brick wall (see Figures 4-1 and 4-12).

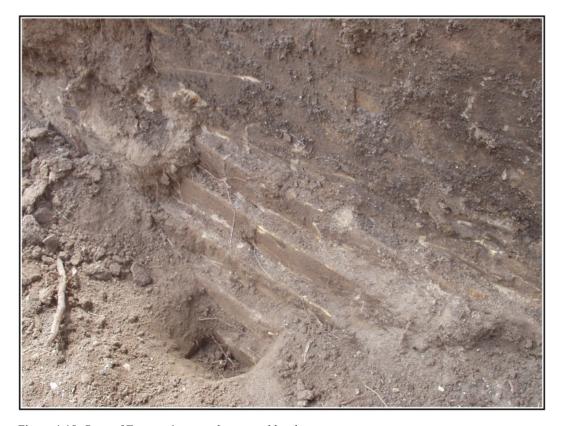
Figure 4-18. Base of Feature 6 noting the stepped bricks.

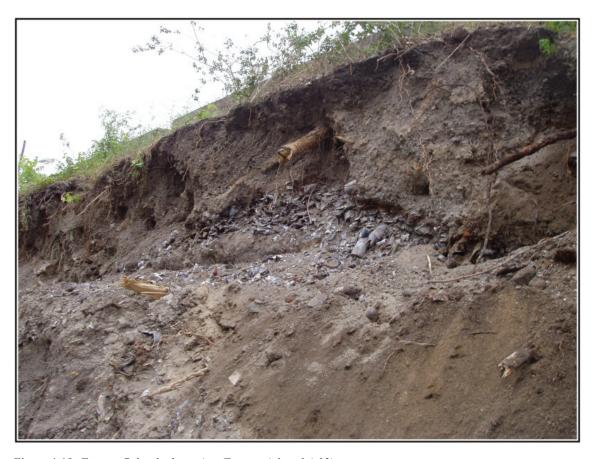
Figure 4-19. Feature 7, bottle dump (see Figures 4-1 and 4-12).

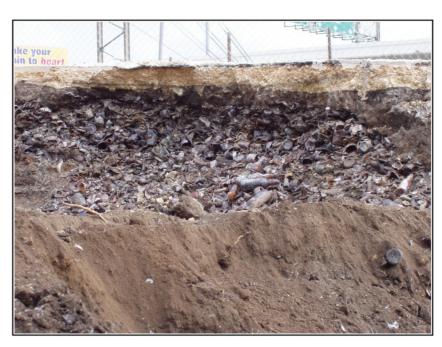
Feature 8 is another bottle dump located along the west bank of the San Antonio River. The feature is located south of Feature 6 and north of Feature 7 (Figure 4-12). The bottle dump appears to be approximately 1 meter thick and spans approximately 5 meters (Figure 4-20). Clear, brown/ amber, and aqua bottles were deposited in this dump. Much of the dump consists of broken fragments of the bottles, though there were quite a few intact bottles. Unique specimen bottles of this dump were returned to the CAR laboratory to be added to the type collection. Many of the intact bottles are molded, with applied lips. The feature lay directly beneath the road base and asphalt that was used in the construction of the parking lot that was along the west bank of the river. According to the 1904 Sannborn's Fire Insurance Map, the feature is located within the vicinity of underground fuel and oil tanks (Figure 4-14). Also, it is located a few short distance to the south of the storage

Figure 4-20. Feature 8, glass bottle deposit (see Figures 4-1 and 4-12).

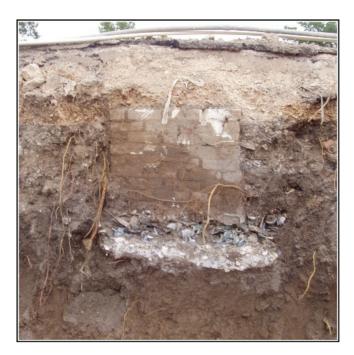
Feature 9 is a yellow brick wall similar to Feature 6 that has a lens of glass at its base (Figure 4-22). The Feature was noted in the east bank of the San Antonio River, approximately 200 feet north of the Brooklyn Street Bridge. The top of the feature was noted approximately 50 cm below the surface of the bank. The yellow brick wall was approximately 90 cm in height, and 80 cm in width. Just below the brick wall was

Figure 4-22. Feature 9, a brick wall with glass at the base (see Figure 4-1).

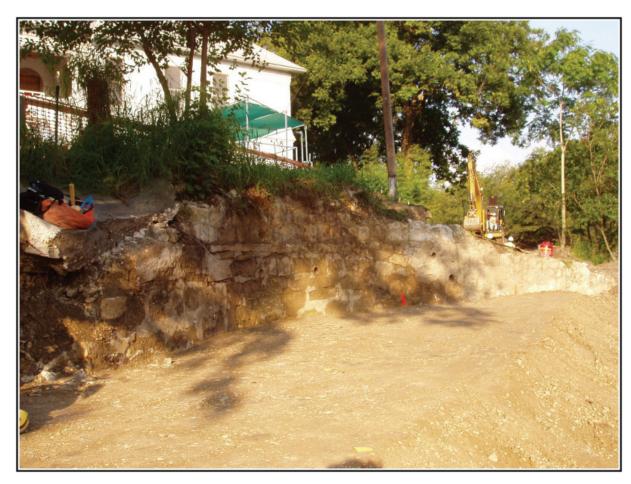
Feature 10 a stone wall that was uncovered adjacent to the VFW Post #76, just south of the Alamo Mills Dam. This feature was located on the east bank of the San Antonio River. The stone wall was constructed of cut limestone and mortar (Figure 4-23). The stone wall was approximately 15 meters in length, and 50cm thick. Backhoe excavations

Figure 4-23. Feature 10, the stone wall located near the VFW Post #76 (see Figure 4-1).

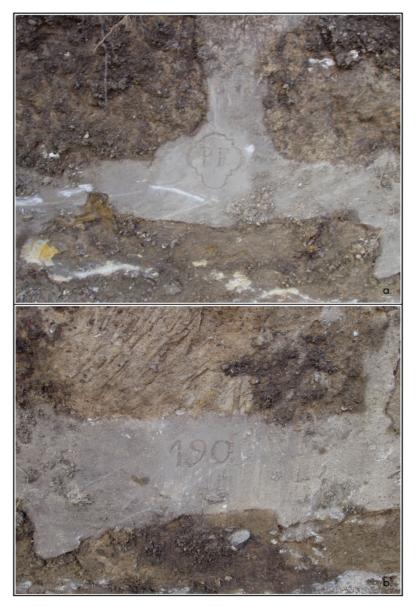
Figure 4-24. Cement in Feature 10 with notation "P.F. 1909".

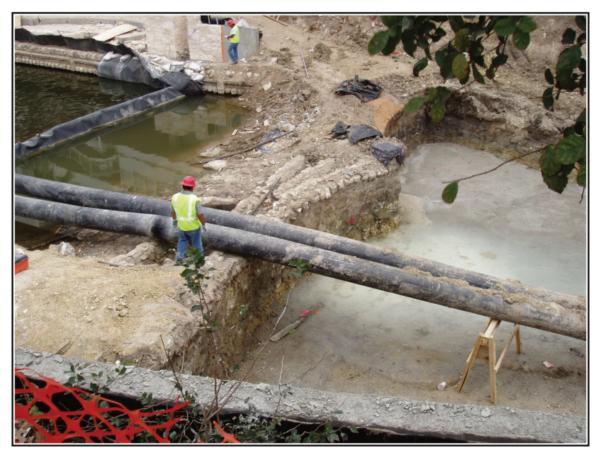
For several decades the Lexington Avenue Dam was obscured by silt from flooding episodes and brush overgrowth. During the construction of the new section of the Riverwalk, the dam was uncovered to reveal that planters had been built into the top of the structure. This dam is just one of the many architectural features Hugman had designed for the Riverwalk. He envisioned an urban park reminiscent of old Spain and Venice. His plan would allow for commercial businesses and restaurants to front the

Figure 4-25. Feature 11, the Lexington Avenue Dam, prior to being cut. The feature was recorded as Site 41BX1818 during the project.

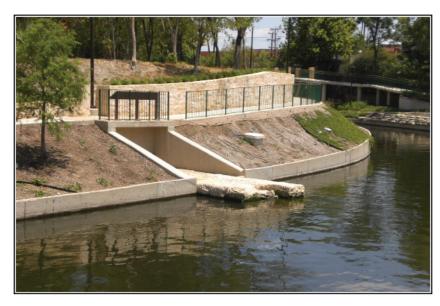
Figure 6-1. The Alamo Mills Dam as it is seen today.

During the course of the monitoring, two sites were recorded. Site 41BX1817, the Alamo Mills Dam has been partially capped by the construction of the new portion of the Riverwalk. In addition to the dam, the raceway wall that was found adjacent to the dam was also capped by the new construction. A portion of the center of the dam was removed to provide clearance for the passage of river barges (Figure 6-1). A small portion of the dam is visible on either bank and is marked by interpretive signage. CAR recommends that the feature continue to be preserved, and if future construction should occur in the area, impact to the feature should be avoided. The dam is potentially eligible for listing on the National Register of Historic Places (NRHP) and as a State Archeological Landmark (SAL).

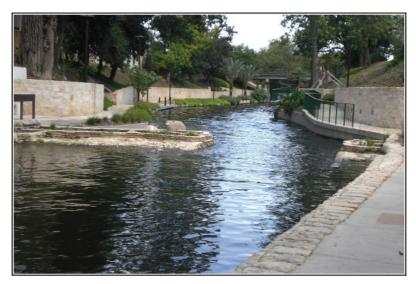
Figure 6-2. The Lexington Avenue Dam after the portion was removed to allow for river barges to pass to the newly improved section of the Riverwalk.

Site 41BX1818, the Lexington Avenue Dam, has also been recorded as a site as a result of the project. The dam has already been altered following coordination with the City of San Antonio and the THC. Approximately one-third of the dam has been removed to allow the passage of river barges to the newly improved section of the Riverwalk (Figure 6-2). The remaining two-thirds of the dam is visible to the public, and is marked by interpretive signage. CAR recommends that no additional segments of the dam be removed.
