# Archaeological Monitoring of the HEB-GSA Parking Lot: Impacts to the San Pedro Acequia

**Center for Archaeological Research**  
**The University of Texas at San Antonio**  
**Archaeological Survey Report, No. 279**  
**1998**

In October, 1997, the Center for Archaeological Research of The University of Texas at San Antonio monitored parking lot construction activities at the Federal Center (41BX622), part of the old United States Arsenal, in downtown San Antonio, Texas. The new parking lot, being constructed by H. E. Butt Grocery Company on land leased from the General Services Administration, will impact a section of the San Pedro Acequia which runs beneath an existing parking lot in the same location. The monitoring of these activities documented two sections of the acequia and corrected previous projections of the acequia's route. It is CAR's recommendation that the monitoring and documentation project has mitigated any adverse effects to the acequia.

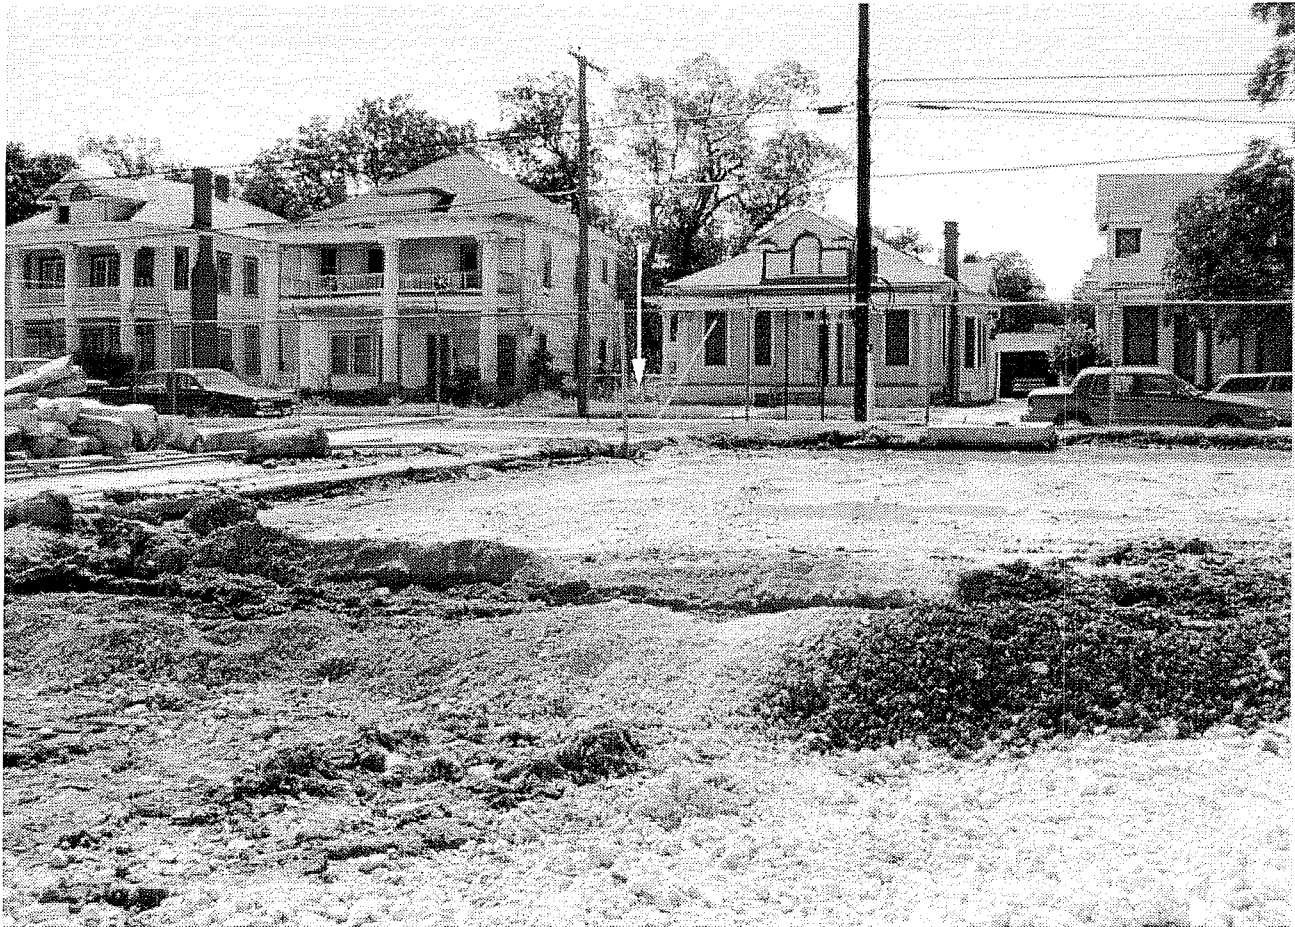
Figure 4. *Project area looking south toward Arsenal Street.* The path of the acequia across Arsenal is marked with the white arrow.

This monitoring of the San Pedro Acequia has served the purpose of further documenting the nature of the construction and course of the channel beyond the known path in this area (Figure 4) and the section excavated farther to the south at the site of the 1981 study (Frkuska 1981). The section observed during this monitoring is probably the result of the construction of 1881 to straighten the acequia as recommended by the Ditch Commissioner to the City Council (CCM, E:311). CAR recommends that the monitoring-level investigations have mitigated the impacts to the acequia. Since all further work for this project is to be surface in nature, no further archaeological investigations are recommended at this time. However, should future work be undertaken in further developments additional monitoring should be considered.
