# Archaeological Testing Within the Southeast Corner of the Plaza at Mission Espada, San Antonio, Bexar County, Texas

**Center for Archaeological Research  
The University of Texas at San Antonio  
Archaeological Survey Report, No. 208**

Texas Antiquities Committee Permit No. 935

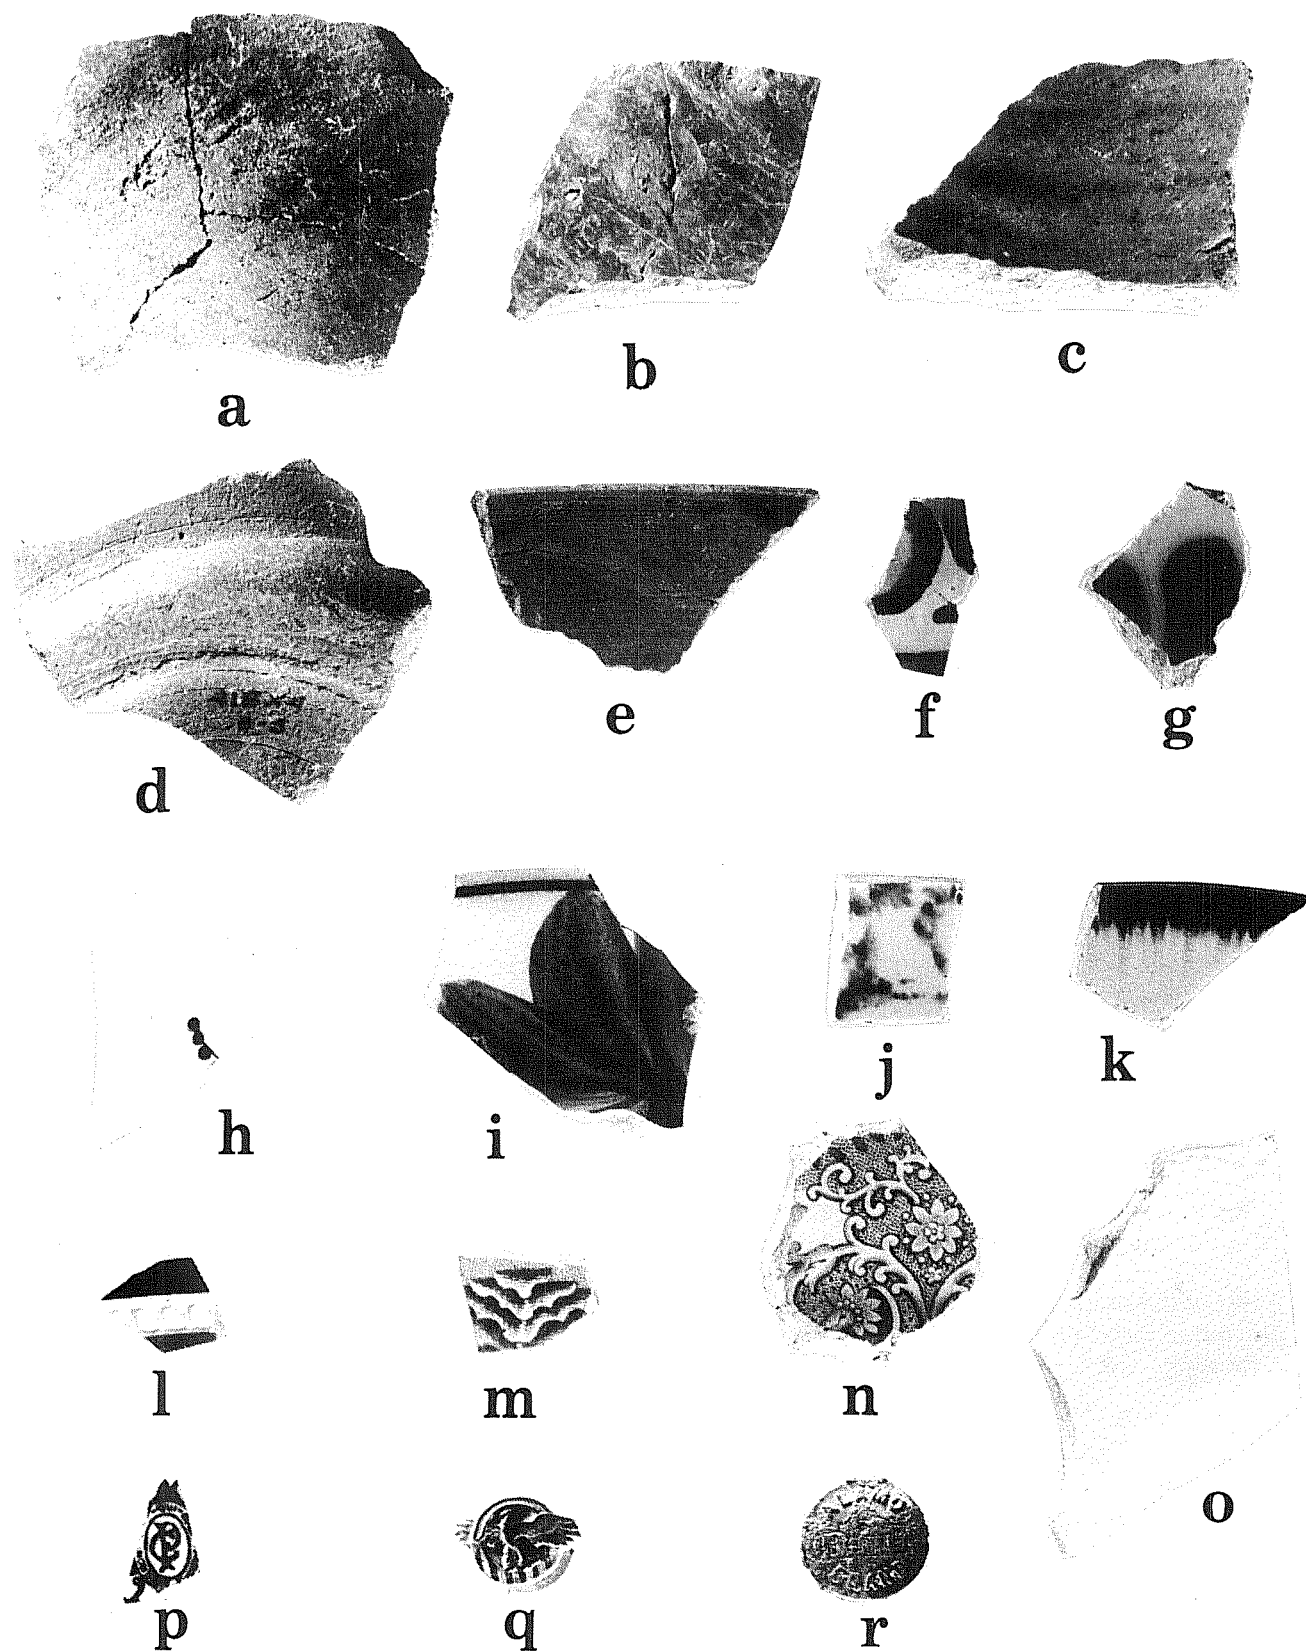
Figure 10. *Sample of Artifacts Recovered.* a, *Goliad*; b, *Goliad* (possibly kiln-fired); c, d, lead glazed (sandy paste); e, lead glazed (green edged); f, *San Diego Polychrome*; g, *Guanajuato*; h, i, hand painted; j, cut sponge ware; k, edge ware; l, banded slip; m, n, transfer ware; o, whiteware; p, backstamp; q, "ruptured duck" World War II military discharge lapel button; r, Alamo Brand button.

#### **Type 3. Cut Sponge (16 specimens; Fig. 10j)**

Other personal items found at Espada include a contemporary watchband fragment from Level 1 of Unit 1 and gold-colored lapel insignia with an eagle found in Unit 2, Level 1. This item, referred to as a "ruptured duck," was issued to honorably discharged World War II veterans (Fig. 10q).
