# Mission San Jose Repointing and Underpinning Project, San Antonio, Texas

**Mission San José  
Repointing and Underpinning Project,  
San Antonio, Texas**

Center for Archaeological Research  
The University of Texas at San Antonio  
Archaeological Survey Report, No. 294

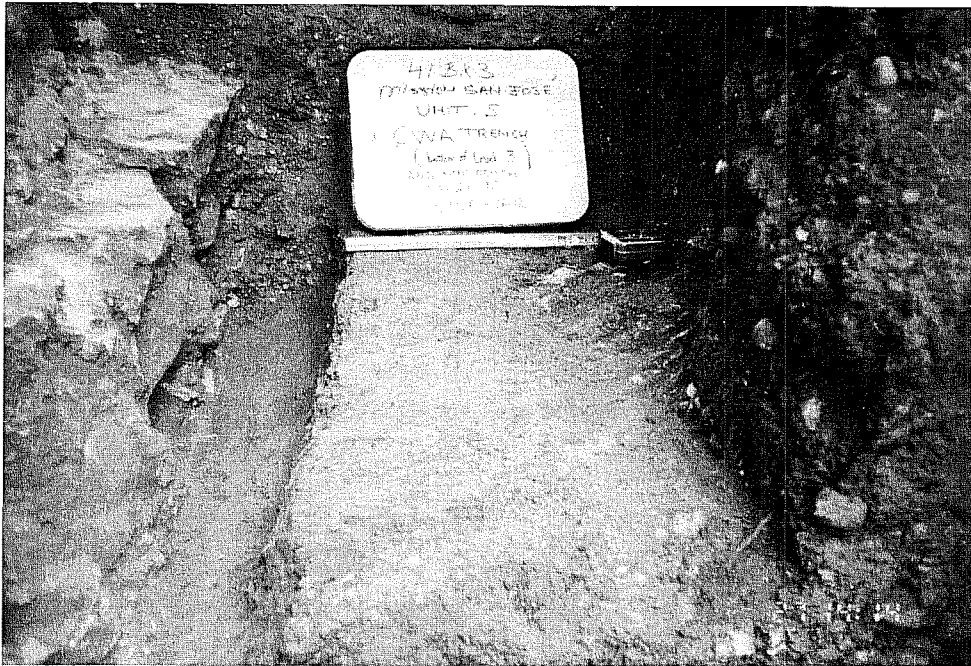
Figure 4. *Outline of the exterior CWA trench.* Note depth and width away from wall base.

To correspond to the drawings in the 1976 report by Roberson and Medlin, measurements during the field work were done in inches and feet. Previous excavations at Mission San José (Tomka and Fox 1998; Tomka and Fox 1999) have established that the heaviest degree of disturbance reaches from surface to a depth of approximately 12 inches. Deposits are less and less disturbed with increasing depth, and the least disturbed colonial materials occur on top of and slightly into the black clay layer that underlies the site. This clay zone begins at a depth of between 22-24 inches bs. This generalized stratigraphy is violated adjacent the interior and exterior bases of the wall. Here, CWA efforts to locate the top of the colonial foundation resulted in trenches paralleling the wall and reaching a depth of between 21-29 inches (Figure 4). The outline of the trench is more notable along the exterior than the interior of the wallbase. The base of the trench could be identified only in one interior unit, Unit 10. In units where the bottom of the CWA trench reached a depth of at least 22 inches bs, intact colonial deposits are no longer present. In the exterior units, the width of the trench ranges from 12-18 inches and often signals the fact that in the excavation units found immediately against the base of the wall, between one-third to one-half of the deposits are

Our excavations in the units immediately paralleling the south wall confirm findings from previous work at Mission San José indicating that CWA efforts to trace the colonial foundation involved the excavation of trenches paralleling the outside and inside walls of the Indian Quarters. The outline of this trench is clearly visible in the excavation units dug immediately next to the south wall of the mission (Units 1–5, and 16). In these units, the trench reached to a depth of between 21–29 inches (Figure 4) heavily disturbing all overlying archaeological deposits. The width of the trench ranges from 12–18 inches resulting in mixed deposits in the northern one-third to one-half of each of the units against the base of the wall.

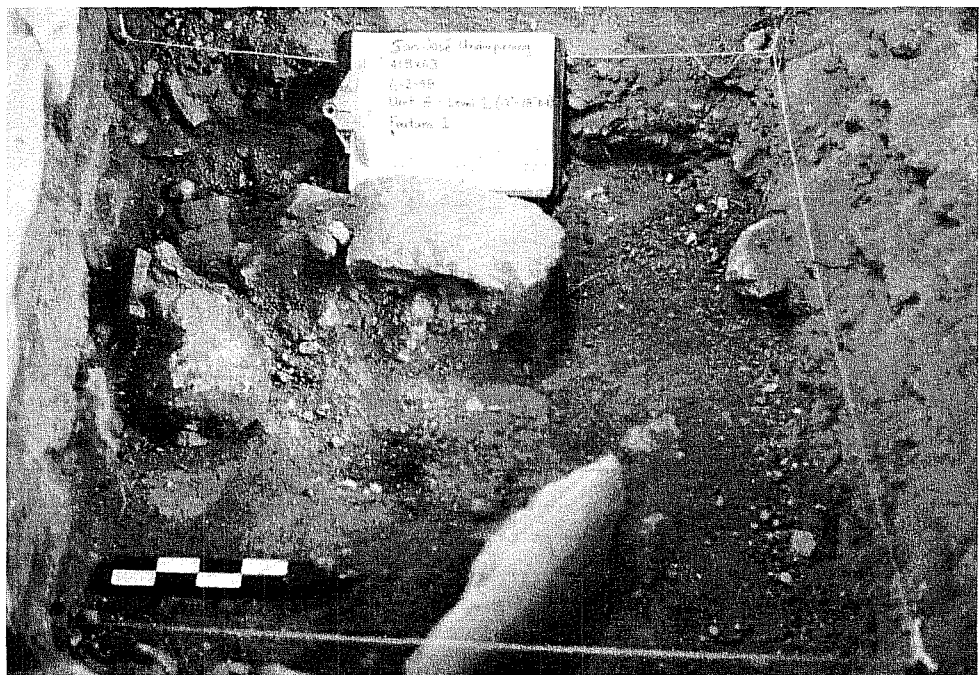
Figure 8. Feature 1, foot support rocks used to stabilize CWA construction scaffolding along inside of Indian Quarters south wall.

cluster of limestone and sandstone cobbles arranged in a circular pattern (Figure 8). One of the larger tabular pieces was set on its edge (see Figure 8, foreground). The soil within this circular cluster was somewhat lighter than the surrounding matrix. A three-inch diameter circular darker stain could be seen in the center of the area. Subsequent excavation showed the hole to be only two inches deep. Based in part on its location within a disturbed context, examinations of historic photographs showing the CWA construction of the mission walls, and the morphology of the feature, it was decided that the feature may have represented the shorings for one of the feet of the scaffoldings erected along the wall.

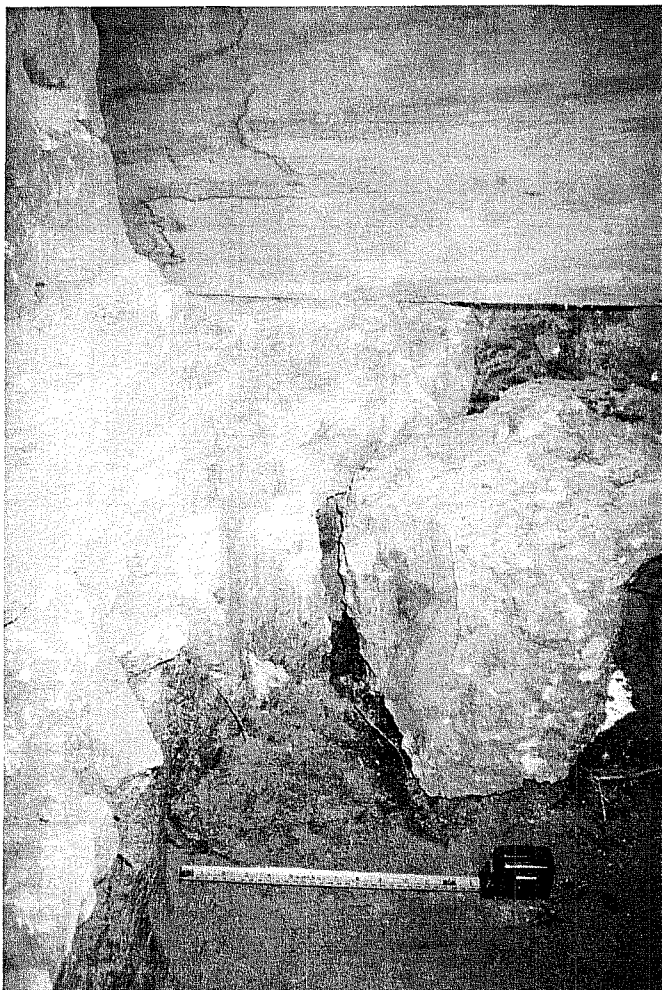
Figure 10. Concrete footing for former gate post at southwest corner of southeast gate.

In addition to the CWA trench, a second feature was also encountered in Unit 16 along the outside of the south wall adjacent the southwest corner of the gate. This feature consisted of a concrete footing for a rectangular 4"-x-4" post (Figure 10). The 4"-x-4" post mold was still visible in the center of the block, al-

though remains of the wooden post were not present. The footing measured approximately 28 inches in outside diameter at the top and was found at a depth of 29 inches bs. To expose the southwest corner of the gate the construction contractor and CAR employees excavated the area immediately between Unit 16 and Unit 6, excavated by CAR in 1993 (see Figure 3, and Hard et al. 1995: Figure 12). Since only about a 12-inch wide area remained intact between the edge of the 1993 unit and the base of the mission wall and the removal of the upper 12 inches indicated heavy construction-related disturbance, the area was not excavated using archaeological methods. The excavations revealed that a large pit was initially dug to house the concrete footing of the post and that this pit was partially filled with concrete and sandstone rubble to reduce its size before the actual post was placed in the pit. The nature of the post and its location suggest that it may have supported a gate placed in the outside of the entryway rather than on the inside as is the case
